# Fire in House—Investigation of the Outbreak and Spread of The Fire in A Countryside House

**Abstract:** Fires in houses are inevitable and they cause loss of life and major repair costs for the damage structure and contents. There is a clear need to prevent its ignition and spread to adjacent areas. This article presents the steps taken, namely: contacts, data collection, tests, analysis and conclusions regarding the accident resulting from the outbreak and spread of a fire, on December 25, 2020, in a traditional Portuguese house in Arganil, Portugal. The owners and the court requested to carry out an expert opinion by a person with specialized technical-scientific knowledge, which led to this work as an expert. The work consists of carrying out observations and data analysis. Then, the observed and analysed data were laboratory tested in order to consistently identify characteristics that lead to the ignition and propagation of the fire. This work identified construction problems, materials used and heat sources that are responsible for the accident. The conclusions may be used to avoid future incidents or accidents with houses of same construction type.

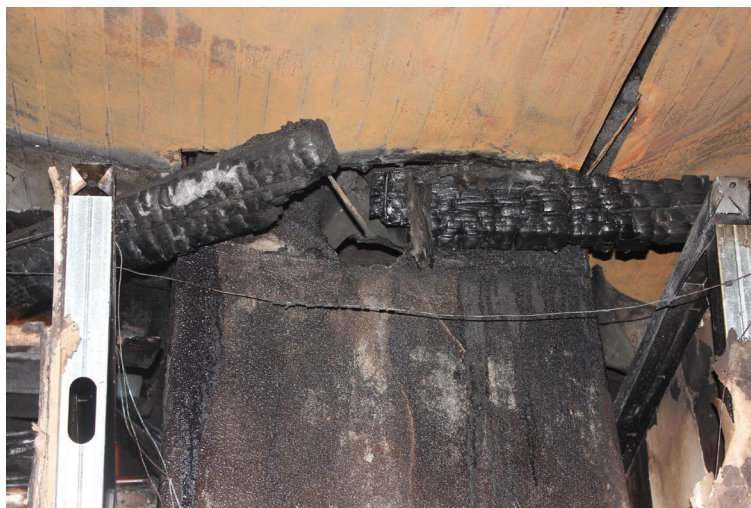
**Figure 1.** Image of the chimney of the fireplace structure and the ceiling of the house.

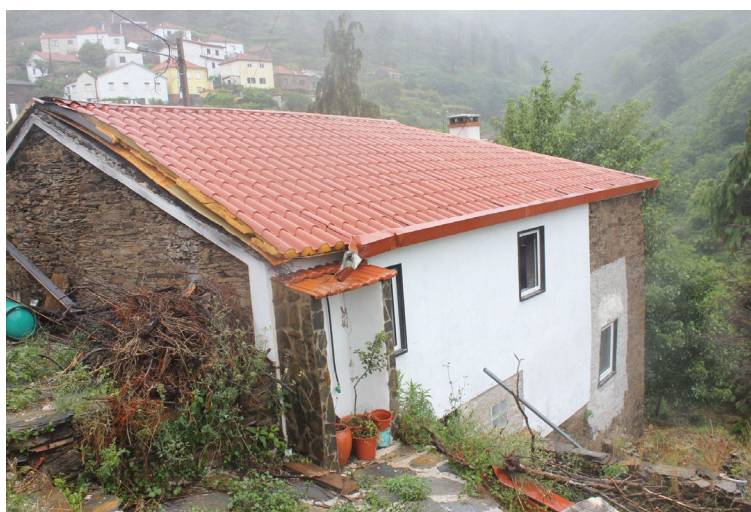
**Figure 2.** Location where the gas cylinders were removed.

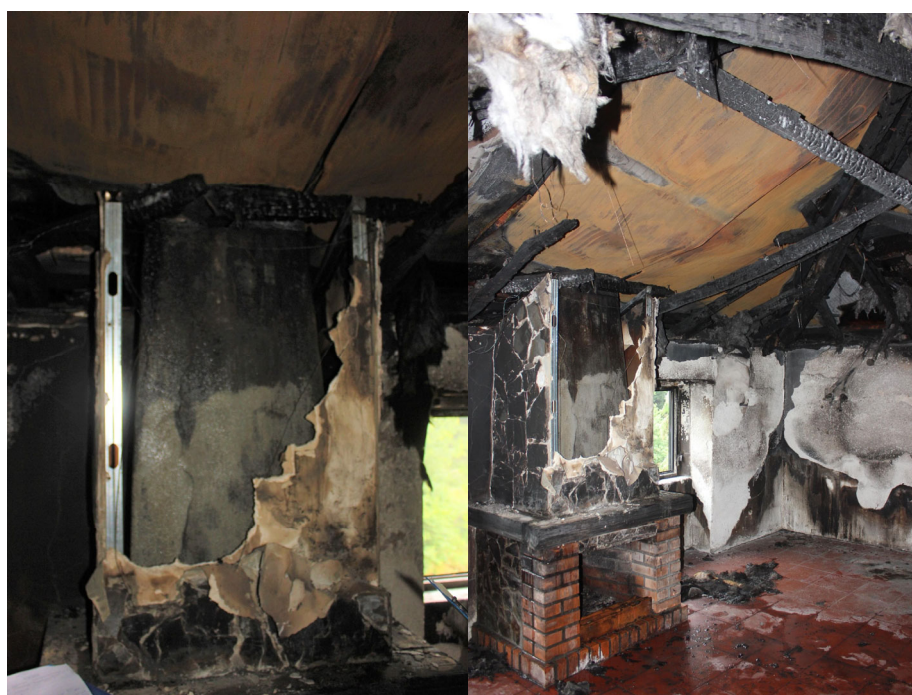
Based on this study, with the elements collected and analysis of the data collected, we consider that the ignition occurred next to the fireplace, which was turned on and burning with woody material, with the wooden beam inside the fireplace and with the false ceiling covered with wood, as shown in Figure 3.

**Figure 3.** plasterboard wall, covered with stone, and a wooden ceiling encompassing a beam inside the fireplace, without ventilation.

The cause of the ignition appears to be directly linked to the insertion of the wooden beam into the chimney structure (with dimensions of 11cm x 5cm), where it came into contact with the hot combustion gases, with temperatures exceeding 600°C. Wood, as it is a natural polymer, when subjected to fire, undergoes depolymerization and carbonization, altering its mechanical properties, depending on the temperature reached and the time of exposure to the heat to which it was subjected. The following table shows the changes that we can observe with increasing temperature in wood.

Shafler (1973) says that woody materials undergo pyrolysis at temperatures in the order of ~300°C. Therefore, this practice of embedding the beams, or the carelessness of not removing them, during the reconstruction, seems to be a serious failure (either of these two actions) that will certainly have led to the outcome of the fire. We also remember that an additional barrier to the release of heat was created, with the outer layer built around the chimney, which would have promoted the accumulation of heat near the lining and wooden beams, as there was rock wool insulation at the top. mineral. Commonly known as sandwich panels were placed on the roof, thin metal sheets with highly combustible polymeric material inside, which would have promoted the rapid spread of the fire across the roof (Figures 4–6)

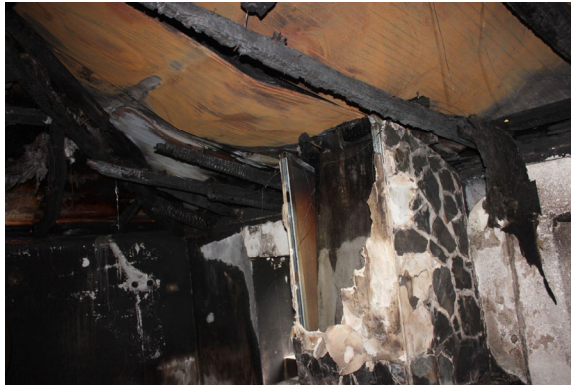
**Figure 4.** Place next to the fireplace where the lining, mineral wool and sandwich panel filling were completely consumed, in the living room.

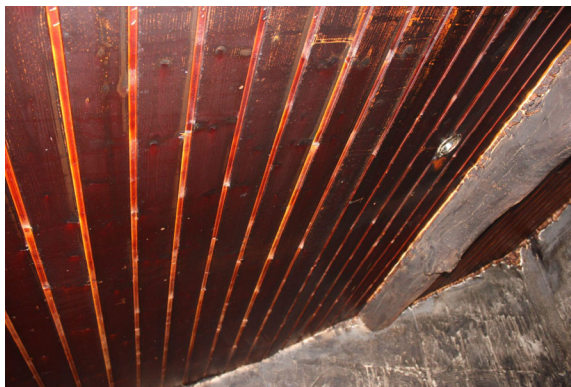
**Figure 5.** Location of the house where the ceiling was not consumed by fire.

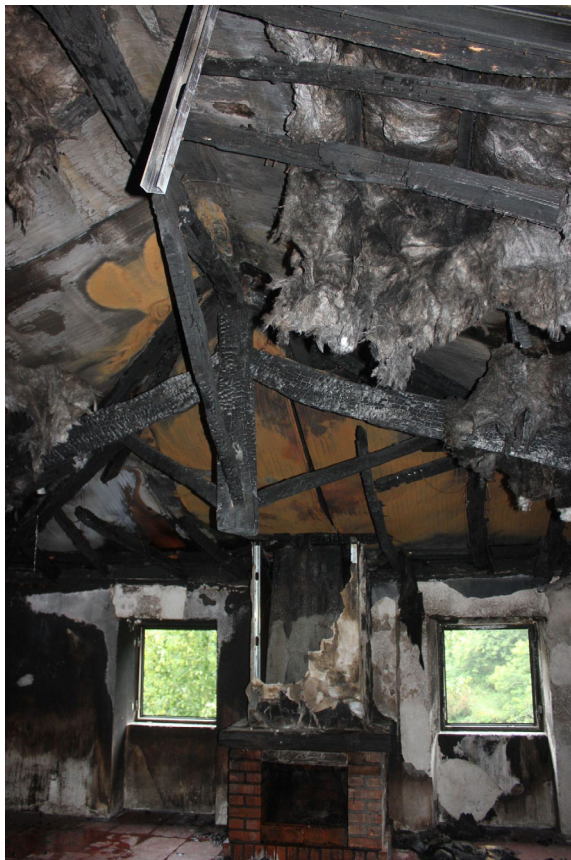
**Figure 6.** Spread through the living room ceiling, completely destroyed.

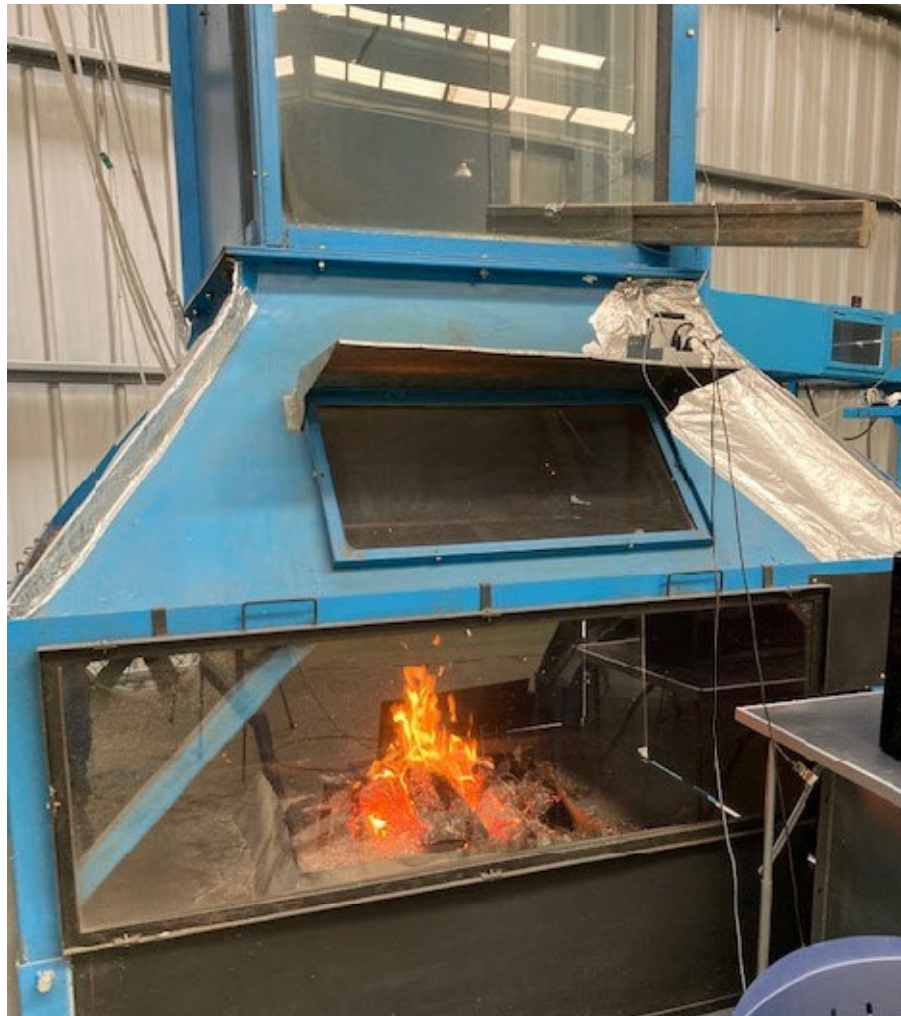
**Figure 7.** Vertical combustion tunnel, with wooden beam during the test.

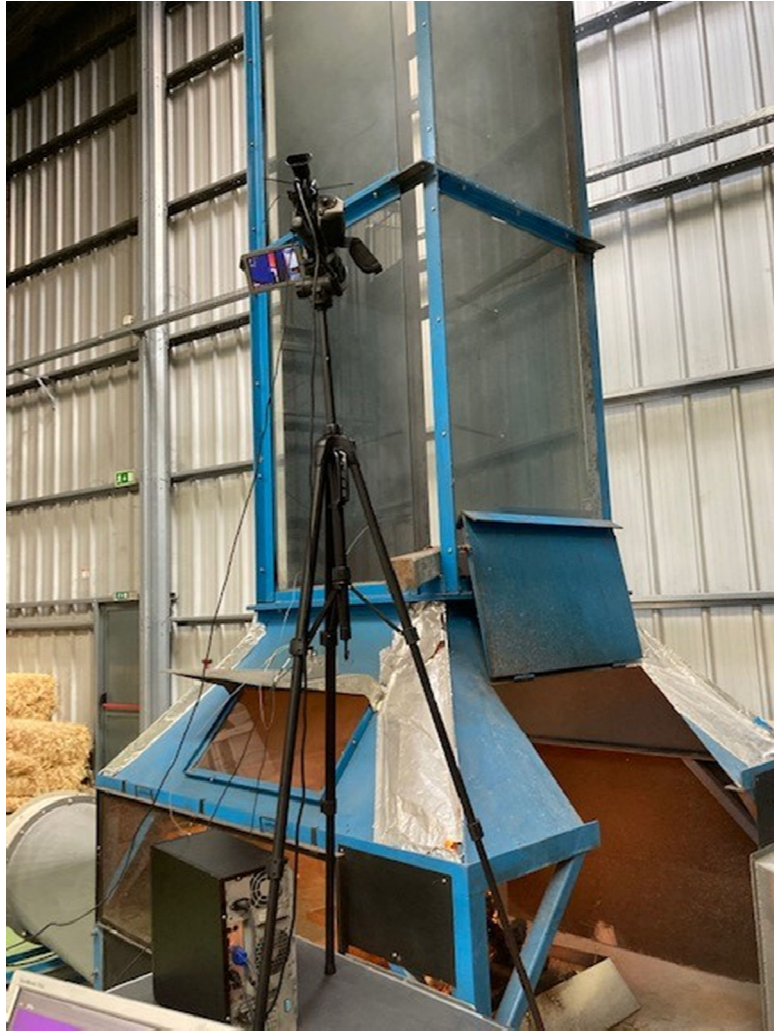
**Figure 8.** General image of the test with the infrared camera.

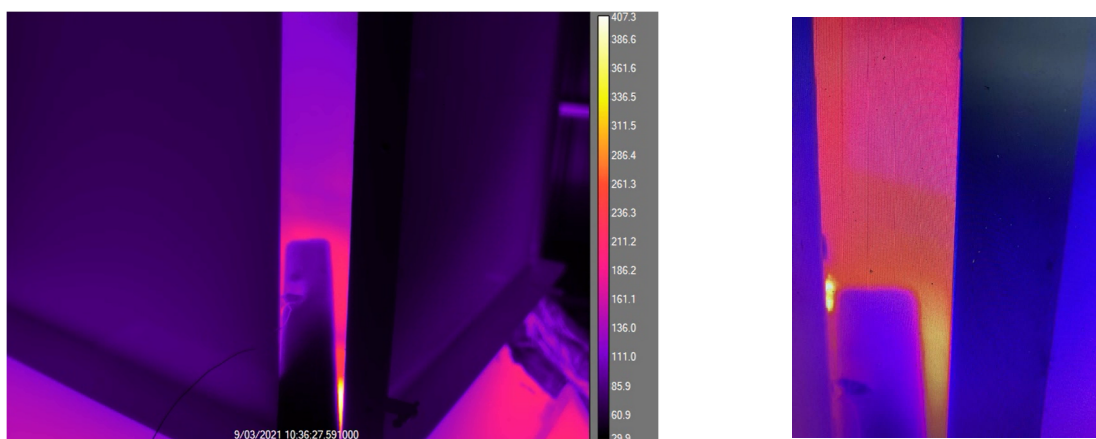
The recording of temperatures made it possible to identify that temperatures exceeding  $360^{\circ}\text{C}$  were reached in the wooden beam, as can be seen in the following figures, in the yellow areas, figure 9.

**Figure 9.** Thermal images from the infrared camera with the beam under test (general view and detail of the beam).

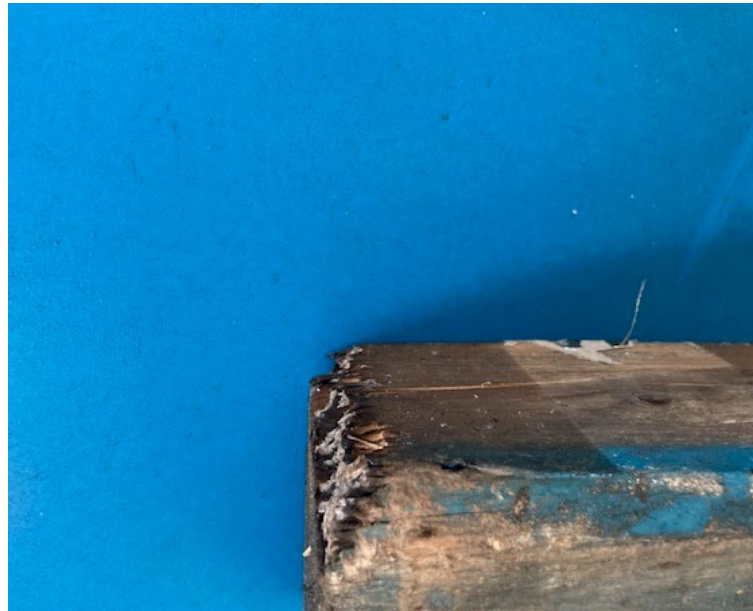
After carrying out the test, which lasted around 40 minutes, the beam was analyzed and photographed, so clearly burned areas could be seen that had combusted, despite not having had contact with the flames and only with the gases. hot, as in the case of the chimney figure 10.

**Figure 10.** Image with wooden beam with evident pyrolysis and carbonization zone.

After carrying out this test and its analysis, it was verified that it was possible for the beam to start the combustion process, that is, in the chimney there were conditions to start a fire. Additionally, in the house we had the continuity of fuels, through the wooden lining on the ceiling, the electrical cables and the sandwich panels on the building's roof, as well as the chimney lining with the plasterboard support structure and stones, with connection to the wooden structure.
