Comprehensive Technical Inspection of a Medieval Bridge (Ponte de Vilanova, in Allariz) Using Microtechnological Tools

Abstract: Ponte de Vilanova, a masonry bridge, was built in Allariz, Galicia, in the 13th-14th centuries. It is still standing. The structure, generally well-preserved, shows minor deformations and wear signs caused by environmental factors. To conduct a comprehensive assessment without impacting the bridge's integrity, drones with thermal and underwater imaging technology were employed. Aerial inspections revealed vegetation growth and minor efflorescence (salt deposits) in some areas, while aerial thermography detected temperature variations along the stone joints, indicating moisture presence. The granite blocks comprising the bridge showed consistent quality and preservation. The underwater inspection confirmed that the bridge's piers are well-set on the riverbed, with no major damage observed, ruling out immediate repair needs. This approach allowed a thorough evaluation of submerged parts without requiring divers, enhancing safety and reducing costs.

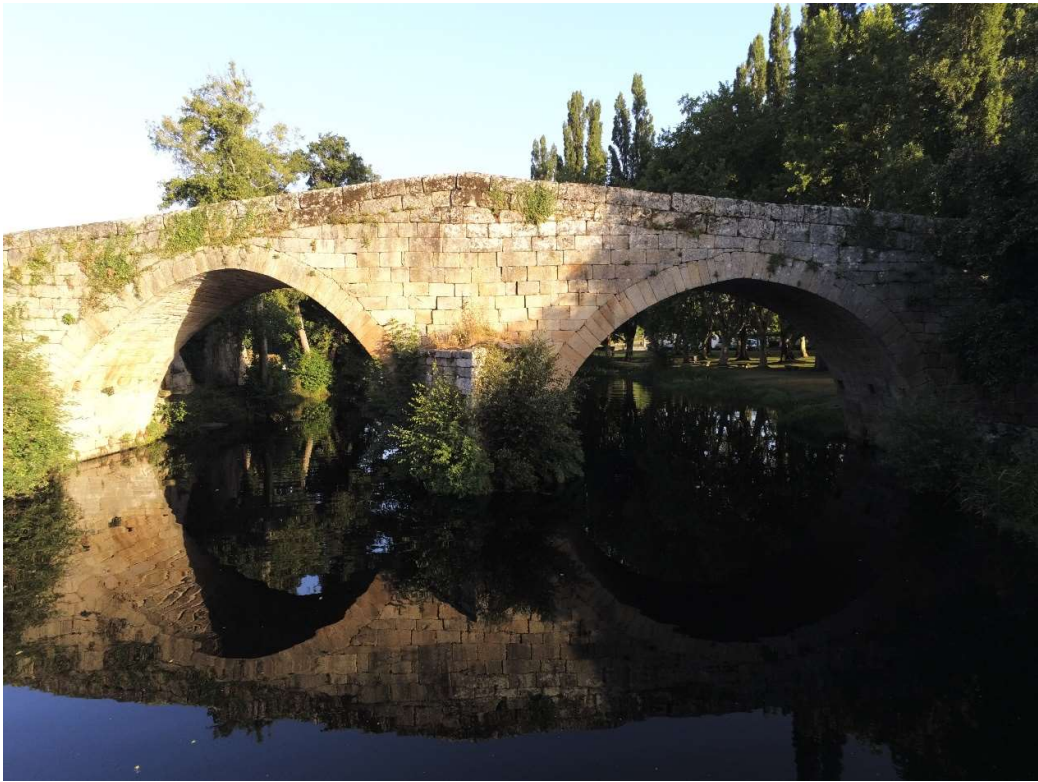
Figure 3. General view of the upstream elevation of the Vilanova Bridge, in an image captured by a quadcopter drone (photo by the author).

The bridge is in good condition. However, a slight deformation can be seen in its arches. This deformation is particularly noticeable in the ashlars of the central area of the upstream wall (Figure 3) and in the ashlars of the downstream cutwater.

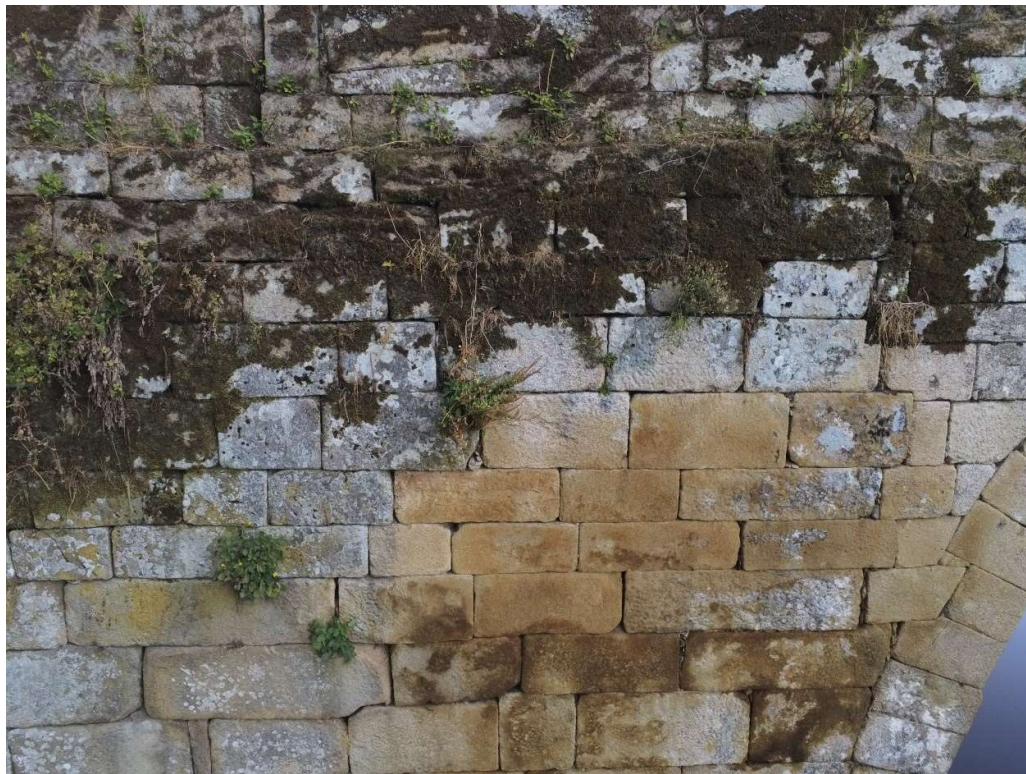
Along with these crusts, there is an abundant presence of biocolonies (plants), which have grown by taking root in the joints between the ashlar, especially in the joints of angular points, which enter into feedback with the phenomena of humidity, efflorescence and runoff water, as reflected in certain observed stains (Figure 9).

Figure 9. View of the external spandrell wall, in a photographic image taken with the drone, where we can see the abundant presence of vegetation and degradation of the stone (photograph by the author).

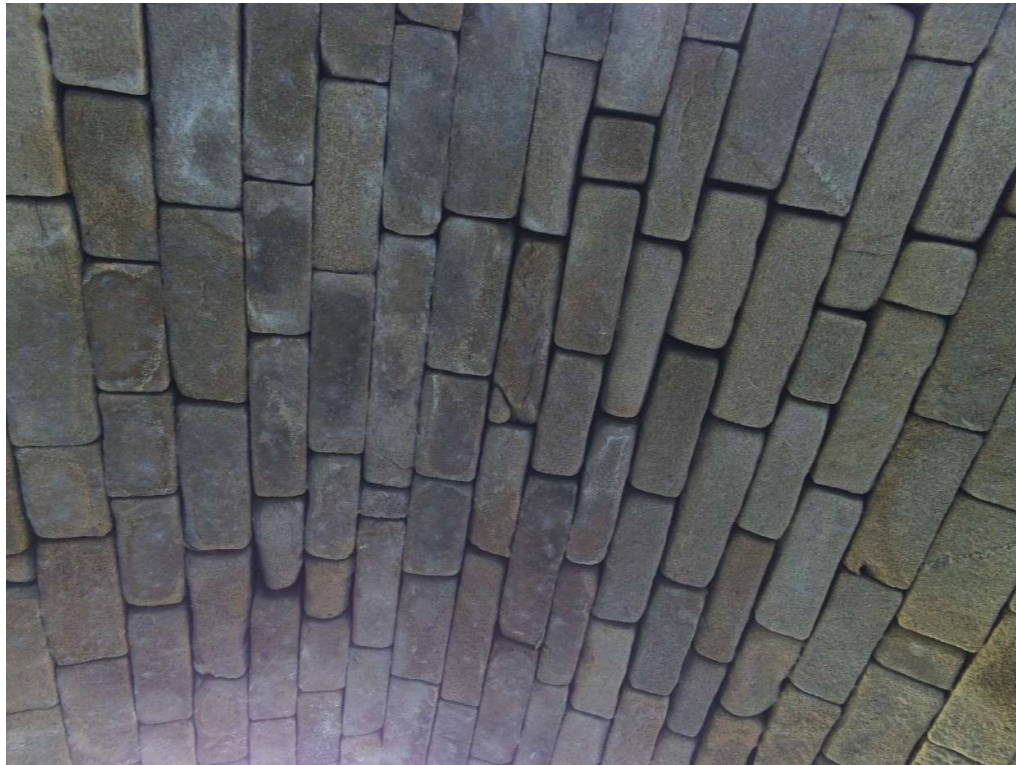
The inspection allowed us to verify the existence of small efflorescences, although in a very slight proportion: such lesions were observed on the intrados of the vaults (Figure 10) and on the elevation of the abutment (Figure 9). Efflorescence and cryptoefflorescence are usually concentrated around areas where there is a high concentration of humidity [25]. Vilanova Bridge is a river bridge; therefore, it is evident that it is in a location where humidity is high.

Figure 10. View of the intrados of the first vault, in a photographic image taken with the drone (photograph by the author).

Also linked to humidity would be the slight proliferation of efflorescence that was diagnosed during the visual inspection carried out months ago on the intrados of the vaults (Figure 10). Efflorescences are indeed usually seen around areas where there is a high concentration of humidity. However, it should be noted that the externalization of the efflorescences is not recorded on the thermogram (Figure 16).

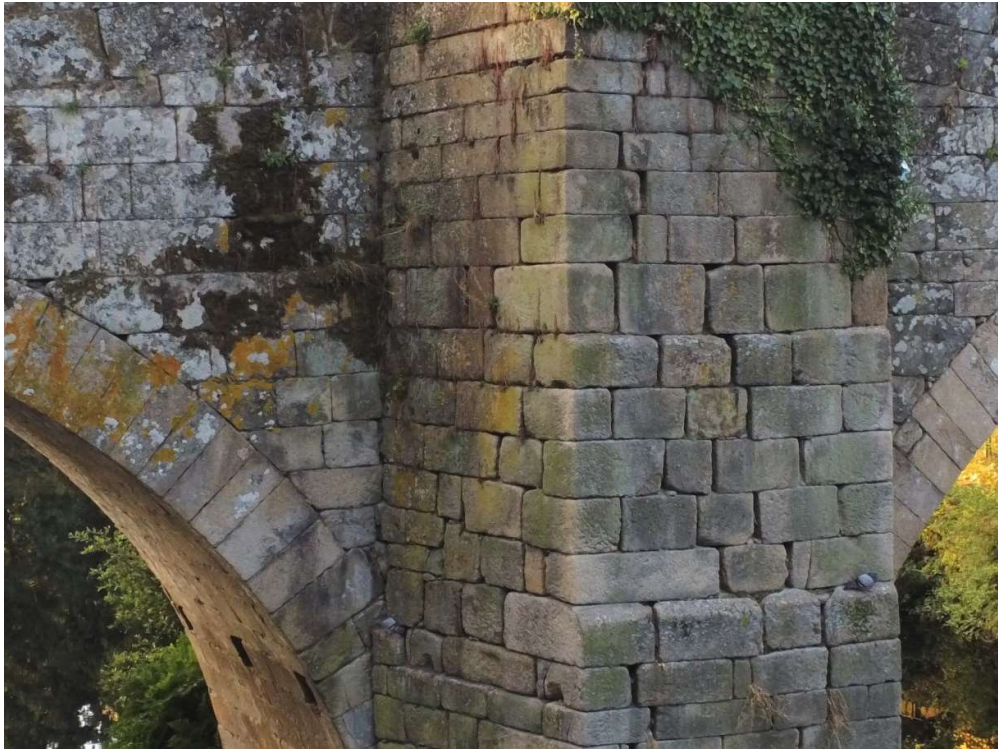
The drone also allowed us to appreciate in detail the separation between the exterior ashlars of the cutwater (Figure 11), , downstream of the bridge, and at the spandrell wall (Figure 12), upstream of the bridge. Looking at this closely allowed us to see that our suspicions were well founded.

Figure 11. Partial view of the cutwater that rises to the road, downstream of the bridge, where the separation between some ashlars can be seen in an image captured with the drone (photograph by the author).

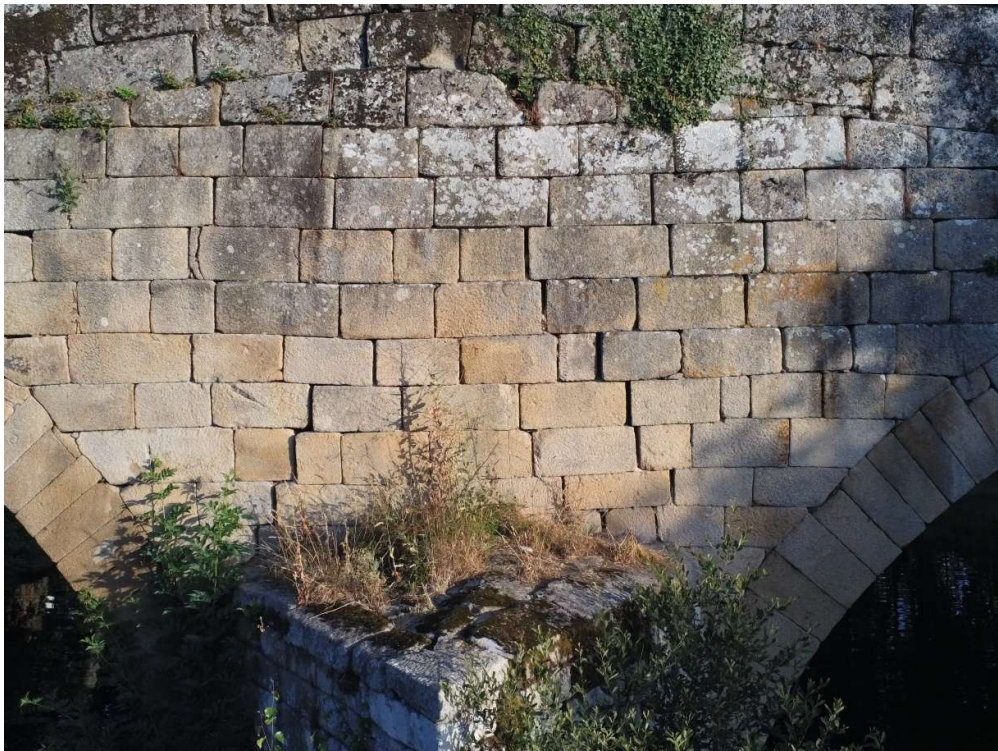
Figure 12. View of the central area of the spandrel wall, upstream of the bridge just above the starling, where the separation between some ashlars can be seen, in an image captured with the drone (photograph by the author).

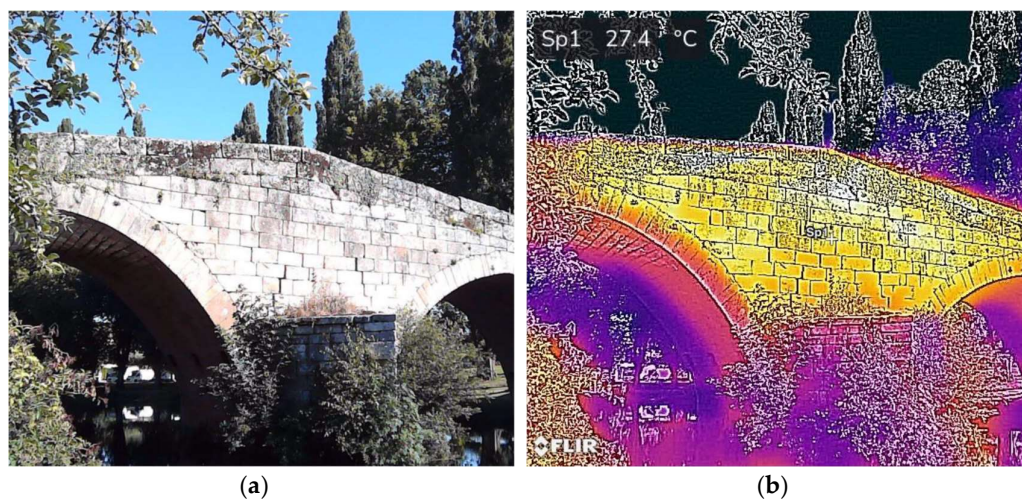
Accordingly, the reconnaissance operation was carried out at dawn on a summer day. As a result, we were able to capture, among others, a thermogram with the downstream elevation of the bridge (Figure 13), and several details of the abutment walls (Figure 14 and Figure 15), which were the accessible points on which a capture of the surface to be analyzed could be made with a viewing angle of between 70° and 90° with respect to it.

Figure 13. General view of the upstream elevation of the Vilanova Bridge: (a) image captured by a camera; (b) thermogram on the left photograph (photographs by the author).

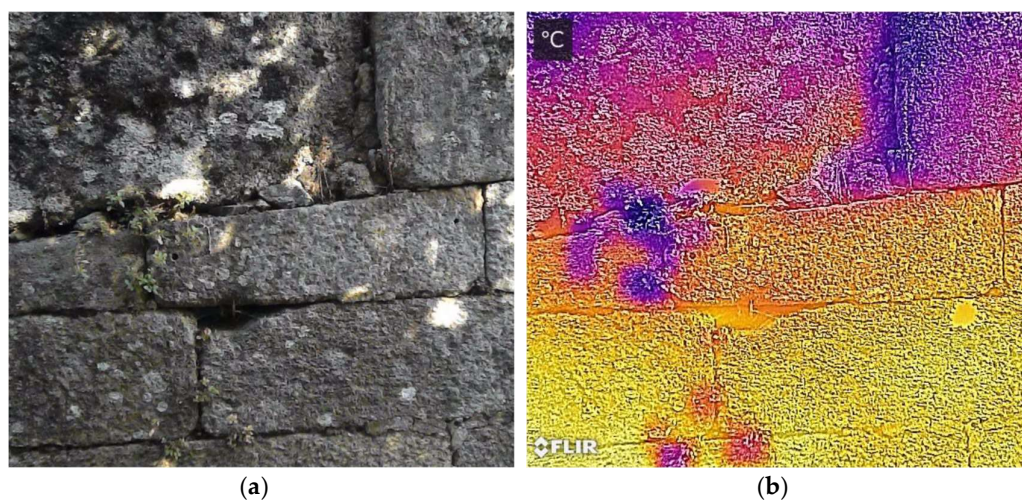
Figure 14. Detail of the southeast abutment wall of the Bridge: (a) image captured by a camera, where different ashlars can be seen; (b) thermogram on the same photograph (photographs by the author).

The first conclusion is obvious: the presence of organic matter and vegetation constitutes the main anomaly observed in the thermograms obtained by terrestrial thermography. The points where the lowest temperatures are recorded correspond to vegetation.

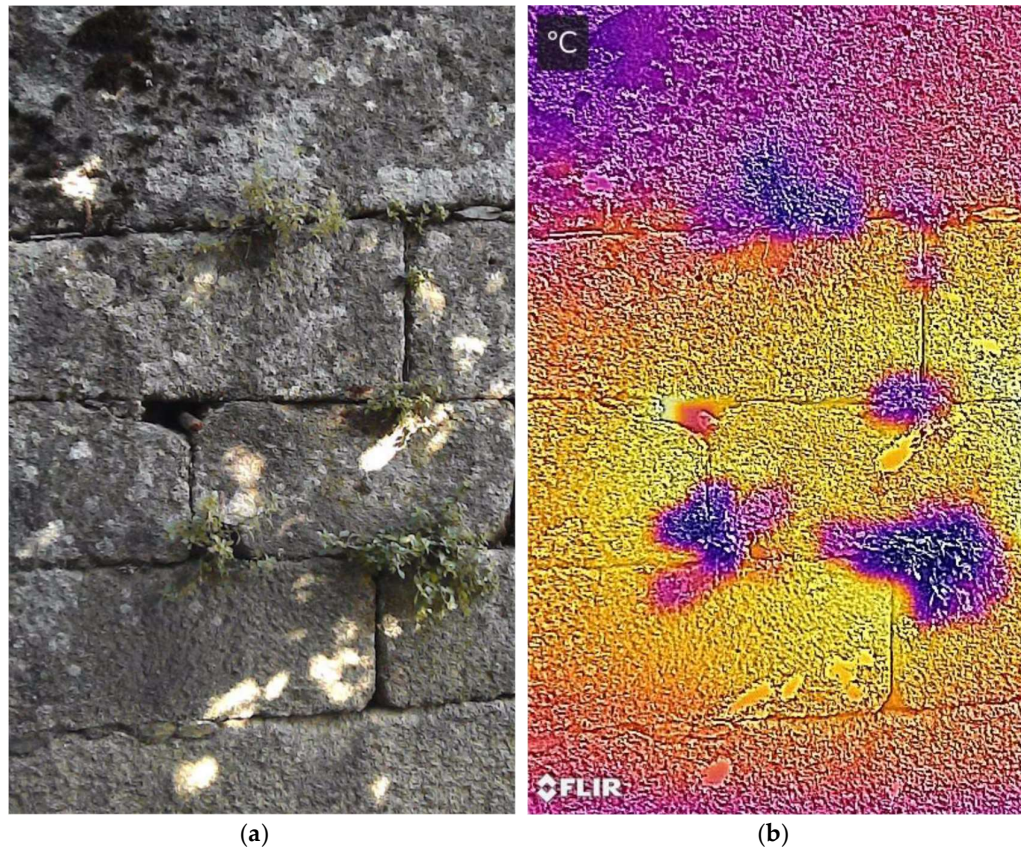
Figure 15. Detail of the southwest abutment wall of the Bridge: (a) image captured by a camera, where different ashlars can be seen; (b) thermogram on the same photograph (photographs by the author).

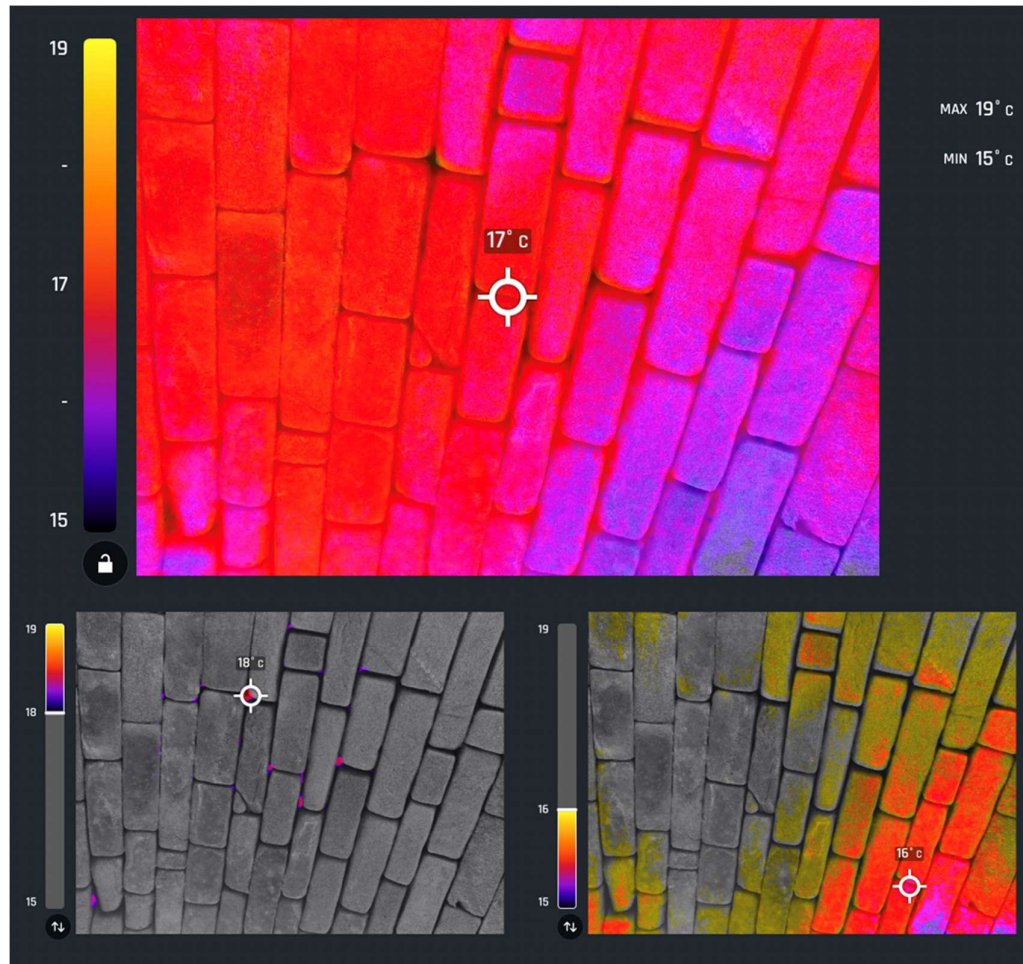
Thermograms of the interior of the vaults revealed an observation (Figure 16): independently of the previous observation of possible efflorescence (Figure 9 and Figure 10), the maximum temperature values are recorded in the joints between the voussoirs or ashlars (especially in the larger cavities), while the minimum values are recorded on the most exposed external face of the vault. The cause is related to humidity.

Figure 16. Thermograms of the intrados of the vault, marking the points of maximum temperature (bottom left) and the points of minimum temperature (bottom right).

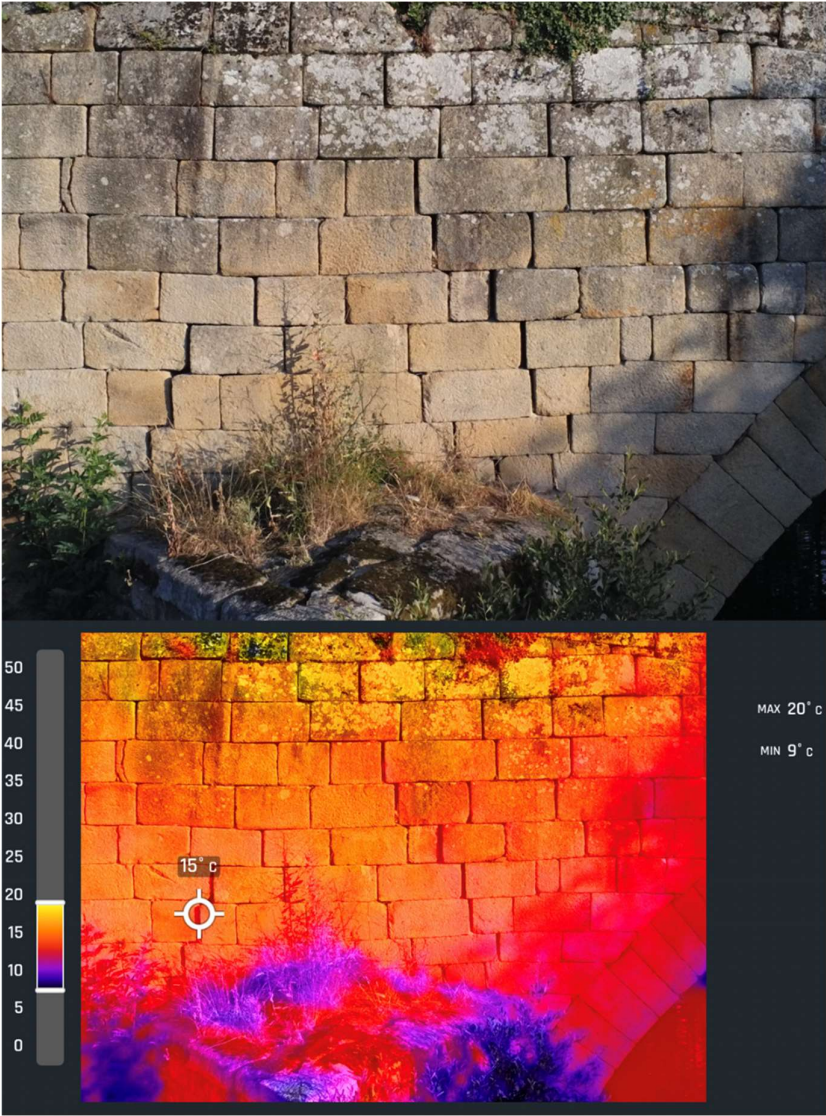
The most interesting aspect of the aerial thermographic inspection was the detailed analysis of the areas of each elevation where the movements between ashlar were recorded (Figure 17 and Figure 18). The analysis led to the conclusion that these separations did not show any alterations in the thermograms, and therefore did not constitute any risk for durability. Indeed, the temperature did not show any alteration in the cavities produced by the displacement of the ashlar.

Figure 17. Photograph (upper figure) and thermogram (lower figure) of the central area of the spandrel wall, upstream of the bridge just above the starling (photograph by the author).

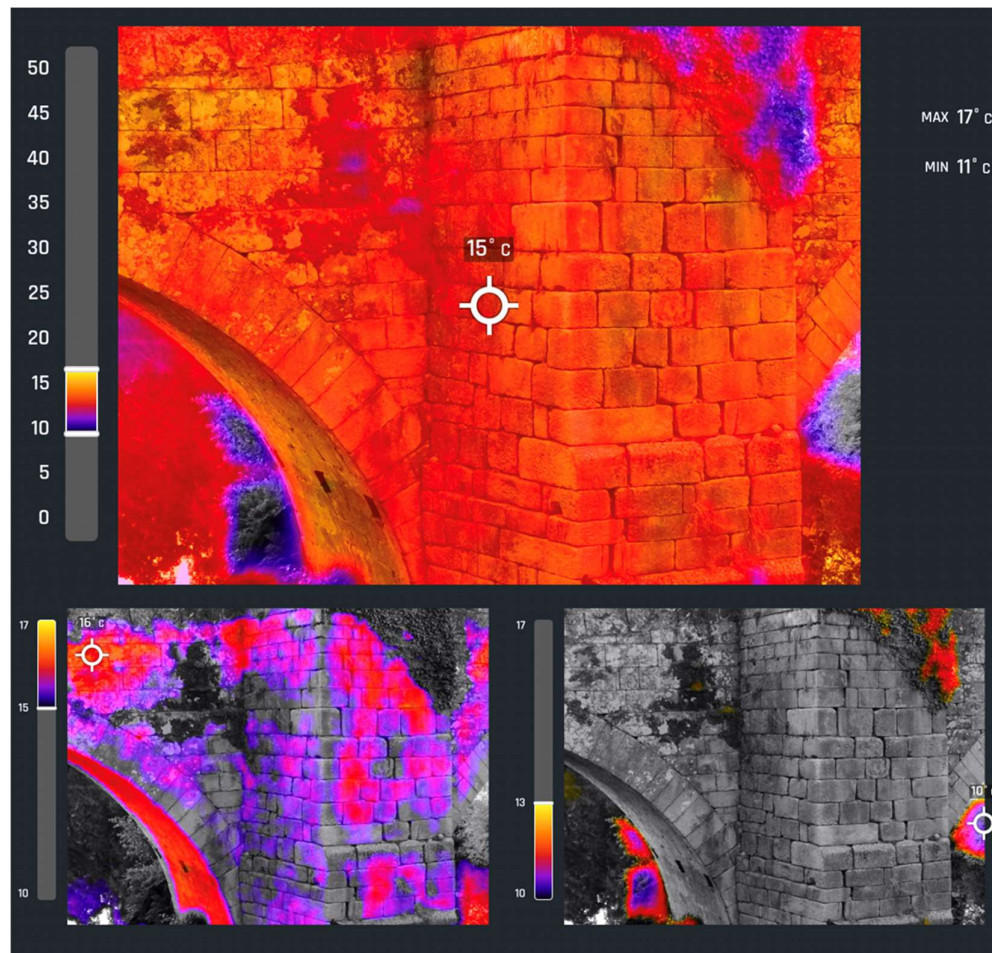
Figure 18. Thermograms of the cutwater downstream of the bridge, marking the points of maximum temperature (bottom left) and the points of minimum temperature (bottom right) to study the separation between some ashlars (photographs by the author).

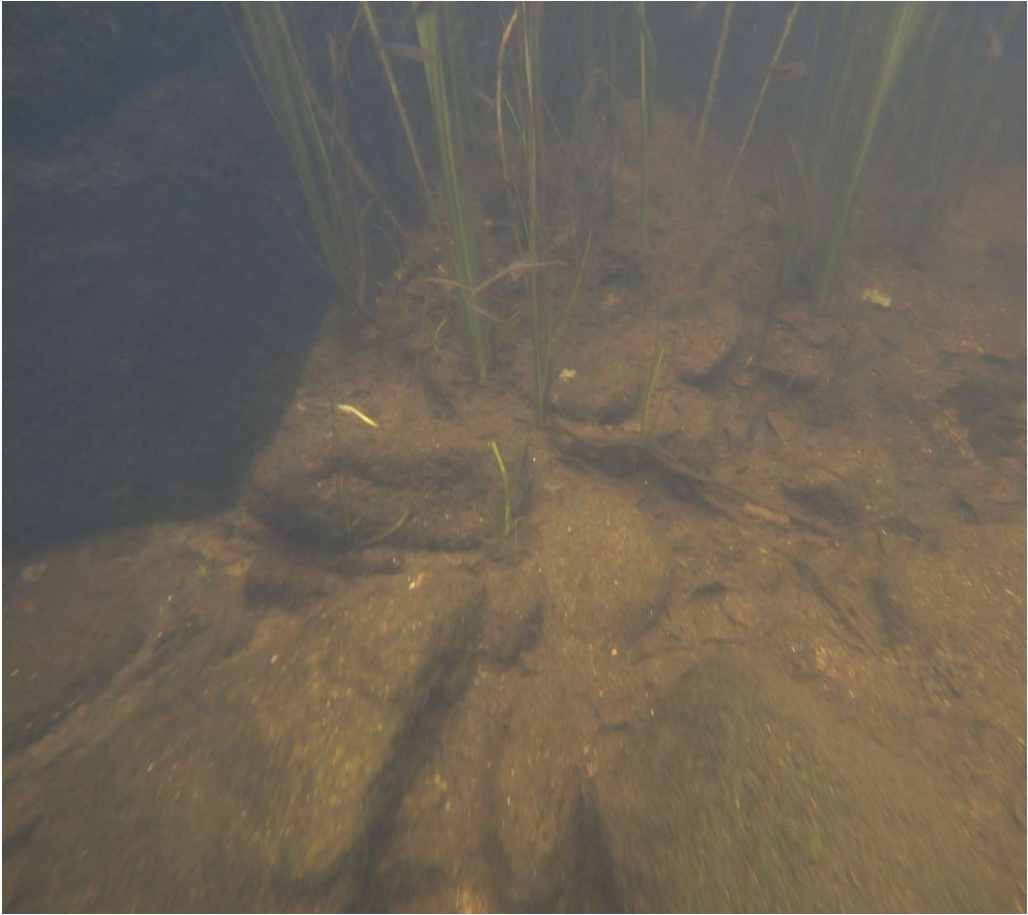
The bed level was practically uniform, with no pits, deposits or any other irregularities that could be caused by the action of water currents on the piers.

Figure 19. Underwater drone images showing: (a) the riverbed around the pier; (b) the status of a fragment of the lower part of the pier; (c) another fragment of the lower part of the element inspected (photos by the author).

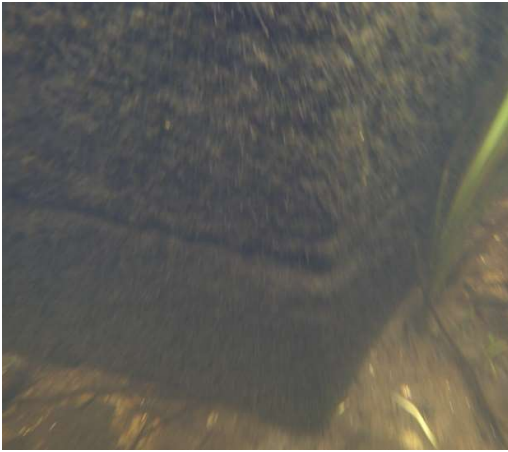
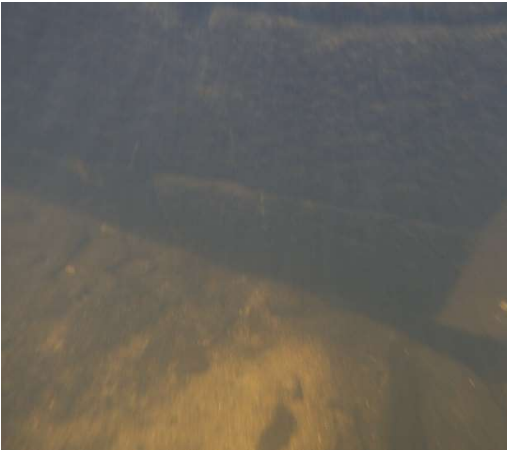
Through the inspection of the submerged parts with the underwater drone, it was possible to verify the adequate state of the elements that are under the water sheet: the absence of any granite ashlar was not observed, and the granite constituting the submerged ashlar was in an adequate state of conservation (Figure 19 (b) and (c)).
