# Risks Associated with Subsidence-Collapse of Sinkholes. A Case Study in the Town of Alcalá de Ebro (Zaragoza, Spain)

[Alberto Gracia](#)\*, [Francisco Javier Torrijo](#), Alberto Garcia, Alberto Boix

Keywords: collapse hazard; sinkhole mitigation; gypsum karst; Alcalá de Ebro; injections; geogrid; evaporitic rocks; topographic auscultation; results obtained

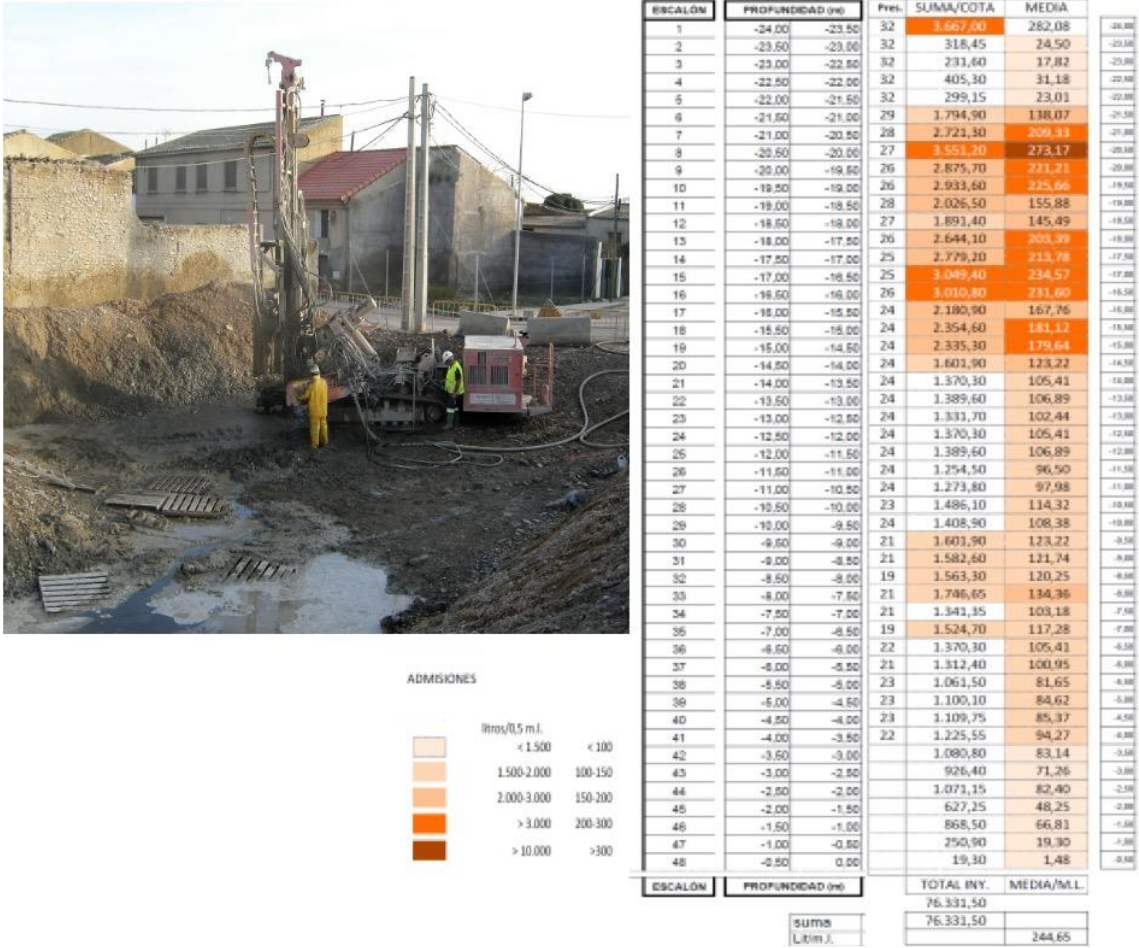
- In this row 2, overconsumptions were also recorded in injections 15 and 18 with more than 700 litres/m.l. less than 2-3 meters from the surface. Although they do not constitute volumes that involve large voids, they can be related to fissures that connect them in depth. The same could be interpreted in the case of perforation No. 29 in row 3, and injection 34 in row 4.

**Figure 1.** Pressure/admission control in row nº2. Admission volumes recorded at each work level. Average in the 13 injections performed.

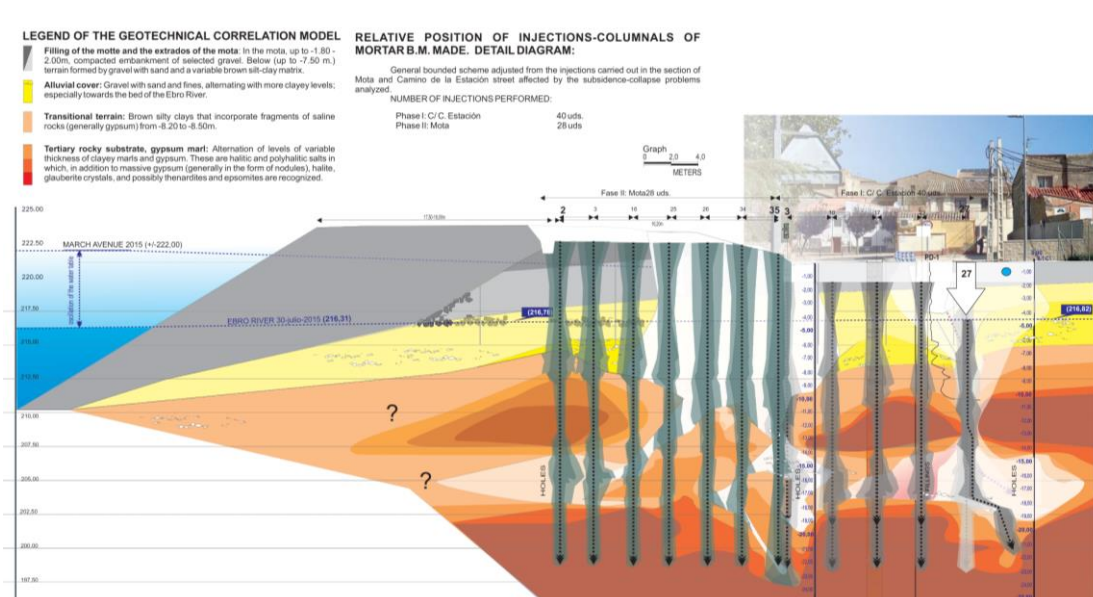
The Figure 4 the position and relative dimensions of the injections carried out on the geological-geotechnical profile obtained through the correlation of surveys and geophysical prospecting techniques. In practically all cases, the firm substrate was reached, and at least 2-3 meters were embedded.

The only thing that has failed, in the most marginal row, towards the village, is injection No. 27, which was apparently made on an old well and which was filled with waste of all kinds. The problem is expressed in the graph.

**Figure 4.** Position of mortar columns B.M. in the geological-geotechnical profile carried out.

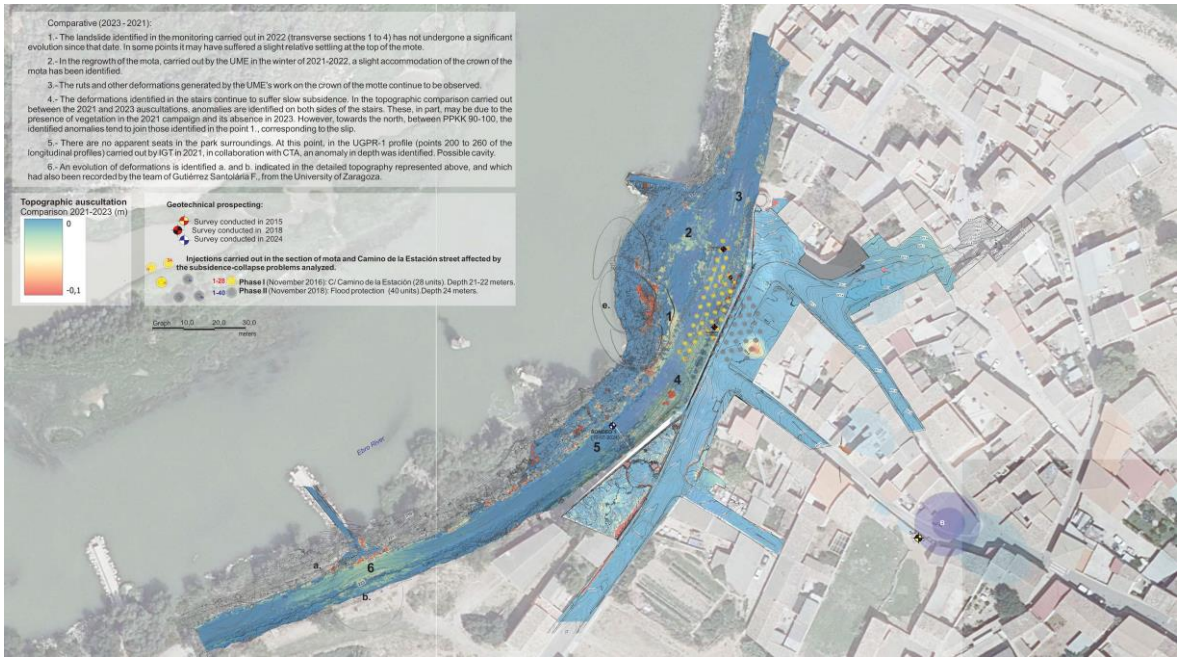
- The deformations identified in the stairs continue to suffer slow subsidence. In the topographic comparison carried out between the 2021 and 2023 auscultations (Figure 7 and 8), anomalies are identified on both sides of the stairs. These, in part, may be due to the presence of vegetation in the 2021 campaign and its absence in 2023. However, towards the north, between PPKK 90-100, the identified anomalies tend to join those identified in the point 1., corresponding to the slip.

**Figure 7.** Topographic comparison between the data obtained on November 22, 2021, and November 5, 2023. Obtained with the RTC360 laser scanner. General situation plan.

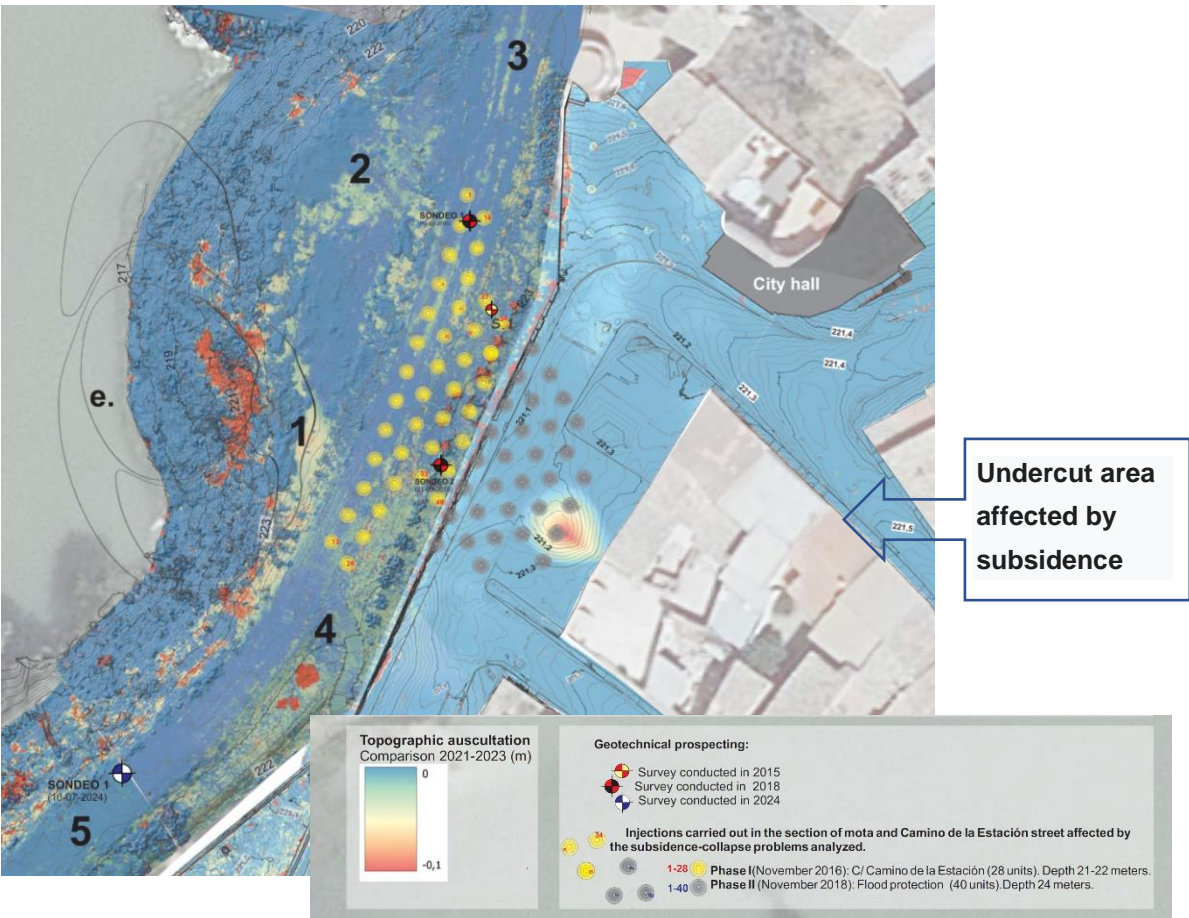
**Figure 8.** Topographic comparison between the data obtained on November 22, 2021, and November 5, 2023. Obtained with the RTC360 laser scanner. Detail of the area in which consolidation measures were carried out using B.M. mortar injections.

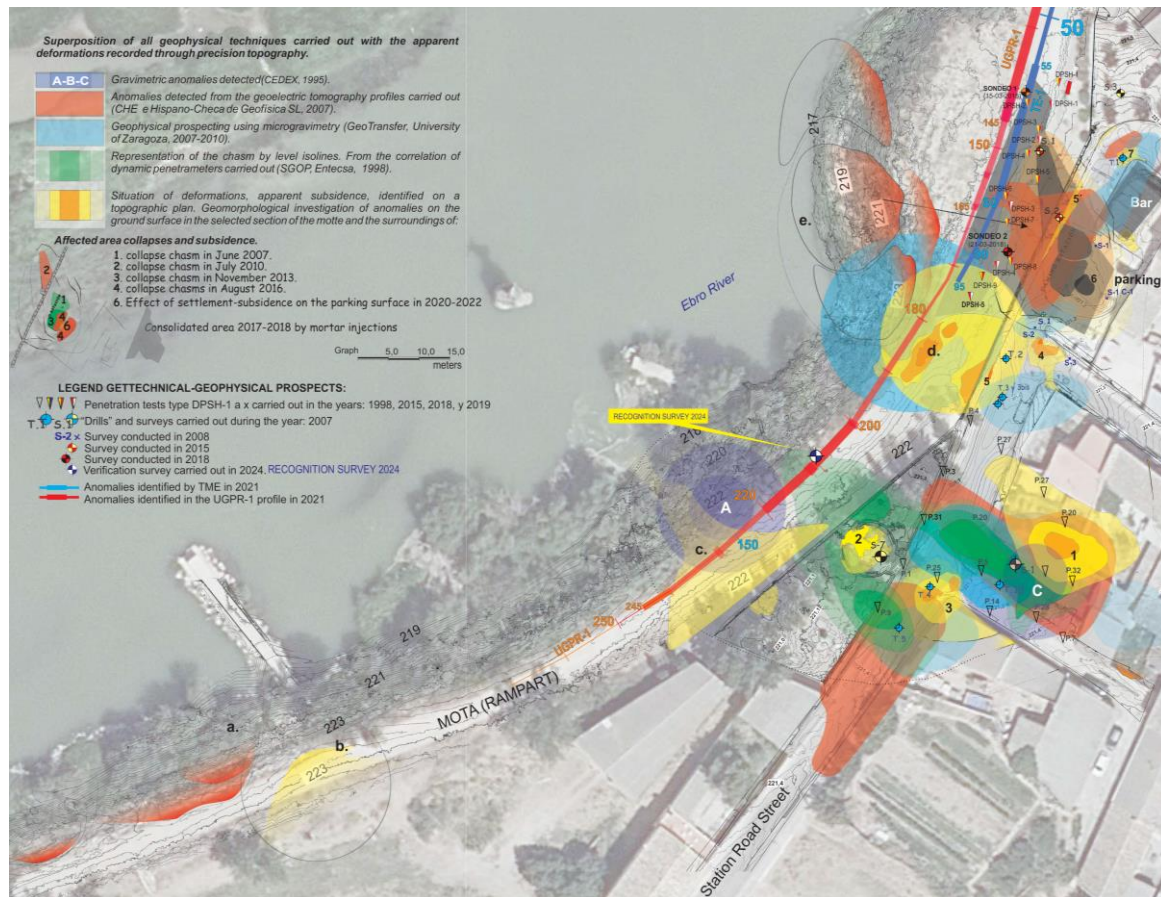
- An evolution of deformations is identified a. and b. (Figure 9) indicated in the detailed topography represented above, and which had also been recorded by [5].

**Figure 9.** Zoning obtained with the anomalies observed in the detailed topography carried out and the different geophysical prospecting campaigns.

- Old sinkhole (1975). Old sinkhole [8].
- 75. Deformations of up to 0.9 – 1.2 cm are observed between November 2021 and October 2023. This differential movement is reflected in cracks identified in the pavement, as well as in the walls that would make up old structures of houses or corrals. In these years, a significant increase in the size and dimension of these cracks has not been observed, given that the recorded evolution is not very high.

- Deformations in the public park. Between November 2021 and October 2023, minor, specific deformations are identified, which generally vary between 0.5 and 0.8 cm, although it can reach 2.0 cm.

- Concentric contour curves are identified in topography. This point is related to deformations in structure No. 11 of Station path. It would be related to points 1 and 2, presenting the rocky substrate at a depth of 22 m.

- Deformation at the corner of Station path and Royal path. Related, in depth, to the collapses that occurred previously in the parking lot area.
- Deformations close to the moat dam wall. In the area around point 5, in the access ramp-stairs to the motte located next to the park, outside the detailed topography, a series of cracks have been observed that indicate a certain relative settlement. Apparently, it is related to the deformation No. 5. According to the topographic comparison carried out, in the time interval 11/22/2021-10/05/2023, a relative settlement of between 0.8 and 1.3 cm has occurred.

- Parking area. Related to the collapses that occurred at this point, which were partially treated in 2016-2017 by injections of low-mobility mortar columns.

- Station path and Don Miguel Cervantes Street. A small deformation has been identified next to the bar, and another larger one, which seem to indicate differential settlements towards the motte. In the area around point 7, a concentric depression is identified, right at the intersection between Station path and Don Miguel Cervantes Street. A subsidence has been measured from

11/22/2021 to 10/05/2023 of the order of 1cm around greatest deformation. This point is in a sewage or supply network manhole, although it appears to move, to a lesser extent, towards the sewer located to the north.

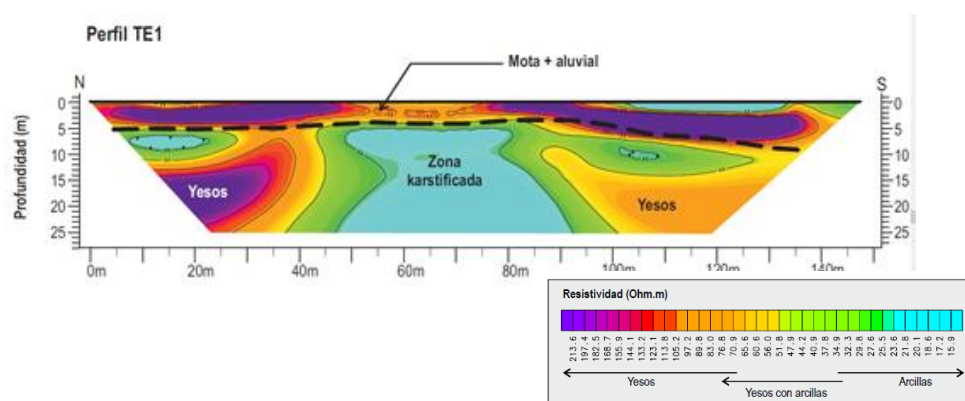
The tomography profile extended 150 m, was composed of 16 electrodes placed 5.5 m apart, and reached a depth of approximately 30 m. In the report written by IGT, it is indicated that the most significant part of a surface level of about 5 m thick, corresponding to the body of the mote and the possible detrital alluvial, is the resistive level interpreted as gypsum (Figure 10) located from 10 - 12 meters deep. This resistive level is abruptly interrupted between meters 45 and 85, where a moderately conductive anomaly is defined, interpreted as a karstified zone in the gypsum materials, and which extends below 30 meters deep.

**Figure 10.** TE 1 Electrical Tomography Profile.

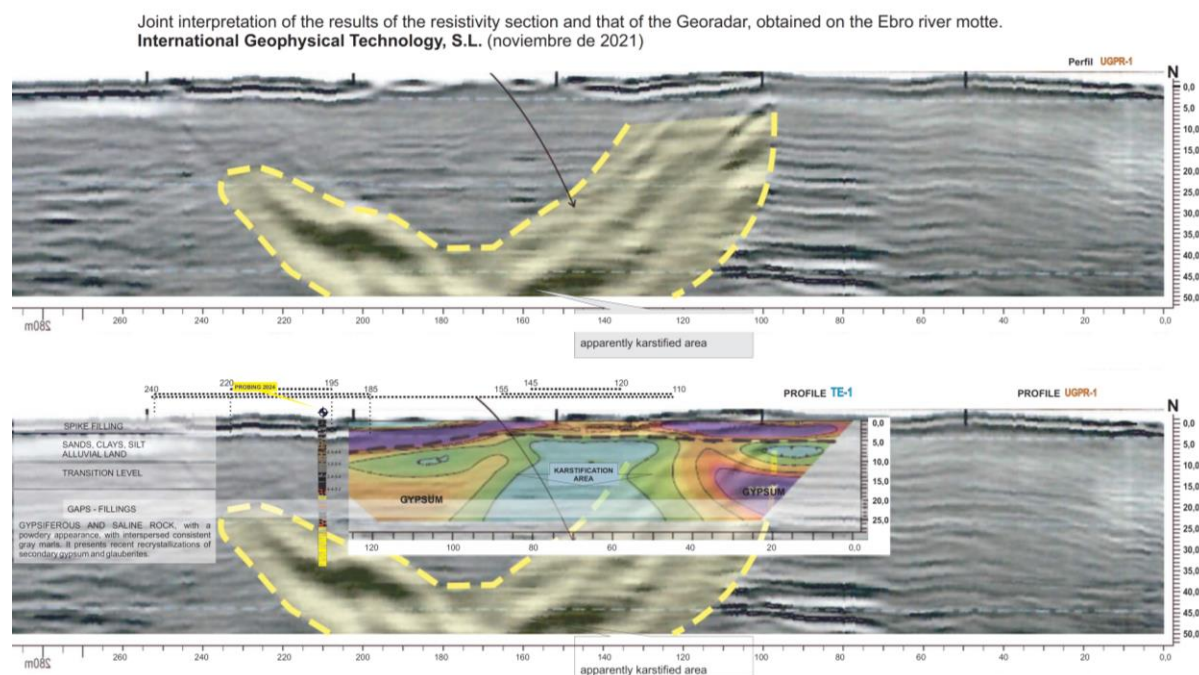
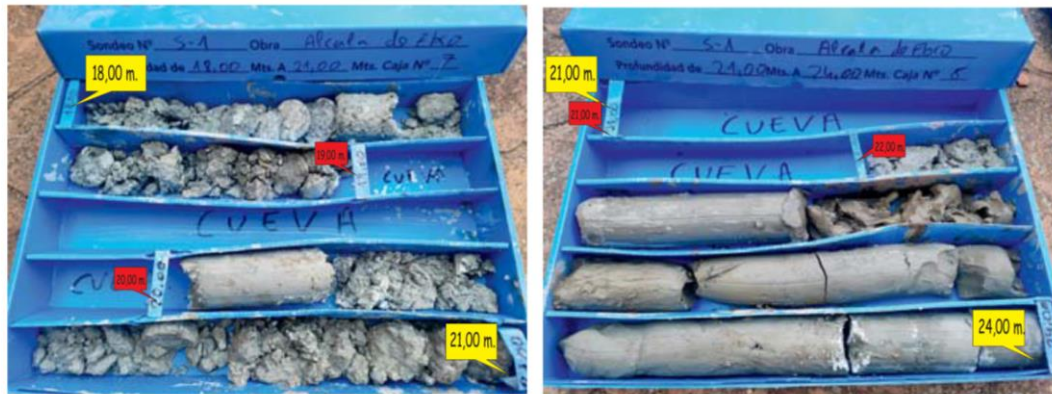
Its clearest manifestation is seen between meters 120 and 220 from 35 meters deep, but it is interesting that the anomaly extends to more superficial levels towards the North, in correspondence with the anomaly defined in the measurements. of Electrical Tomography, as can be seen by observing the results of both measurements (Figure 11).

The TE1 electrical tomography profile correlates with the UGPR-1 section, measured along the Ebro River moat. This georadar profile also reveals the existence of an anomalous zone with a considerable lateral extension and in depth. It is reasonable to interpret that this anomaly is due to the effect of an intensely karstified or altered area of the subsoil because there is no evidence of possible interference in the georadar records by elements located on the ground.

Its most apparent manifestation is observed between meters 100-165 and 180-245m. In the first section, especially in its central part (between 129 and 145m.), it clearly coincides with the anomalies recorded through the survey carried out using electrical tomography. The projection of the disturbance is even recognized towards the surface. In this same sense, it coincides with the projection towards the river (towards the north) of the area that has registered subsidence in recent years on Station path and the parking area.

A second section in which a situation in latent development could be assessed and that could pose an obvious threat, is recorded in the section 180 to 245m. In this case, the anomaly is located at a relative depth of between -30 and -45 meters. Towards the south there is an apparent projection towards the surface.

As in the previous case, it could be interpreted as a reflection in continuity towards the moat, in the direction of the river, with the area of arrival to Alcalá from the south, where the first recorded sinkings (that we know of) are located. in the 70s-80s of the last century. Also with some manifestations, now recorded as apparent sinking on the surface. Both sections seem to converge at depth in what is interpreted as a strongly karstified area that would be located at depths below the order of 40-70 meters.

**Figure 11.** Combination of Electrical Tomography in 3D mode and the UltraGPR type Georadar.

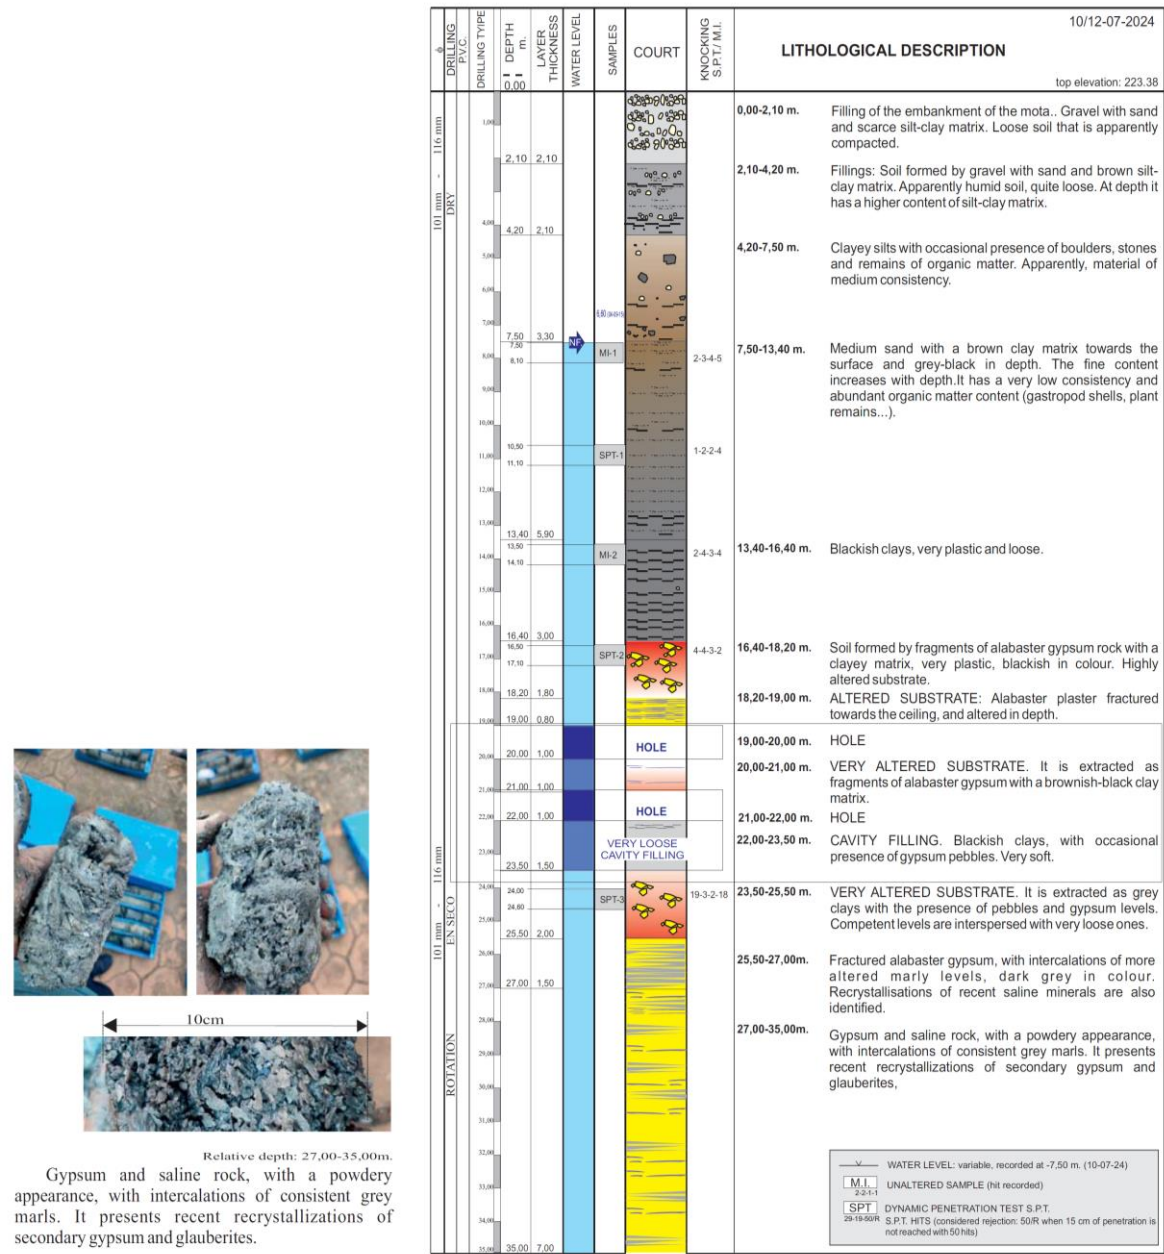
**Figure 12.** : Rotation survey with continuous core extraction located in an area with apparent anomalies recorded through geophysical prospecting.

Below the surface level of the motte fill, 4.20 m thick, a fundamentally sandy and silty level is identified, with occasional presence of boulders and gravel ridges. Towards the surface, the matrix is brown, but at depth, due to its greater apparent content of organic matter, it becomes dark brown. The consistency of this level is very low, with N15 SPT hits of 4 to 7. These values correlate very well, laterally, with the graphs extracted from the dynamic penetration tests carried out in 1998.

Below, between -13.40 and -14.60), a transitional terrain to the rocky substrate has been identified, composed of blackish clays, very plastic, and of very low consistency. It is possible that it is a very altered rock substrate, as a consequence of the presence and continuous circulation of water.

From -14.60 m, levels of gypsum and marl begin to be identified with very variable degrees of alteration. It should be noted that what is generally defined as “gypsum rock” is, more specifically, halitic and polyhalitic salts in which, in addition to massive gypsum (generally in the form of nodules), halite, crystals are recognized. of glauberite and, possibly, thenardite and epsomite.

This substrate is altered in the area closest to the contact with the alluvial cover, affected by variations in the water table, especially in the area closest to the bed of the Ebro River. The infiltration of water to deeper levels, from cracks or more altered levels, they can give rise to karst processes. Consequently, internal dissolution-undermining processes are being generated that favour the formation of chasms or sinkholes.

In this case, in the S-1 survey (2024) a hole has been identified between 19.00 and 20.00m deep, and between -21.00 and -22.00 m, with a clay fill level between - 22.00 and -23.50 m depth. Practically, at the same topographic level, a gap of 80 cm (between -17.30 and 18.10 m) was identified in the S-7 survey carried out in 1979 by the SGOP, under which haulages were identified that, we understand, they would fill the cavity.

For this reason, in anticipation of recognizing and, where appropriate, being able to anticipate phenomena of subsidence or collapse that affect the body of the embankment, which could put the population of Alcalá de Ebro at risk due to flooding, it is recommended to continue carrying out At least a topographical control of the motte and its closest surroundings.
