Structural Performance of Exceptionally Slender Gothic Pillars: The Role of Marés Stone in Palma Cathedral

Rubén Rodríguez Elizalde *

Posted Date: 5 May 2025

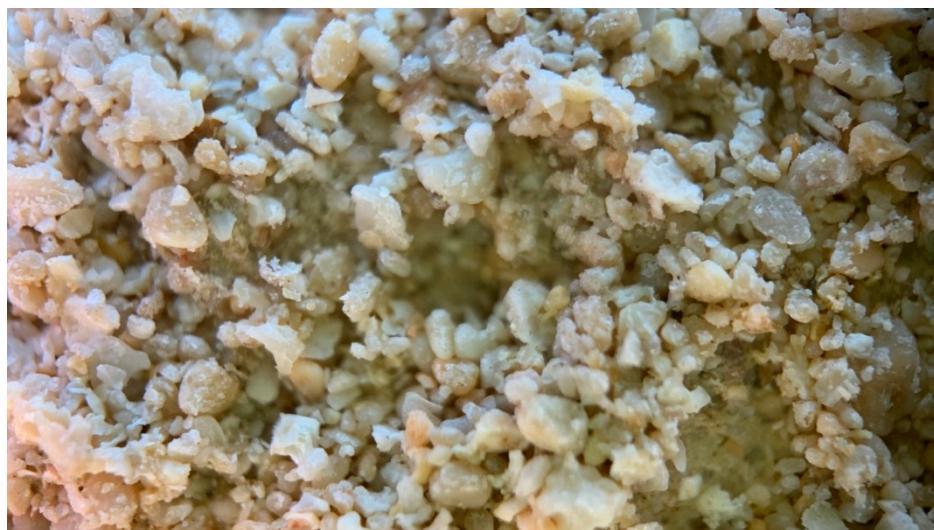
Figure 5. Enlarged image of an ashlar captured with a digital loupe. Rounded bioclastic grains, poor cementation, and interconnected channels are visible, all of which promote capillary action and moisture retention (photograph by the author).

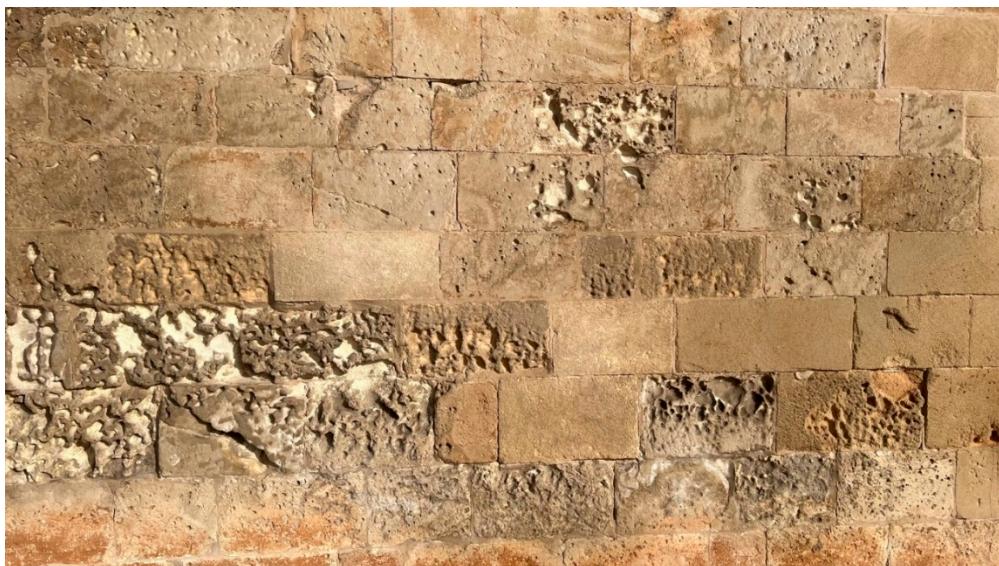
Visual analysis of the stone masonry of Mallorca Cathedral has revealed a wide range of alteration processes affecting the ashlar blocks in different ways (Figure 6).

Figure 6. Wall section showing a combination of pathologies: granular disintegration, alveolization, and black crusts on the surface of mares sandstone. A restored area using a different material is also visible (photograph by the author).

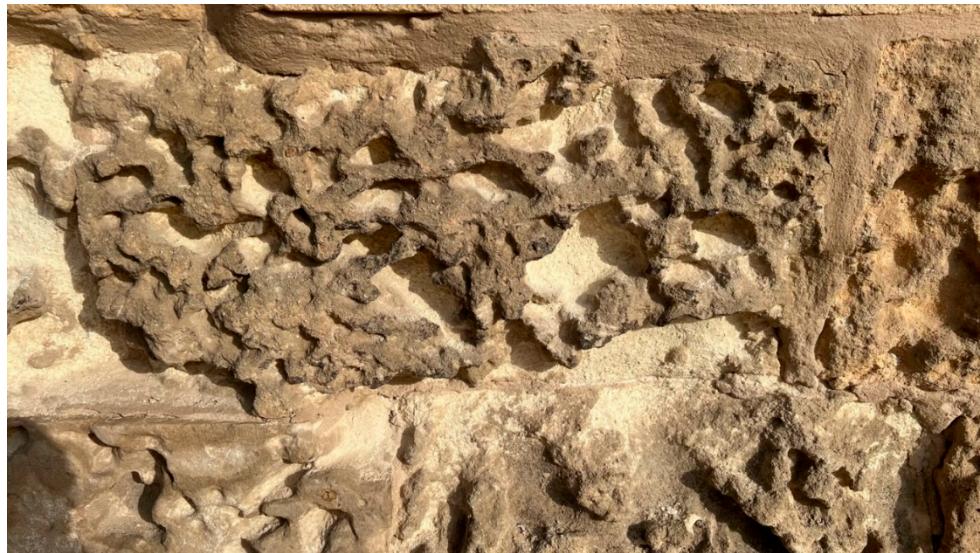
These cavities (Figure 7) not only diminish the building's visual integrity but also reduce the structural cross-section of affected elements, especially in sculpted or molded components.

Figure 7. Advanced-stage alveolization. The loss of material volume compromises the geometry of the ashlar block (photograph by the author).

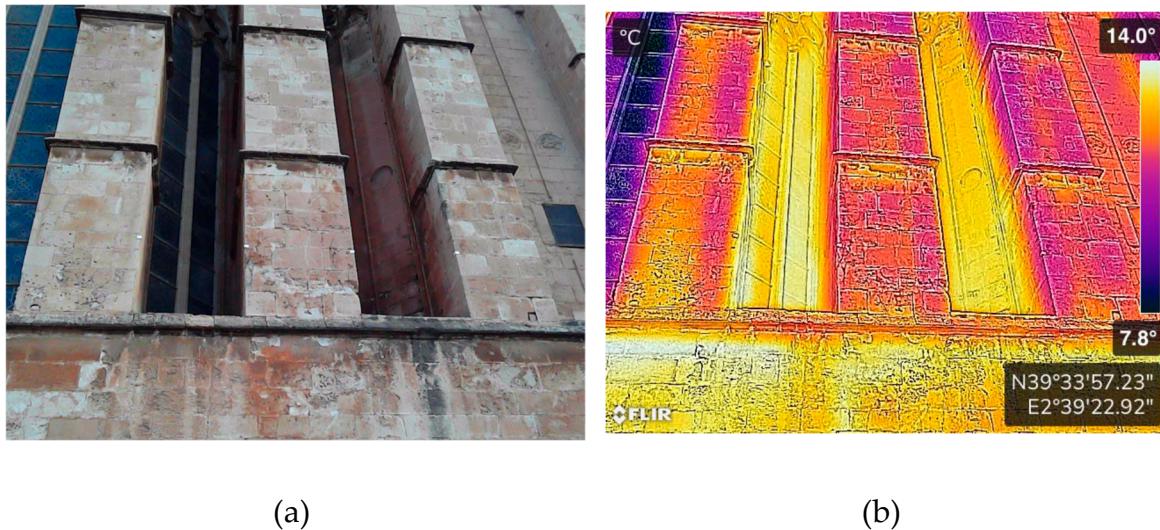
- Vertical thermal gradients in exterior buttresses and piers, with pronounced cooling at the base. Figure 8 shows a thermal difference of over 6 °C between the base (7.8 °C) and the upper section (14.0 °C), indicative of rising damp or moisture accumulation in the lower wall sections. This temperature contrast, recorded without direct solar radiation, suggests retained capillary moisture likely due to the marés' active porosity and lack of a horizontal damp-proof course.

Figure 8. Photograph (a) and thermogram (b) showing a vertical thermal gradient in an exterior buttress. The base shows significant cooling compared to the upper third (7.8–14.0 °C), indicating ascending moisture in lower ashlar blocks (FLIR image by the author).

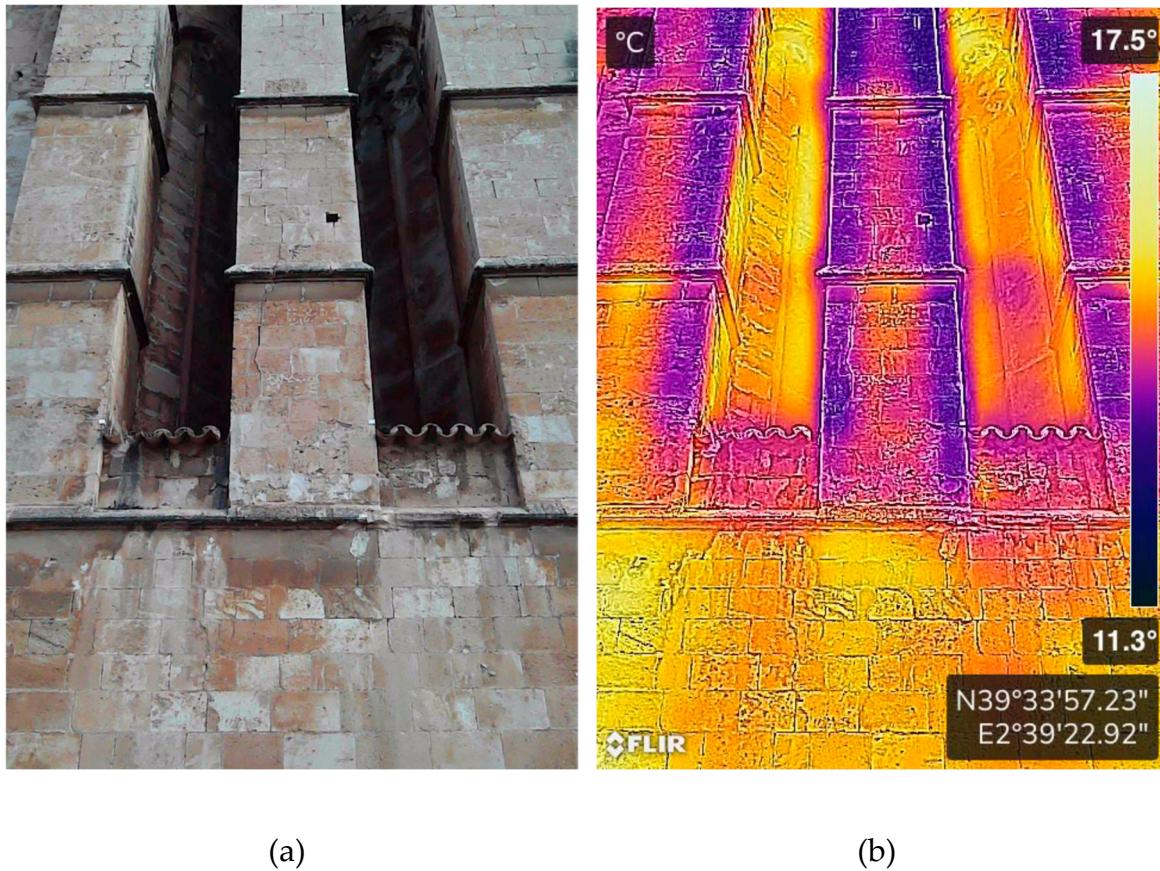
- Localized cold spots with no relation to joints or construction geometry. As shown in Figure 9, some areas display temperatures over 5 °C lower than their immediate surroundings—interpreted as retained moisture or internal stone disaggregation.

Figure 9. Photograph (a) and thermogram (b) showing isolated cold thermal spots on exterior buttresses. Several zones show significantly lower temperatures (11.3 °C) than adjacent elements (up to 17.5 °C), indicating retained moisture or internal disintegration (FLIR image by the author).

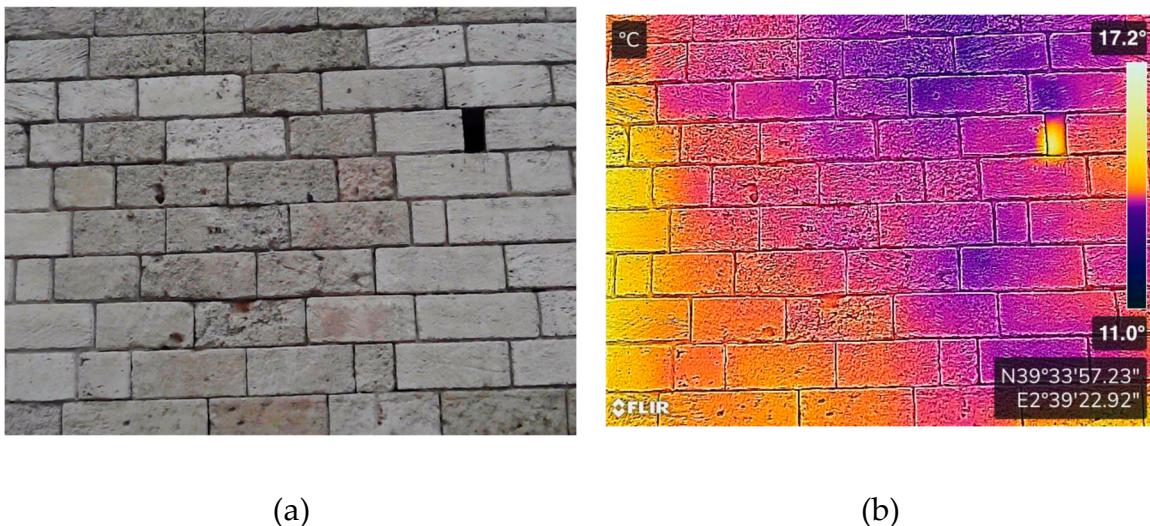
- Thermal contrasts between adjacent ashlar blocks, revealing incompatible repairs or stone replacements. Figure 10 shows blocks with a thermal response of 20.3 °C—deviating from the dominant wall pattern (15–17 °C)—suggesting differences in density, porosity, or surface treatment.

Figure 10. Photograph (a) and thermogram (b) showing a thermal contrast between adjacent ashlars. Despite visual homogeneity, certain blocks show significantly higher temperatures (20.3 °C) than their surroundings (15–17 °C), suggesting incompatible repairs or materials with distinct thermal properties (FLIR image by the author).

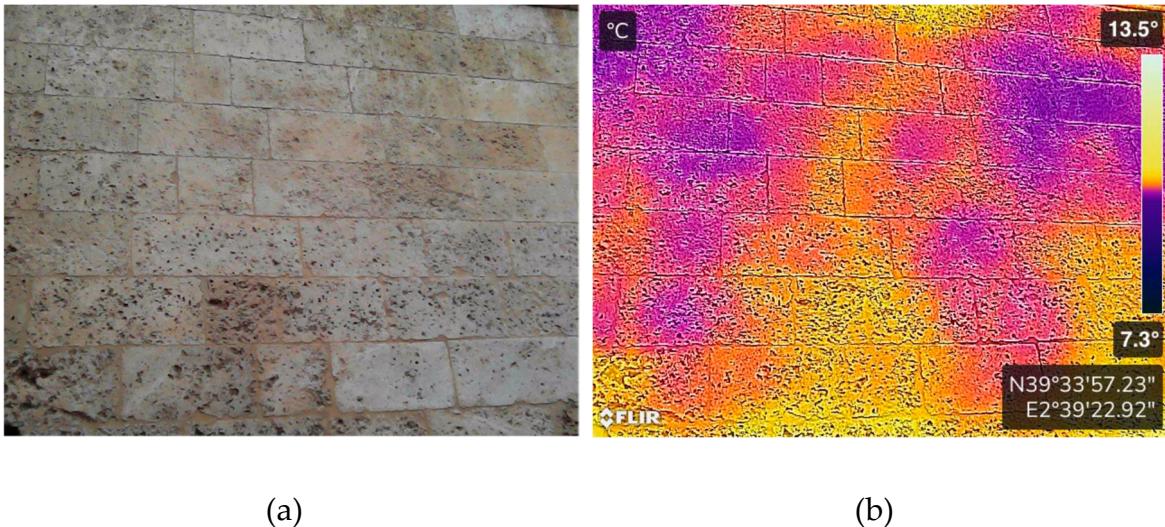
- Generalized thermal heterogeneity, attributable to accumulated microstructural differences due to differential disaggregation. Figure 11 displays an irregular thermal pattern unrelated to geometry, suggesting progressive, uneven loss of cohesion among stone units.

Figure 11. Photograph (a) and thermogram (b) showing a thermal heterogeneity in marés masonry. Alternating cold (7.3 °C) and warm zones (13.5 °C) reflect variations in moisture content, density, or surface texture—typical of differential disintegration or heterogeneous weathering (FLIR image by the author).

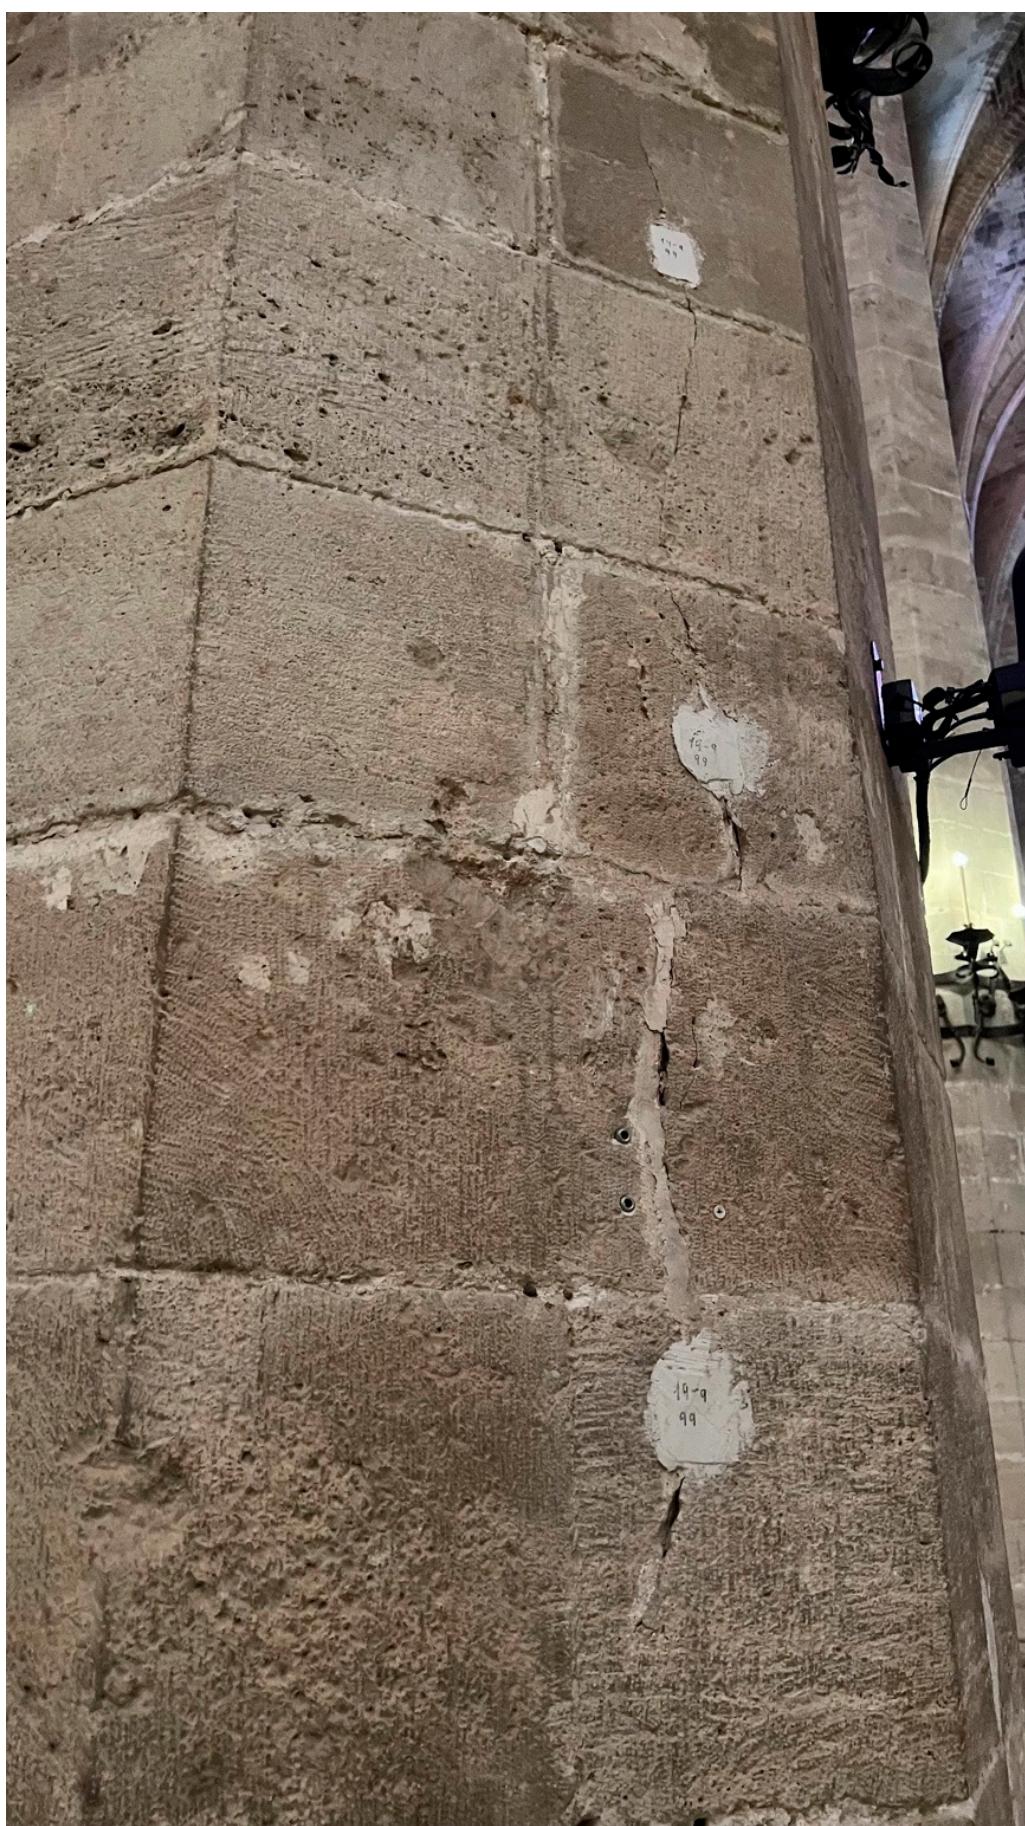
A notable feature in several of these instances is the presence of gypsum monitoring markers from earlier interventions, used to passively track fissure activity. One such marker, located on the west face of a pier (Figure 12), shows partial fracturing, while two others arranged vertically remain intact. The oldest bears a date inscription from 1999, indicating that structural movement has been monitored for at least a quarter century.

Figure 12. Cracked pier with gypsum monitoring markers (photograph by the author).

The morphology and continuity of these fissures—crossing stone blocks rather than following mortar joints—suggest they result from structural mechanisms rather than simple material degradation. Possible causes include:

Despite their rudimentary nature, the gypsum markers provide valuable information: the fact that not all are fractured suggests potential stabilization, though it does not eliminate the need for more rigorous monitoring using modern tools (fissure gauges, laser scanning, or deformation sensors). Their presence also reflects a localized, historical awareness of structural risk.

- Periodic thermal monitoring across contrasting seasons (winter/summer);
- Review and update of crack monitoring markers using more precise technologies;
- Minimally invasive interventions compatible with the stone's nature;
- Detailed study of pillar kinematics through modeling or passive instrumentation.
