# Investigation and Identification of the Causes for the Unprecedented Accident at the "Chaira" Pumped Hydroelectric Energy Storage Plant

**Abstract:** The present study deals with an accident analysis of the "Chaira"- Bulgaria high pressure Pumped Hydroelectric Energy Storage (PHES), especially the failures of the Francis large scale Hydraulic Unit No. 4 (HU4). The causes of overloading and cracking of the stay vanes and their functionality are investigated. Despite many studies on the behavior of the runner and its safe operation the complete destruction of the system because of the stay vanes failure has not been sufficiently studied and published in the scientific literature. The aim is to assess the reasons that have led to this unprecedented accident of the "Chaira" PHES of total destructions of the stay vanes. Based on the historical data and the operating modes, as well as of the identification of the critical elements an objective assessment of the risks of damage of the stay vanes and of entire unit is proposed. A virtual prototype is built for simulation of the system behavior in working and emergency conditions. The loads, stresses and deformations are precisely calcul

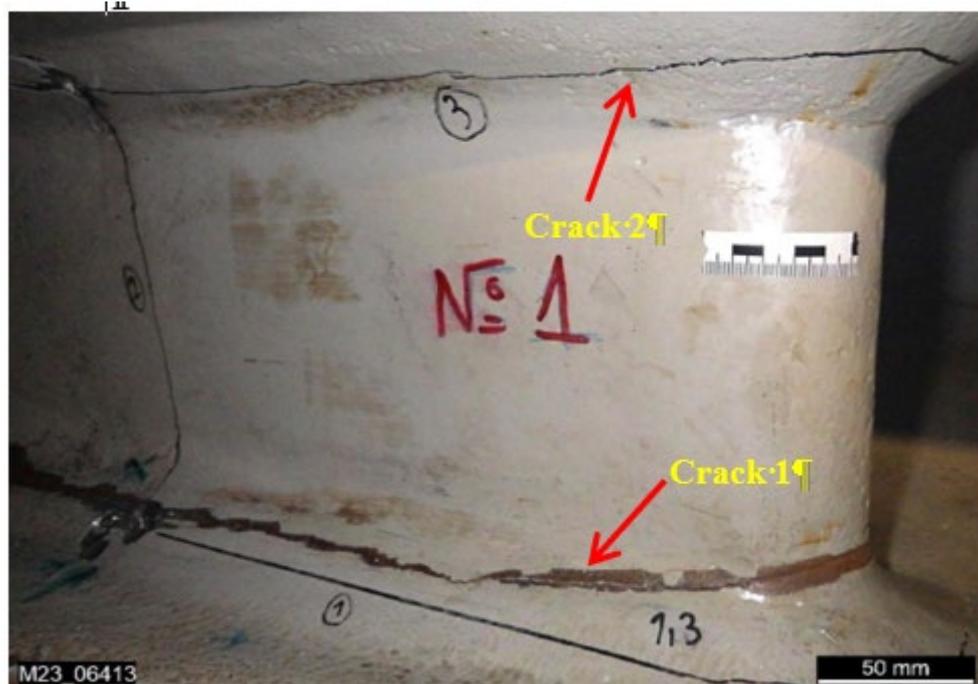
In Figure 4 the destruction of the stay vane No. 1 of HU4 is presented. The cracks 1 and 2 are along the welding part of the stay vane. The inscriptions of the figure were made by the control officers before the photo was taken. The presence of such cracks indicates that the yield stresses were exceeded which led to local failure without visible plastic deformation in these areas. The analysis indicates that such destruction can be caused by static, dynamic or cyclic loads [18]. Specimens (test bodies) were taken from the defective elements (stay vanes) and research was conducted on the material characteristics after more than 20 years of operation. With particular relevance and importance, this accident poses the question of the causes that led to these avalanche-like cracks and the reliability of the remaining HUs.

**Figure 4.** The destruction of the stay vane No. 1 and the cracks.

It can be affirmed with a high degree of confidence that the cracks in eight of the ten stay vanes of HU4, obtained during the pre-commissioning test trials, are in the result of low cycle material fatigue. The reason is high working loads in certain stay vane's zones leading to accumulated micro-plastic deformations caused by the cyclic load during starting, stopping and especially when load rejection events have occurred. This is followed by a rapid growth of the micro-cracks and an additional concentration of stresses until an avalanche-like destruction process is reached in these areas.

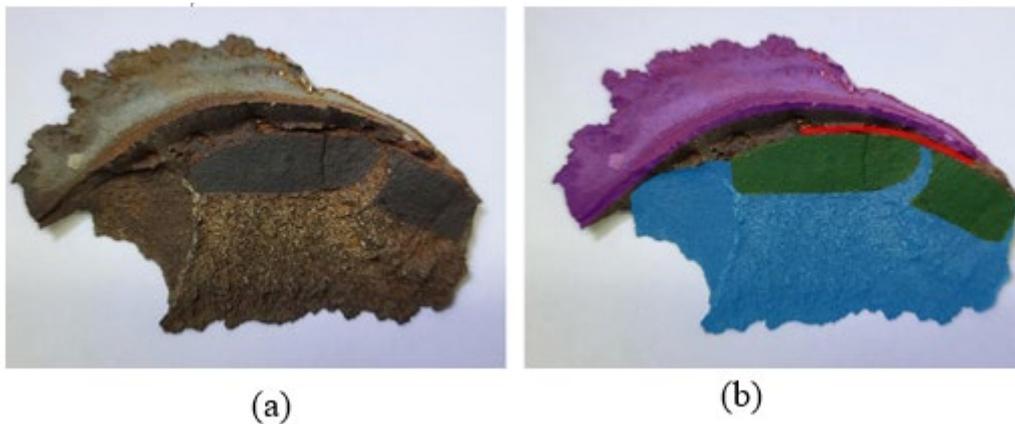
In the same report, the presence of incompletely cleaned cracks was also found and a hypothesis was raised about residual uncleaned micro-cracks and subsequent initiation of cracks. The hypothesis was based on the conclusion that the failure of the stay vanes was due to inadequate mechanical

properties of the material used for welding and that after cleaning, a small part of the cracks was not completely repaired and covered by welding. This was probably made before the rehabilitation carried out in a traditional manual way for similar cases of welding used by National Electric Company (NEK) EAD [<https://www.nek.bg/index.php/en/>]. The inclusion of these specific areas in the virtual prototype aims to analyze the possibility that the cracking process started and grew in this way. The micro-cracks, the cavities, from the front side of the defective stay vanes are shown in Figure 8.

**Figure 8.** Specimens of the micro-cracks from the welded zones at the stay vanes edge: (a) used specimen; (b) specimen with marked zones.

Erosion defects and micro-cracks were found on the front surfaces of the stay vanes on the side of the runner. These places were cleaned and welded to the nominal shape before the rehabilitation activities were carried out. However, the impact zones are much smaller than the regions of overload stay vanes and micro-plastic strains accumulation leading to low-cycle fatigue. It is possible that these interventions are related to the cracking process, but they are definitely not the main reason for the occurrence of fatigue failure. This is also proven by the fact that complete cracking of two stator

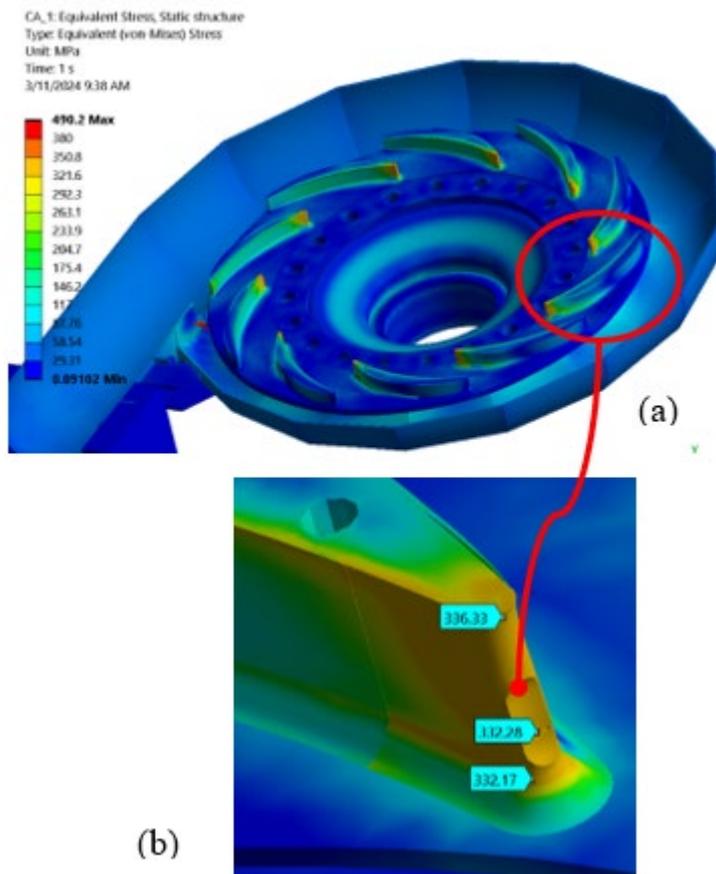
The results of the engineering analyzes for the sixth stay vane at load rejection (mode S5) are presented. In the Figures 19 (a) and in the Figure 20 (a) the values of the equivalent stresses and the equivalent strains, respectively, are shown using colors. In the Figures 19 (b) and 20 (b) these values are directly shown on a front edge of the sixth stay

**Figure 19.** S5 – the engineering analyzes for the stay vanes: (a) maximal values of the equivalent stresses of the vanes; (b) the equivalent stresses on the front edge of the sixth stay vane

vane. It can be seen that for this load mode the highest values of the stresses and strains are on the front edges of the stay vanes and reach values between 380 and 500 MPa.

The results, taking into account the plasticity of the materials, indicate that the maximum stresses of the materials are not exceeded the material limits during the initial testing of the hydraulic units. However, zones of plastic strengthening were noticed, which lead to this drop of the stresses and, accordingly, to the appearance of micro-plastics and the opportunities of initiation of cracks in the hydraulic unit HU4. The transient processes starting, stopping and reversing of the hydroelectric plant can be the reason for reaching of high levels of the work loads. The resulting stresses at the limits of transition to micro-plastics can definitely be the cause of LCF.

These results indicate that the most probable cause of the crack is the low-cycle fatigue in the zones of maximum load of the stay vanes.
