# Copper Mountain Mine Tailings Dam Safety Review Supplement

Daniel Brox

**Abstract:** Copper Mountain Mine tailings dam slope stability research based on recommendations of the 2021 Tetra Tech Dam Safety Review, including computation of tailings dam factors of safety, satellite imagery, steady state and transient seepage analyses, and assessment of internal erosion risk. 3D dam factors of safety satisfy BC's normal operating legal requirement of 1.5 but are in possible violation of the post-seismic legal requirement of 1.2.

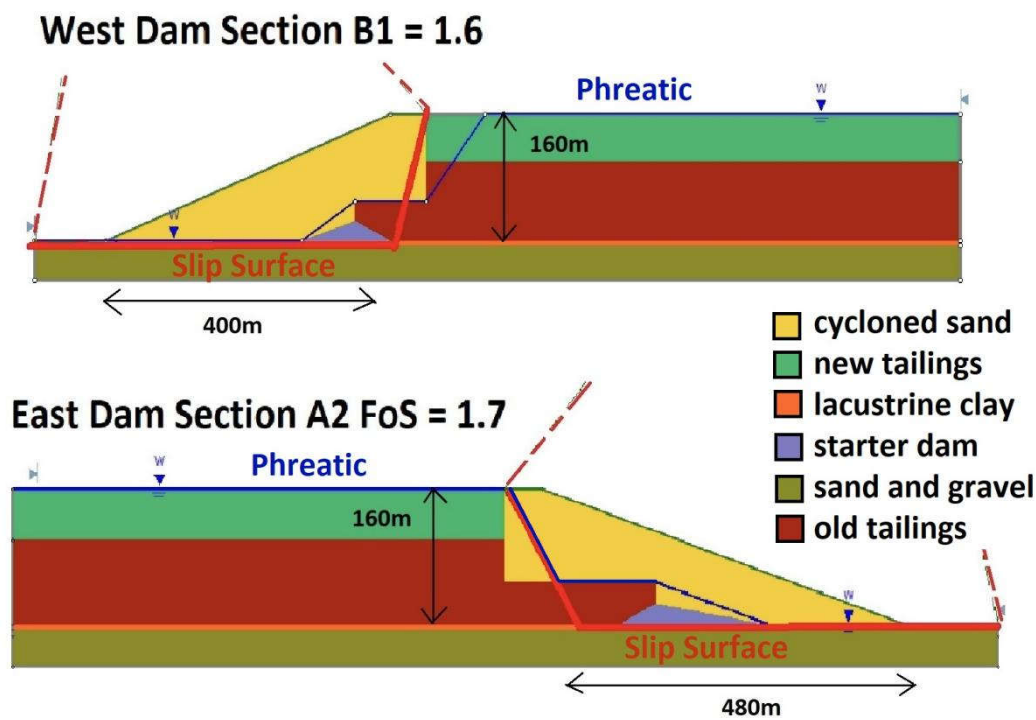
**Figure 1-left** shows the FoS=1.6 result of applying the 2D Morgenstern-Price limit equilibrium method in Rocscience Slide2 to compute the FoS of West Dam cross section B1 using an approximation of the 2020 KCB model, including the reported phreatic surface level, assignment of drained Mohr-Coulomb material shear strengths to dam construction and sand/gravel foundation materials, assignment of undrained SHANSEP material shear strength to lacustrine clay foundation material, and the reported critical slip surface. Material models/parameters used are listed in **Table 1**, in which the Mohr-Coulomb and SHANSEP models are abbreviated as MC and S. In this table, the densities of the sand and gravel foundation, lacustrine clay, starter dam, and old/new tailings are water saturated densities, while the density of cycloned sand is an unsaturated wet density.

**Figure 1.** Morgenstern-Price computed FoS for West and East Dam 2D cross sections B1 and A2.

**Figure 1-right** shows the FoS=1.7 result of applying the 2D Morgenstern-Price limit equilibrium method to compute the FoS of East Dam cross section A2 using a model approximating the 2020 KCB model, including the reported phreatic surface level, assignment of drained Mohr-Coulomb material shear strengths to dam construction and sand/gravel foundation materials, assignment of undrained SHANSEP material shear strength to lacustrine clay foundation material, and the reported critical slip surface. It is important to note that neither the West nor East Dam 2D FoS computations reported here used a computer search algorithm to determine the dam critical slip surface, implying these 2D FoS values are overreported. It is also noted that in 2016, AMEC reported an end-of-construction FoS of 1.3 for a model of East Dam cross section A2 in which a continuous lacustrine clay layer was present in the foundation, while in 2020, KCB reported an FoS of 1.9 for the same cross section at time-of-construction.

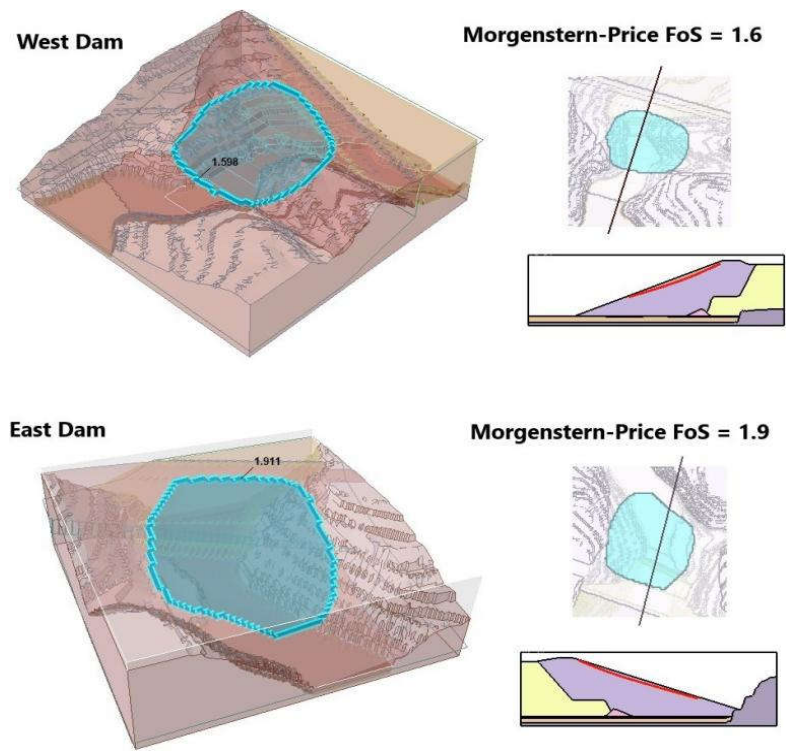
**Figure 2** shows the result of computing 3D FoS values for the West Dam and East Dam in 2025 using Rocscience Slide3. The 3D models are based on valley topographic data provided by the foundation investigation documentation and 2016/2023 ADSI reports, and dam construction projections based on the 2023 ADSI report. Because the foundation investigation documentation showed boreholes in the vicinity of the West and East starter dams having average surface/bedrock elevations of 810.4m/795.4m and 811.8m/781.6m, while the 2023 ADSI specifies the West and East starter dam base elevations for sections B1 and A2 as being 800m, foundation topography was

**Figure 2.** West Dam and East Dam 2025 3D Morgenstern-Price FoS values computed for critical slip surfaces determined by Rocscience Slide3 classic ellipsoidal particle swarm search. Phreatic surface levels are based on 2D FEFLOW seepage analysis of probable maximum flood conditions.

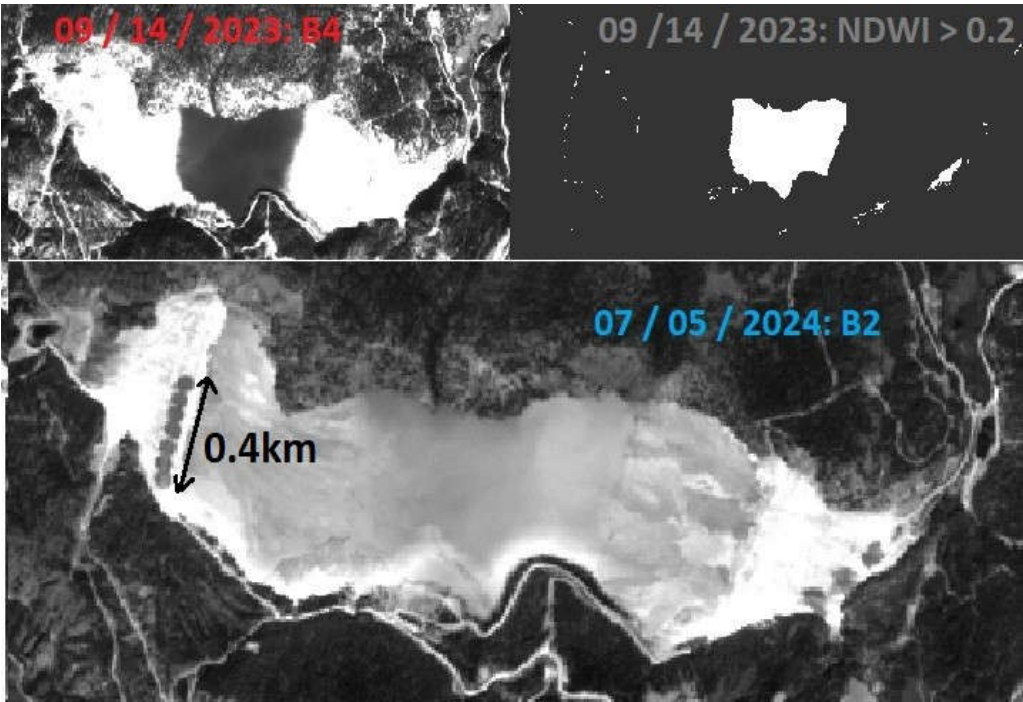
to detect presence of surface water, where B3 and B8 are the satellite measured reflectances in the green and near-infrared bands [Du, 2016, O'Donovan, 2022]. **Figure 3-top** shows images of the Copper Mountain Mine TSF on September 14, 2023, filtered in the red band B4 (left) and binary processed to display  $NDWI > 0.2$  (right) to identify presence of surface water. **Figure 3-bottom** shows an image of the TSF on July 5, 2024, filtered through band B2 (blue-490nm), in which circular surface structures of approximate diameter 60m and 100m with optical reflectivity less than surrounding dam material are visible on the West and East dam downstream slopes. A hypothesis offered for presence of the structures in accordance with the 2021 DSR is that they were formed by sprinkler systems to limit dust generation.

**Figure 3.** Sentinel-2 images Copper Mountain Mine TSF, dated 09/14/2023 (top), and 07/05/2024 (bottom). Top images show the TSF in red band B4 (left), in which boundaries of the tailings pond are clear, and the same image binary processed for the condition  $NDWI>0.2$  (right) to identify presence of water at the surface of the TSF. The bottom image shows the TSF in blue band (B2) in which 7 circular structures on the West Dam crest/downstream slope of approximate diameter 60m and 3 circular structures on the East Dam downstream slope of approximate diameter 100m are visible, and distinguishable from dam downstream slope, beach, and tailings pond materials by their reflectance in blue, red, and infrared bands.

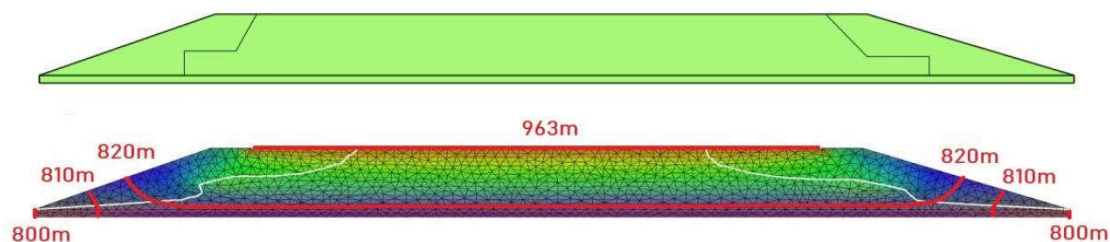
**Figure 4** shows the FEFLOW computed 2023 steady state phreatic surface level and hydraulic head isolines for the entire TSF and its foundation analyzed as a simplified 2 dam system in which constructed drains are omitted, beach lengths are 0m, and the material permeabilities listed in **Table 5** have been used. This analysis indicates the 2023 hydraulic head in TSF foundation upstream of West and East starter dams is approximately constant at 810m. The total seepage flows out of the West and East Dams are computed to be 1.4L/s/m and 1.2L/s/m, and in both cases more than 90 percent of this flow passes through the foundation. These seepage analysis results are in contrast to 2014 piezometer readings of VWP10-05W-3/VWP10-01E-3 in West/East Dam upstream foundations in excess of 835m/845m, pointing to the importance of accounting for transient seepage conditions and the effect of 3D TSF geometry on seepage flow, including any low permeability path from the TSF pond through the TSF abutments into the foundation [Klohn Crippen, 1998].

**Figure 4.** West/East Dam FEFLOW steady state analysis of 2023 2 dam system indicates hydraulic head in TSF foundation upstream of West and East starter dams is approximately constant at 810m.

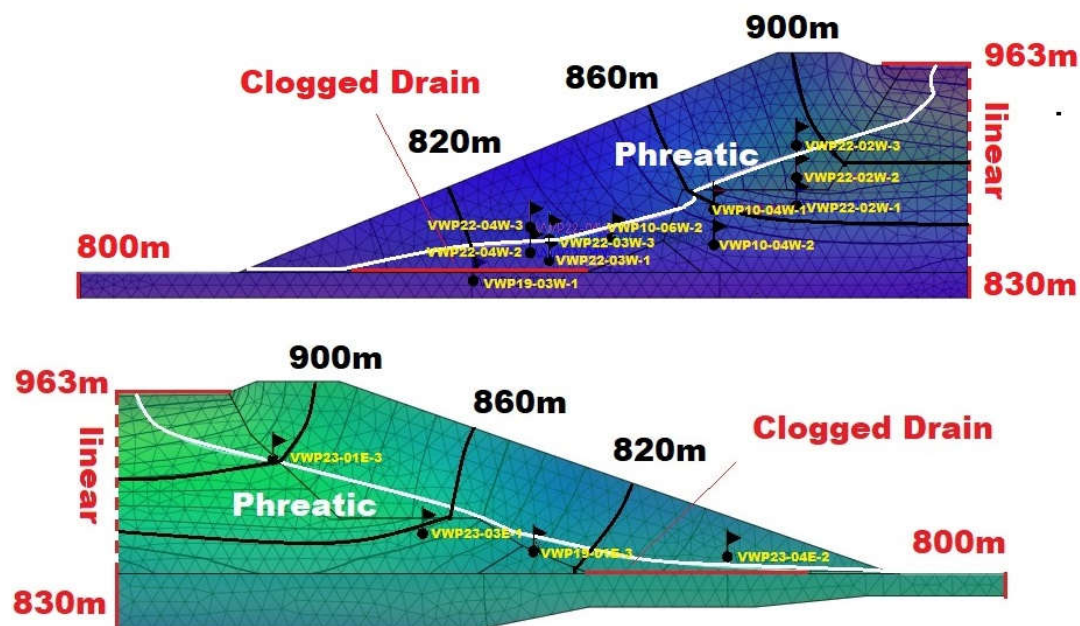
Figure 5 shows West/East Dam FEFLOW steady state seepage analyses with drain function and boundary conditions adjusted to obtain approximate agreement of hydraulic heads with 2023 readings of West/East Dam piezometer readings. For both dams, an upstream foundation total head of 830m was assigned based on readings of piezometer VWP12-01E-2 and results of analyzing the 2 dam system. For the West Dam, to obtain agreement with downstream piezometer VWP22-04W-1 and VWP22-03W-3 readings of 811m and 827.5m, it was necessary to assume 100m of the blanket/finger drain system downstream of the starter dam has been clogged, and to obtain agreement with piezometer VWP10-04W-1 and VWP22-02W-3 readings of 859.5m and 900m it was necessary to assume a beach length of 0m. For the East Dam, to obtain agreement with downstream piezometer VWP23-04E-2 and VWP19-01E-3 readings of 815.3m and 834m, it was necessary to assume 200m of the blanket/finger drain system downstream of the starter dam has been clogged, and to obtain agreement with piezometer VWP23-03E-2 and VWP23-01E-3 readings of 855m and 911.5m it was necessary to assume a beach length of 0m. After this initial adjustment of drain permeability and seepage flow boundary conditions, material and drain permeabilities were calibrated to 2023 piezometer readings using FePEST. For both West/East Dam FePEST permeability calibrations, the effect on phreatic surface position was not substantial, but calibrated cycloned sand permeability  $5e^{-7}$ m/s was two orders of magnitude lower than reported in the 2021 DSR, and calibrated permeabilities ranged from  $3.3e^{-5}$ m/s to  $5.8e^{-3}$ m/s for sections of drain 0-100 and 100-200 meters downstream of the starter dams. Inclusion of daintube crest drainage in West and East Dam steady state seepage analyses as FEFLOW fluid transfer boundary conditions was not observed to have any effect on phreatic surface level of pore water pressure due to location of the drains above the phreatic surface.

**Figure 5.** West/East Dam FEFLOW 2023 steady state seepage analysis with drain function, boundary conditions, and material permeabilities calibrated to 2023 piezometer readings.

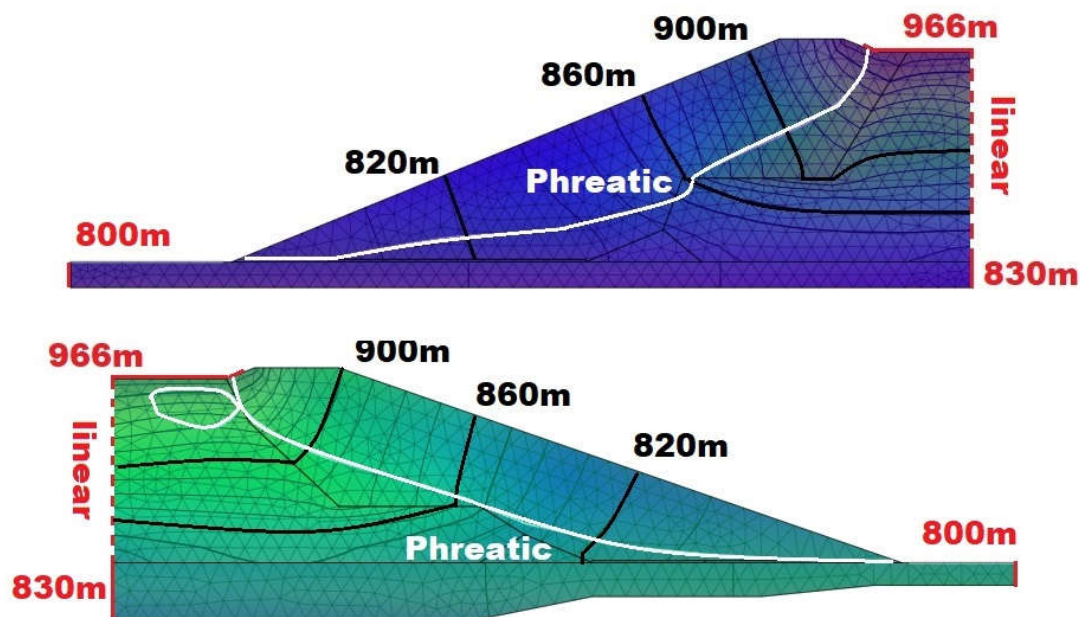
The design minimum freeboard of 2m assumes an initial freeboard of 5m is decreased by occurrence of a probable maximum flood. Because the 2023 ADSI reports a freeboard of 10m, transient seepage analysis has been performed assuming an increase in water level of 3m takes place with occurrence of a probable maximum flood of duration 72 hours, and that a month is required to pump the flood water out of the reservoir to return the pond height to its original level. **Figure 6** shows the West/East Dam transient seepage analysis in which phreatic surfaces are not significantly changed from steady state levels, but the hydraulic head of water saturated cycloned sand and tailings beneath the dam crests is increased by 10-20m.

**Figure 6.** West/East Dam FEFLOW 2023 transient seepage analysis results 30 days after 72 hour probable maximum flood decreases dam freeboard by 3m.

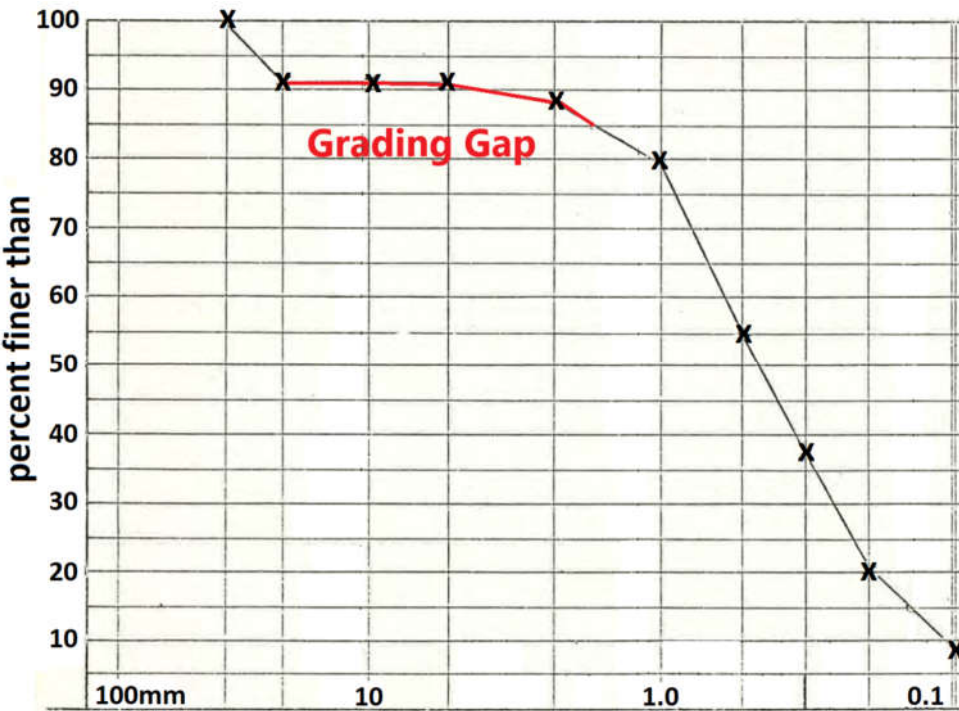
**Figure 7.** Grain size distribution curve for silty gravelly sand 17.2 to 18.7 feet deep in borehole SL-9 in the East Dam foundation.

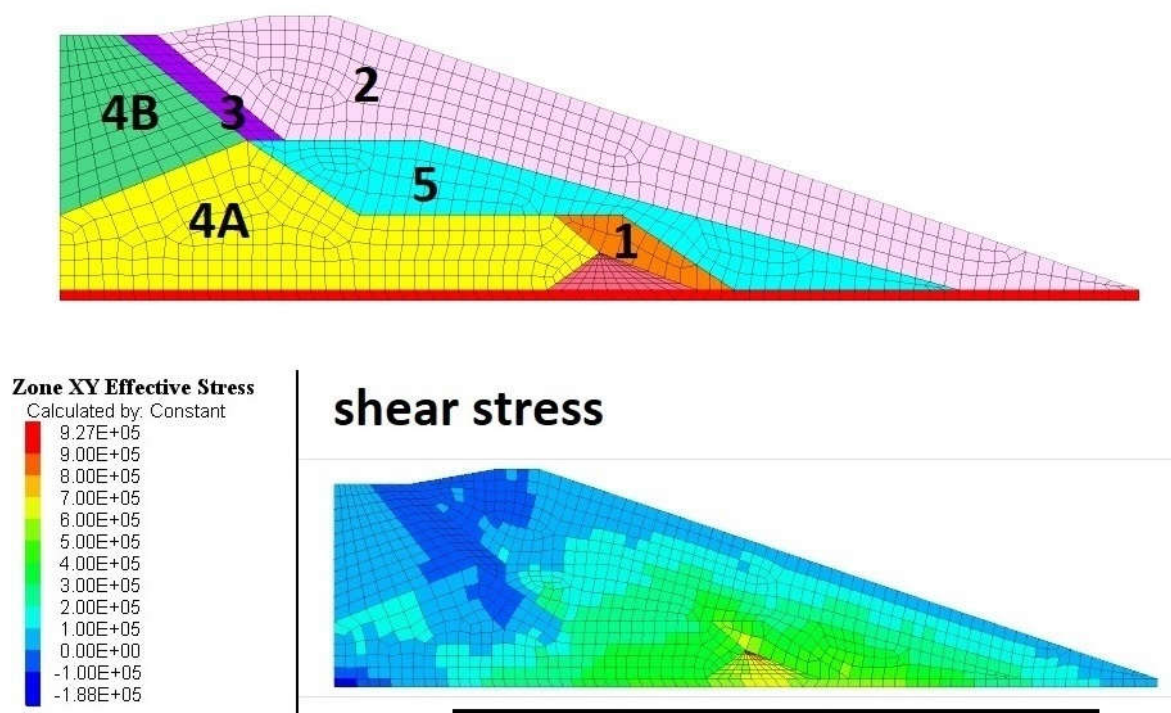
**Figure 8.** FLAC2D computation of shear stress in 2025 East Dam cross section A1 shows the shear stress in the vicinity of the starter dam and its foundation exceeds 100kPa. Dam zone labels 1:compactified cycloned sand, 2:uncompactified cycloned sand, 3:tailings sand + cyclone overflow, 4:tailings slimes, 5:water saturated cycloned sand.

- Chapter 7 - FLAC2D computation of shear stress in the East Dam suggests inclinometer displacements can be attributed to secondary creep of water saturated material in the vicinity of the starter dam and its foundation.

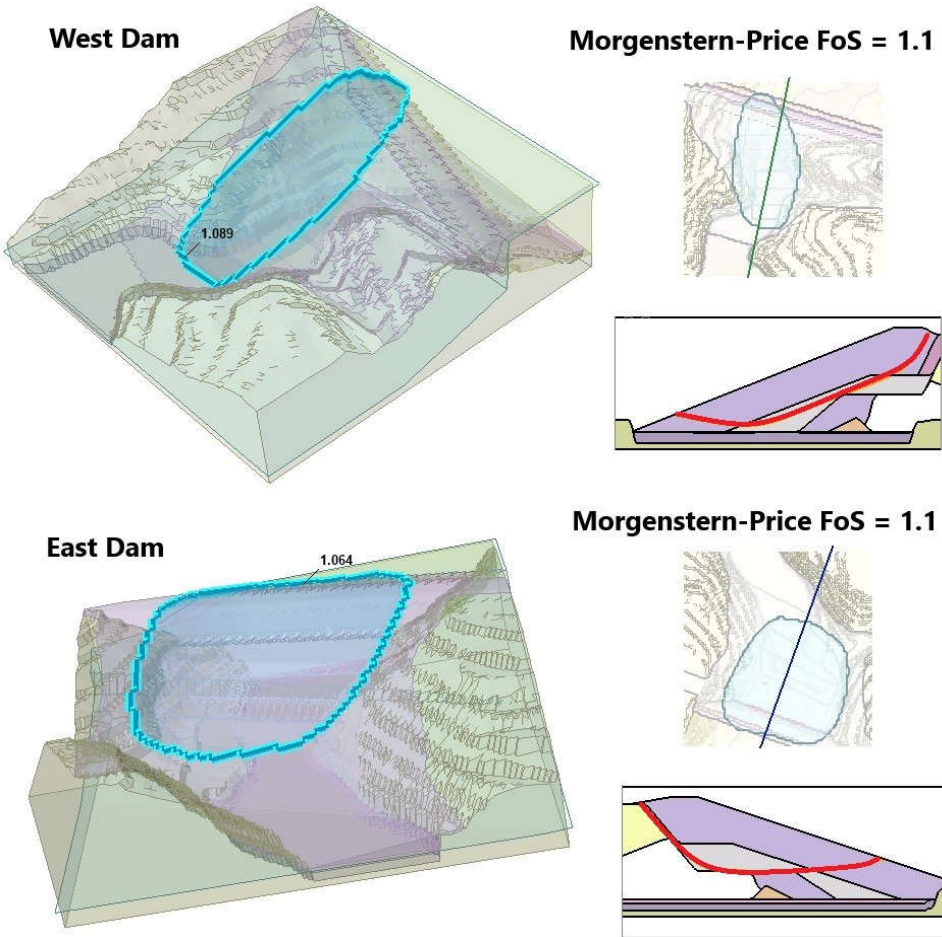
Post-liquefaction stability of the West and East Dams has been assessed by assigning residual undrained shear strength ratios of 0.22 and 0.07 to zones 4A and 4B, following the 2020 KCB stability analysis, and 0.055 to zones 3 and 5, assuming an SPT blow count value of 10 for water saturated cycloned sand based on the 1989 TSF Design Review and a residual undrained strength ratio multiplicative factor of 0.0055 [Klohn Leonoff, 1989, Stark, 1992]. **Figure 9** shows the resulting Morgenstern-Price 3D FoS values of 1.1 and 1.1 computed in Slide3 for the West and East Dams, and the associated critical slip surfaces. **Table 7** shows FoS values similarly computed for different values of the unsaturated cycloned sand internal friction angle and water saturated sand SPT blow count. It is noted that while the assignment of residual undrained shear strength ratio 0.055 to zone 5 is overly

Figure 9. Post-liquefaction Morgenstern-Price FoS computation results in Slide3.

If liquefaction triggered slope instability is identified by direct measurement as an ongoing threat to dam stability, wick drainage of excess pore water pressure in the tailings beaches and/or relief well drilling down into the foundation may be necessary. To avoid the complication of correctly predicting liquefaction triggers, it is noted that current best practice is to assume liquefaction could be triggered and design/construct dams to a post-seismic stability standard  $FoS > 1.1$  [International Commission on Large Dams, 2019, O'Brien, 2020].
