# NDT Anatomy of the Medieval Masonry of the SAN Niccolò' Tower-Gate in Florence (Italy)

[Massimo Coli](#)<sup>\*</sup>, Anna Livia Ciuffreda, Costanza Stramaccioni, Giorgio Caselli, [Giorgio Lacanna](#), Emanuele Marchetti

Keywords: medieval; masonry; tower-gate; ndt; anatomy

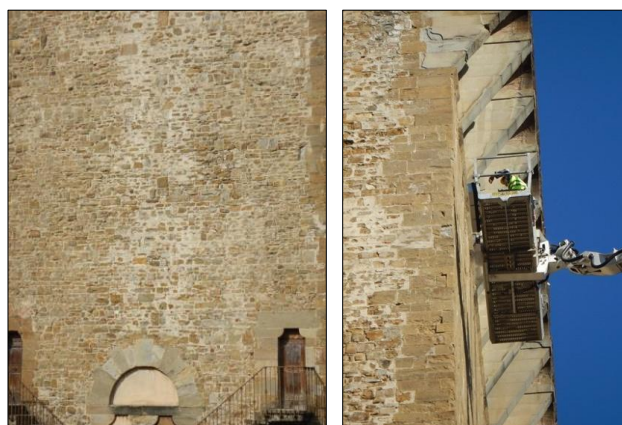
**Figure 4.** Left: Ordinary masonry facing made of Pietraforte sandstone elements and mortar; right: corbels in Pietra Serena sandstone on the east side. To be noted the GPR antenna mounted the external of a lift-basket for executing the GPR survey of the Tower facades.

The corbels at the ridge of the east elevation, reinstated in the 1930s, are made with overlapping beams of Pietra Serena sandstone (Figure 4b).

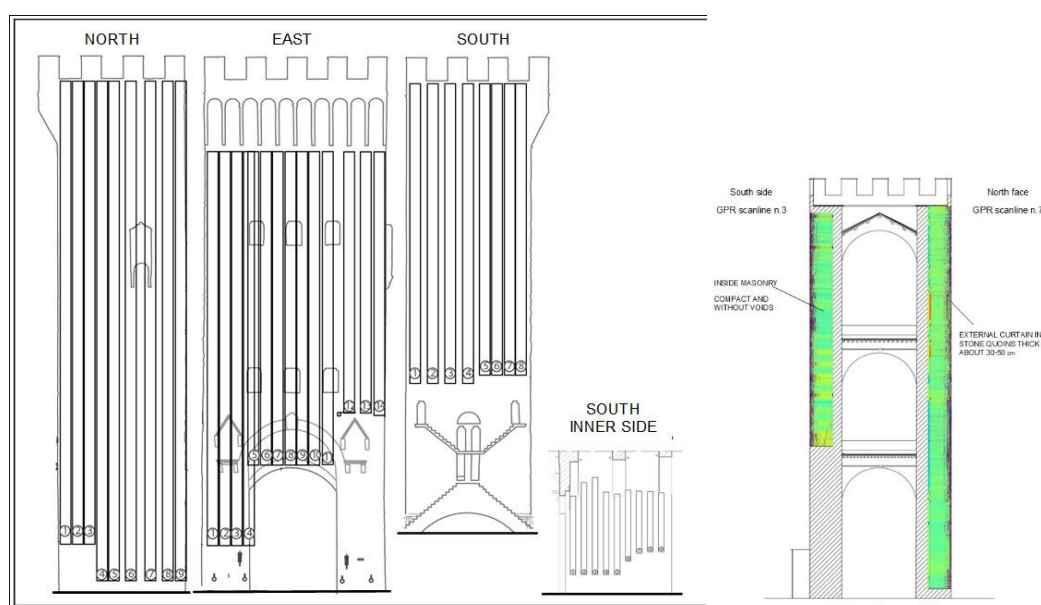
The georadar scans, which extend to a depth of approximately 2 m, identify evident surface reflections in the first 30-50 cm above a homogeneous body not associated with evident discontinuities and/or structural criticalities. This trend of reflections present in the radargrams is consistent with an external curtain of *facciavista* quoins, with a thickness of approximately 30-50 cm, followed by a full and compact masonry, and seem to exclude significant voids and/or cavities (Figure 5b).

**Figure 5.** a) layout of the GPR scanlines on the outer facades; b) example of radargrams mounted in their proper position showing the structure of the masonry (elaboration A.L. Ciuffreda).

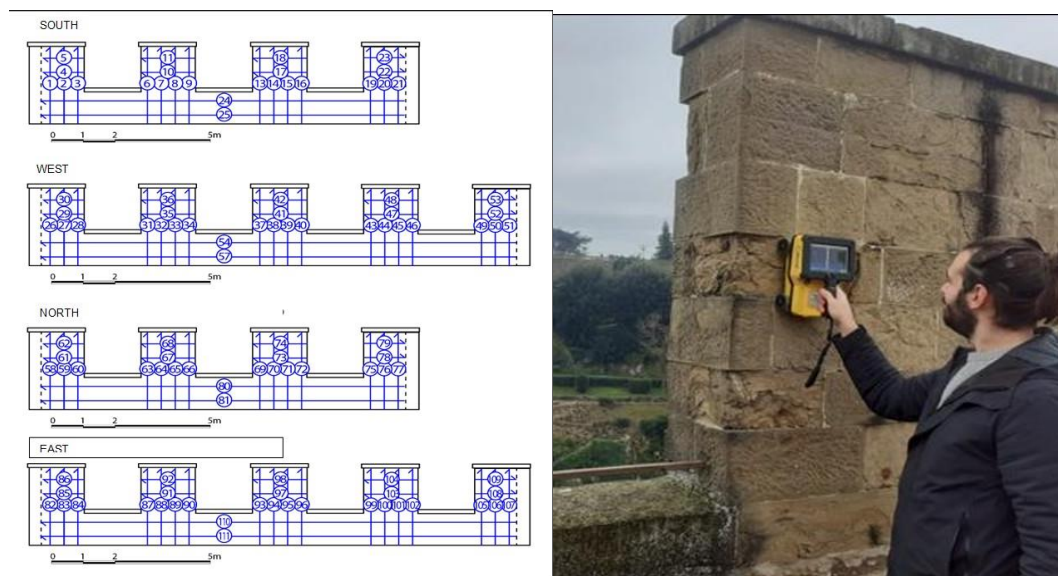
The georadar survey on the battlements was carried out using a C-Thru radar (Figure 6). The high frequency of the electromagnetic wave makes the C-Thru particularly efficient in analyses aimed at the internal characterisation of bodies of limited thickness and is therefore the ideal tool perfect for analysing the battlements with a thickness of 40 cm, with the aim of evaluating the possible presence of metal elements inserted inside.

The analysis of the radargrams suggests an irregular structure with smaller stones in correspondence with the balustrade, and a structure with homogeneous quoins in the battlement above the balustrade; the mortar interposed between distinct quoins is well detected by reflections.

**Figure 6.** Layout of the GPR scanlines on the battlements and one moment of the survey (elaboration E. Marchetti, photo M. Coli).

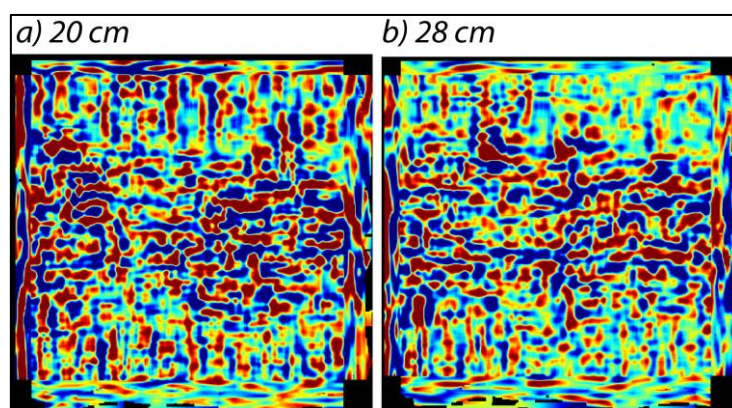
The acquisitions carried out on the inter-storey slabs have highlighted a slab of about 15 cm that rests on the beams oriented East-West, which in turn rest on the central arch with North-South development. The masonry above the arch, visible from the scans carried out in the West-East direction appears to have a compact and homogeneous structure and no disconnections are evident (Figure 7).

**Figure 7.** Slices of the tomographic analysis carried out on the second floor showing the beam structure that is inserted into the load-bearing arch at a depth of approximately 20 cm (a) and the homogeneous structure of the load-bearing arch at a depth of approximately 28 cm (b).

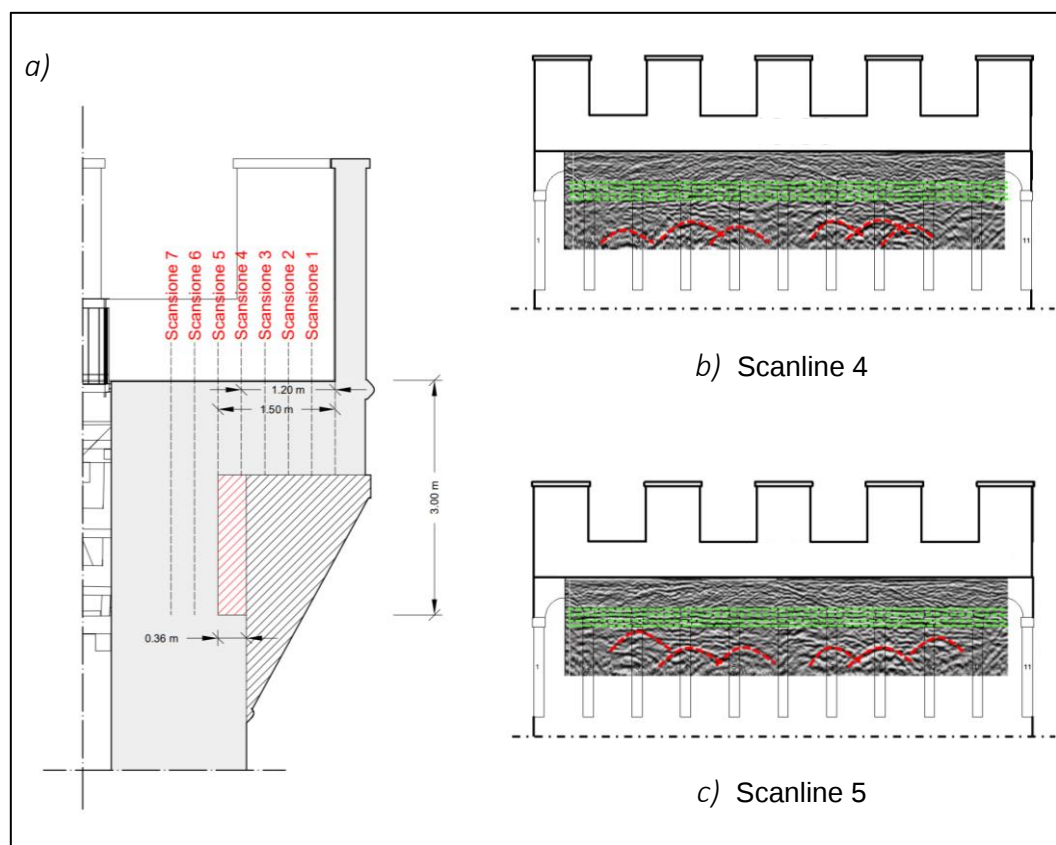
In order to provide a detailed knowledge of the setting of the corbels on the Tower's wall structure, an additional analysis involved the western portion of the summit walkway, where 7 scans were performed parallel to the eastern wall of the Tower and with a spacing of 30 cm. The results highlight the characteristic reflections of the vaults that support the battlements of the eastern facade of the Tower starting from a depth of about 1.5 m, the reflections produced by the stone bars that constitute the corbels (Figure 8). The analysis of these scans highlighted that the reflections by the bars of the corbels are detectable up a distance of about 190 cm from the external side of the battlements, suggesting a clamping of the bars in the masonry of the Tower of about 40 cm.

**Figure 8.** a) Location of the corbels' clamping identified. b) Radargram n.4 that shows the compact wall structure of the western side of the Tower with an evident horizontal stratification in the first 100-150 cm (highlighted in green) and some reflections (in red), positioned around 1.5 m deep, in correspondence with the vaults supporting the walkway. c) Radargram of scanline n.5 (elaboration E. Marchetti).

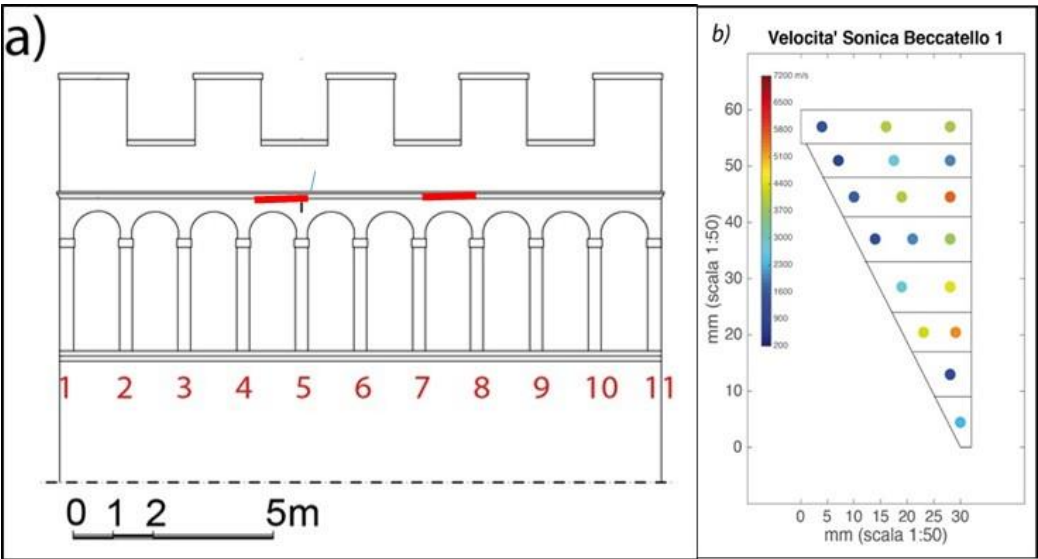
For the corbels, 18-point sonic measurements were done on each single corbel (Figure 9); for each point, in order to obtain a more representative value, multiple acquisitions were made. The investigations on the corbels show a general decrease in velocities in the outermost portion of the top stone-bars, which indicate a decrease in mechanical characteristics linked to an increase in internal fracturing and alteration. The maximum velocity values found on a single segment ( $> 6,000$  m/s) are compatible, in fact, with a compact rock, while the minimum values (900 m/s) suggest a significant degree of alteration. Considering the 11 corbels, as evident from the overall results a situation of greatest alteration is found in the external corbels (1 and 11) and in those adjacent to the grates of the summit terrace.

**Figure 9.** a) Corbel setting, b) example of the sonic velocity detected for the corbel n.1, in red the position of the grates (elaboration M. Coli).

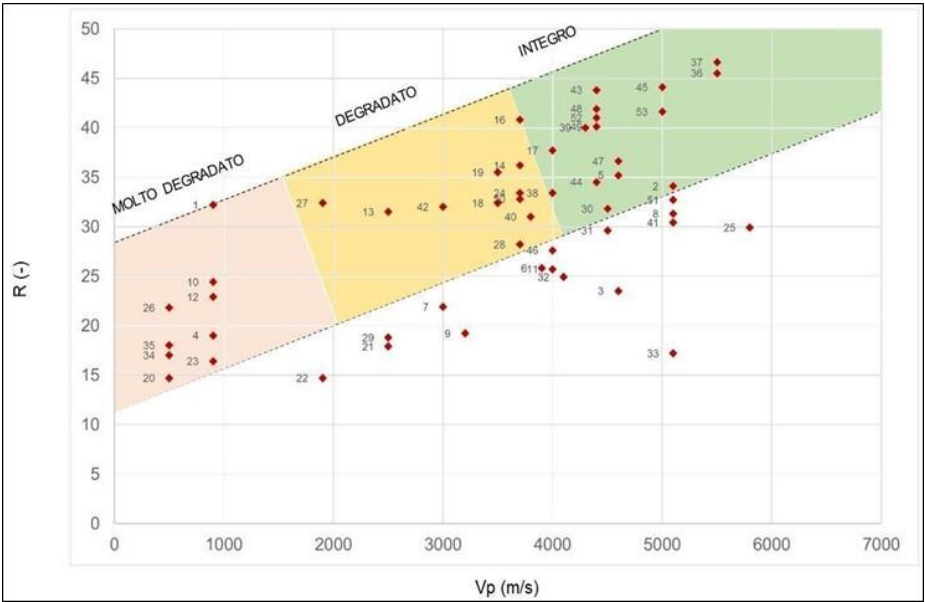
Regarding the corbels, the Pietra Serena sandstone beams, which have been in place for approximately 100 years ago, show evident surface degradation, already slightly repaired in previous restorations, caused by heavy exposure to rainwater and water percolating from the upper walkway. This aspect is clearly highlighted by the results of the georadar, sonic, and rebound hammer tests performed.

The comparison of the measured sonic velocities ( $V_p$ ) and the rebound index ( $R$ ) from the rebound hammer test, both indicative of the cortical state of the material investigated, provides a clear indication of the level of degradation of the Pietra Serena sandstones of the corbels (Figure 15).

**Figure 15.** Ratio between  $V_p$  and  $R$  for Pietra Serena beams of the corbels to verify the level of surface degradation.
