# An Empirical Examination of the Adverse and Favorable Effects of Marine Environmental Conditions on the Durability of Optical-Fiber Submarine Cables

Yukitoshi Ogasawara

This study investigates the factors contributing to the degradation of spirally wound armored steel wires used to protect core-structured unarmored optical-fiber submarine cables, driven by coupled multi-factor corrosion mechanisms in marine environments. It also assesses the influence of physical properties of deep-sea sediments on the durability of unarmored cables. The objective is to establish a scientific basis for cable longevity by integrating theoretical insights with empirical evidence. Although the steel utilized in armor is cost-effective and durable, it remains vulnerable to corrosion. Since the inaugural practical deployment of submarine communication cables between the United Kingdom and France in the 1850s, only a limited number of studies worldwide have examined the armor's corrosion and durability. Furthermore, there is limited literature on the physical characteristics of deep-sea surface sediments that directly affect the service life of the mechanically fragile polyethylene sheath. An in-dept

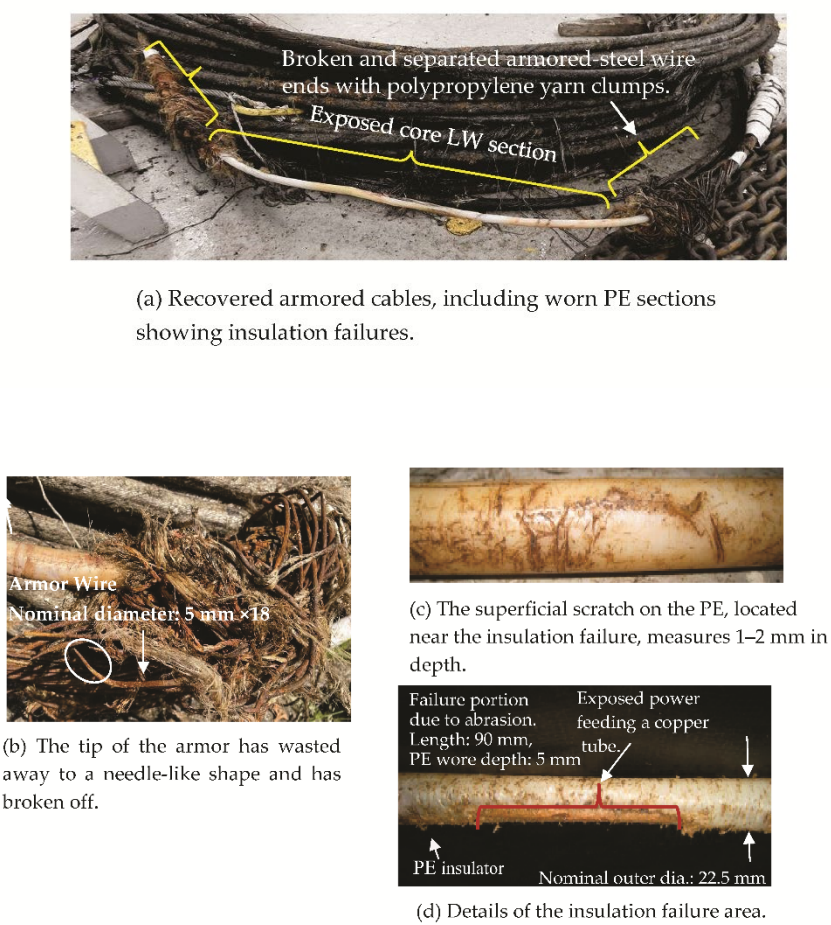
Figure 7. (a–d) A detailed view of an insulation failure within a section of the single armored cables.

Figure 7 illustrates a typical insulation failure that occurs when the PE insulator in armored cables is damaged due to environmental factors, and Figure 8 shows the same failure in unarmored cables. Mechanical damage from external forces, such as friction, is clearly the main cause of

| Ref. Figure | Cable Type | Water Depth (m) | Laying method | Changes in cable condition affect insulation failure | Identification of failure locations and the undersea environment |
|---|---|---|---|---|---|
| 7 | Single armored (SAM) | 200 | Surface Lay (The application of the burial method was not possible due to the underlying feature forming a steep slope of rock.) | (1) The tip of the damaged armor is needle-like due to corrosion wastage (shown by the white circle in Fig. 7(b)). When a cable is subjected to external forces and vibrates, the spirally wound armor wire gradually fails due to metal fatigue. | Tsugaru Strait.<br>Within narrow straits, cauldrons sculpt the seabed, setting up steep valleys.<br>The Tsugaru Warm Current, which flows eastward through this topography, interacts with tidal streams that periodically vary in response to tidal-level fluctuations on both sides of the strait, producing intricate, rapidly flowing currents. Details will be described in Section 3. |
| | | | | (2) Residual forces within the armor shrink both ends of the broken armor axially along the cable, simultaneously pulling on the polypropylene threads that protect the armor from corrosion. As a result, the core's LW is exposed. (Fig. 7(a)) | |
| | | | | (3) Furthermore, numerous surface scratches and complex friction marks were observed on the LW surface (Fig. 7(c)), indicating exposure to a harsh environment. | |
| | | | | (4) At the fault location shown in Fig. 7(d), a part of the PE has worn away in the cable's axial direction, exposing the power-feeding conductor. | |

Based on the analysis above, the environmental factors that are detailed in Section 5 are responsible for cable failures in both the eastern and western regions. Armor corrosion results from these multi-coupled environmental factors. Although an AC-electrified railway tunnel and submarine power cable are near the fault area and cross the studied communications system, there is no clear evidence of armor corrosion from stray currents originating from these artificial sources. Furthermore, no other industrial activities, such as fishing, contributed to the cable failure (see Figure 7 (a–c)), and human factors were not responsible.

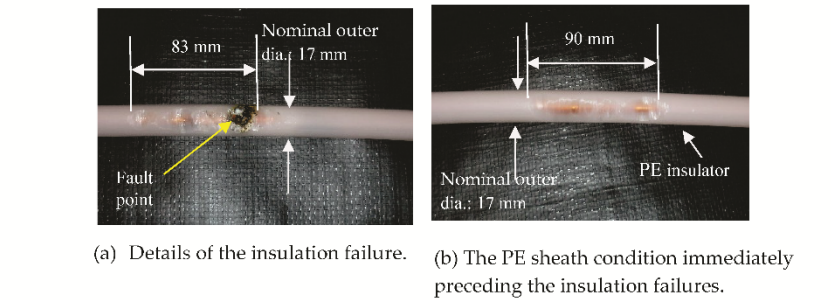
Figure 8. (a, b) A detailed view of an insulation failure within a segment of the unarmored cables (LW).

| Ref. Figure | Cable Type | Water Depth (m) | Laying method | Changes in cable condition affect insulation failure | Identification of failure locations and the undersea environment |
|---|---|---|---|---|---|
| 8 | Un-armored (LW) | 4000–6000 | Surface Lay | The contact surface between the cable and the seabed in a hanging section has sharp edges which cause localized damage to the PE sheath due to friction, exposing part of the power-feeding conductor. | A decreasing thickness of surface sediments has been reported in the subduction zone of the Northwest Pacific; see Section 4 for details. |

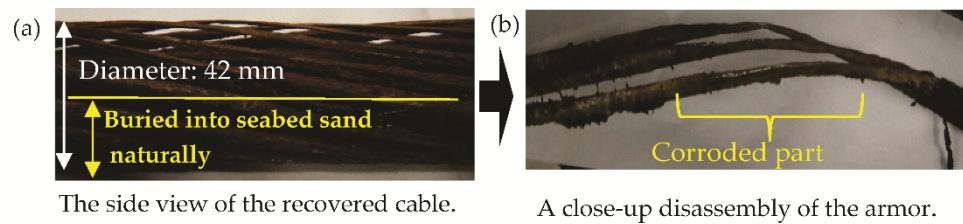
Figure 30. (a, b) Detail view of the recovered cable.

The recovered cable and the sections with reduced armor thickness due to corrosion are illustrated in Figure 30.

Since it was not possible to distinguish the upper and lower surfaces of the recovered cable on the seabed based on its appearance, the side exhibiting thinning of the armor wire due to corrosion was presumed to be the upper surface and was subsequently analyzed.

As shown in Figure 30(a), only the upper surface of the armor is corroded. The lower surface cable is believed to have been partially buried naturally in the seabed sand due to its weight in water and to have been protected from seawater flow. One possible cause of corrosion is environmentally coupled multi-factors, such as wet corrosion, seawater flow, and the Earth’s magnetic field. Conversely, as shown in Figure 30(b), the armor diameter is thinning. Figure 31 presents the measurement results for the armor’s outer diameter, including the thinned region.

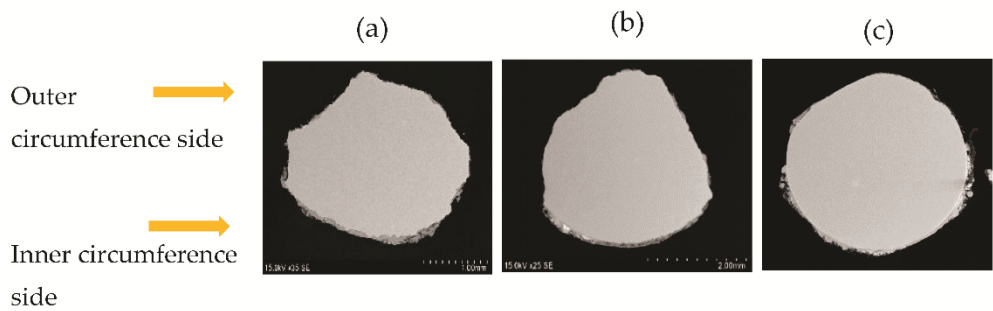
Figure 32. Compares corrosion progression as observed by SEM.

Figure 32. illustrates cross-sectional observations obtained through SEM of three regions: (a) with a significant thinning, (b) with a moderate thinning, and (c) with a minimal thinning in Figure 31.

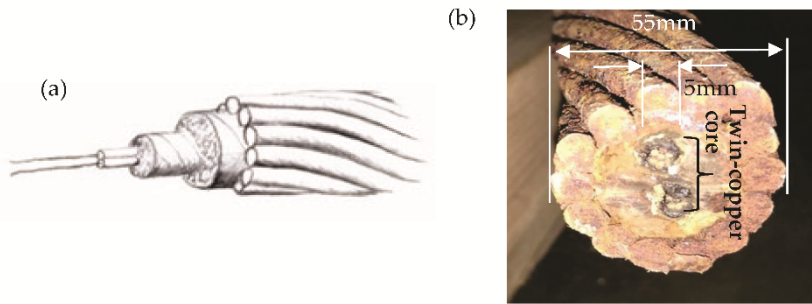
**Figure 35.** Details of the recovered Nemuro-Kunashiri Island cable.  
(a) Structural Appearance, Courtesy of Mr. Hiroaki Kubo in Hokkaido, Japan.  
(b) Close-up of the cross-section and dimensions, courtesy of Nemuro City Hall in Hokkaido, Japan.

Figure 35 illustrates the structural appearance and cross-section of the recovered cable.
