# Catastrophic Failure Analysis of a Wind Turbine Gearbox by Finite Element Method and Fracture Analysis

Posted Date: 27 September 2024

Keywords: Renewable energy; wind turbine; gearbox; catastrophic failure; fatigue

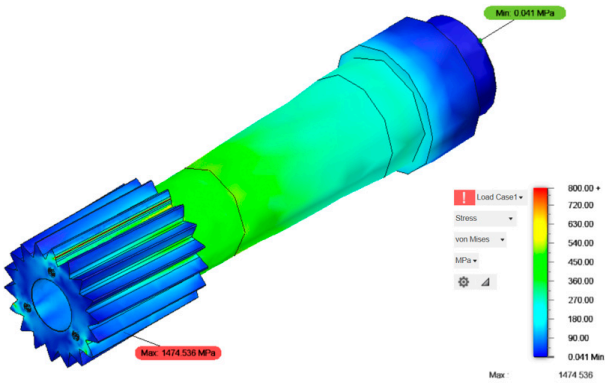
Figures 4 and 5 show the von Mises stresses throughout the sun shaft. The highest stress was found in the contact area of the teeth, reaching a maximum of 1,474.536 MPa.

Figure 4. Maximum von Mises stress (MPa).

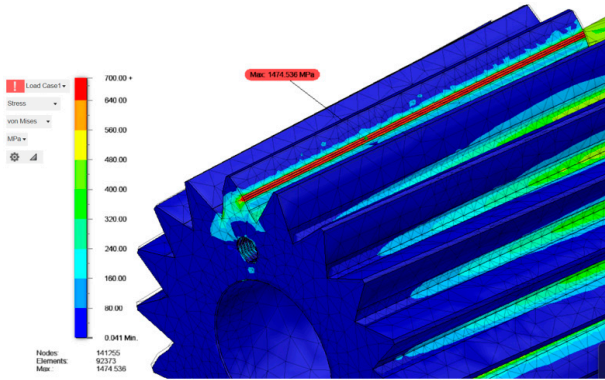
Figure 5. Profile of von Mises stress localized on the tooth.

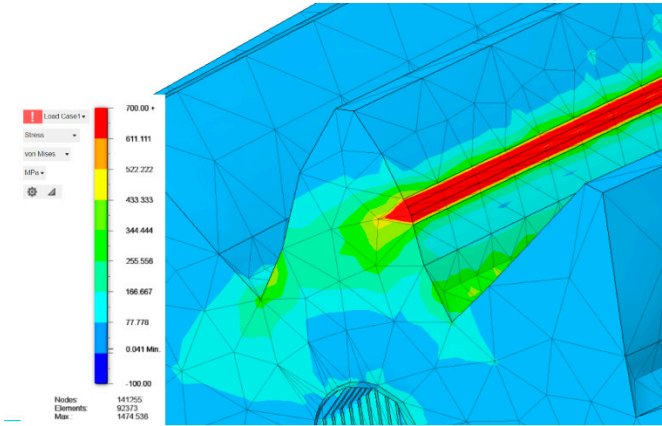
Figure 6 shows the morphology of the von Mises stress. The region of the highest contact and the gradient of stresses are more evident, with the tooth fillet revealed as the second region of high stress. The top land of the tooth does not present high stress.

Figure 6. Profile of von Mises stress localized at ½ length in the tooth.

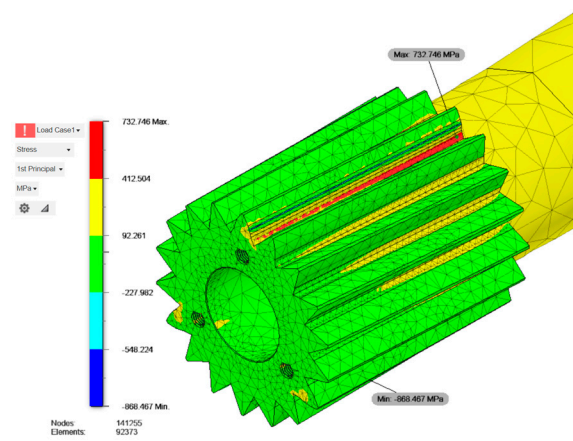
Principal stress  $\sigma_1$  (Figure 7) shows the maximum stress at the region of the tooth fillet as the minimum stress. The maximum value is 732.746 MPa, and the minimum is -868.467 MPa. Figure 8 demonstrates stress  $\sigma_3$  with a maximum compressive stress of -1,978.142 MPa and a tensile stress of 125.383 MPa.

Figure 7. 1st principal stress on tooth.

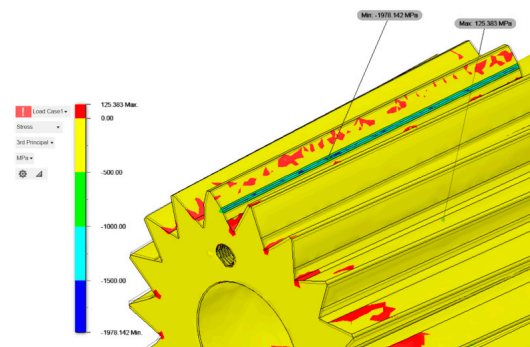
Figure 8. 3rd principal stress on tooth.

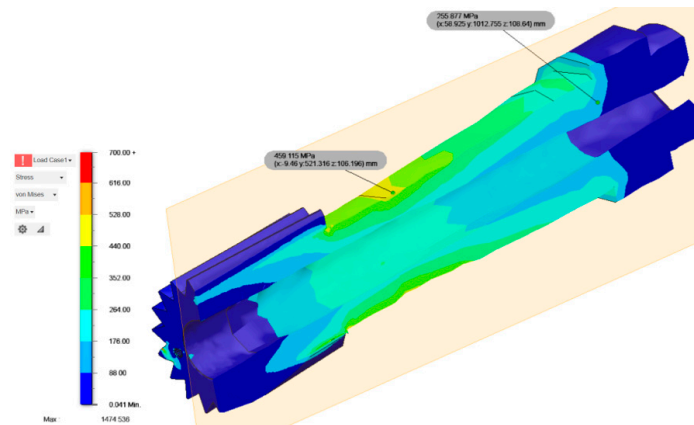
Figure 9 shows a longitudinal cross-section of the sun shaft. There is a von Mises stress of 755.877 MPa close to the spline, where the shaft has a fixed constraint. And a stress of 459.115 MPa close to the gear at the external diameter of the shaft.

Figure 9. Distribution of von Mises stress along the sun shaft.

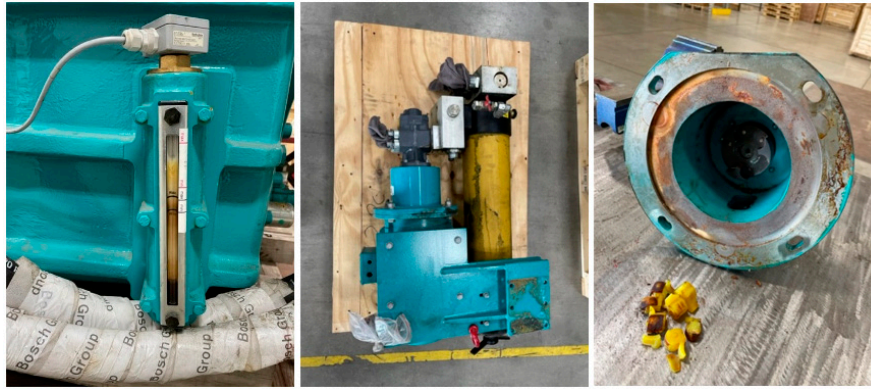
The analyses with pictures that follow demonstrate the significant changes in the original condition or design of the gearbox and its peripherals. The first hint obtained from the condition of the lubrication system was the glass window, which showed a significant presence of air in the oil, creating a thick foam (Figure 10 - left). Also, with the hydraulic system (Figure 10 – mid) disassembled, it was verified that the coupling had the main spider slatted (Figure 10 – right), which created temporary miss lubrication and mechanical/hydraulic impacts in the system

**Figure 10.** Lubrication system (**left**) foam into the oil (**mid**), coupling spider slattered (**right**).

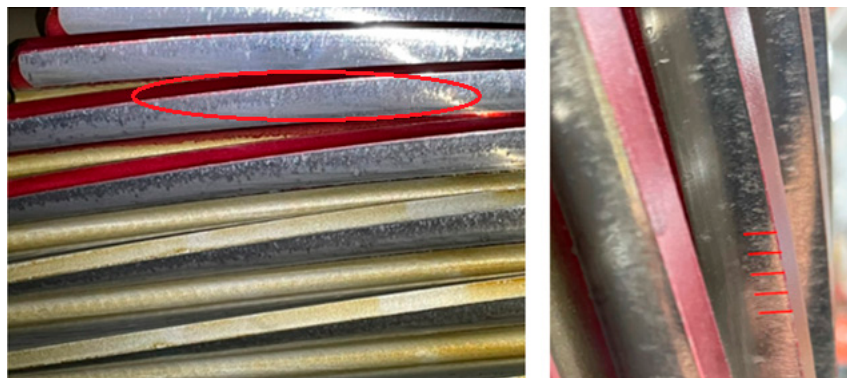
**Figure 11.** High-speed shaft teeth.

When looking closer at the high-speed shaft, noticeable adhesion wear marks are seen on the teeth' faces and close to the flank. Adhesion wear marks were also localized on the teeth' faces (Figure 11 - right) and close to the flank (Figure 11 – left).

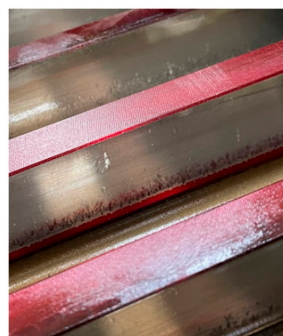
**Figure 12.** Low-speed gear.

The low-speed gear presented many dents on the teeth, most likely due to material between the teeth contacting the intermediate shaft gear. When measured, the dents presented a surface roughness of around 4.8 microns (Rz) (Figure 12).

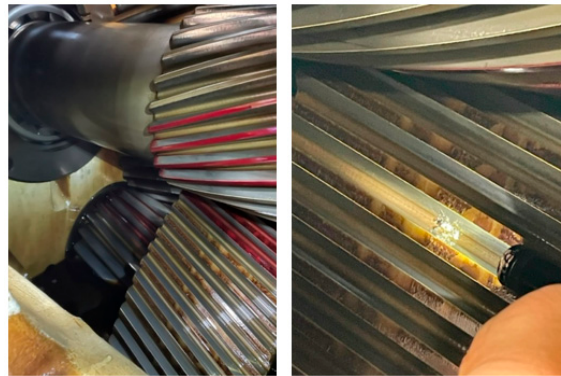
A few particles were found stuck on the teeth roots when looking at the connection between the high-speed shaft and the intermediate spur gear (Figure 13).

**Figure 13.** View of the HSS and Intermediate helical gear engagement.

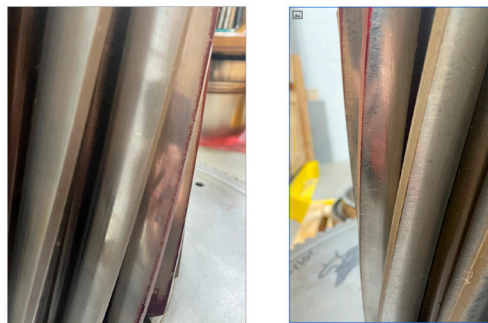
**Figure 14.** Intermediate shaft.

Figures 14 and 15 present a visual analysis that reveals that both sides of the gear do not present damages like dents, risks, or deep scratches; it has only a few fretting (risks) at the bottom of the teeth, but they are very minor and not significant for the gearbox's functioning.

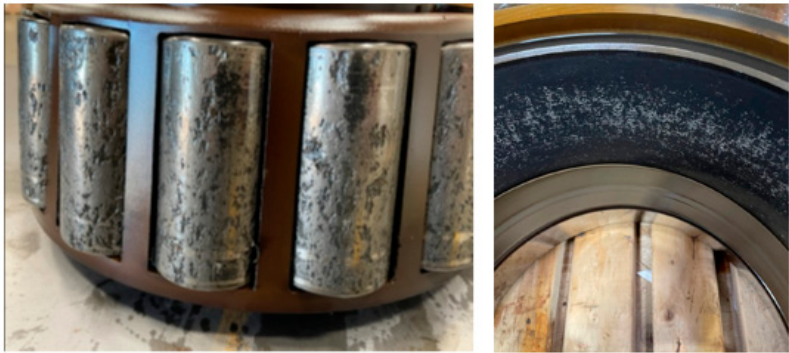
The sun shaft and the bearings had damage. Figure 16 shows the conditions of the planet's bearings. It exhibits the damages on the rollers, which had the black coating peeled off and pieces of material removed from them, and the inner part of the outer race, which also had the black coating detached from it.

**Figure 16.** View of the planet gear bearing.

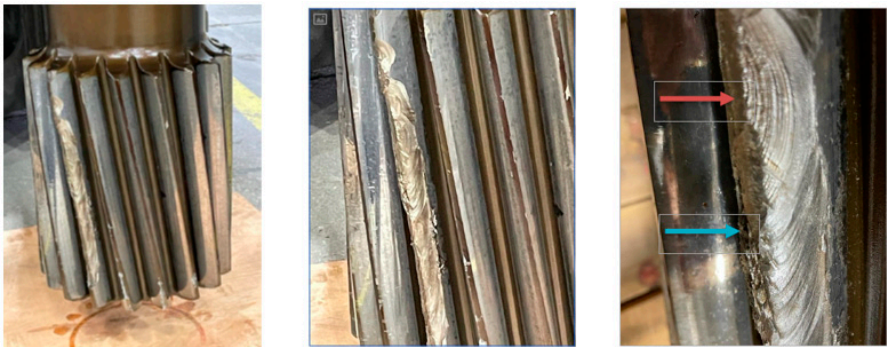
Among the gears analyzed, the sun shaft was the most damaged. It presents craters on the dedendum, flank, and tooth face. All defects are highly detrimental to the part and easily contribute to the final fracture (Figure 17). The teeth show many crack initiation and beach marks. The crack nucleation started at the tip of the tooth and moved toward the flank (see arrows). Beach marks reveal the propagation of the cracks throughout the flank of the sun shaft tooth.

**Figure 17.** Sun shaft – upper arrow shows crack propagation / lower arrow shows core separation.

With that said, the failure of the gearbox occurred because of a premature fracture of the sun shaft since it suffered predominantly a fatigue phenomenon (evidenced by beach marks on the tooth), even though a few signs of impact were observed. Moreover, there were multiple points where the teeth's surface had cracks initiated at the top land. In addition, a void was observed underneath the teeth due to a clear void in the sun shaft tooth (inclusion into the material). The gearbox was also compromised due to contamination of metallic particles peeling off planet gears' bearing coating. The cause of black coating removal was pitting corrosion.

This study reinforces the need for strict controls on heat treatment in terms of case depth thickness and hardness, control of raw material cleanliness, regular visual inspections, mainly by borescope, at the planet stage and high-speed shaft, vibration monitoring at the same stages, oil contamination monitoring, and regular checking of the lubrication system, manifold, filter cartridge, and coupling.

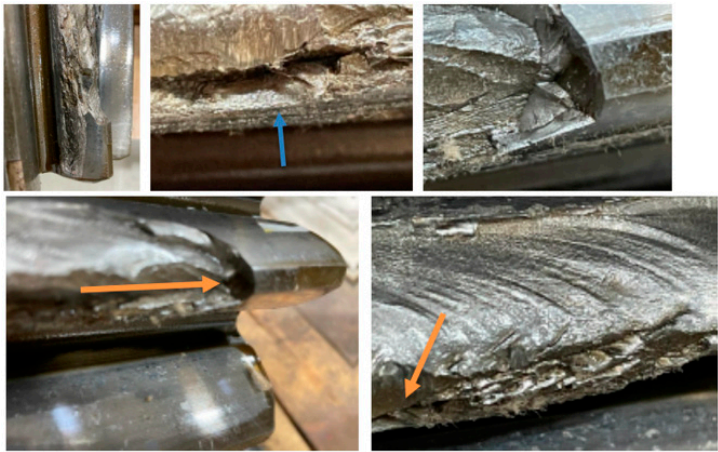
Moreover, on the top of the tooth, there is a crack where the material separation occurred, with a crack flowing throughout the tooth length, called Case/Core separation (Figure 18). It usually happens when compressive residual stresses in the case exceed the tensile strength of the material in the core near the tooth tip due to excessive case depth at the tip (Errichello & Milburn, 2020) (Parrish, 1999) (AGMA, 2014). Internal cracks propagated, causing corners, edges, or entire teeth’s top land to separate. Cracks can appear immediately after the heat treatment, during handling or storage, or after time in service. (Parrish, 1999).

**Figure 18.** Sun shaft – arrows show material separation.

A lack of material is noticeable at the bottom of the tooth, which indicates a void generated by inclusion (Figure 18 – bottom left). On the other side of the tooth, the flank had material severely removed and deformed plastically (smashed), which indicates that there were also heavy impacts on the gearbox (Figure 19).

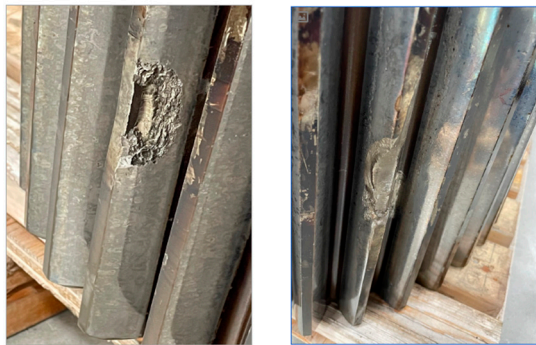
Figure 20. Planet gears.

A visual inspection of the planet gears revealed severe damage with chunks of teeth missing. This occurred most likely due to pieces of the bearing rollers falling between the sun shaft and planet gears and at the bottom of the tooth ring (Figure 20). Once the tooth ring has particles within the teeth, the contact with the planet gears generates intense damage (profound craters, dents, and marks).

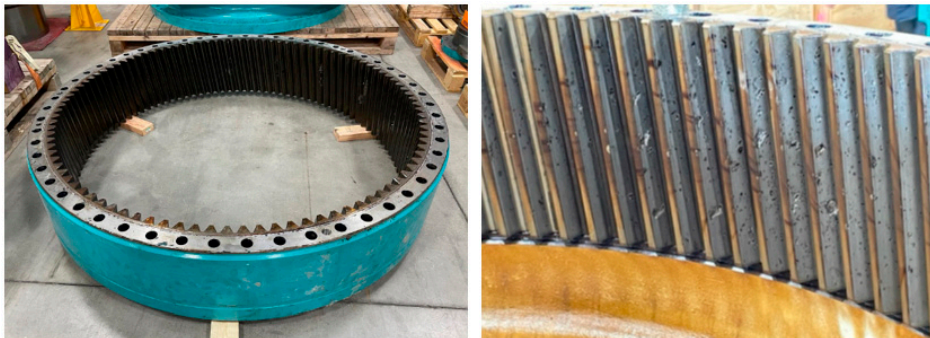
Figure 21. Ring gear.

The next step was verifying the ring gear’s integrity, as shown in Figures 21–23. These figures show how severely the metallic particles damaged the tooth ring.

The planet gears, sun shaft, and roller bearings had chunks of material peeled off. And the tooth ring was completely damaged with many dents on the bottom of the gearbox due to the falling of the pieces of the parts' metal by gravity.

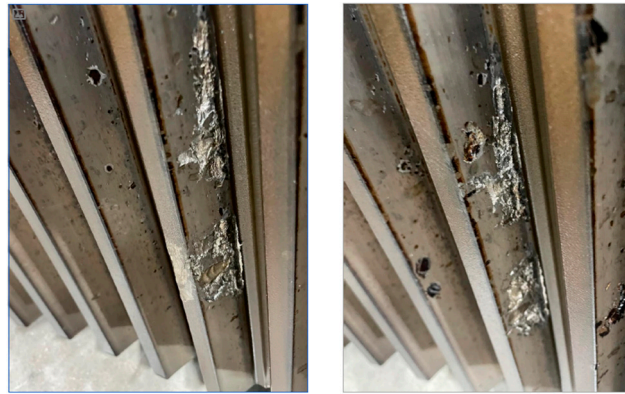
**Figure 22.** Ring gear teeth.

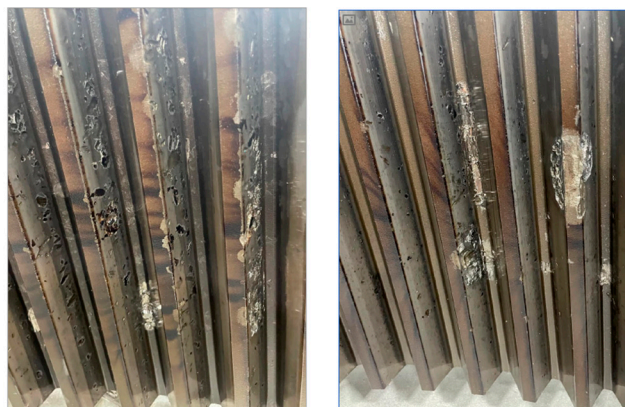
**Figure 23.** Ring gear teeth.
