# Early 20th-Century Mortars from Teatro Nacional de São João (Porto, Portugal): Characterization of Degradation Mechanisms

Posted Date: 5 February 2026

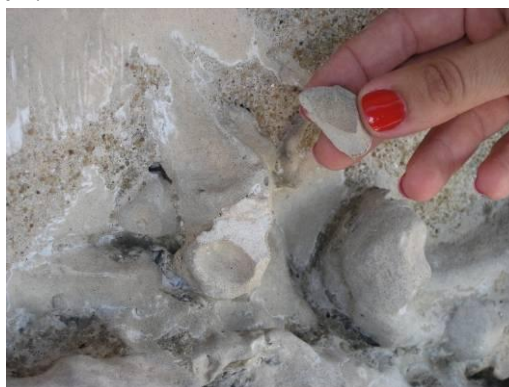
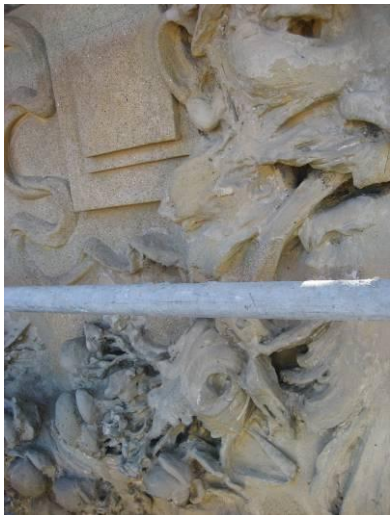
(a)

**Figure 2.** Sampling performed on facades of TNSJ. Samples: a), b) FPo-2 Polymorphic motif (Zone evidently subjected to recent intervention, sample drawn by hand); c) FPo-8 Mask; d) FPo-10 Geometric ornament; e) FPri-A1P1 Frieze; f) FPri-PB Frieze, bottom part; g) FN-V2P1 Flower ornament.

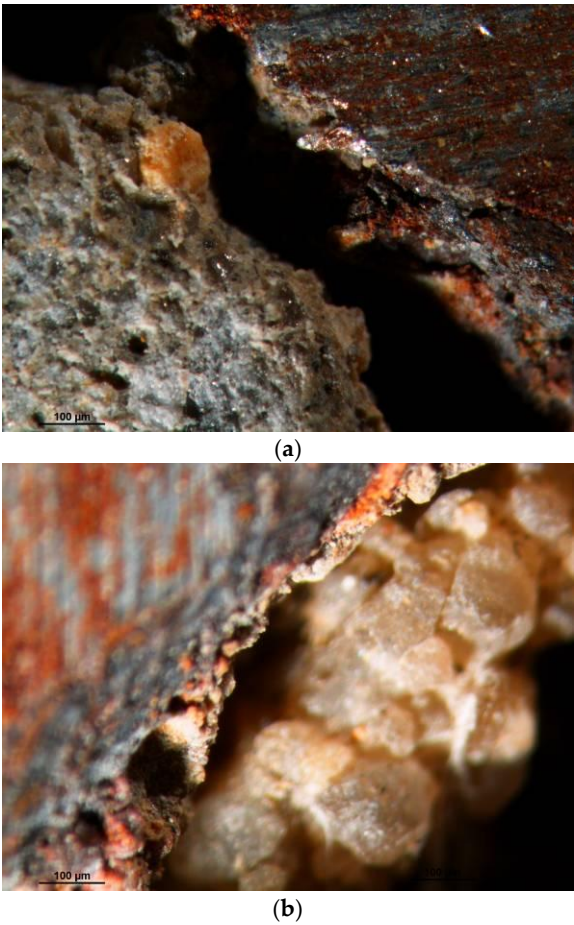
Polished surfaces of the steel/mortar interface were viewed under the optical microscope to evaluate the effect of corrosion. The mortar thickness over the steel structure varied extremely, ranging from barely a few mm to 6 to 7 cm. Figure 7 depicts the lack of cohesion between mortar and steel and the corrosion of the steel frame.

**Figure 7.** Steel structure/mortar interface showing strong discontinuity and steel corrosion FPo-8.

Mortar carbonation was extensive, reaching the steel frame, due to environmental action and possibly porous mortars at an initial stage. This led to steel depassivation and consequent corrosion and expansion of the steel frame. This fact created the main problems in the various ornaments in TNSJ facades, as the stresses produced by the volume increase of the steel frame created generalized cracking in mortars and lack of cohesion between the mortar and the steel. Mortars over the steel frame are almost loose and prone to detachment.

Study of early 20th Century mortars is crucial towards the adequate conservation of buildings from this specific time, many of which need intervention. This experimental architectural solution was used in various other cases. Mortars made with natural cement or lime/cement mixes must be repaired with hydraulic binders with similar characteristics (physical and mechanical) as those of the original mortars. Decisive factors for success in this intervention are high mortar pH and suitable coating thickness, whenever steel frames were used.
