Critical Failures in Aviation Components: The Role of Hydrogen Embrittlement

Kadir Kaan Karaveli ^{1,2}, Mete Kalaycioglu ¹, Burak Bal ² and Tamer Saracayakupoglu ^{1,*}

¹ Turkish Aerospace Industries, 06980 Ankara, Türkiye; kadirkaan.karaveli@tai.com.tr (K.K.K.); kalayciolu@yahoo.com (M.K.)

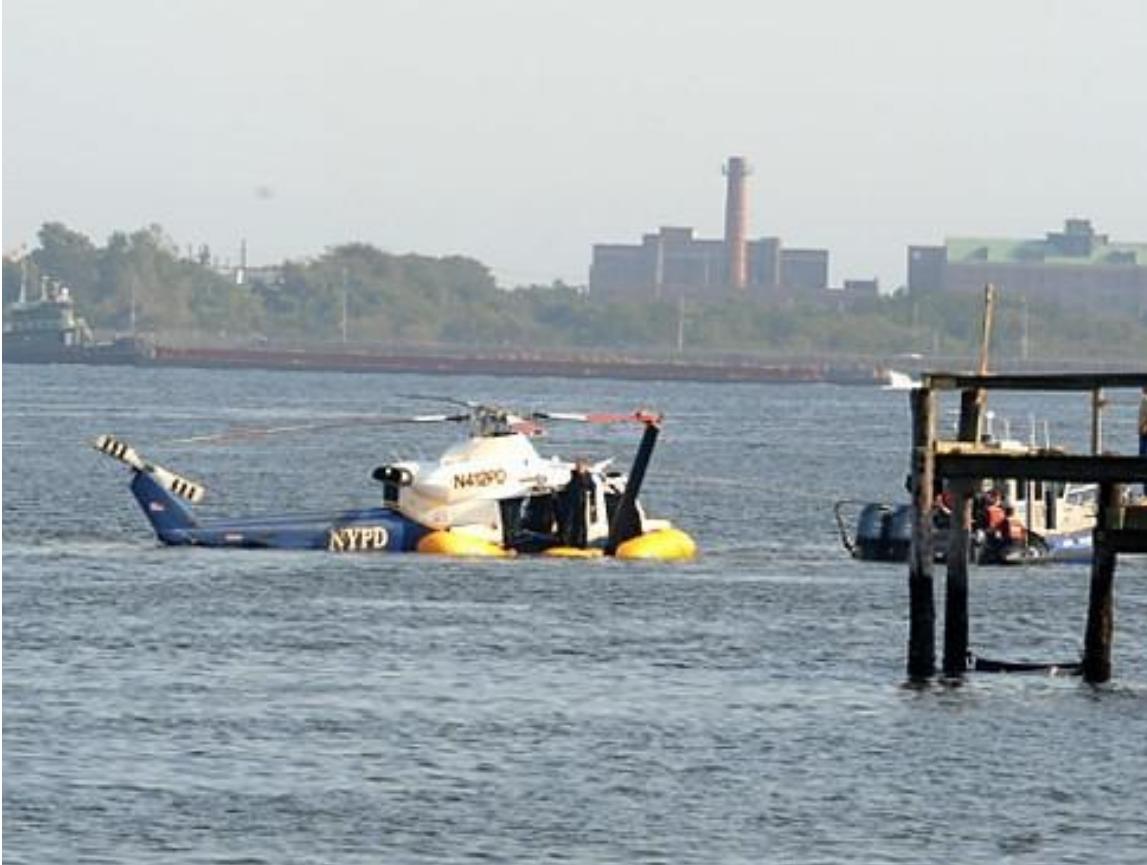
On September 22, 2010, a Bell 412EP helicopter, encountered a critical mechanical failure during its final approach to Floyd Bennett Field in Brooklyn, New York. The sudden mechanical failure forced the pilot to execute an emergency autorotation landing into Jamaica Bay. Thankfully, all six crew members sustained only minor injuries, but the helicopter suffered significant damage, particularly to its powerplant system. The flotation devices, shown in **Figure 5**, successfully deployed, preventing the helicopter from sinking despite the severe damage incurred during the emergency landing.

Figure 5. The Bell 412EP helicopter resting in Jamaica Bay after the emergency landing [64].

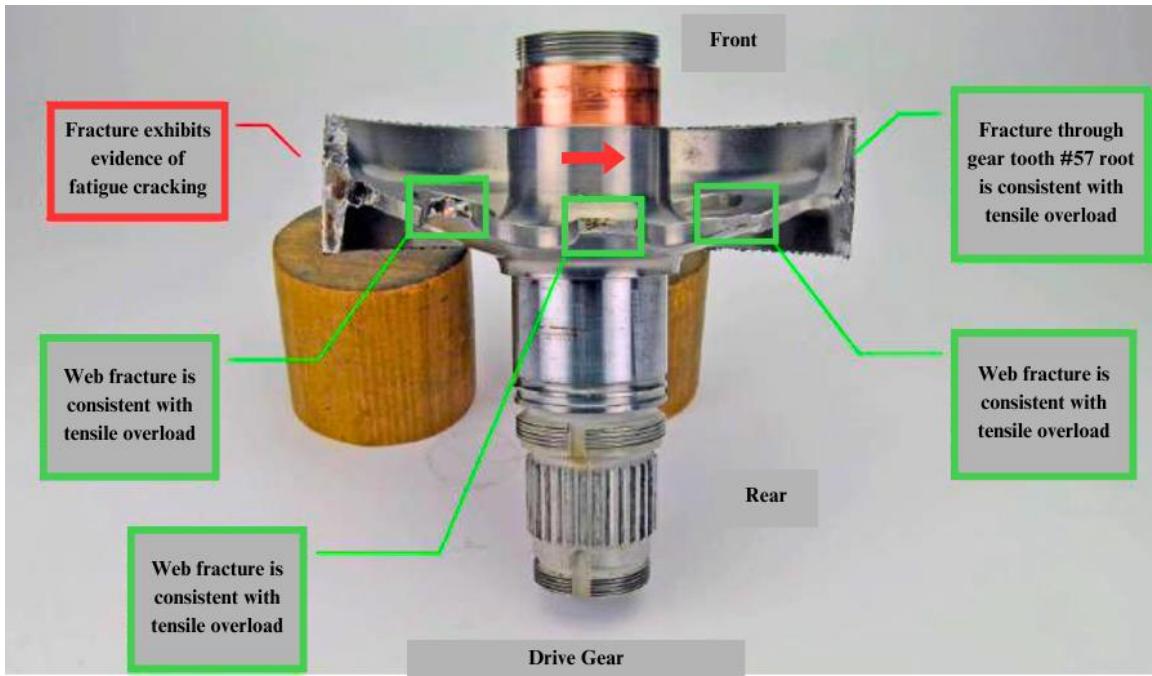
Subsequent investigations pinpointed the failure's origin in the output drive gear (ODG) of the helicopter's reduction gearbox. A detailed metallurgical analysis revealed a fatigue fracture that initiated at the root of one of the gear teeth, shown in **Figure 6**. The fracture propagated due to hydrogen embrittlement (HE), a phenomenon where hydrogen atoms penetrate the metal, resulting in brittleness and cracking. The microscopic examination identified both intergranular and transgranular crack propagation patterns, which are hallmark indicators of hydrogen embrittlement.

Figure 6. Detailed view of the fractured output drive gear from the reduction gearbox [64].

The Bell 412EP incident underscores the urgent need for improved manufacturing controls and rigorous quality assurance to address hydrogen embrittlement risks. The current reliance on destructive testing for hydrogen detection is inadequate for comprehensive component evaluation. This incident exemplifies the critical importance of advancing non-destructive testing methods to identify residual hydrogen during manufacturing and maintenance. By implementing these improvements, the aviation industry can enhance the reliability of high-stress components and mitigate risks associated with hydrogen embrittlement.

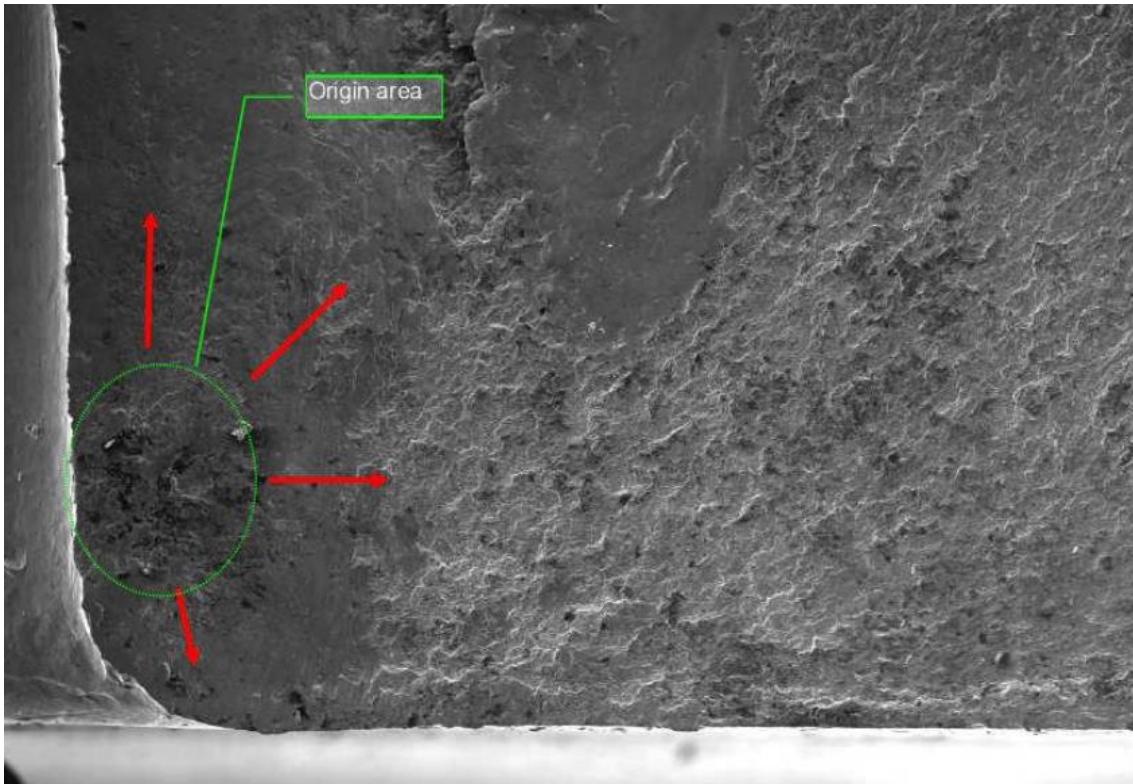
The microscopic examination provided further insight into the failure mechanism. As depicted in **Figures 7 and 8**, intergranular cracking at the gear tooth root and distinct patterns of fatigue crack propagation were observed. The intergranular cracking, shown in **Figure 7**, highlighted hydrogen's role in weakening grain boundaries, making the material more susceptible to stress. Meanwhile, **Figure 8** revealed the propagation of fatigue cracks emanating from the hydrogen-embrittled region, with the microscopic evidence clearly indicating the insufficient removal of residual hydrogen during dehydrogenation treatments. Together, these findings confirmed hydrogen embrittlement as the root cause of the component's failure.

Figure 7. Close-up of the origin region of the fatigue crack on the output drive gear, showing the initial intergranular cracking due to hydrogen embrittlement [64].

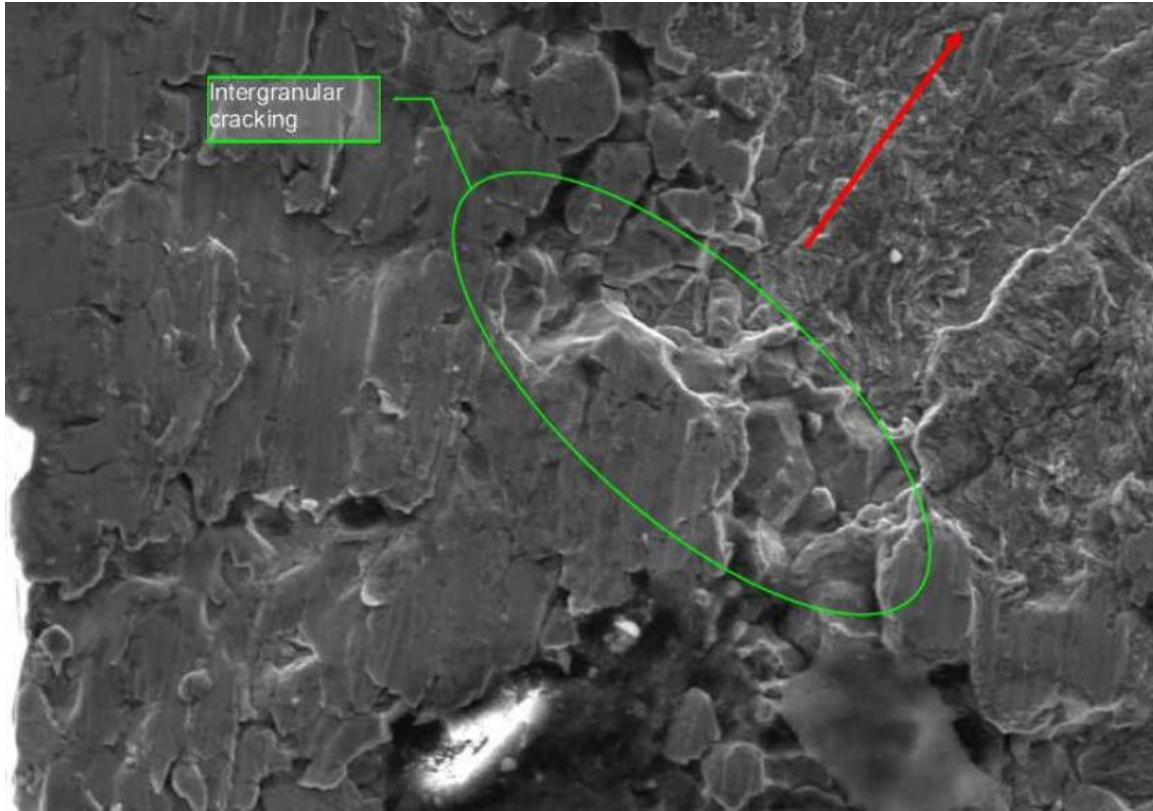
Figure 8. Microscopic view of the fracture surface, showing the distinct patterns of fatigue crack propagation starting from the hydrogen-embrittled region [64].

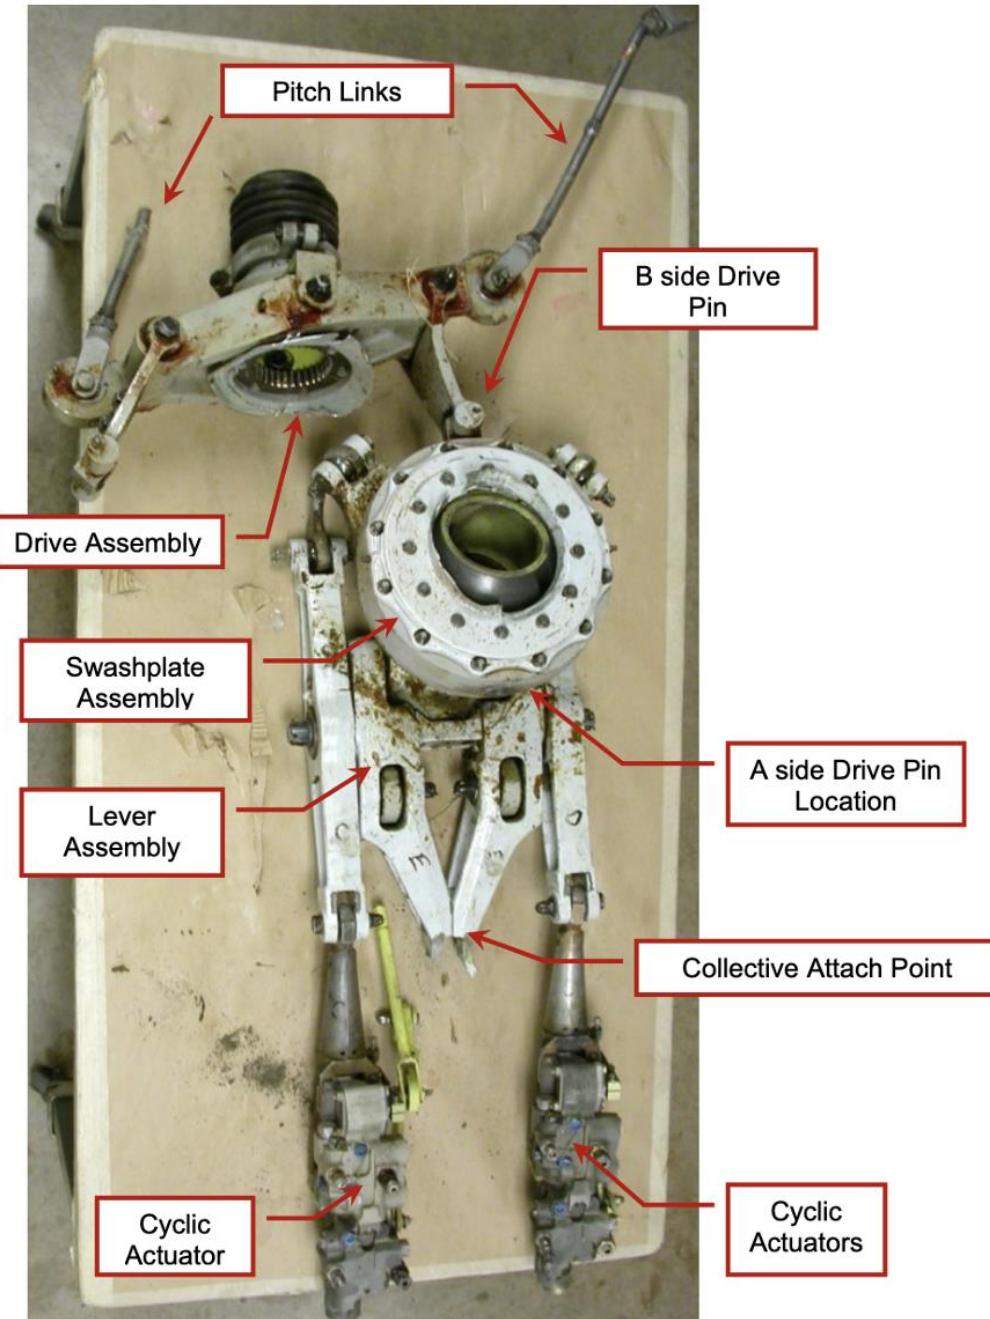
Subsequent investigations revealed that the primary cause of the structural failure was the fracture of the A-side drive pin within the swashplate assembly. Metallurgical analysis identified the fracture as overstress-induced, but further detailed examination of the fracture surface revealed brittle cleavage features and intergranular separations consistent with hydrogen embrittlement (HE). Measurements taken from the fractured pin confirmed hydrogen levels between 8.7 and 9.3 ppm, indicating that absorbed hydrogen significantly contributed to material degradation. **Figure 10** shows the rotor components after disassembly, with failure points, including the A-side drive pin, highlighted.

Figure 10. Separated rotor components prior to disassembly, highlighting the critical assemblies (swashplate, drive assembly, and pitch links) [65].

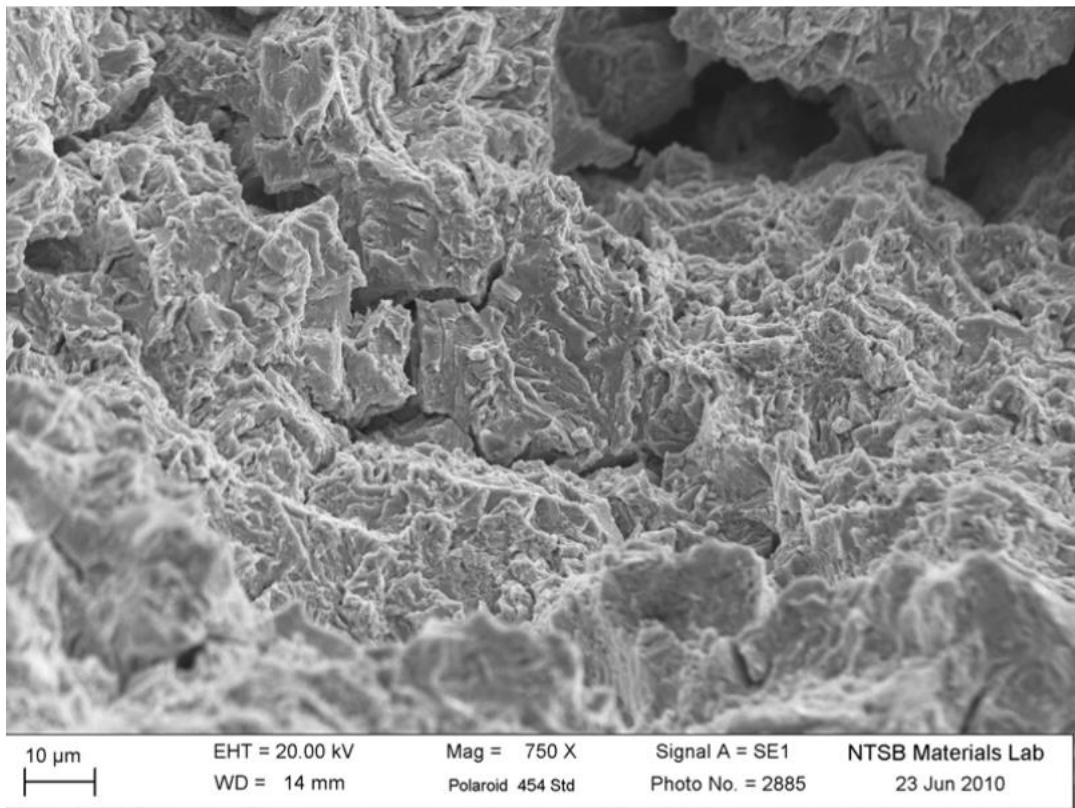
Further examination under a scanning electron microscope (SEM) provided critical evidence of the brittle failure mechanism. The fractured surface of the A-side drive pin showed brittle cleavage and intergranular separations, highlighting how hydrogen atoms migrated into areas of high stress within the material. This accumulation of hydrogen weakened the structural bonds, leading to the failure of the drive pin under conditions it would normally withstand. Additionally, **Figure 11** shows radial cracks on the washer face of the A-side pin, further supporting hydrogen embrittlement as a key contributor to the failure. These cracks, observed at low magnifications, intersect the primary fracture and demonstrate localized plasticity near initiation sites where hydrogen atoms accumulated.

Figure 11. SEM image of radial cracks on the washer face of the A-side pin, showing areas of localized plasticity [65].

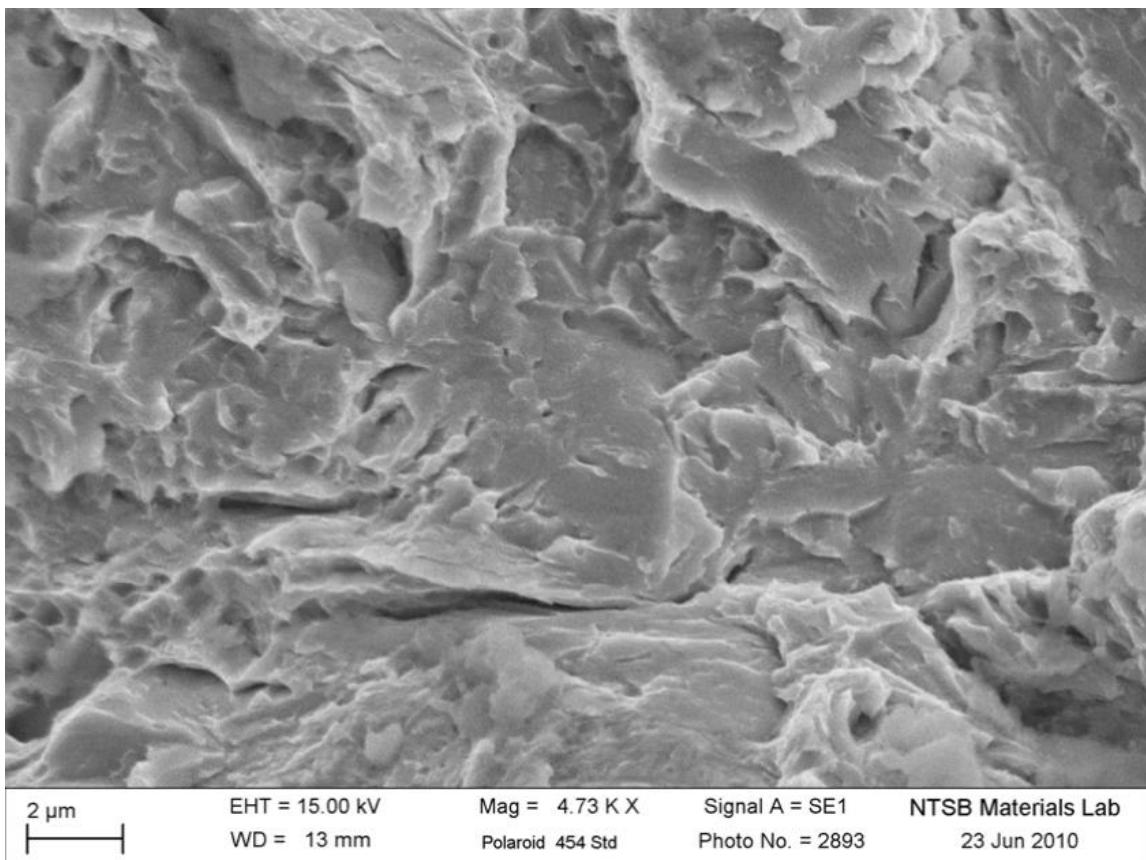
At higher magnifications, SEM analysis revealed ductile dimples adjacent to the main fracture surface, contrasting with brittle cleavage areas, as shown in **Figure 12**. This contrast suggests that the failure initiated in brittle regions due to hydrogen embrittlement and propagated until the final stages, where localized ductility emerged in isolated areas.

Figure 12. Higher magnification SEM image showing the transition between brittle cleavage and ductile dimples on the A-side drive pin fracture surface [65].

These findings highlight the urgent need for strict hydrogen control during the manufacturing and maintenance of aviation components. The incident involving the Bell 222U helicopter emphasizes the importance of comprehensive post-treatment procedures, such as baking after cadmium plating, to effectively remove absorbed hydrogen. Without these precautions, residual hydrogen can significantly weaken high-strength materials, potentially resulting in catastrophic failures in critical aerospace systems.

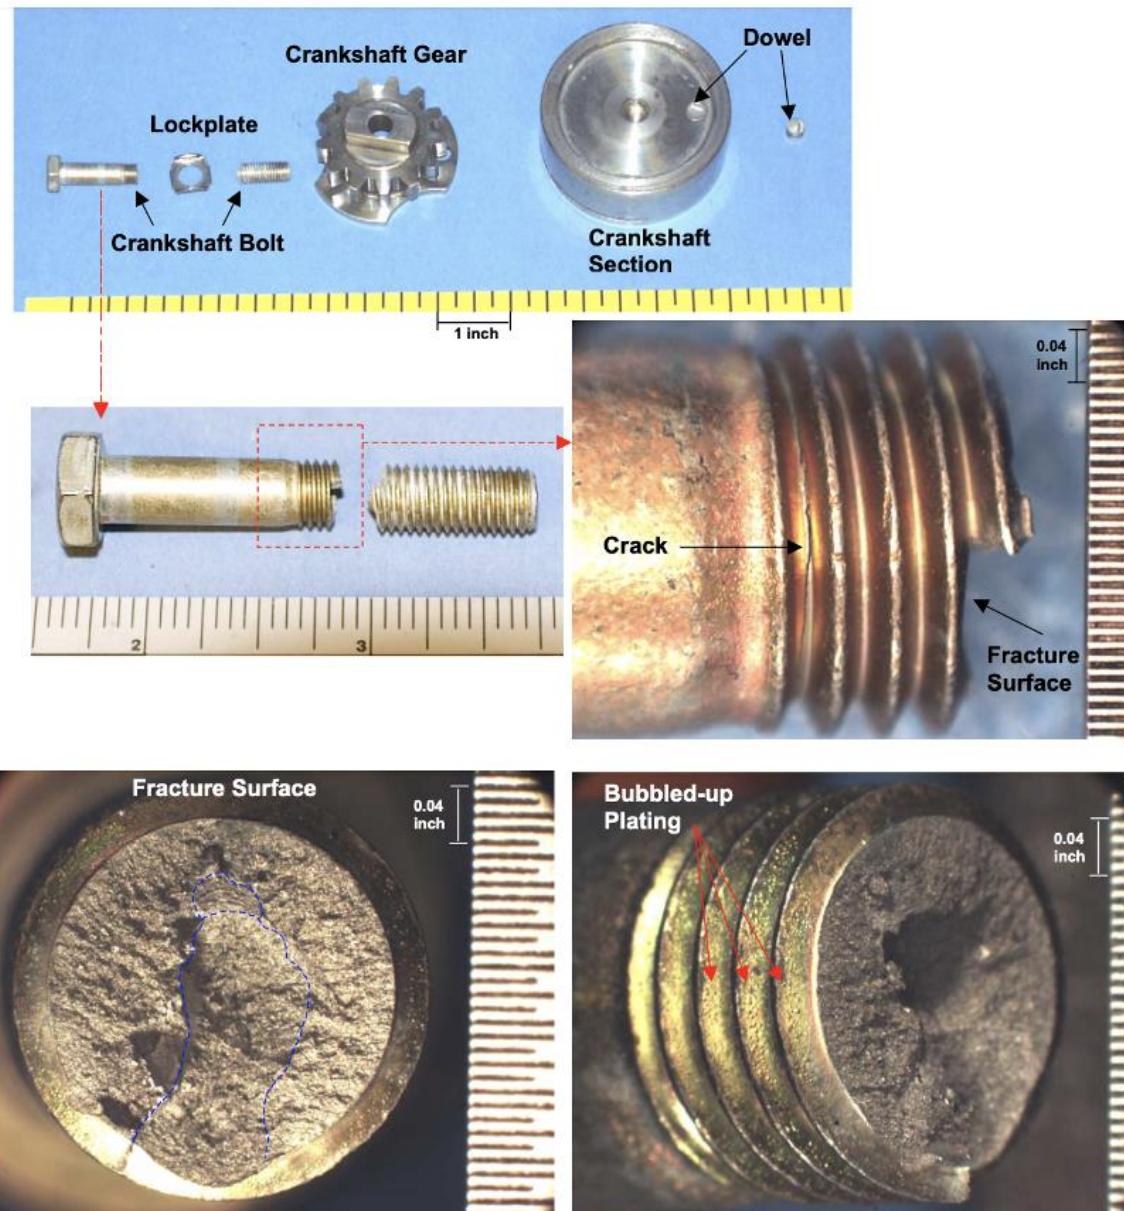
Investigations identified the failed crankshaft gear bolt (part number STD-2209, SAE J429 grade 8 steel) as the root cause. Metallurgical analysis revealed hydrogen embrittlement as the primary failure mechanism. This condition was traced to residual hydrogen introduced during the zinc electroplating process. Unlike cadmium-plated bolts traditionally used, the substituted zinc-plated bolts lacked effective post-treatment baking, a critical step to mitigate hydrogen absorption. **Figure 13** shows the disassembled crankshaft assembly, highlighting the fractured bolt.

Figure 13. Image of the crankshaft assembly and fractured crankshaft gear retaining bolt after disassembly [66].

This case underscores the critical need for robust post-plating treatments, such as baking, to eliminate residual hydrogen effectively. It also highlights the importance of continuous monitoring and material verification, especially for high-stress components. In response to this incident, the FAA issued an emergency Airworthiness Directive requiring the immediate replacement of zinc-plated crankshaft gear bolts to prevent similar failures.

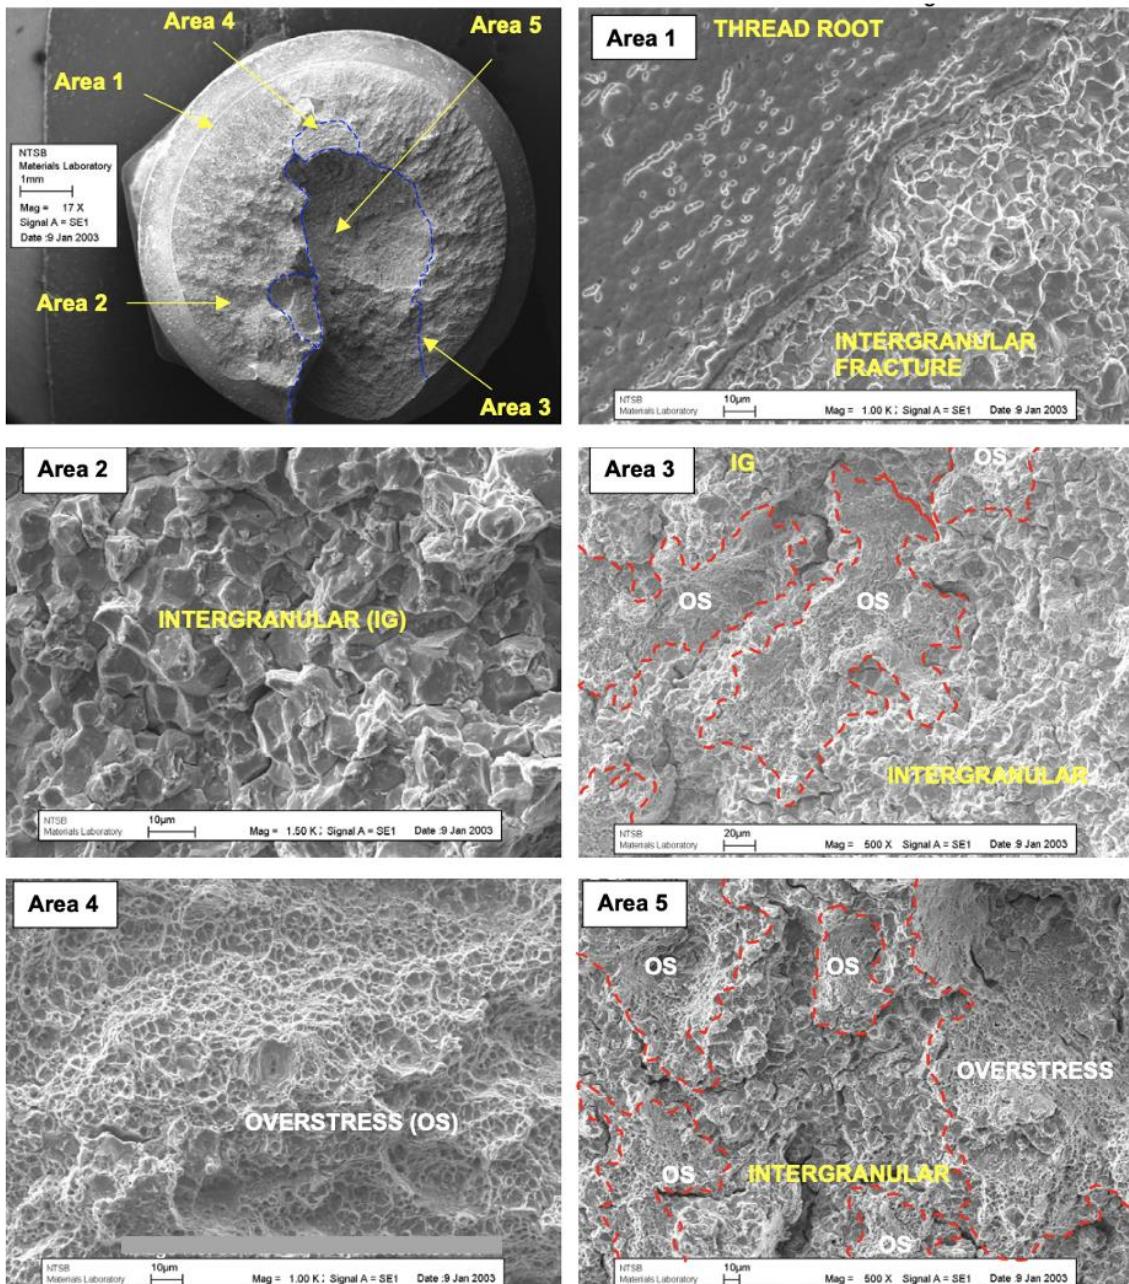
Scanning Electron Microscopy (SEM) provided insights into the failure mode, as illustrated in **Figure 14**. The fracture surface exhibited intergranular cracking and ductile failure patterns,

hallmarks of hydrogen-assisted cracking. The fracture originated at the thread roots and propagated radially due to accumulated hydrogen, compromising the bolt's integrity.

Figure 14. SEM image showing intergranular cracking along the fracture surface of the crankshaft bolt, indicating hydrogen-assisted cracking [66].

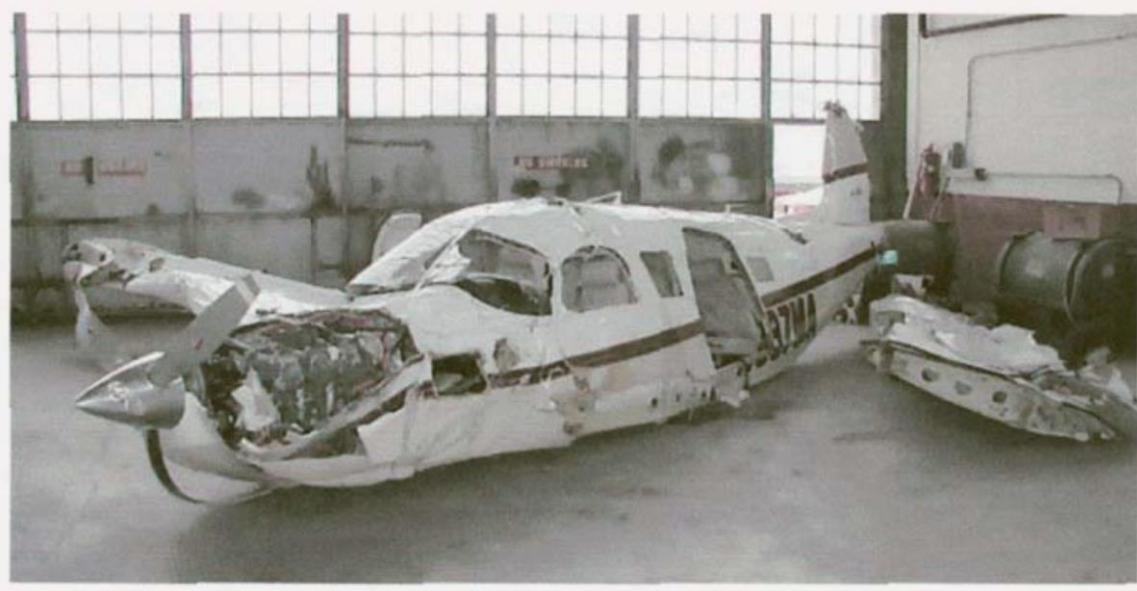
On June 7, 2002, a Piper PA-32R-301 suffered a catastrophic engine failure during a training flight near Key Field in Meridian, Mississippi. Operated by a private pilot, the aircraft experienced a sudden engine failure at 500-600 feet altitude, resulting in an emergency landing attempt. Unfortunately, the aircraft impacted a field and trees, overturning upon landing. The pilot sustained severe injuries, and the aircraft was destroyed. **Figure 15** illustrates the wreckage following its recovery.

Figure 15. Front view of the aircraft wreckage after recovery at Meridian Aviation [67].

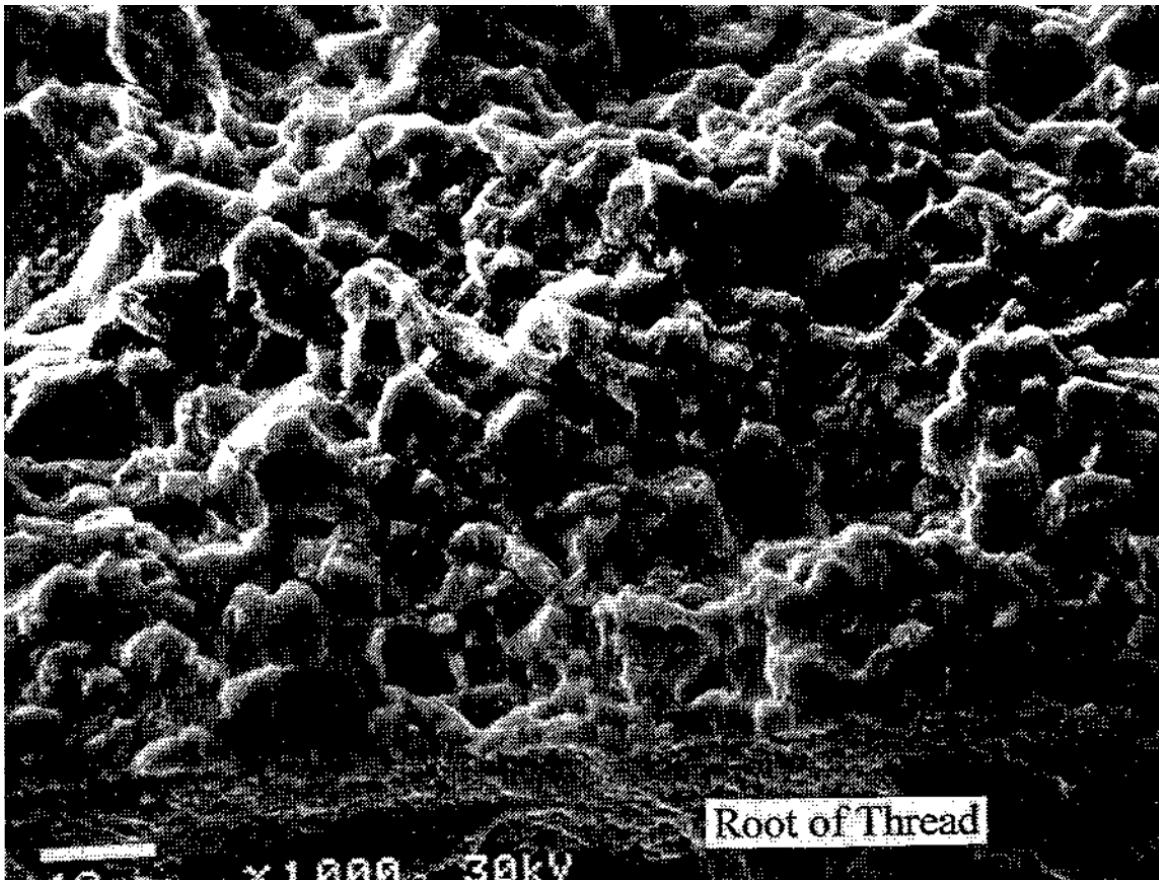
A thorough investigation of the crankshaft gear bolt failure by the Lycoming Materials Laboratory identified hydrogen embrittlement as the root cause. The bolt fractured primarily between the second and fifth threads from the shank, with additional cracks extending through the twelfth and thirteenth threads. These fractures exhibited intergranular separation, a distinct characteristic of hydrogen-assisted cracking. **Figure 17** provides a detailed SEM image, highlighting the intergranular separation indicative of hydrogen embrittlement.

The hydrogen embrittlement was traced to the zinc electroplating process, which introduced hydrogen into the bolt material. Despite conforming to specifications for hardness and coating thickness, the inadequate post-plating dehydrogenation treatments allowed residual hydrogen to remain, compromising the bolt's structural integrity. This residual hydrogen accumulated at the grain boundaries under operational stresses, leading to the initiation and propagation of cracks.

Figure 17. SEM image under 1000x magnification showing intergranular separation on the fractured surface of the crankshaft gear bolt, indicating hydrogen-assisted cracking [67].

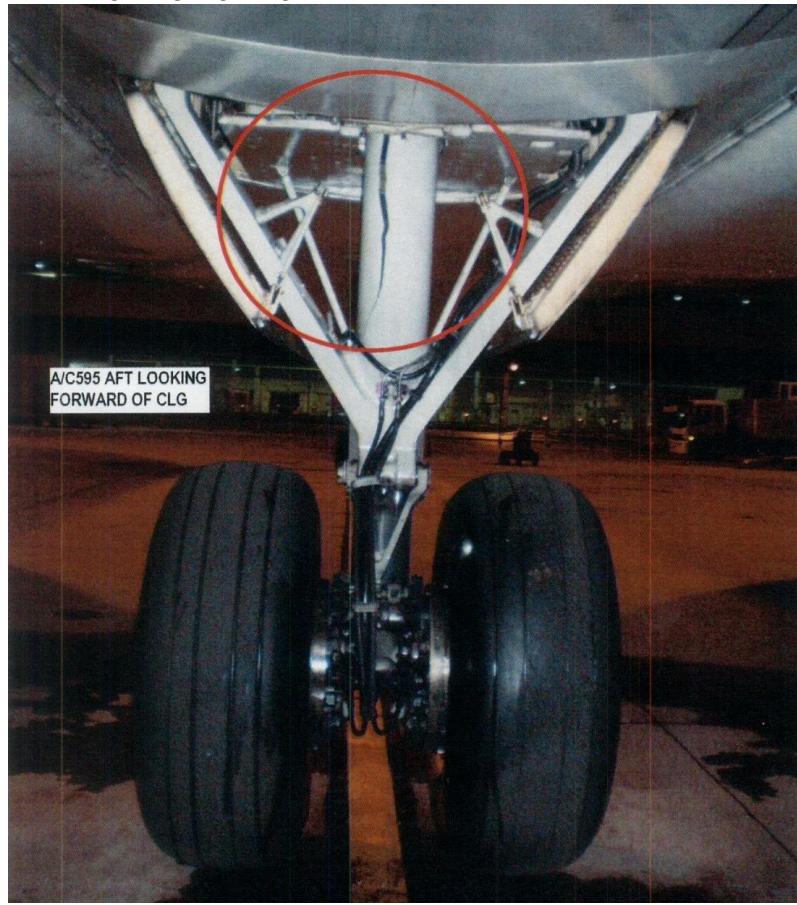
On April 27, 2008, during a routine pre-flight inspection at Singapore Changi Airport (SIN), hydraulic fluid was discovered near the center landing gear (CLG) strut of a FedEx MD-11 aircraft. A detailed examination revealed a 33-inch longitudinal crack on the aft side of the CLG strut cylinder. The crack's presence prompted the removal of the CLG strut for teardown and analysis, which was carried out at the Boeing Southern California Materials Laboratory. The strut had accumulated 5,058 cycles since its last installation on February 22, 2001, with a total lifetime of 9,379 cycles. **Figure 18** shows the initial findings, highlighting the visible crack.

Figure 18. Photograph of the cracked CLG strut cylinder, showing the longitudinal crack along the aft side [68].

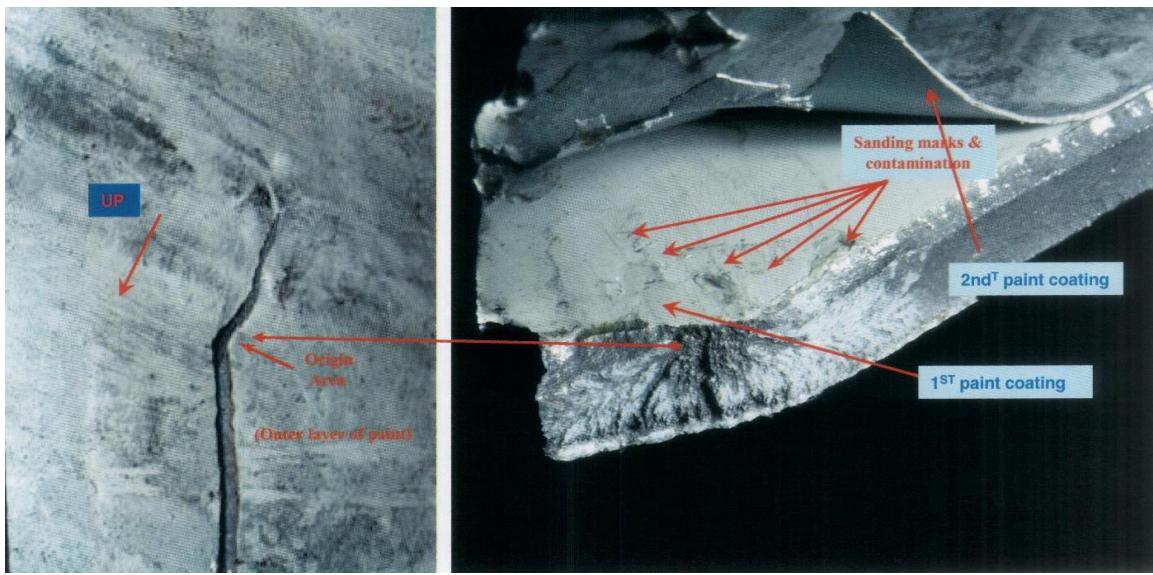
Metallurgical analysis confirmed that the failure was due to intergranular cracking, which originated from surface contamination introduced during a prior maintenance procedure. The contamination resulted from improper cleaning before the application of paint. Residual chemicals from paint removal solutions contributed to hydrogen embrittlement, causing the intergranular cracking to propagate through the cylinder wall and compromise its structural integrity. A cross-sectional view (**Figure 19**) of the fracture origin highlights the intergranular cracking and subsequent progression.

Figure 19. Cross-sectional view of the CLG strut cylinder, showing the intergranular cracking that initiated the failure [68].

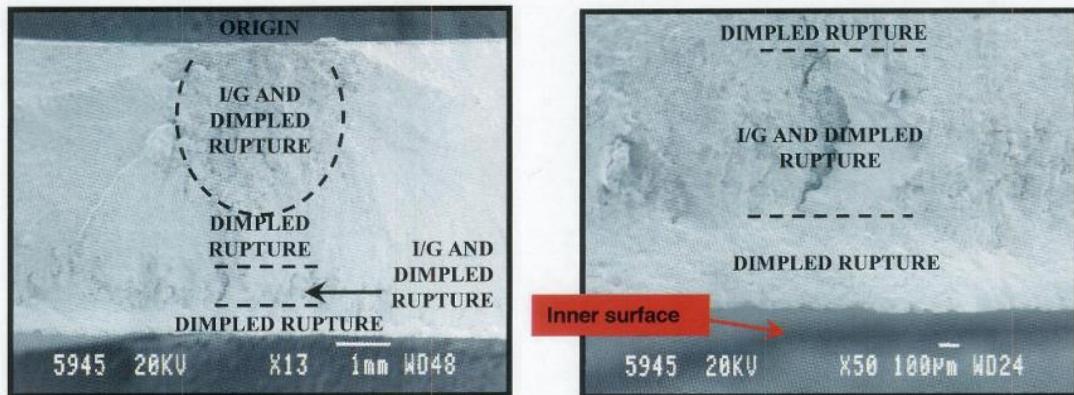
Teardown observations indicated high residual stresses in the material. While cutting the cylinder, loud “bangs” were reported, revealing further crack propagation due to residual stresses. Scanning Electron Microscope (SEM) analysis (Figure 20) provided evidence of mixed-mode failure. The fracture surface exhibited intergranular separation at the origin and dimpled rupture in other areas, which is characteristic of ductile overload failure.

Figure 20. SEM image of the fracture surface, showing a combination of intergranular cracking and ductile overload [68].

Further inspection revealed sanding and paint repair marks in the region of failure. Surface sanding likely introduced contamination, and the hydrogen absorbed during the cleaning and painting process contributed to the intergranular cracking. The primary fracture was traced to this contaminated region, approximately 18.2 inches from the bottom of the cylinder.

This failure underscores the critical importance of proper surface treatments and material handling during maintenance. The hydrogen embrittlement was caused by contamination from cleaning agents, combined with operational stresses.
