# Drones as a Tool for the Sustainable Conservation of Heritage Metal Structures

The Requejo Bridge, also known as the Pino Bridge, is an impressive engineering work that spans the Duero River. The bridge is located in the province of Zamora, Spain (Figure 1), with its exact position defined by the following coordinates:

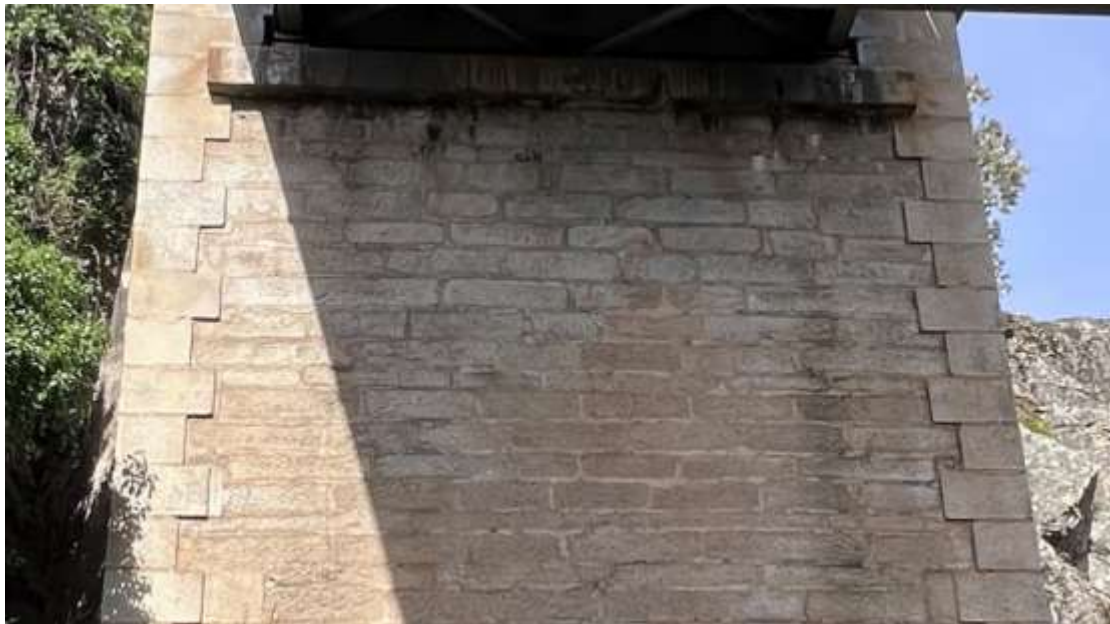
Previous observations (Figure 8) had already indicated that, despite its century-old age, the concrete foundation elements presented a generally acceptable state of conservation, showing slight deterioration related to the material's durability, particularly due to runoff water. The action of runoff water was also the primary pathology observed on the abutment walls, where stains associated with moisture caused by the continuous process of surface runoff sliding down the wall face were detected (Figure 12).

**Figure 12.** Wall of the second abutment with runoff water traces (photograph by the author, taken with a drone).

Notably, the transverse beams at the ends of the deck, over the abutments, displayed significant corrosion on the face closest to the abutment guard wall (Figure 12 and Figure 14).

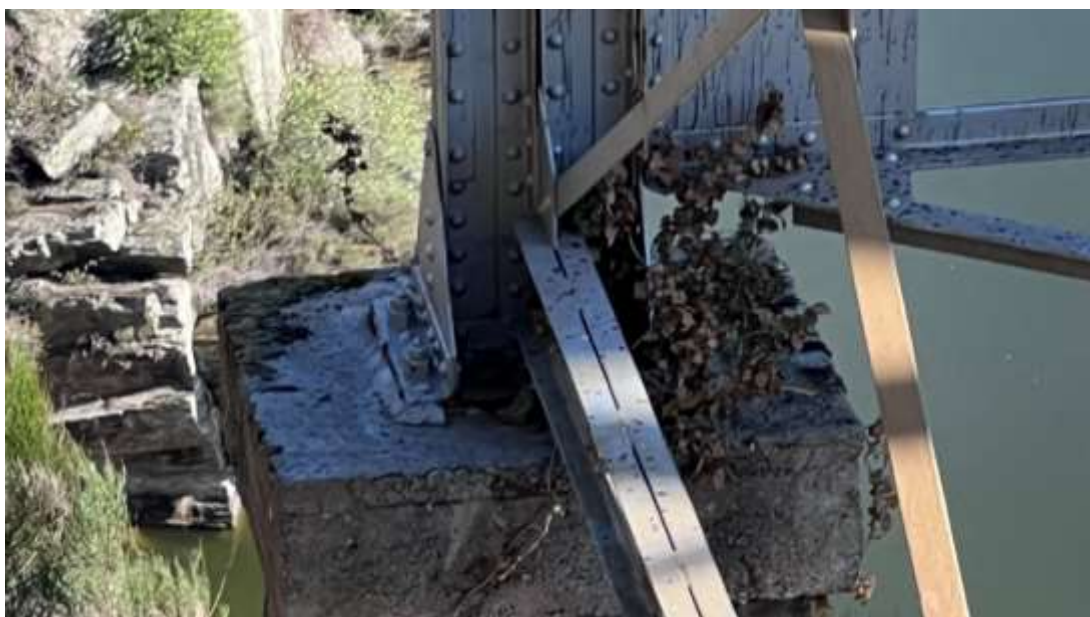
Vegetation and organic matter, primarily moss, were found on some of the support footings of the sheet pile walls, with the sixth sheet pile, near the second abutment, being particularly affected (Figure 13). The presence of vegetation on concrete elements always indicates suboptimal maintenance. Deterioration of concrete caused by vegetation constitutes a form of chemical attack induced by living organisms. In the case of higher plants, this effect combines both mechanical and chemical actions, as roots exert pressure on joints or cracks where they take hold, while simultaneously retaining moisture, thereby exacerbating the damage.

**Figure 13.** Presence of organic matter and vegetation on the concrete footing of sheet pile wall 6, downstream side (photograph by the author, taken with a drone).

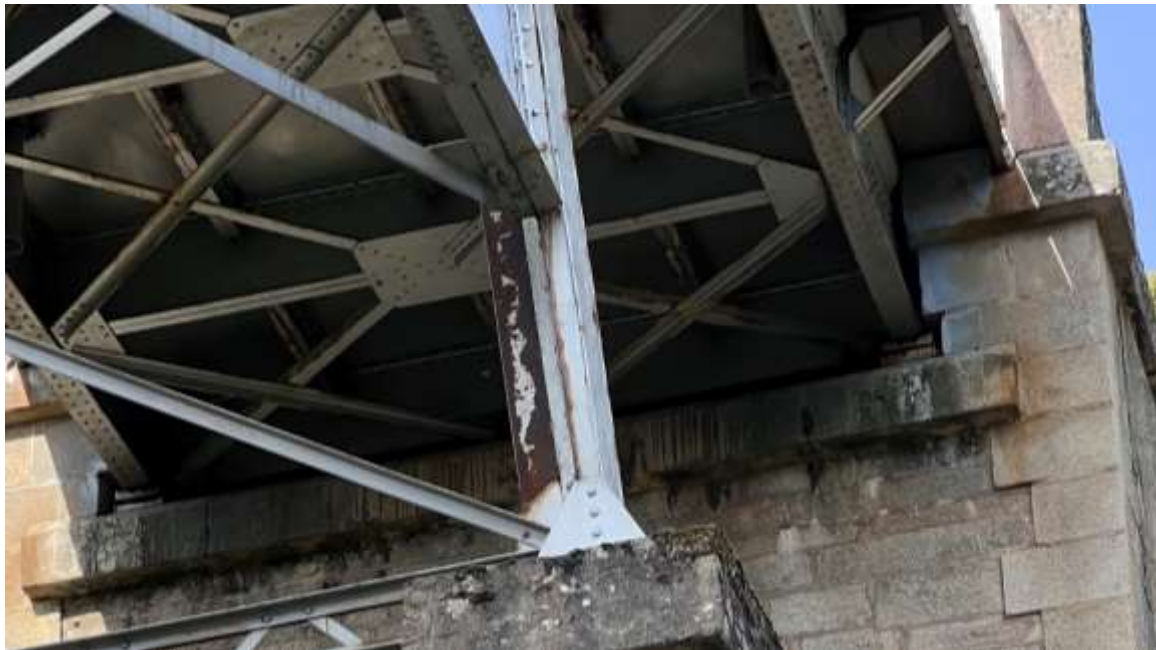
The sheet pile walls exhibited widespread deterioration of the corrosion protection system. This damage was more severe on the end walls: the first sheet pile wall on the downstream side and the seventh sheet pile wall, also on the downstream side (Figure 14). Additionally, localized corrosion of components was observed at the ends of the sheet piles, attributed to the tendency of these areas to accumulate moisture.

**Figure 14.** Corrosion on sheet pile wall number 7, the one closest to the second abutment, downstream side (photograph by the author, taken with a drone).

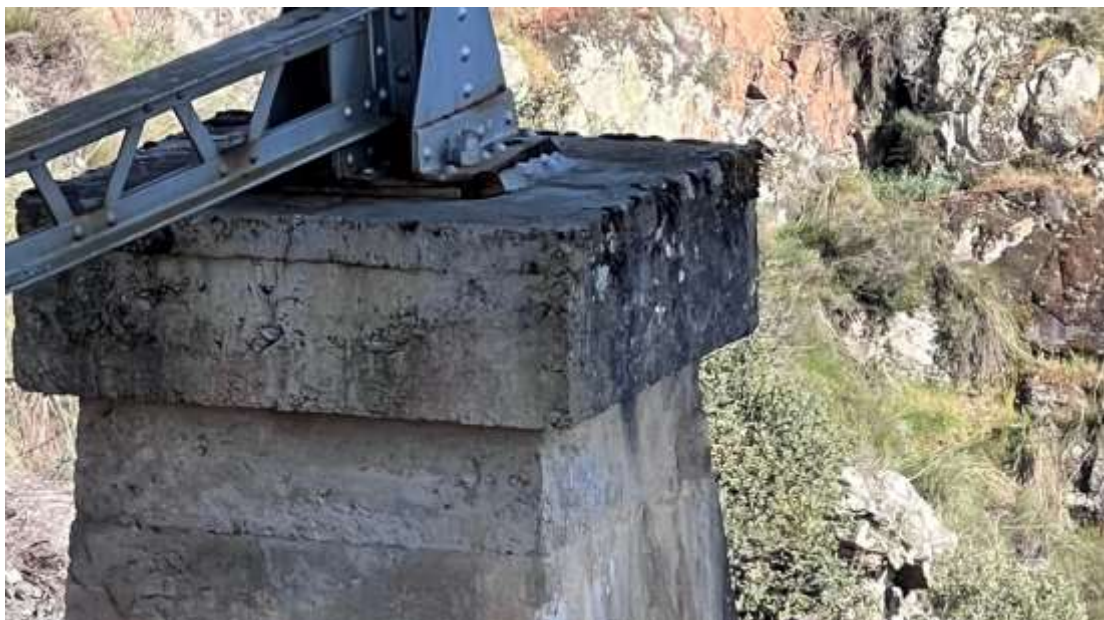
In the case of the last sheet pile wall, the seventh one, the drone inspection revealed the loss of the head of one of the anchor bars on the downstream support (Figure 15). This loss appeared to be linked to the corrosion present on the bar, which likely caused its eventual breakage.

**Figure 15.** Loss of an anchor head on sheet pile wall 7, downstream side (photograph by the author, taken with a drone).

Based on the observations, it is deemed appropriate to equip the structure with a new protection system that will offer corrosion resistance for at least another 25 years. Before this, localized repairs should be made to the observed defects and deterioration, with particular attention given to cleaning and preparing corroded areas. This will ensure that the new protection system has a proper base, preventing premature failure before reaching its full service life. In other words, both preventive actions to halt the progression of corrosion and remedial actions to repair some metallic elements are proposed. Examples include installing a new anchor bar in Pier 7 and replacing stiffeners in railings.

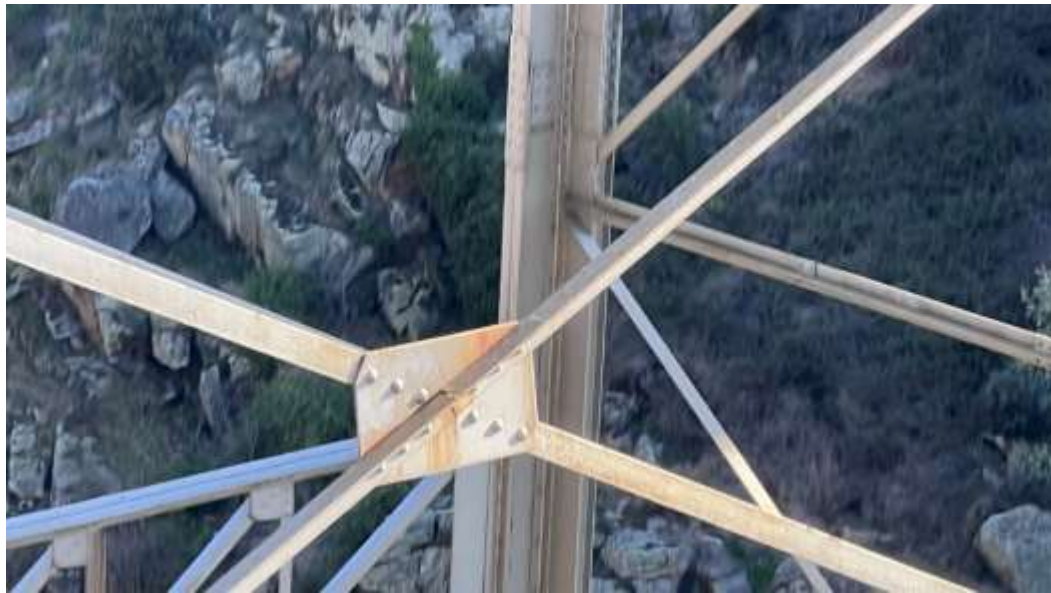
The analysis of the ends concluded with the detection of localized corrosion on some of the braces, which was more pronounced near the second abutment (Figure 16). This deterioration is undoubtedly the result of the combined action of atmospheric oxygen and humidity, exacerbated by the lack of an adequate protective surface treatment on the metal elements.

**Figure 16.** Localized corrosion on one of the braces of the sheet pile walls at the western end of the bridge, upstream side (photograph by the author, taken with a drone).

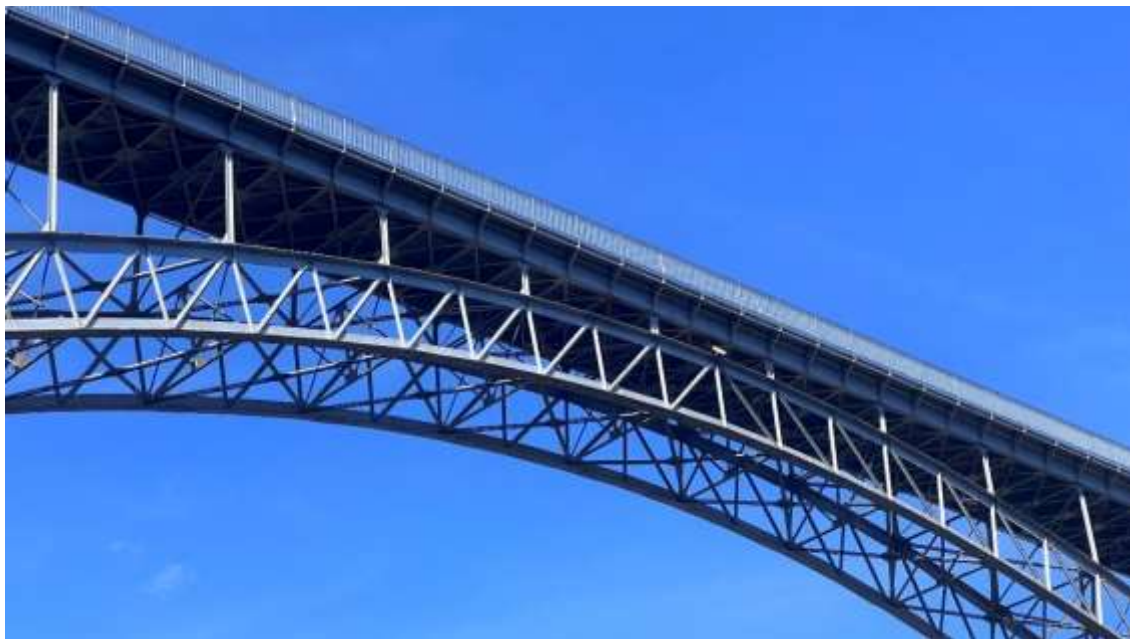
**Figure 17.** Bottom view of the arch from the downstream side (photograph by the author, taken with a drone).

Stains produced by the discharge of water and other liquids through the drainpipes were also observed. At the time of the visit, these pipes were not long enough to discharge water away from the arch (a pipe can be seen in the center of the arch in Figure 7 and Figure 17).

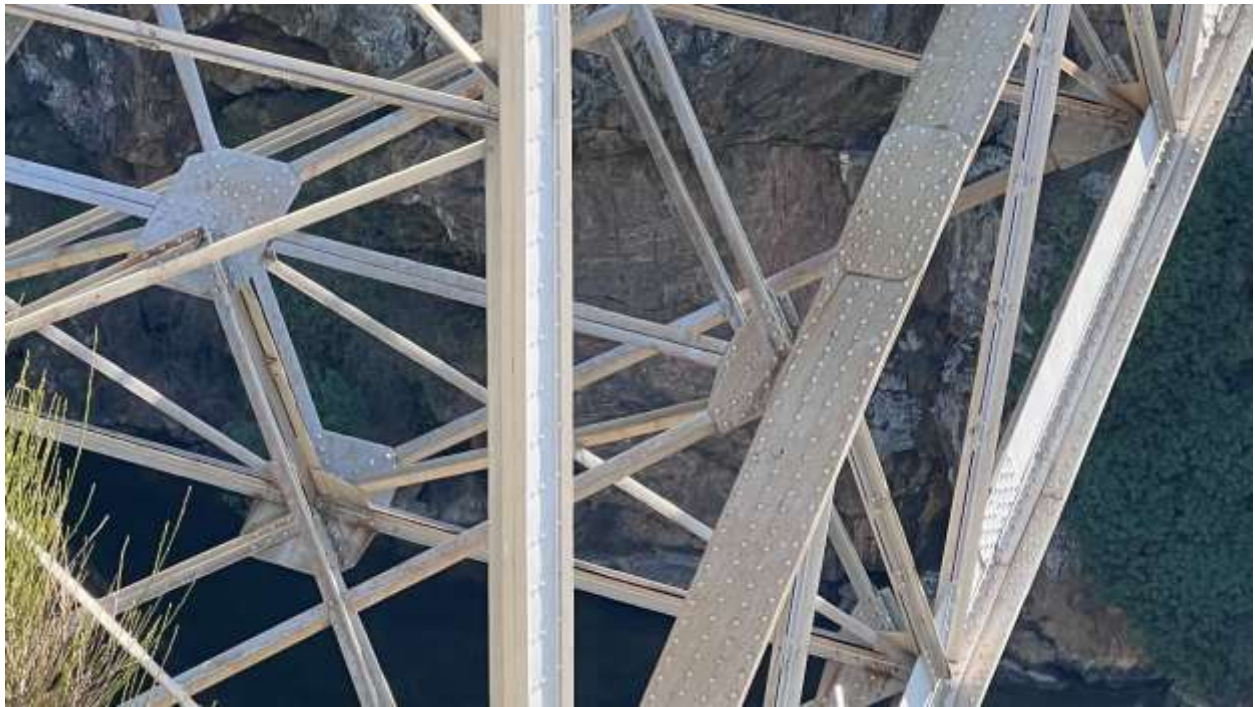
During the inspection, the arch only showed deterioration due to the aging of the corrosion protection system (Figure 18), with patches of rust visible on the upper part of the heads of the lateral beams forming the arch, as well as localized rust at connection points between elements (Figure 19).

**Figure 18.** General state of the arch, in a section between support uprights (photograph by the author, taken with a drone).

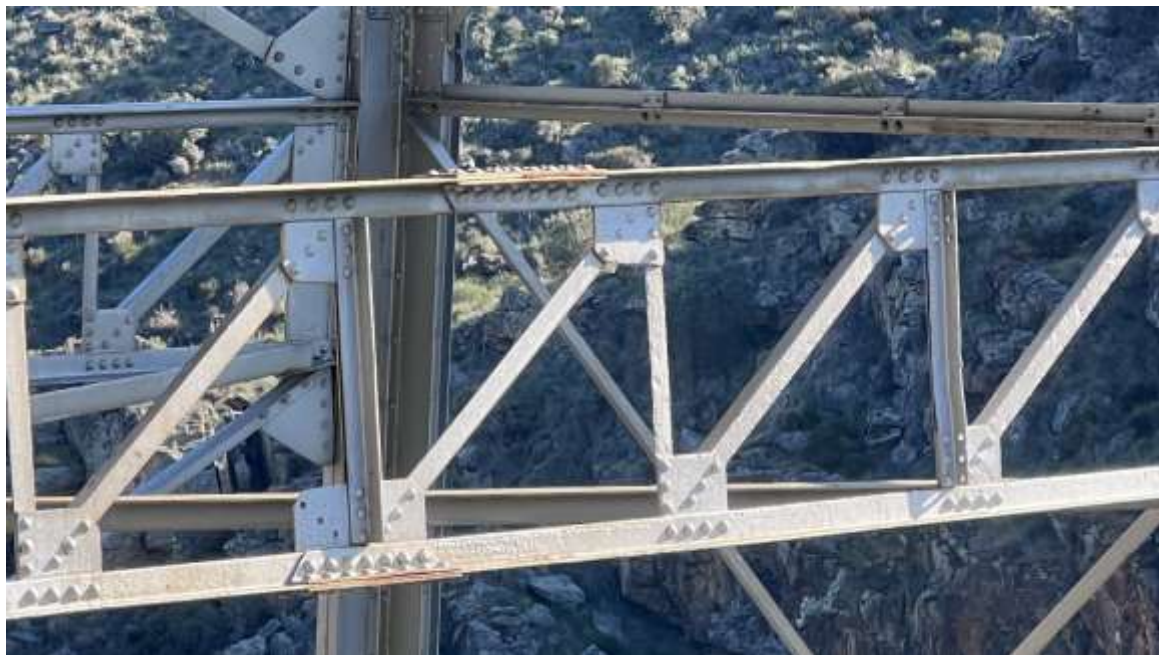
**Figure 19.** Detailed view of an arch section with localized corrosion at connection points (photograph by the author, taken with a drone).

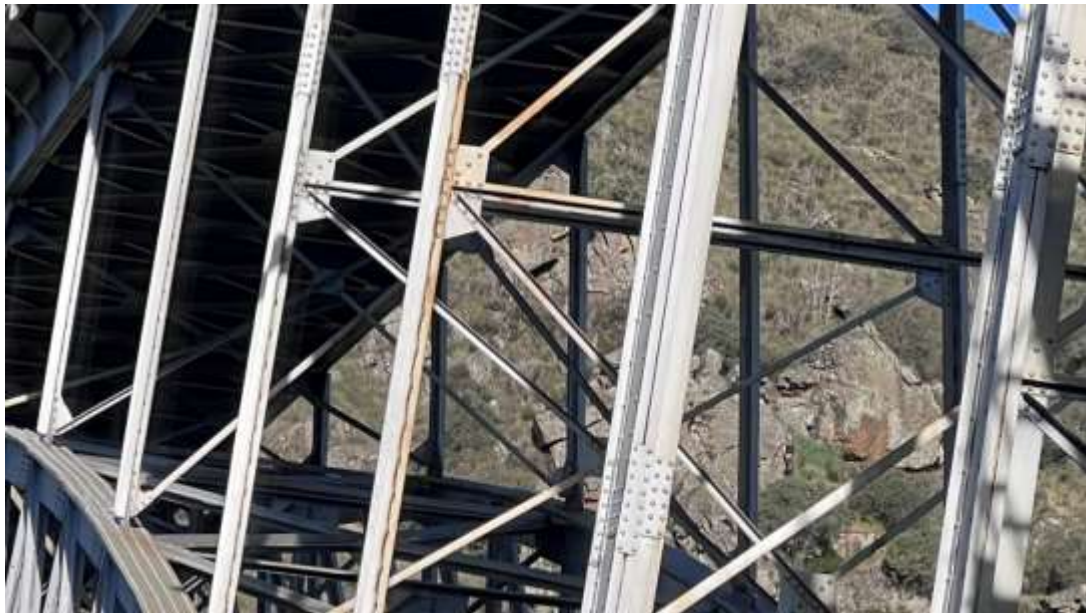
The uprights on the arch exhibited widespread deterioration of the corrosion protection system due to aging. Corrosion spots were observed between elements comprising the uprights, such as plates and L-shaped profiles (Figure 20).

**Figure 20.** Detail of corrosion on one of the uprights over the arch (photograph by the author, taken with a drone).

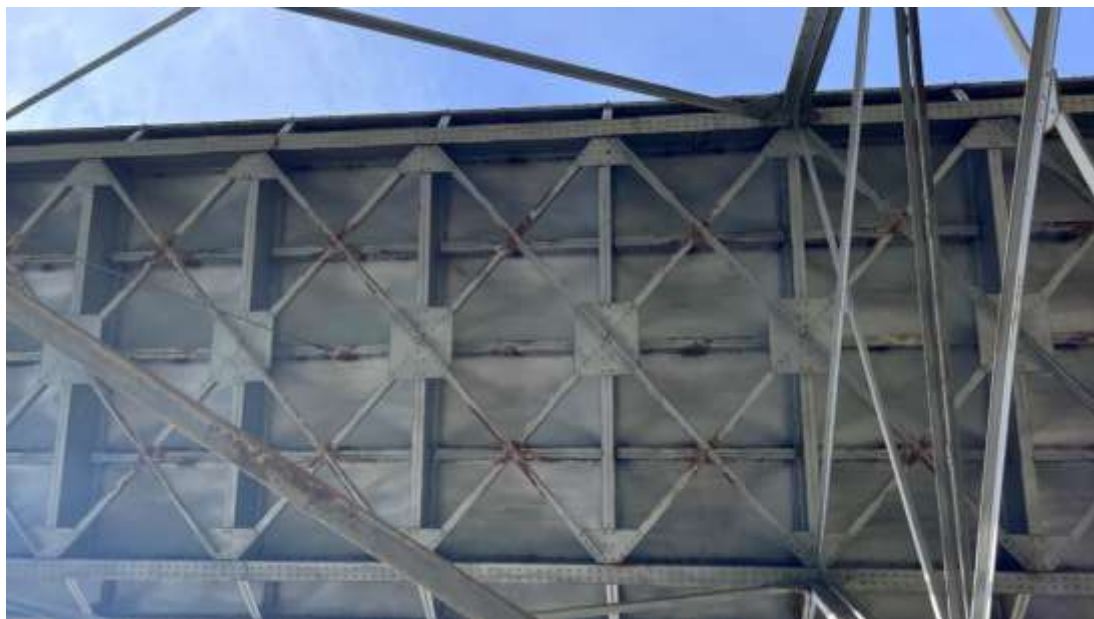
Atop the arch lay the deck, which also exhibited localized corrosion at numerous points along its entire length and width (Figure 21). A closer examination confirmed that corrosion was particularly concentrated at the connections between stringers and the slab, as well as at the connections between transverse beams and the X-shaped cross braces (Figure 22).

**Figure 21.** Bottom view of a deck section, showing numerous elements with localized corrosion symptoms (photograph by the author, taken with a drone).

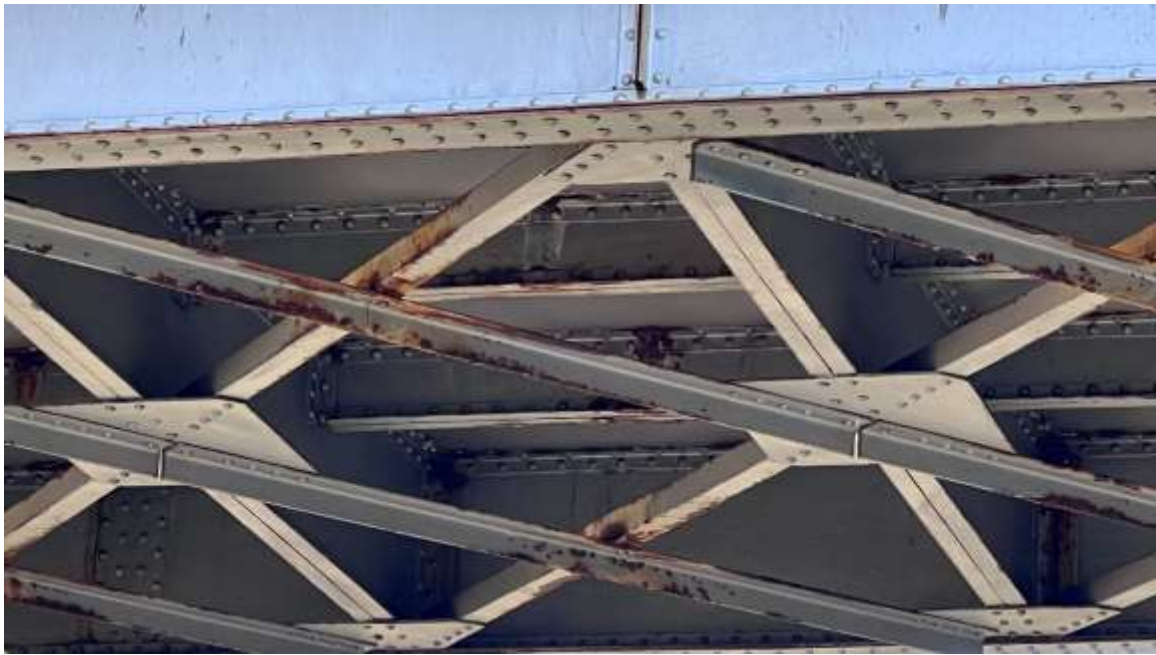
**Figure 22.** Detailed view of a deck section with localized corrosion on several elements (photograph by the author, taken with a drone).

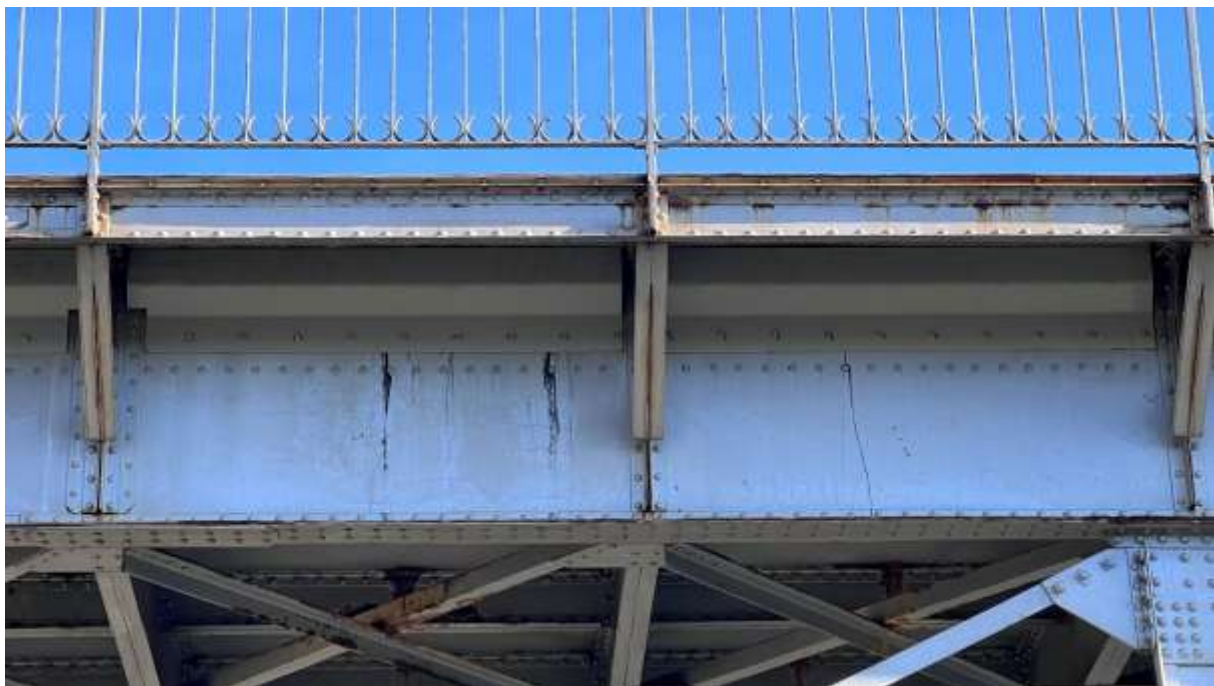
Finally, the cantilevered walkways, formed by metal plates supported on metal brackets, were also subject to corrosion (Figure 23), with traces of rust and stained runoff water visible on all elements.

**Figure 23.** View of the cornice and the underside of the perimeter protective railing (photograph by the author, taken with a drone).

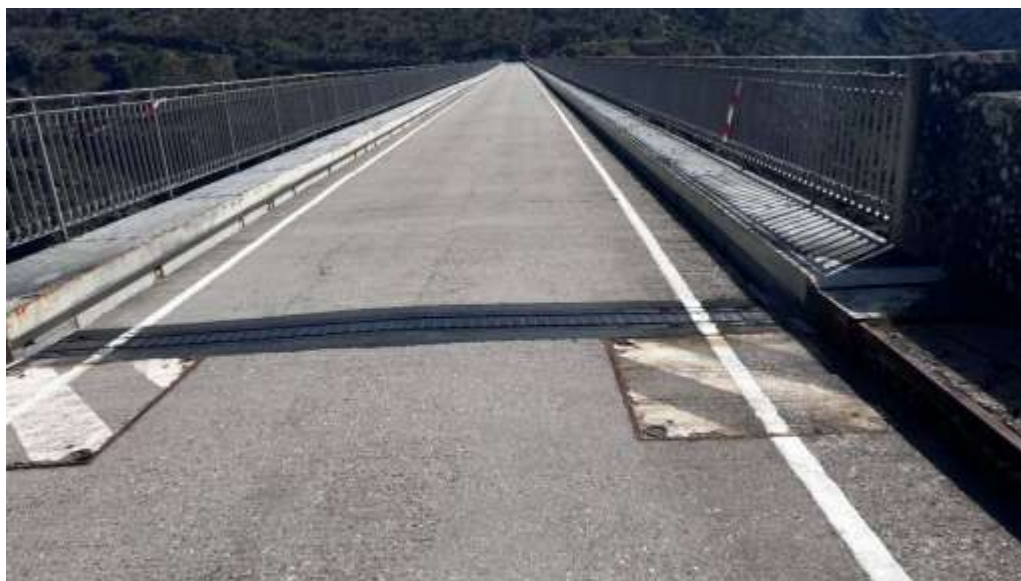
On the platform, corrosion was detected on the railings and walkways (Figure 24), along with localized deformation of the handrails on both railings, caused by the loss or theft of cylindrical stiffeners and, in some cases, the detachment of the crowning curb. Additionally, slight deterioration of the joints due to aging, as well as corrosion of the metal planters on the four access sidewalks to the structure, was observed (Figure 24).

**Figure 24.** View of the road platform above, taken from the second abutment (photograph by the author, taken with a drone).
