Hydrogen Embrittlement in Aviation Components: An Incident Based Overview and Analysis

4.1. Failure of the Bell 412EP Helicopter (ERA10TA493)

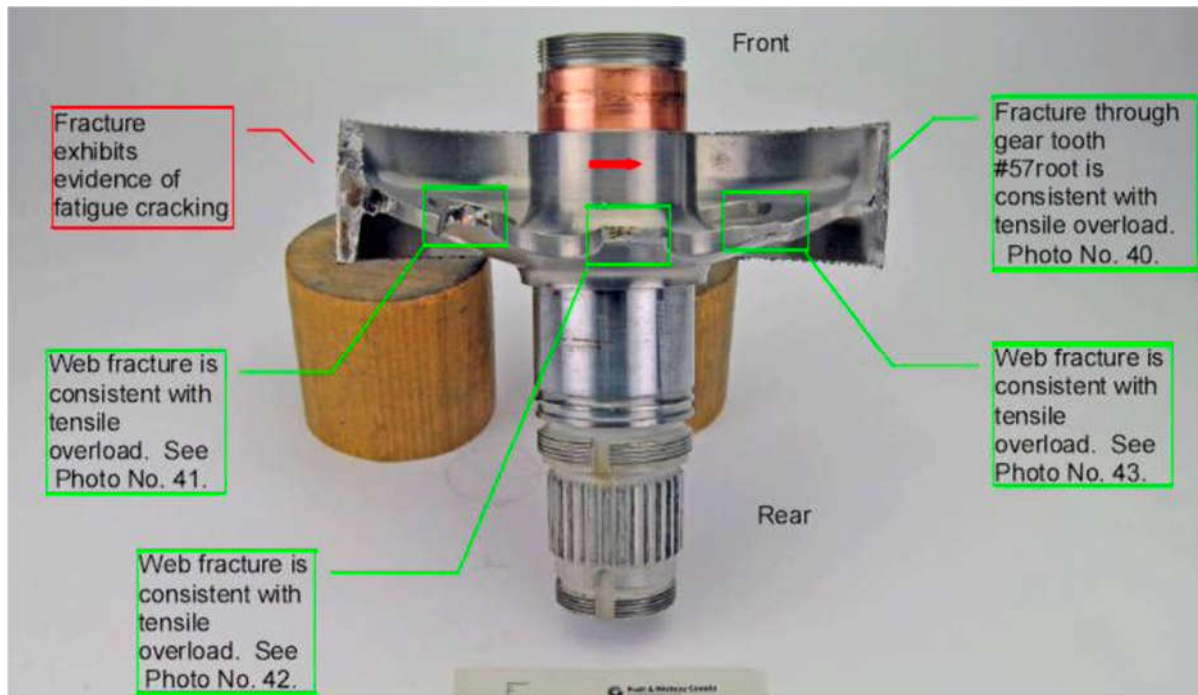
Figure 2. Detailed view of the fractured output drive gear from the reduction gearbox.

The crack, initiated at the root of a gear tooth, eventually led to the failure of the entire component. The microscopic examination of the fracture surface, as depicted in Figure 3, highlighted the presence of intergranular cracking at the root of the gear tooth. This is a characteristic sign of hydrogen embrittlement, where cracks propagate along the grain boundaries of the metal. The analysis revealed both intergranular and transgranular crack propagation, further confirming the role of hydrogen embrittlement in the failure.

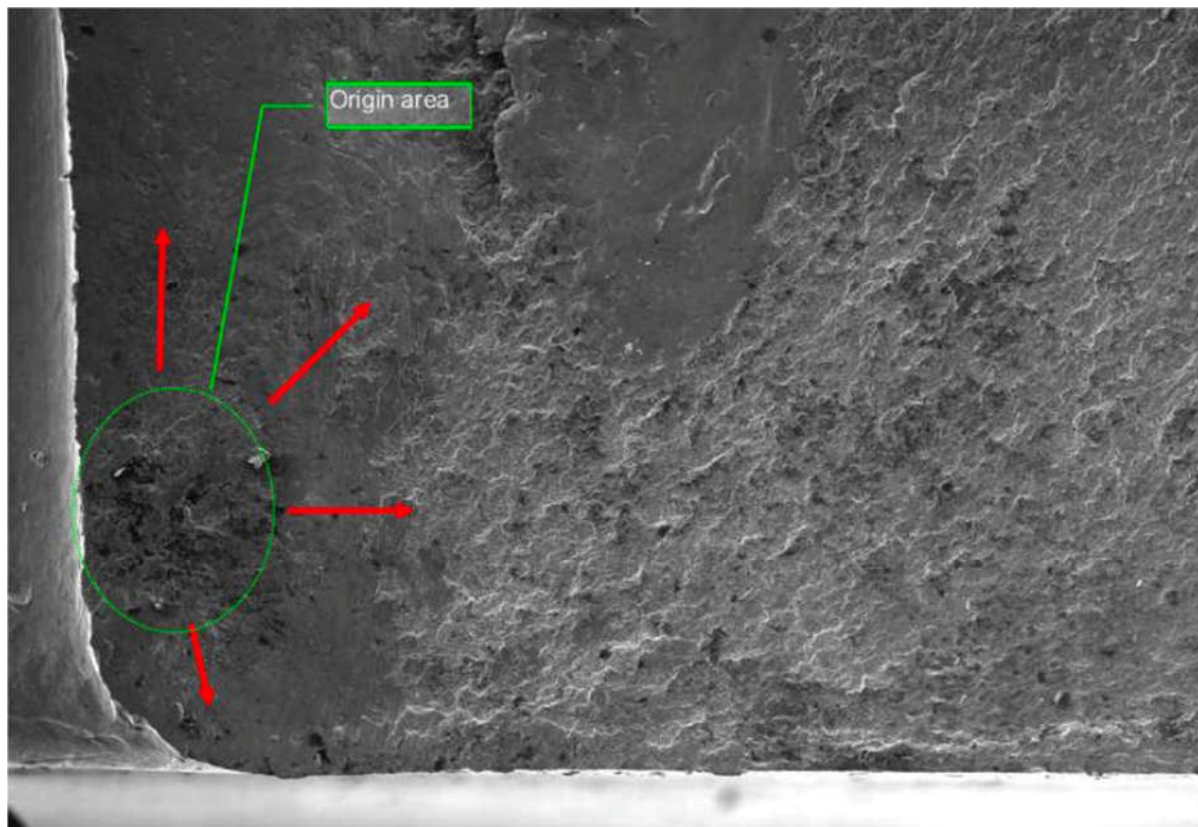
Figure 3. Close-up of the origin region of the fatigue crack on the output drive gear, showing the initial intergranular cracking due to hydrogen embrittlement.

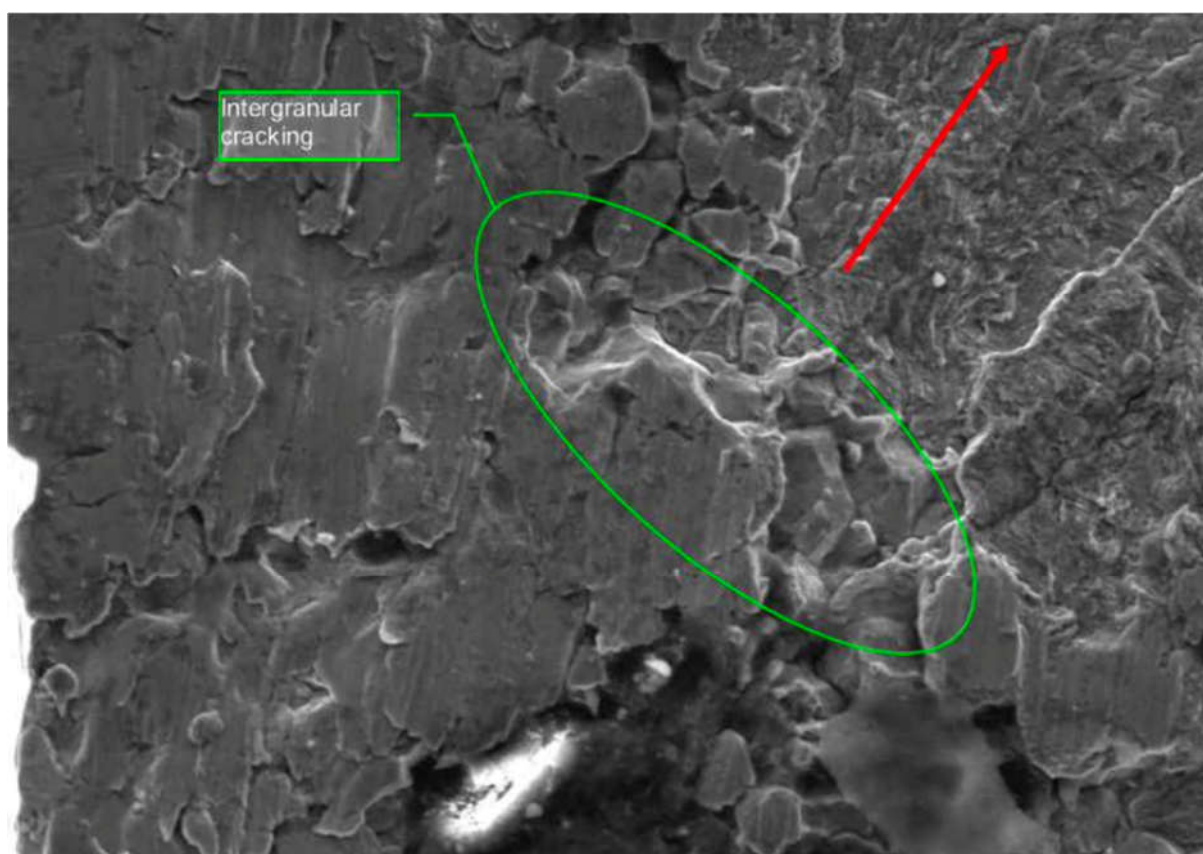
Figure 4. Microscopic view of the fracture surface, showing the distinct patterns of fatigue crack propagation starting from the hydrogen-embrittled region.

The hydrogen was likely introduced during the electrochemical plating process used in the gear's manufacture. Although dehydrogenation treatments were applied to remove absorbed hydrogen, the analysis showed that these treatments were insufficient, leaving residual hydrogen that ultimately led to the component's failure. The fatigue cracks that propagated from this region, leading to the final fracture, is consistent with the effects of hydrogen embrittlement.

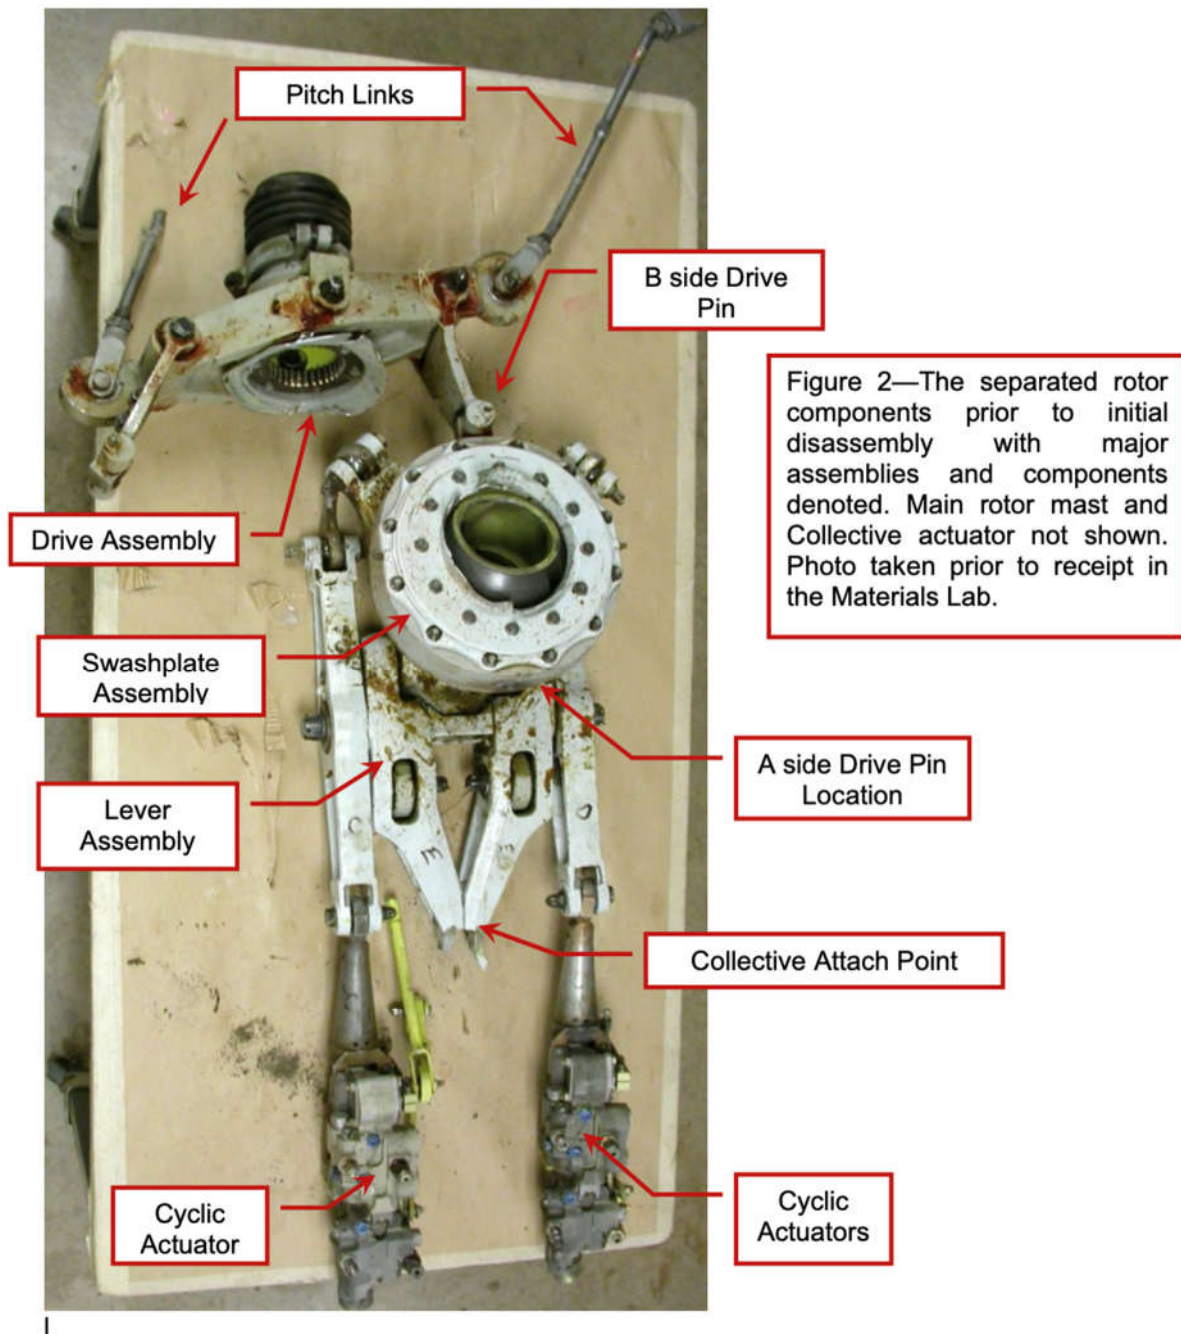
The investigation identified the failure of the A-side drive pin in the swashplate assembly as the primary cause of the in-flight breakup. Metallurgical analysis revealed that the pin fractured due to overstress, but the fracture surface exhibited brittle cleavage features and intergranular separations, which are consistent with hydrogen embrittlement. Hydrogen levels measured in the fractured pin ranged between 8.7 and 9.3 ppm, confirming the involvement of hydrogen in weakening the material. Figure 6 shows the rotor components after separation, highlighting the failure points, including the A-side drive pin.

Figure 6. Separated rotor components prior to disassembly, highlighting the critical assemblies (swashplate, drive assembly, and pitch links).

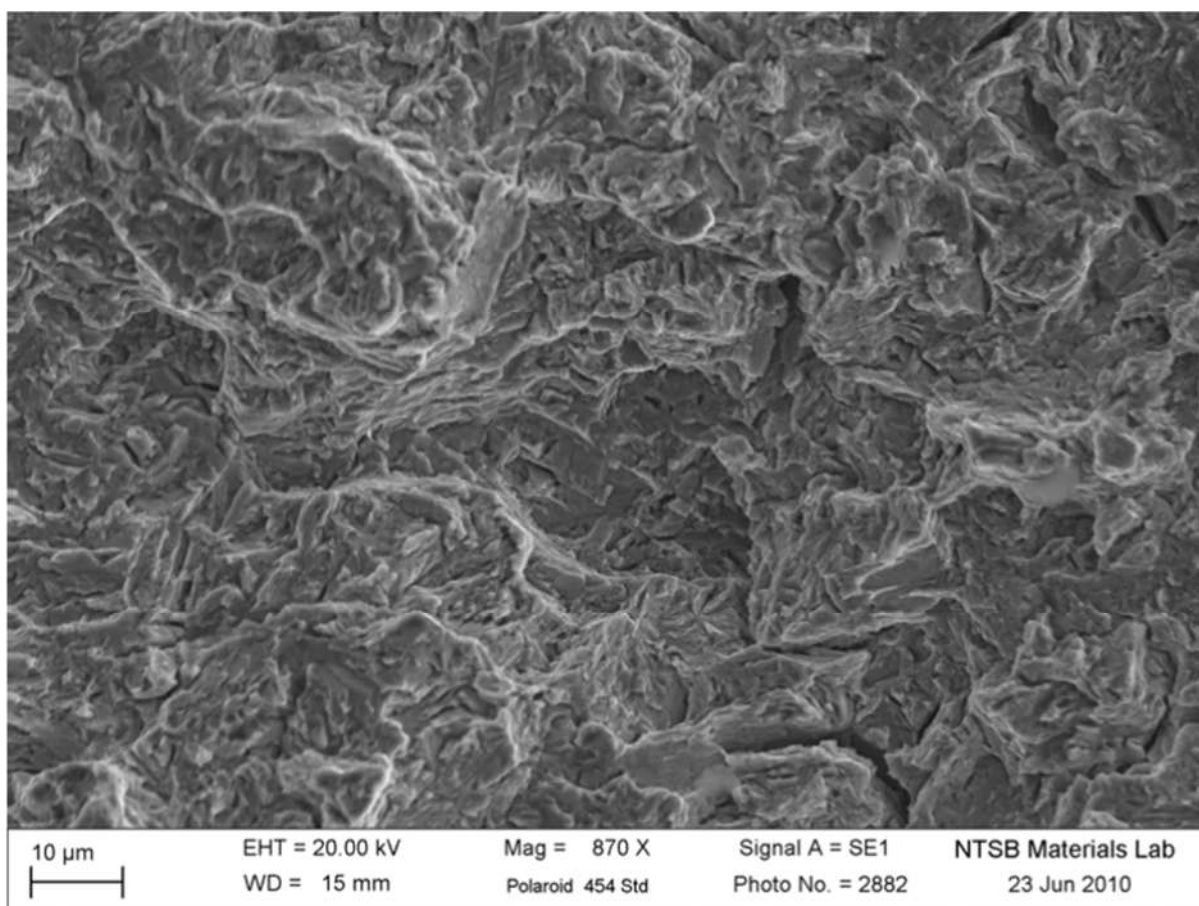
Further examination under a scanning electron microscope (SEM) provided critical evidence of the brittle failure mechanism. Figure 7 shows the fractured surface of the A-side drive pin, with clear indications of brittle cleavage and intergranular separations. These SEM images highlight how hydrogen atoms migrated into areas of high stress within the material, causing the drive pin to fracture under conditions it would normally withstand.

Figure 7. SEM image showing the fractured A-side drive pin with brittle cleavage and intergranular separations.

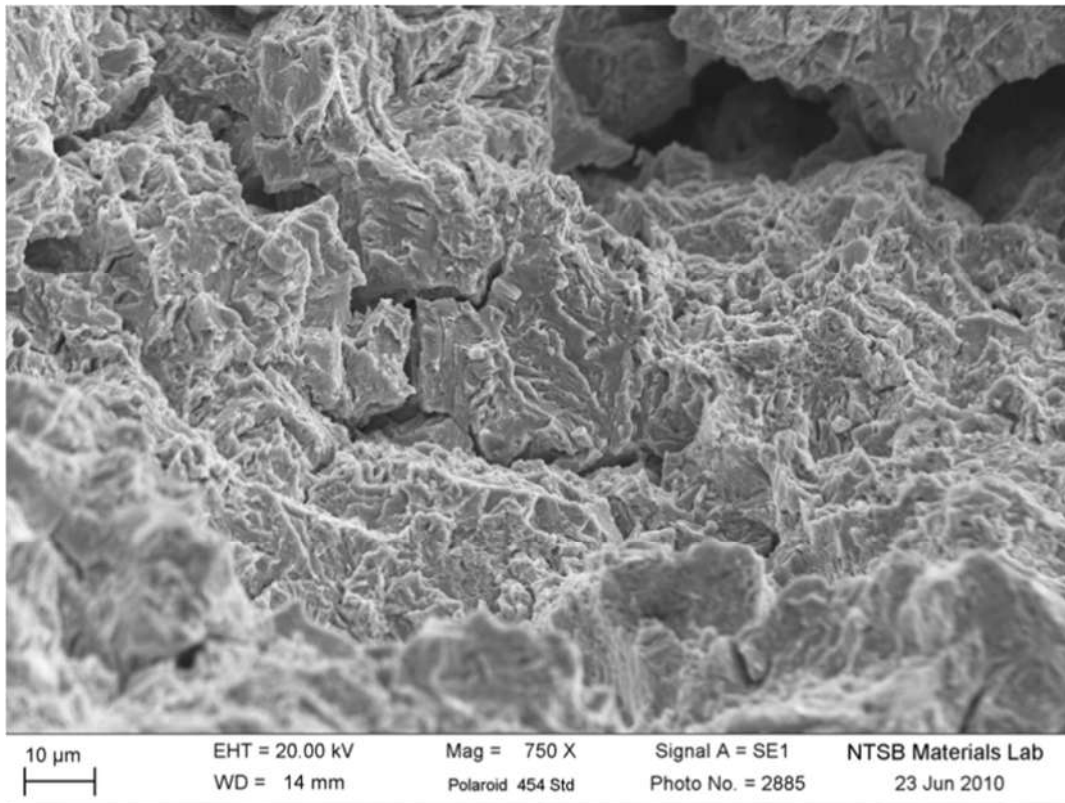
In addition to the primary fracture, Figure 8 provides another SEM image showing multiple radial cracks on the washer face of the A-side pin. These cracks, observed at low magnifications, intersected the main fracture, further supporting the conclusion that hydrogen embrittlement played a significant role in the failure. This image underscores the localized plasticity near the fracture initiation sites, where hydrogen atoms likely accumulated.

Figure 8. SEM image of radial cracks on the washer face of the A-side pin, showing areas of localized plasticity.

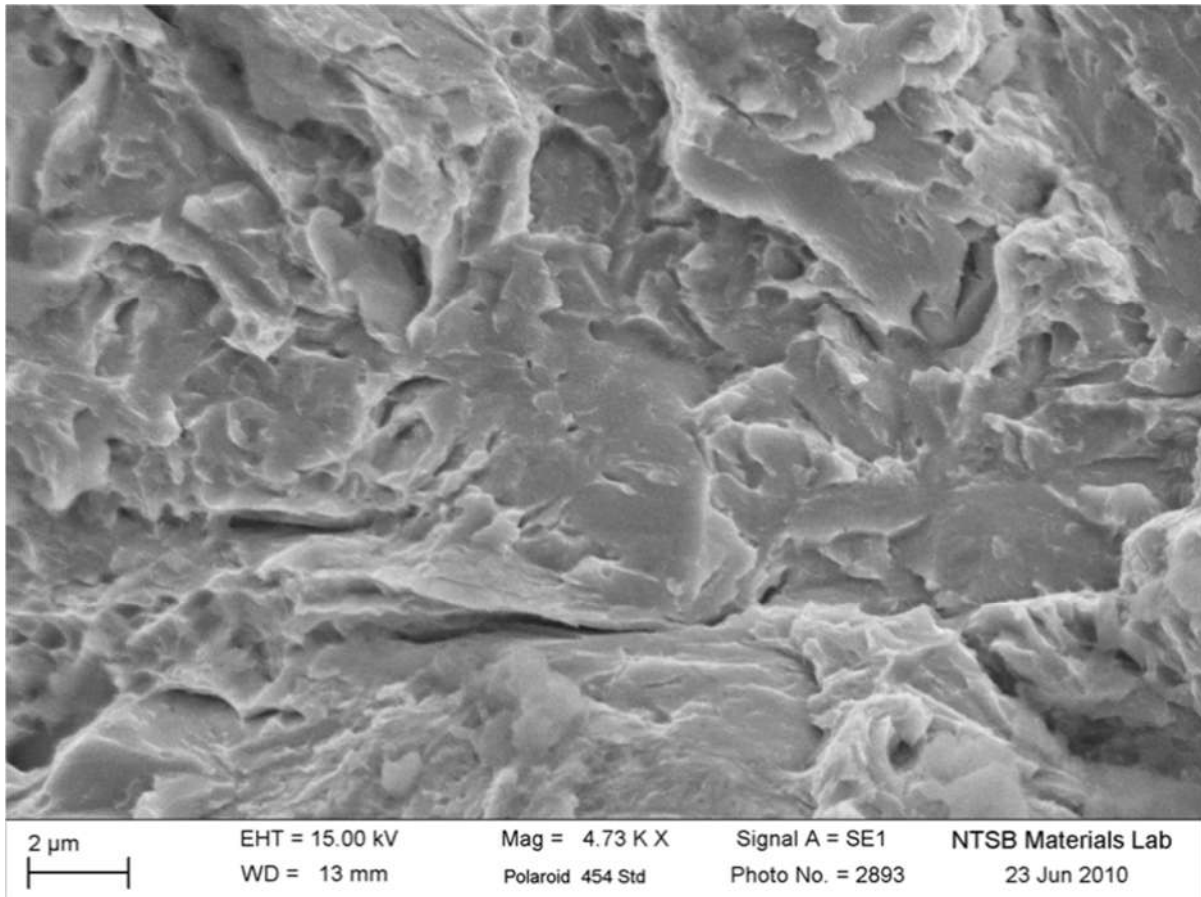
Moreover, SEM analysis at higher magnifications in Figure 9 reveals ductile dimples adjacent to the main fracture, contrasting with the brittle cleavage areas. This observation shows that the fracture initiated in brittle areas due to hydrogen embrittlement and propagated until final failure, where localized ductility emerged in isolated regions.

Figure 9. Higher magnification SEM image showing the transition between brittle cleavage and ductile dimples on the A-side drive pin fracture surface.

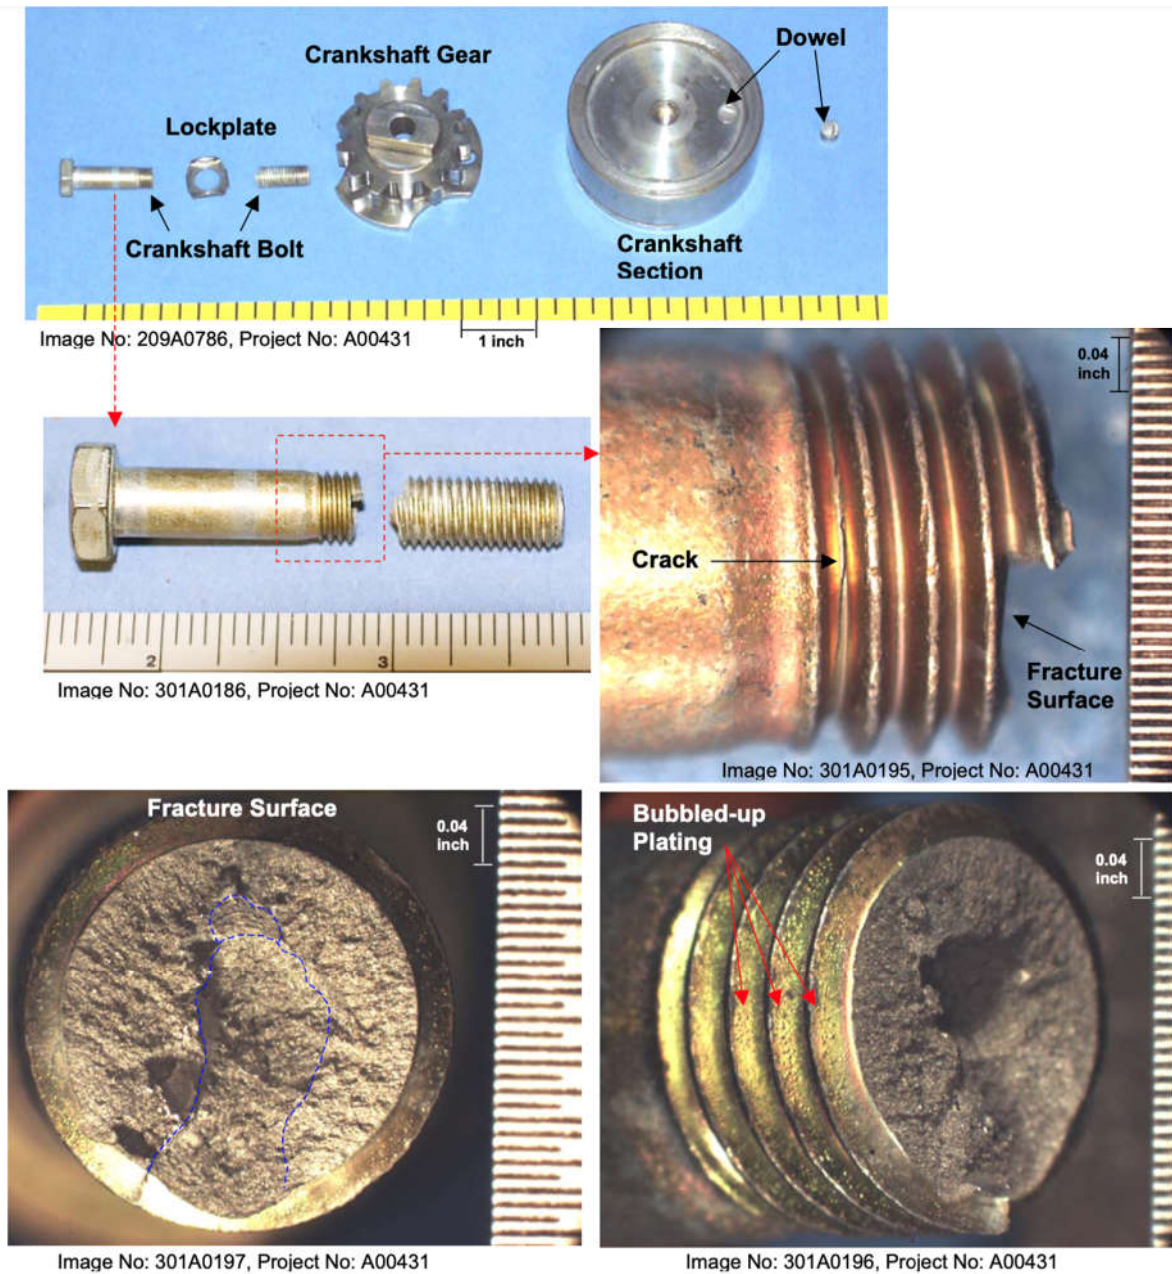
The failure was traced to the engine's crankshaft gear bolt, part number STD-2209, which was made of SAE J429 grade 8 steel. The bolt fractured due to hydrogen embrittlement; a failure mechanism linked to improper post-plating treatments of zinc-plated bolts. Prior to the incident, engines of this type were built with cadmium-plated bolts, but zinc-plated bolts had been substituted during production, leading to a known issue of bolt failures across various aircraft. Figure 11 shows the crankshaft section of the Piper PA-32R-301T's engine, including the fractured bolt and gear assembly as found during post-accident examination.

Figure 11. Image of the crankshaft assembly and fractured crankshaft gear retaining bolt after disassembly.

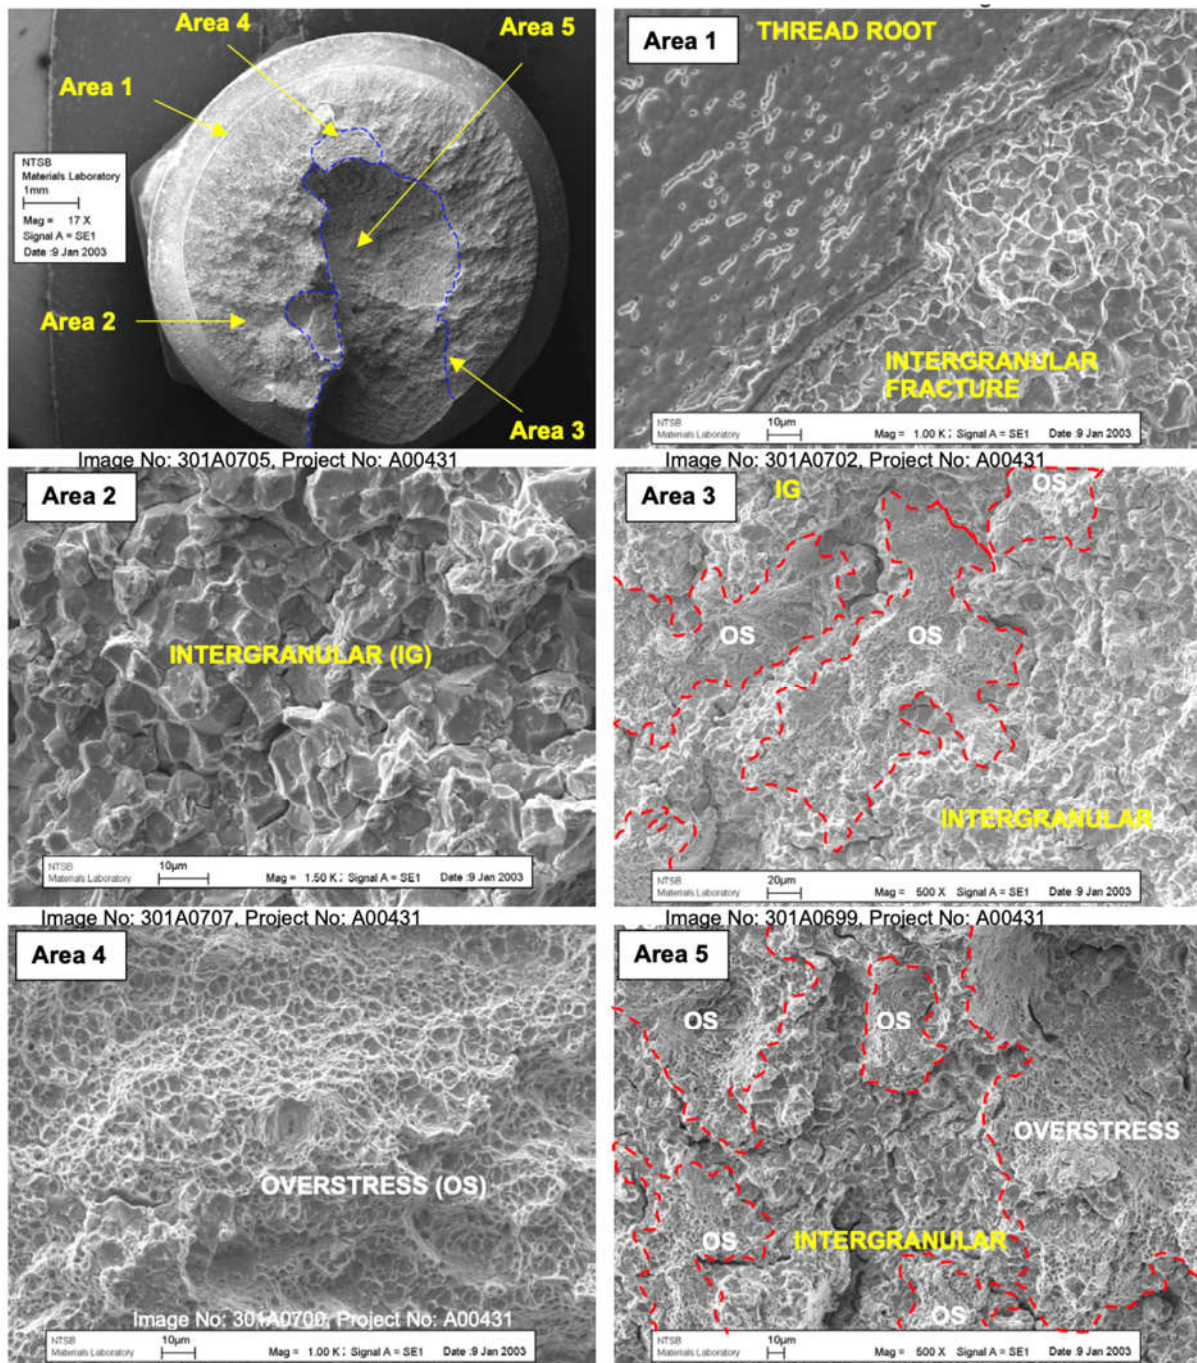
The Scanning Electron Microscope (SEM) and metallographic analysis revealed key findings about the failure mode. Figure 12 illustrates intergranular cracking and ductile failures present on the bolt's fracture surface, highlighting the role of hydrogen embrittlement. The SEM image shows intergranular cracking along the fracture surface of the crankshaft bolt, indicating hydrogen-assisted cracking. The metallographic examination confirmed that the fracture initiated at the thread roots and propagated radially due to hydrogen accumulation.

Figure 12. SEM image showing intergranular cracking along the fracture surface of the crankshaft bolt, indicating hydrogen-assisted cracking.

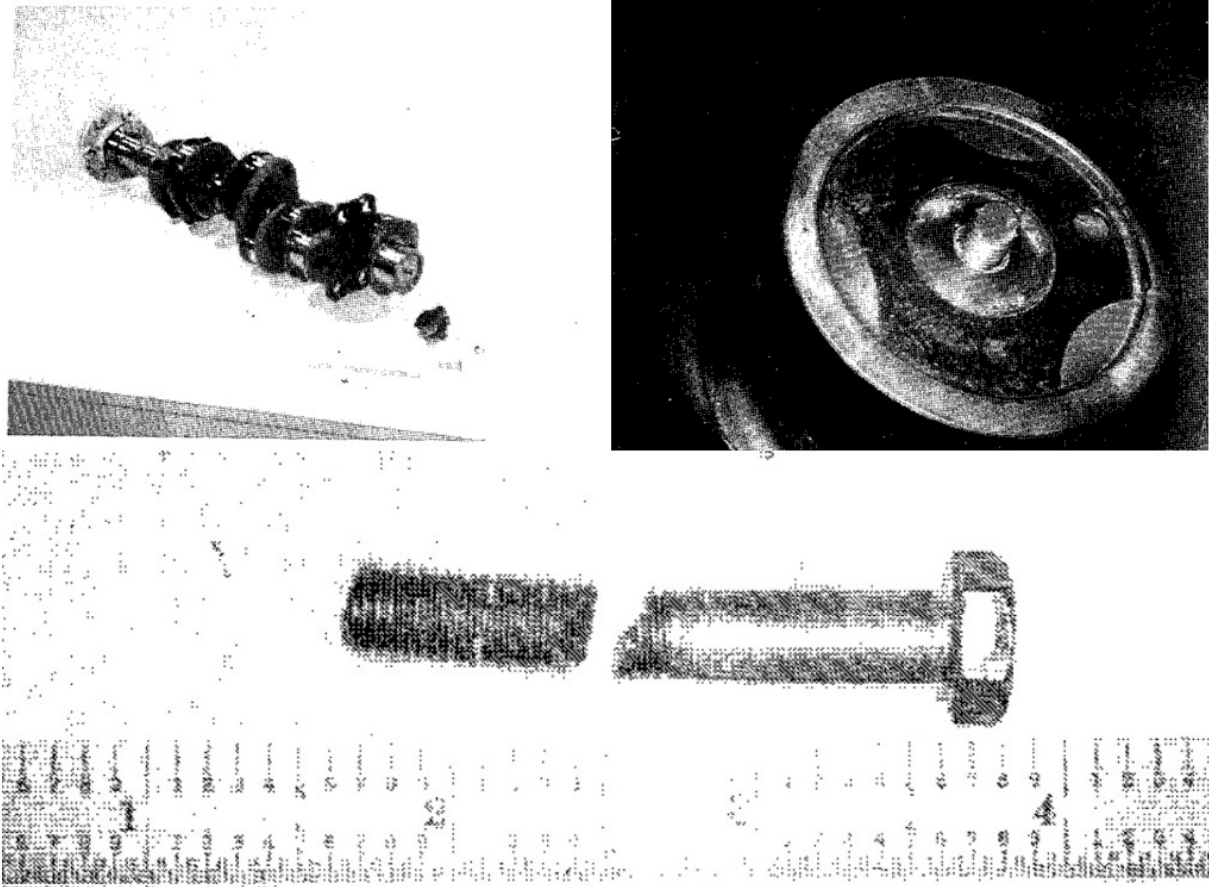
Subsequent investigation revealed that the engine failure was caused by the fracture of the crankshaft gear bolt, part number STD-2209, in the Lycoming IO-540-K1G5 engine (Serial No: L-25968-48A). The bolt failure led to the separation of the crankshaft gear from the rear of the crankshaft. Figure 14 shows the disassembled components of the engine, including the failed crankshaft gear bolt, which was the primary cause of the engine failure.

Figure 14. Image of the disassembled engine components, highlighting the fractured crankshaft gear bolt (P/N STD-2209).

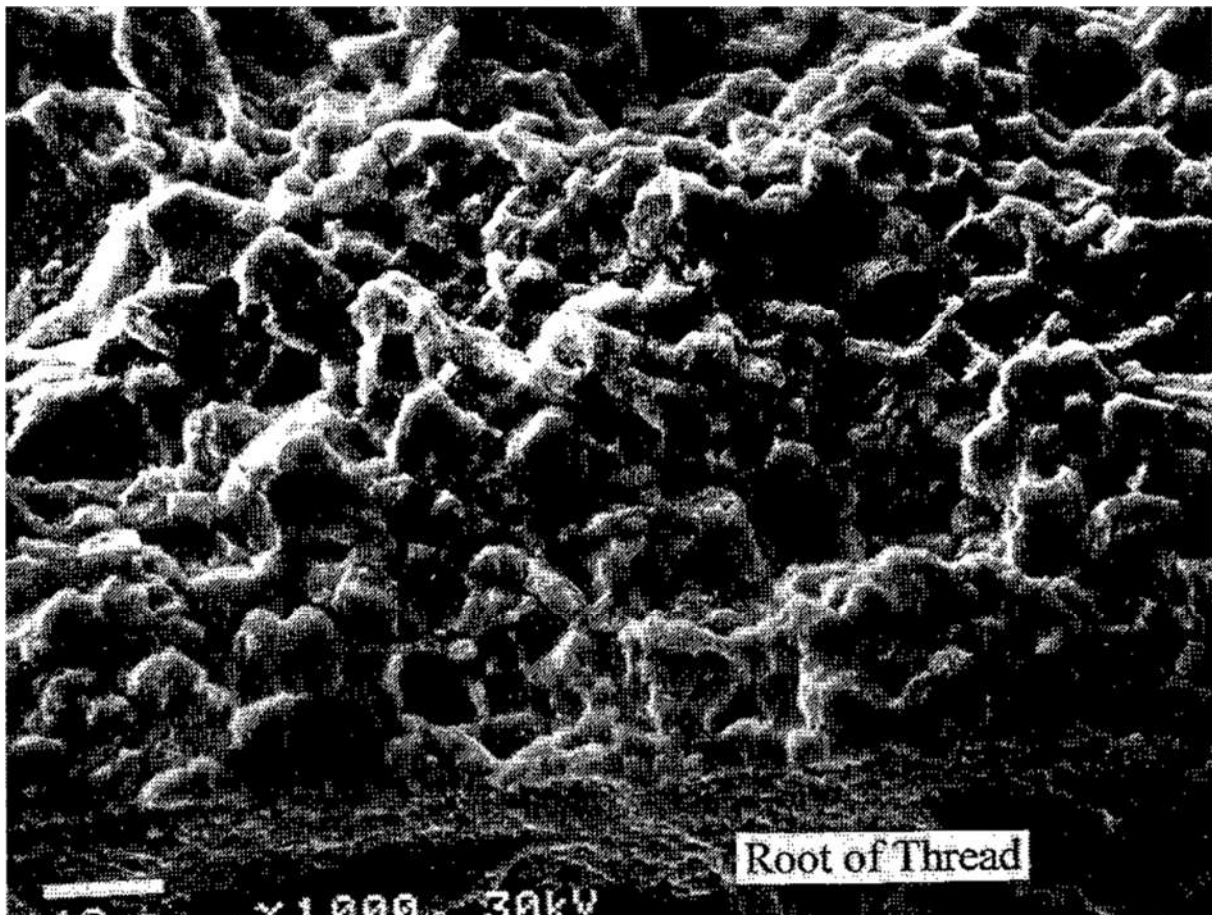
A detailed examination of the crankshaft gear bolt by the Lycoming Materials Laboratory revealed that the failure was caused by hydrogen embrittlement. The bolt fractured through the second to fifth threads from the shank, and two additional cracks were found extending through the twelfth and thirteenth threads. These fractures exhibited intergranular separation, a hallmark of hydrogen-assisted cracking. The zinc plating on the bolt was identified as the source of the hydrogen, which penetrated the bolt material during the manufacturing process. Figure 15 illustrates the SEM image of the fractured surface, showing intergranular separation caused by hydrogen embrittlement.

Figure 15. SEM image under 1000x magnification showing intergranular separation on the fractured surface of the crankshaft gear bolt (P/N STD-2209), indicating hydrogen-assisted cracking.

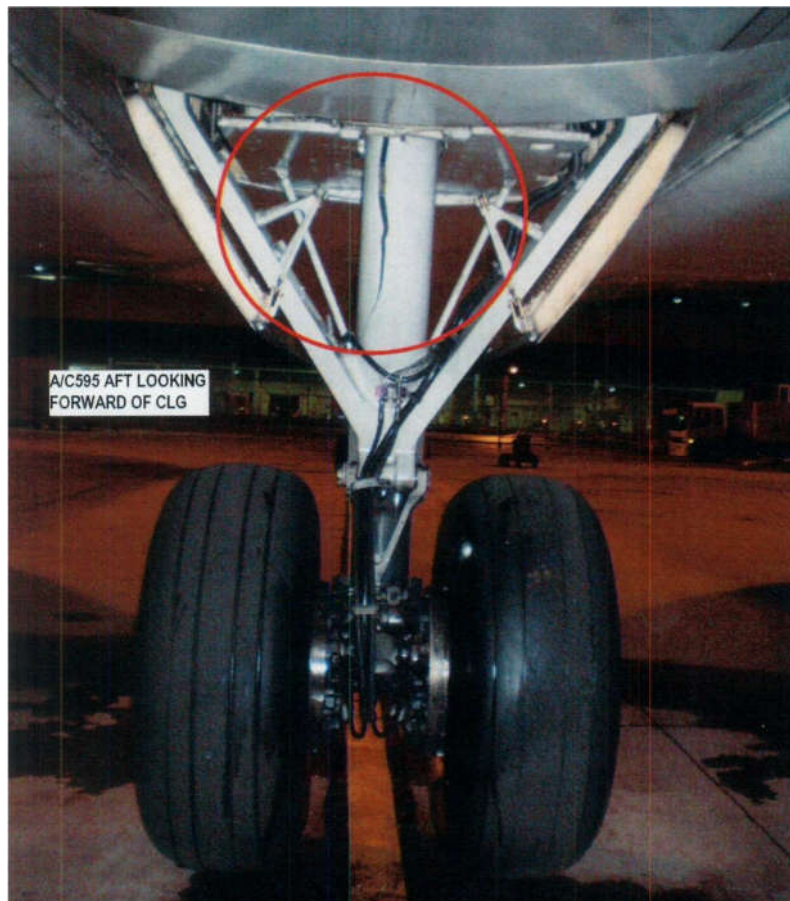
Figure 16. Photograph of the cracked CLG strut cylinder, showing the longitudinal crack along the aft side.

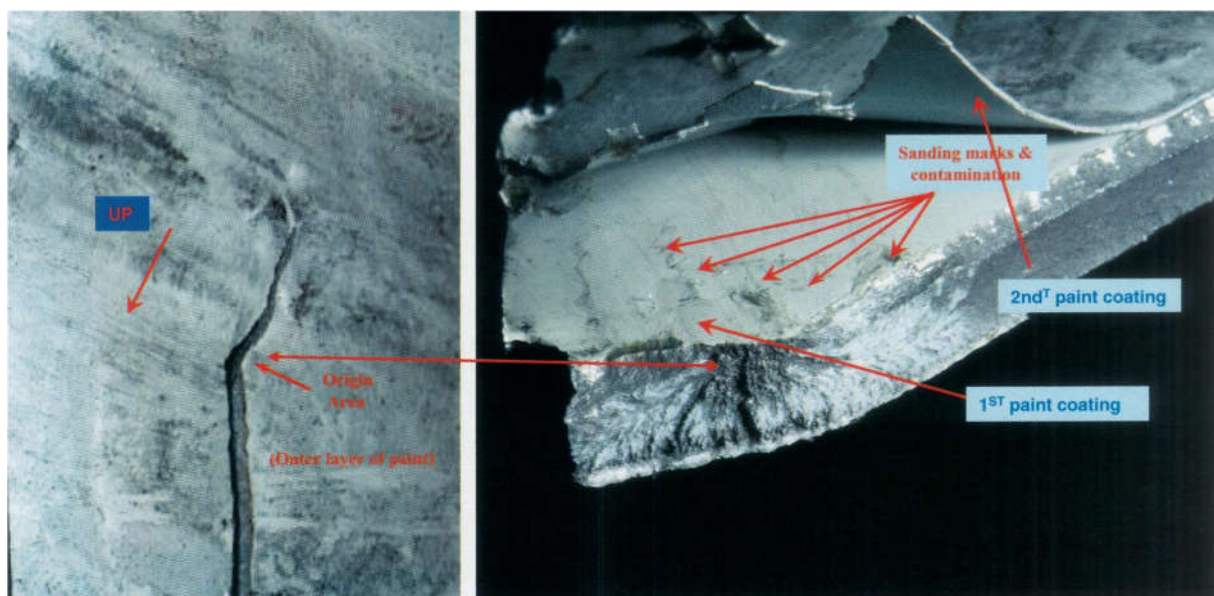
Metallurgical analysis revealed that the CLG strut cylinder failure was caused by intergranular (IG) cracking, which originated from surface contamination during a prior maintenance procedure. The failure was traced to improperly cleaning the surface before painting, where residual chemicals from paint removal solutions contributed to hydrogen embrittlement. The intergranular cracking extended deep into the wall of the cylinder, weakening the structure. Figure 17 shows a cross-sectional view of the fracture origin area, highlighting the intergranular cracking.

Figure 17. Cross-sectional view of the CLG strut cylinder, showing the intergranular cracking that initiated the failure.

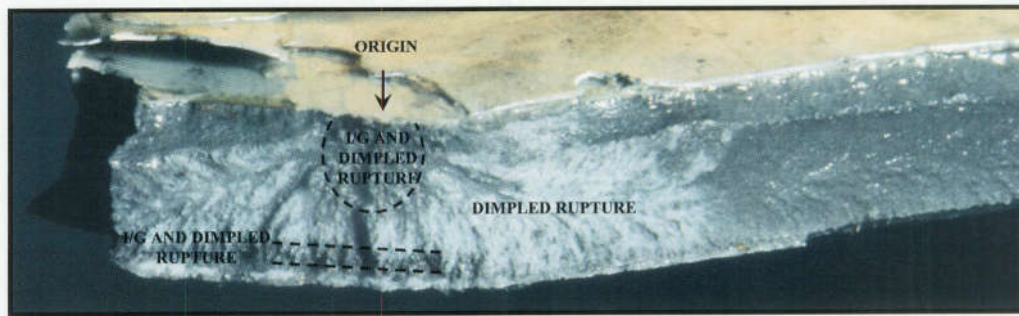
During the teardown process, it was noted that cutting through the CLG cylinder with an abrasive wheel resulted in loud cracking noises, indicating a high level of residual stress in the material. This observation suggested that the failure was exacerbated by residual stresses in the cylinder wall. Visual and macroscopic examination confirmed that the fracture originated at the outer surface of the cylinder, approximately 18.2 inches from the bottom of the cylinder. Figure 18 shows the fracture surface of the CLG cylinder after disassembly.

Figure 18. The fracture surface of the CLG cylinder shows the location of the crack and the progression of failure.

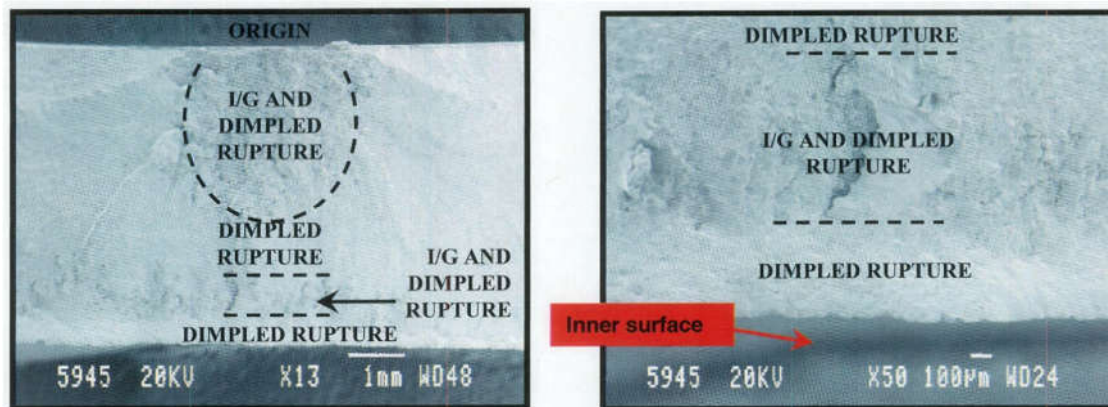
A more detailed Scanning Electron Microscope (SEM) analysis revealed a mixed-mode failure. The fracture surface exhibited intergranular separation along the origin, and dimples indicated ductile overload in other areas. This mixed-mode fracture suggested that the initial failure occurred due to hydrogen embrittlement, which initiated the intergranular cracking. As the crack propagated, it transitioned into an overload failure mode. Figure 19 illustrates the SEM image of the fracture surface, showing both intergranular facets and dimpled regions.

Figure 19. SEM image of the fracture surface, showing a combination of intergranular cracking and ductile overload.
