Copper Mountain Mine Tailings Dam Safety Review Supplement

Abstract:—Copper Mountain Mine tailings dam slope stability research based on recommendations of the 2021 Tetra Tech Dam Safety Review, including computation of tailings dam factors of safety, satellite imagery, steady state and transient seepage analyses, assessment of internal erosion risk, and flow liquefaction hazard analysis. Dam topographic information provided by foundation investigation and annual dam safety inspection reports is used to specify 3D dam models and compute dam factors of safety that satisfy normal operating requirement but are in possible violation of post-seismic requirement.

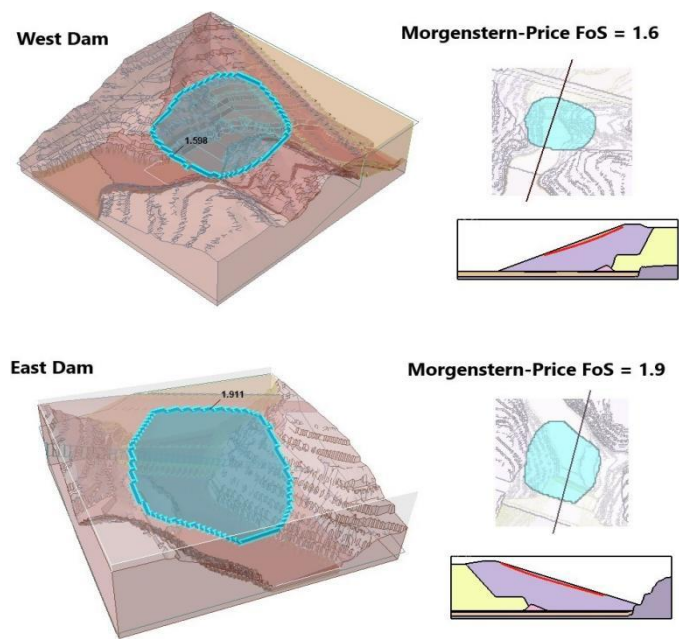
Figure 2 shows the result of computing 3D FoS values for models of the West Dam and East Dam using Rocscience Slide3. The 3D models are based on valley topographic data provided by the foundation investigation documentation and 2016/2023 ADSI reports, and dam construction projections based on the 2023 ADSI report. Because the foundation investigation documentation showed boreholes

in the vicinity of the West and East starter dams having average surface/bedrock elevations of 810.4m/795.4m and 811.8m/781.6m elevations, while the 2023 ADSI indicates the West and East starter dam base elevations for sections B1 and A2 are 800m, foundation topography was simplified to have uniform surface/bedrock elevations of 800m/780m, since the sand and gravel material in the foundation below the elevation of the surface lacustrine clay layers is not anticipated to affect slip surface geometry. Model phreatic surfaces are based on calibration of FEFLOW 2D seepage analyses to 2023 piezometer data, assuming water is ponded against dam crests during probable maximum flood events. For minimal slip surfaces determined by the Slide3 classic ellipsoidal particle swarm search, the Morgenstern-Price FoS value is 1.6 for the West Dam is 1.6, and 1.9 for the East Dam. The fact that neither 3D slip surface passes through the tailings and clay foundation demonstrates the importance of the narrowness of dam valley geometry to enhancing stability of the dam slopes.

Figure 2. West Dam and East Dam 2025 3D Morgenstern-Price FoS values computed for minimal spline slip surfaces determined by Rocscience Slide3 classic ellipsoidal particle swarm search. Phreatic surface based on 2D FEFLOW analysis of probable maximum flood conditions.

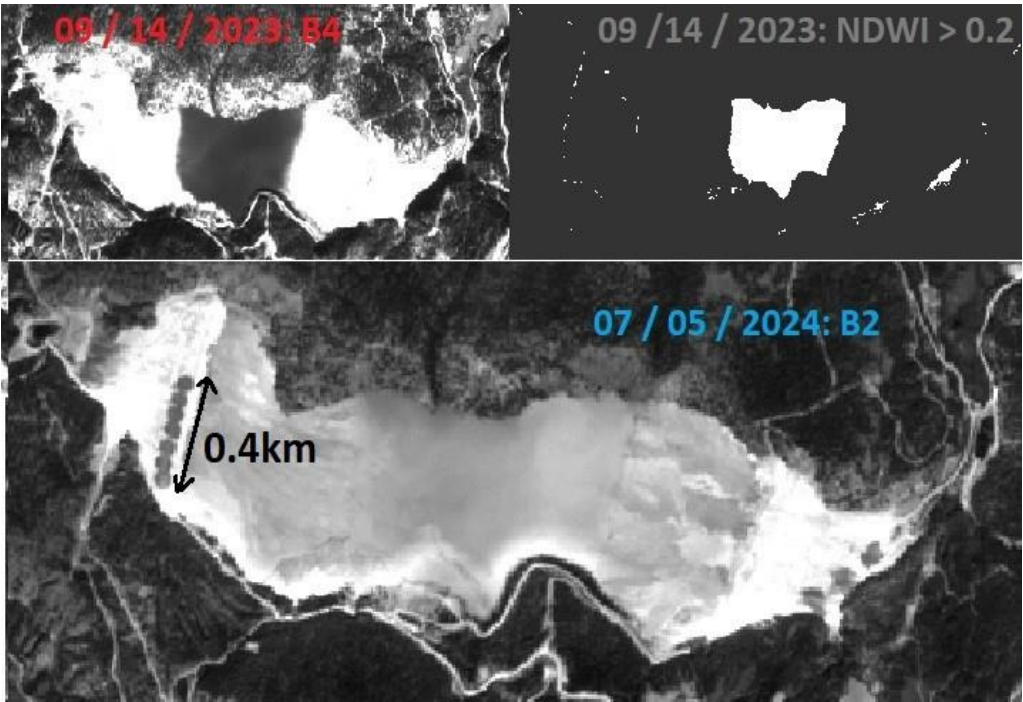
to detect presence of surface water [13,44]. **Figure 3-top** shows images of the Copper Mountain Mine TSF on September 14, 2023, filtered in the red band B4 (left) and binary processed to display $NDWI > 0.2$ to identify presence of surface water. **Figure 3-bottom** shows an image of the TSF on July 5, 2024, filtered through band B2 (blue-490nm), in which circular surface structures of approximate diameter 60 and 100km with optical reflectivity less than surrounding dam material are visible on the West and East dam downstream slopes. A hypothesis offered for presence of the structures in accordance with the 2021 DSR is that they were formed by sprinkler systems to limit dust generation.

Figure 3. Sentinel-2 images Copper Mountain Mine TSF, dated 09/14/2023 (top), and 07/05/2024 (bottom). Top images show the TSF in red band B4 (left), in which boundaries of the tailings pond are clear, and the same

image binary processed for the condition $NDWI > 0.2$ to identify presence of water at the surface of the TSF. The bottom image shows the TSF in blue band (B2) in which 7 circular structures on the West Dam crest/downstream slope of approximate diameter 60m and 3 circular structures on the East Dam downstream slope of approximate diameter 100m are visible, and distinguishable from dam downstream slope, beach, and tailings pond materials by their reflectance in blue, red, and infrared bands.

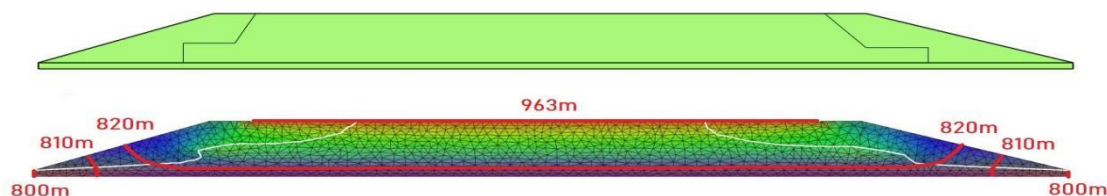
Figure 4 shows the FEFLOW computed 2023 phreatic surface level and hydraulic head isolines for the entire TSF and its foundation analyzed as a simplified 2 dam system in which drainage systems are ignored, beach lengths are 0m, and the material permeabilities listed in **Table 5** have

been used. This analysis indicates the 2023 hydraulic head in TSF foundation upstream of West and East starter dams is approximately constant at 810m. The total seepage flows out of the West and East Dams are computed to be 1.4L/s/m and 1.2L/s/m, and in both cases more than 90 percent of this flow passes through the foundation. These seepage analysis results are in contrast to 2014 piezometer readings of VWP10-05W-3/VWP10-01E-3 in West/East Dam upstream foundations in excess of 835m/845m, pointing to the importance of considering the effect of 3D TSF geometry on seepage flow, and accounting for any low permeability path from the TSF pond through the TSF abutments into the foundation as previously reported to be of concern [26].

Figure 4. West/East Dam FEFLOW analysis of 2023 2 dam system indicates hydraulic head in TSF foundation upstream of West and East starter dams is approximately constant at 810m, in contrast to 2014 piezometer readings of VWP10-05W-3/VWP10-01E-3 in West/East Dam upstream foundations in excess of 835m/845m.

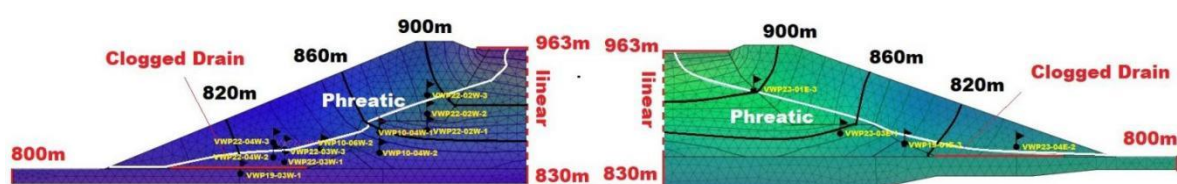
Figure 5 shows West/East Dam FEFLOW steady state seepage analyses with drain function and boundary conditions adjusted to obtain approximate agreement of hydraulic heads with 2023 readings of West/East Dam piezometer readings. For both dams, an upstream foundation total head of 830m was assigned based on readings of piezometer VWP12-01E-2 and results of analyzing the 2 dam system. For the West Dam, to obtain agreement with downstream piezometer VWP22-04W-1 and VWP22-03W-3 readings of 811m and 827.5m, it was necessary to assume 100m of the blanket/finger drain system downstream of the starter dam has been clogged, and to obtain agreement with piezometer VWP10-04W-1 and VWP22-02W-3 readings of 859.5m and 900m it was necessary to assume a beach length of 0m. For the East Dam, to obtain agreement with downstream piezometer VWP23-04E-2 and VWP19-01E-3 readings of 815.3m and 834m, it was necessary to assume 200m of the blanket/finger drain system downstream of the starter dam has been clogged, and to obtain agreement with piezometer VWP23-03E-2 and VWP23-01E-3 readings of 855m and 911.5m it was necessary to assume a beach length of 0m. After this initial adjustment of drain permeability and seepage flow boundary conditions, material and drain permeabilities were calibrated to 2023 piezometer readings using FePEST. For both West/East Dam FePEST permeability calibrations, the effect on phreatic surface position was not substantial, but returned cycloned sand permeability $5e^{-7}m/s$ was two orders of magnitude lower than reported in the 2021 DSR, and permeabilities ranging from $3.3e^{-5}m/s$ to $5.8e^{-3}m/s$ for sections of drain 0-100 and 100-200 meters downstream of the starter dams were returned. The low value of cycloned sand permeability is attributed to the presence of a structural zone intermediate between tailings and cycloned sand downstream slopes in which tailings and sand materials by 2 percent of waves are 1.7m and 1.3m. The setups for these waves, defined by the formula:

Figure 5. West/East Dam FEFLOW 2023 steady state seepage analysis with drain function, boundary conditions, and material permeabilities adjusted so the analysis hydraulic heads are in approximate agreement with 2023 piezometer readings.

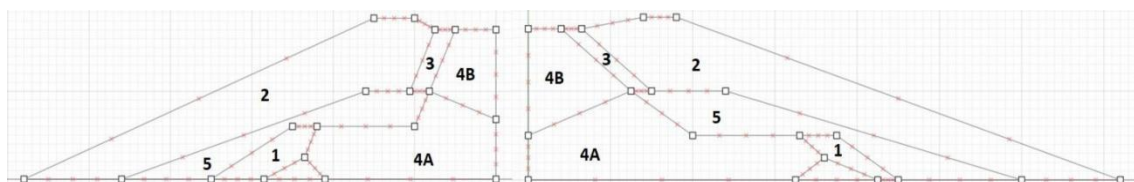
2019 CPT tests of the West Dam at 4 different locations at the crest and downstream slope indicate that for conservative assignment of the state parameter ψ to different parts of the dam, tailings/cycloned sand material above elevation 880m in the vicinity of the dam crest should be assigned a value of ψ between 0 and 0.1, while water saturated cycloned sand above and downstream of the West starter dam should be assigned a value of ψ between -0.05 and 0. Based on these 2019 CPT test results, the West Dam has been divided into 5 zones as shown in **Figure 8**, in which a liquefaction susceptible fifth zone consisting of water saturated cycloned sand has been added to the 1989 TSF Design Review zone division. In this figure, a similar zone division of the East Dam based on the 1989 TSF Design Review and 2019 CPT test results is also shown.

Figure 8. FLAC2D sketch of above foundation tailings/cycloned sand material in 2025 West/East Dam cross sections B2/A1 divided into zones 1:compacted cycloned sand, 2:uncompacted cycloned sand, 3:cyclone overflow+tailings, 4:tailings, 5:water saturated cycloned sand based on the 1989 TSF Design Review, and the 2014 and 2023 ADSI reports. Zone 5 in each dam is distinguished from Zone 2 based on the results of 2019 CPT tests and 2023 piezometer data.

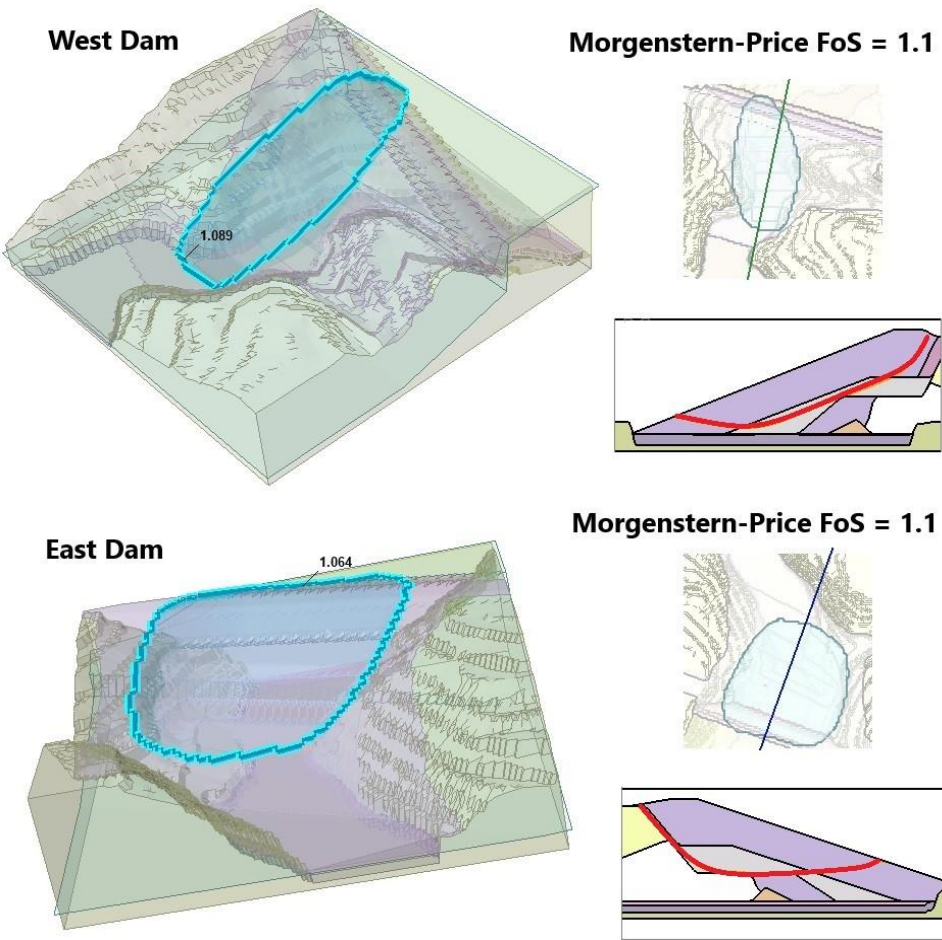
Post-liquefaction stability of the West and East Dams has been assessed by assigning residual undrained shear strength ratios of 0.22 and 0.07 to zones 4A and 4B, following the 2020 KCB stability analysis, and 0.055 to zones 3 and 5, assuming an SPT blow count value of 10 for water saturated cycloned sand based on the 1989 TSF Design Review and a residual undrained strength ratio multiplicative factor of 0.0055 [24,54]. **Figure 9** shows the resulting Slide3 Morgenstern-Price 3D limit equilibrium analysis FoS values of 1.1 and 1.1 for the West and East Dams, and the associated slip surfaces. **Table 7** shows FoS values similarly computed for different values of the unsaturated cycloned sand internal friction angle and water saturated sand SPT blow count. It is noted that while the assignment of residual undrained shear strength ratio of 0.055 to zone 5 is overly conservative based on 2019 CPT data, it is not known what post-2023 CPT data would show in regards to the current extent of water saturated cycloned sand and its liquefaction susceptibility. [54]. Moreover, it is not guaranteed Slide3 FoS computation is finding West/East Dam critical slip surfaces, although both intelligent search and addition of weak layers were attempted without lowering the returned Morgenstern-Price FoS. Slide3 allowance for tension cracking of the cycloned sand dam crests was not observed to have any effect on FoS or slip surface results.

Figure 9. Post-liquefaction FoS computation Slide3 results. Slip surfaces returned by classic ellipsoidal search with assignment of residual undrained shear strength ratios 0.22 to zone 4A, 0.07 to zone 4B, and 0.055 to zones 3 and 5.
