Corrosion Failure Analysis of Duplex Stainless Steel Used as Shell and Tube Heat Exchanger with Seawater as the Cooling Medium

Materials Science and Engineering Research Group, Faculty of Mechanical and Aerospace Engineering,
Institut Teknologi Bandung, Bandung 40131, Indonesia

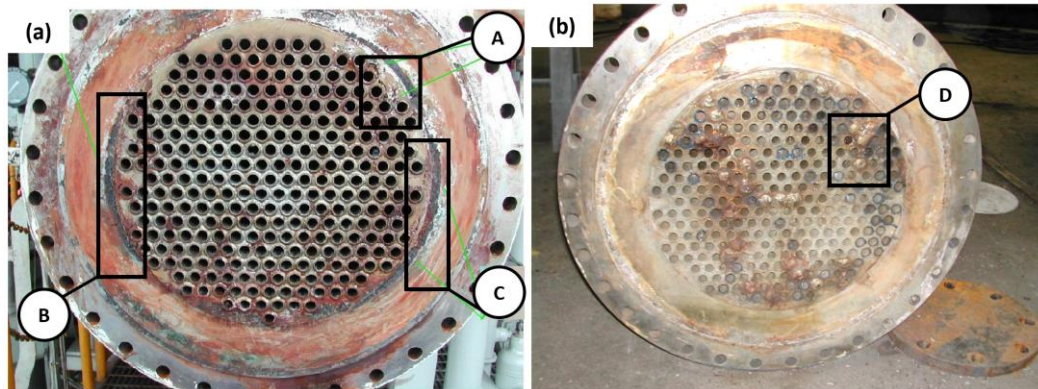
Visual examinations were conducted on two heat exchangers. Figure 2(a) is the photograph of heat exchangers at the platform; defects were found on the welded section between the tube and tube sheet in A section, B, and C sections show the defect of the tube sheet under the gasket area, the further examination of this defect are shown at Figure 3(a,b). The heat exchanger's tube sheet at the warehouse (Figure 2(b)) contains some leaked tubes. D section shows that some leaked tubes were plugged and weld overlayed. For further examination, the heat exchanger at the warehouse was cut into some sections, including the tube sheet and gasket interface, tube sheet inlet sections, and the tube itself.

Figure 2. Failed heat exchangers appearance: (a) Heat-exchanger's tube sheet at the platform; (b) Heat-exchanger's tube sheet at the warehouse.

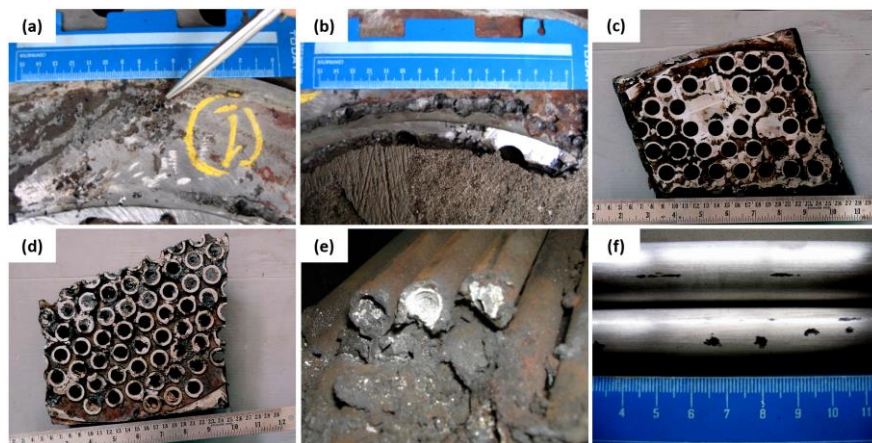
Figure 3. (a,b)) Tube sheet and gasket interface; (c,d) Tube sheet inlet sections; (e) Lateral section of tubes; (f) Tube surface condition.

Figure 3(a,b) are the further examination of Figure 2(a) in the B section. Pitting defects under the gasket can be seen at those tube sheet interfaces; this defective surface will be examined further to determine the root cause of pitting defects. Figure 3(c,d) are the cut piece of seawater inlet tube sheets. As practical information, when corrosion was found on the tube sheet, a plug was applied to the corroded tube, and the tube sheet was repaired by overlaying the tube sheet. Figure 3(e) shows a cut plugged tube on the outlet side; white scale deposits were observed inside the tubes. Two pieces of the plugged tubes were cut for laboratory examinations to examine the crack locations. The outer surface of the tube was cleaned with fine emery paper and observed visually by dye penetrant and magnifying glass. There was no crack observed on the outer surface of the tube. Some shallow pitting was observed on the outer surface closed to the outlet side. However, this pitting was started from the outer surface, and some of them can be removed by emery paper. Figure 3(f) shows the defective tube's surface appearance. For further examination, the appearance of the tube's inner surface conditions was done by cutting the tube longitudinally; this examination was conducted on the plugged tube, an unplugged tube, and a good tube, a standard tube without defect.

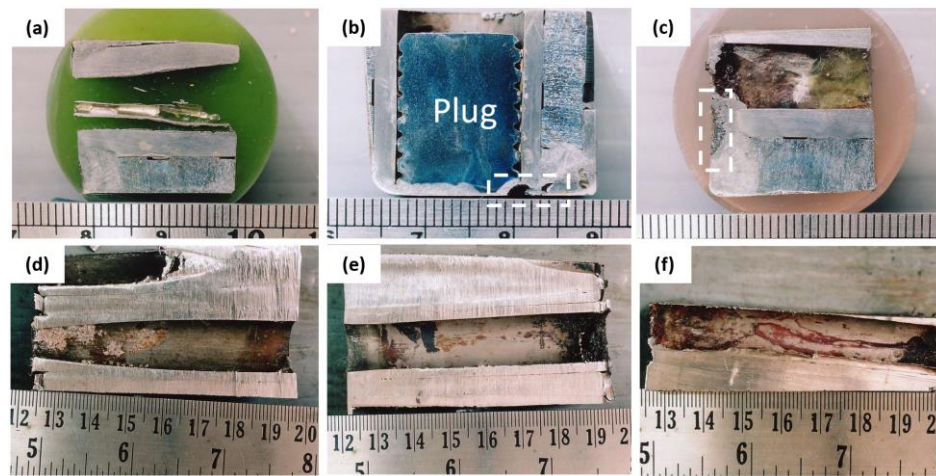
The cross-section of the excellent tube Figure 4(a) shows that a weld overlay joined the tube and tube sheet; the overlay of the tube sheet protected it from corrosion and sealed the possible gap between the tube and tube sheet. No defect like corrosion or leak was observed in this tube, and the weld overlay sealed the gap between the tube and tube-sheet well. Figure 4(b,c) are the macro-photograph of the plugged tube, and the tube was initially cold expanded to the tube sheet. Corrosion occurred on the tube sheet and has been repaired by weld overlay. Figure 4(d,e) are pictures of the plugged tube's inner surface. Heavy deposits under the plug were observed, and some deposits along

the tube indicated the presence of biofilm that may promote microbiological-induced corrosion. Figure 4(f) is the cross-section of the unplugged tube. Heavy deposit on the entrance side was observed, and some deposits along the tube indicated the presence of biofilm that may promote microbiological-induced corrosion.

Figure 4. Longitudinal cross-section of (a) Tube without defect; (c-e) Plugged tube; (f) Unplugged tube.

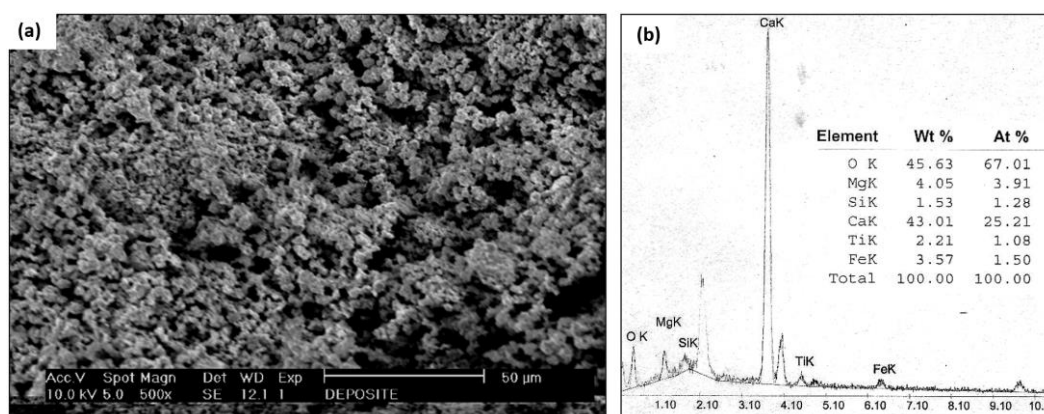
The tube deposit from Figure 3(e) was examined using SEM and EDS. Figure 5(a) is the SEM macrograph of the tube scale deposit; the particle size is very fine, indicating that it was formed through a chemical reaction. Figure 5(b) results from energy dispersive spectrometry of the tube deposit, with dominant calcium, magnesium, and oxygen elements. An XRD examination will further analyze this result, as shown in Figure 6.

Figure 5. SEM examination and EDS result on tube scale deposit.

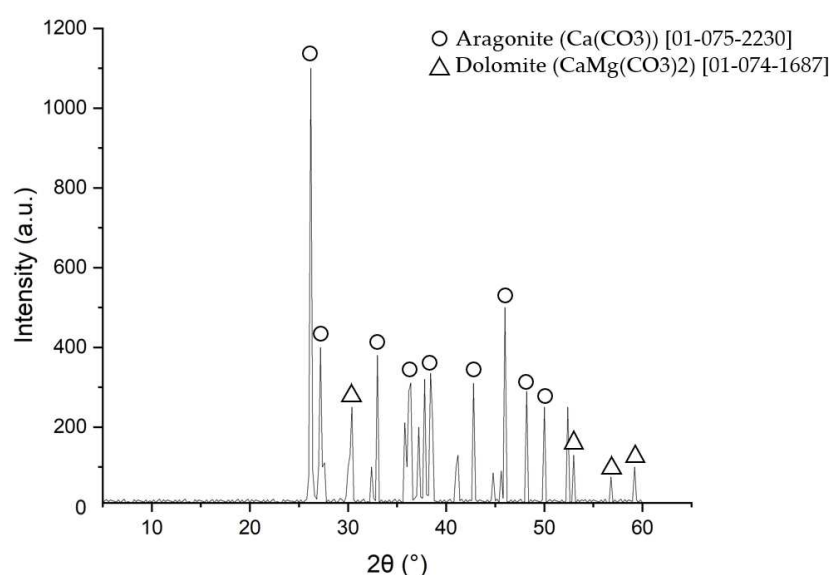
Based on the XRD examination results, the majority of the tube scale is Aragonite (CaCO_3) and Dolomite ($\text{CaMg}(\text{CO}_3)_2$). The X-ray diffraction result confirmed the energy dispersive spectrometry data, which showed that calcium, magnesium, and oxygen are the main components in the tube deposit. The mechanism of scale formation and the composition of the scale will be discussed further in the discussion section.

Figure 6. XRD examination on tube scale deposit.

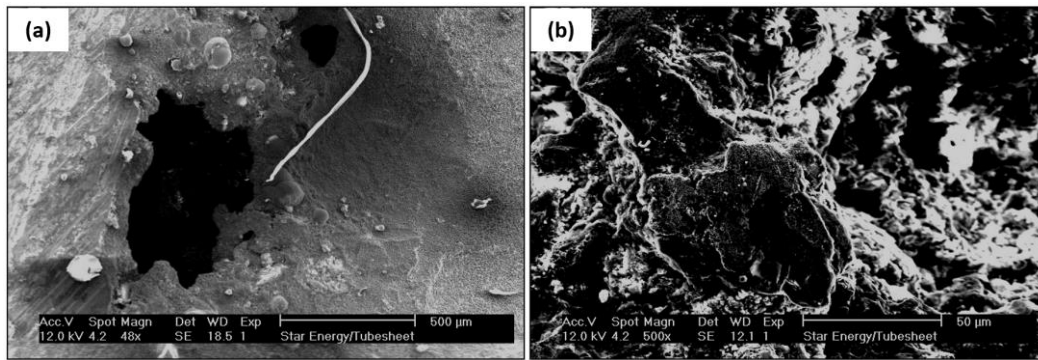
The surface of the tube sheet in Figure 3(a,b) was cleaned with Clark solution before examination; the dirt on the surface cannot be entirely removed by Clark solution. The SEM micrograph of the tube sheet's defective surface shown in Figure 7(a) reveals traces of barnacles. The pitting present indicates the effect of a microbiological attack on the surface [31]. Figure 7(b) is the scanning electron macrograph of another defective surface; the pitting geometry indicates the effect of crevice corrosion attack or corrosion under deposit. Detail examination of the defective surface cannot be performed because a permanent deposit still covers the surface.

Figure 7. SEM examination on tube sheet defective surface.

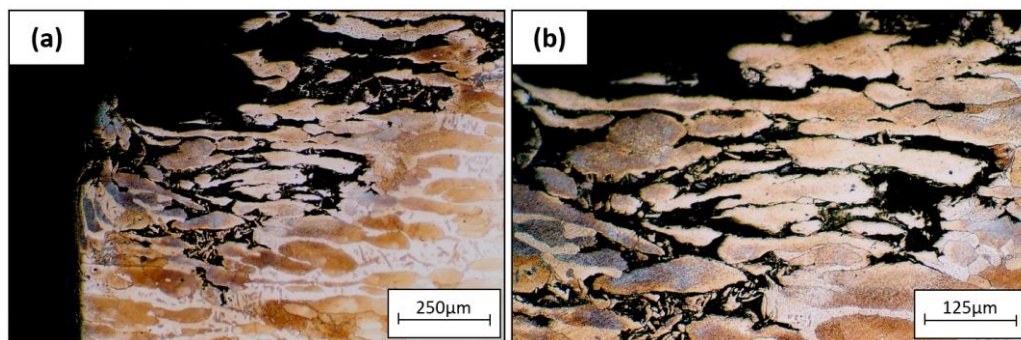
The corroded surface of the tube sheet from Figure 3(a) was examined using an optical micrograph. According to Figure 8(a,b), corrosion attack occurred preferentially along the austenite grains. On the contrary, there is no attack on the ferrite grain. Preferential attack on the austenite grain of the weld metal has also been observed during the crevice corrosion test of Ferralium Alloy 255 duplex stainless steel weldments (Cr = 25.5%, Ni = 5.5%, Mo = 3.0%) [32]. The corrosion attack on this part of the tube sheet is caused by crevice corrosion that forms pitting colonies on the tube sheet surface.

Figure 8. Optical micrograph of a corroded section of tube sheet 3(a).

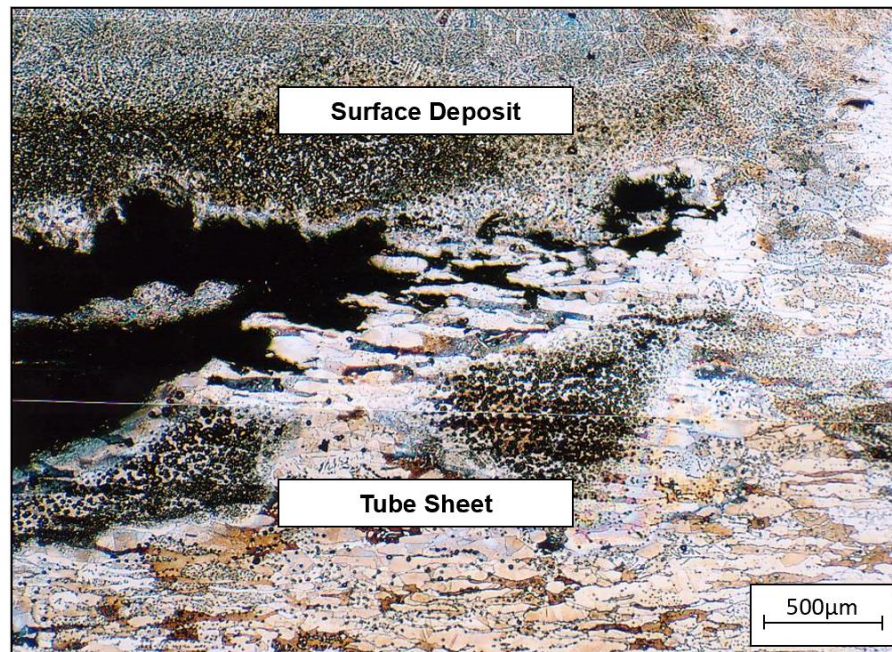
Figure 9 is the optical micrograph of the corroded tube sheet at the other location. The type of attack is different from that of Figure 8. The corrosion attack occurred under deposit. Previous fractography data indicated that corrosion in this site is caused by micro/macro fouling. However, the corrosion occurred under the gasket; therefore, the macro/micro fouling was formed and attacked the tube sheet surface. The corrosion mechanism combines crevice and microbiological corrosion[33].

Figure 9. Optical micrograph of a corroded section of tube sheet 3(b).

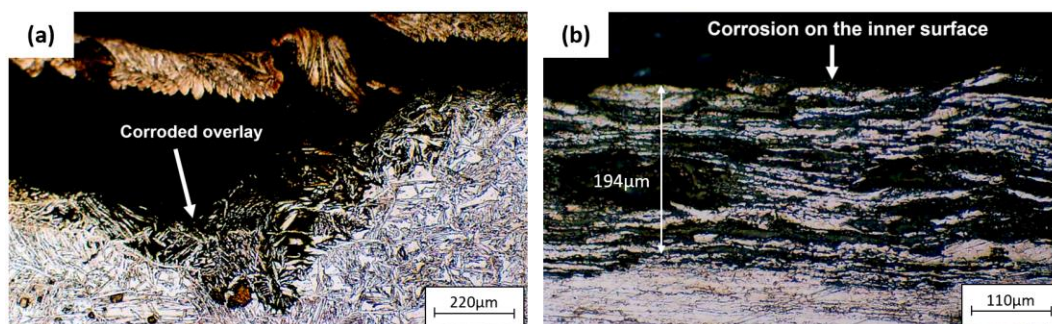
Figure 10 is the optical micrograph of the unplugged tube, corrosion occurred on the inner surface of the tube, and the austenite grains were attacked by crevice corrosion. Corrosion also occurred on the tube sheet overlay.

Figure 10. Optical micrograph of (a) corrosion on tube sheet overlay of the unplugged tube, (b) corrosion on the inner surface of the unplugged tube.

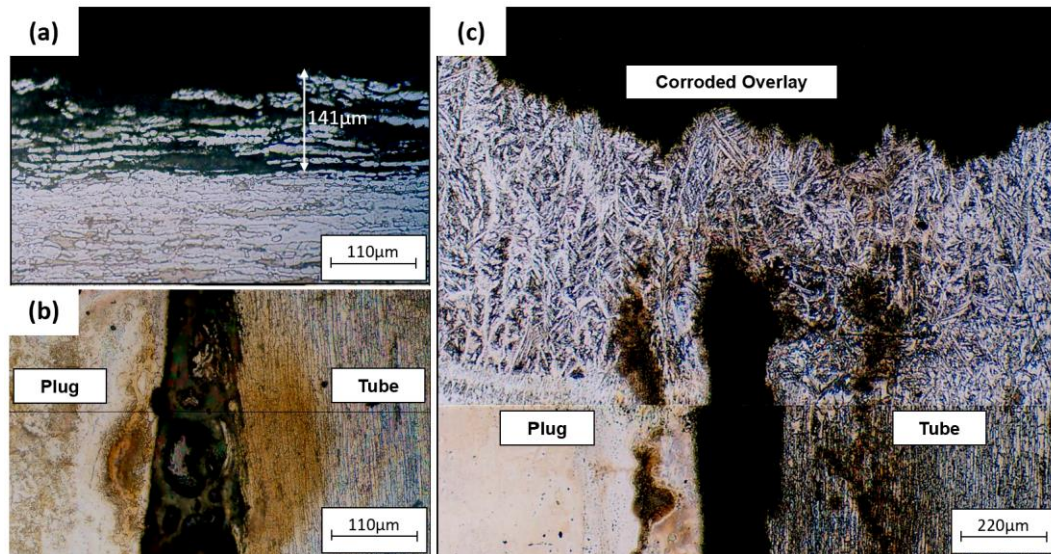
Figure 11 is an optical micrograph of a plugged tube. Figure 11(a) shows the inner surface of the tube attacked by corrosion, with the depth of the austenite grains attacked being 141µm. Figure 11(b) shows the occurrence of corrosion in the crevice between the plug and the tube. The tube-sheet overlay is also attacked by corrosion (Figure 11(c)).

Figure 11. Optical micrograph of (a) corrosion on the inner surface of the plugged tube, (b) tube and plug corroded interface (c) corrosion on tube sheet overlay of the plugged tube.
