# Copper Mountain Mine Tailings Dam Safety Review Supplement

[Daniel Brox](#)\*

Keywords: tailings dam; foundation investigation; seepage analysis; internal erosion; flow liquefaction

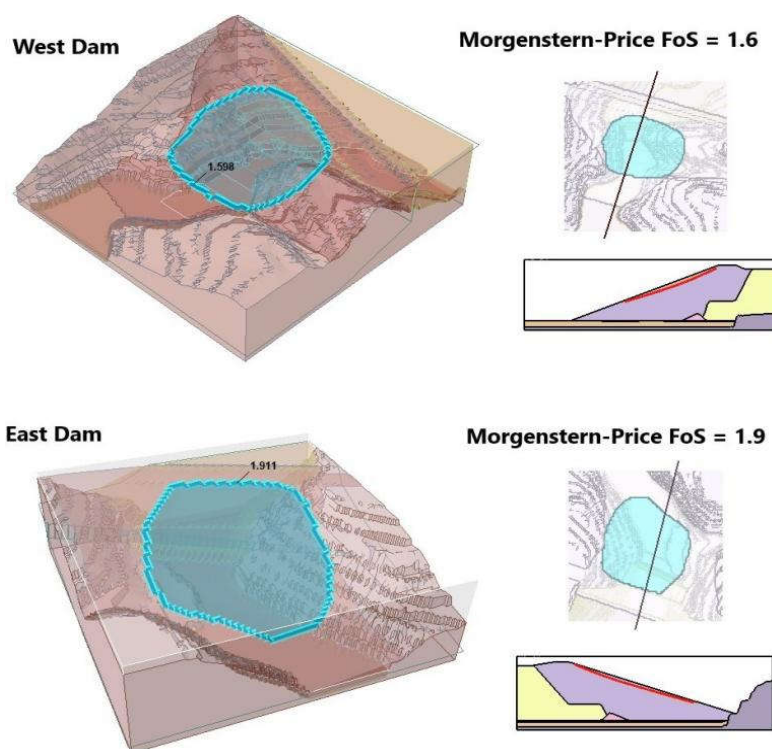
Figure 2 shows the result of computing 3D FoS values for models of the West Dam and East Dam using Rocscience Slide3. The 3D models are based on valley topographic data provided by the foundation investigation documentation and 2016/2023 ADSI reports, and dam construction projections based on the 2023 ADSI report. Because the foundation investigation documentation showed boreholes in the vicinity of the West and East starter dams having average surface/bedrock elevations of 810.4m/795.4m and 811.8m/781.6m elevations, while the 2023 ADSI indicates the West and East starter dam base elevations for sections B1 and A2 are 800m, foundation topography was simplified to have uniform surface/bedrock elevations of 800m/780m, since the sand and gravel material in the foundation below the elevation of the surface lacustrine clay layers is not anticipated to affect slip surface geometry. Model phreatic surfaces are based on calibration of FEFLOW 2D seepage analyses to 2023 piezometer data, assuming water is ponded against dam crests during probable maximum flood events. For minimal slip surfaces determined by the Slide3 classic ellipsoidal particle swarm search, the Morgenstern-Price FoS value is 1.6 for the West Dam is 1.6, and 1.9 for the East Dam. The fact that neither 3D slip surface passes through the tailings and clay foundation demonstrates the importance of the narrowness of dam valley geometry to enhancing stability of the dam slopes.

**Figure 2.** West Dam and East Dam 2025 3D Morgenstern-Price FoS values computed for minimal spline slip surfaces determined by Rocscience Slide3 classic ellipsoidal particle swarm search. Phreatic surface based on 2D FEFLOW analysis of probable maximum flood conditions.

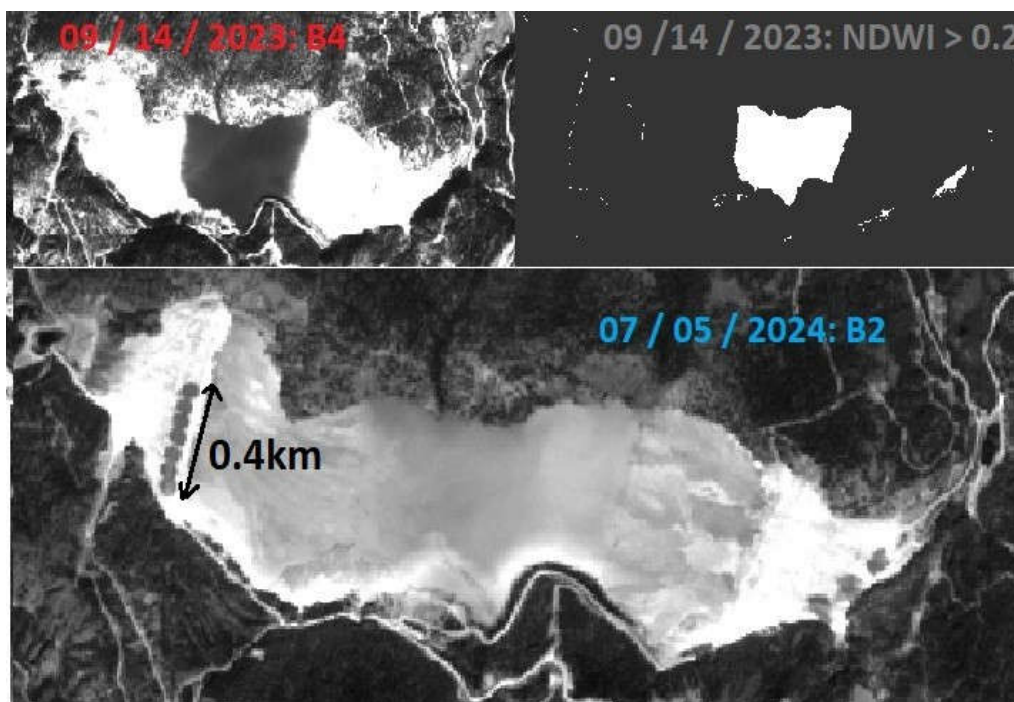
to detect presence of surface water [Du, 2016, O'Donovan, 2022]. Figure 3-top shows images of the Copper Mountain Mine TSF on September 14, 2023, filtered in the red band B4 (left) and binary processed to display  $NDWI > 0.2$  to identify presence of surface water. Figure 3-bottom shows an image of the TSF on July 5, 2024, filtered through band B2 (blue-490nm), in which circular surface structures of approximate diameter 60 and 100km with optical reflectivity less than surrounding dam material are visible on the West and East dam downstream slopes. A hypothesis offered for

presence of the structures in accordance with the 2021 DSR is that they were formed by sprinkler systems to limit dust generation.

**Figure 3.** Sentinel-2 images Copper Mountain Mine TSF, dated 09/14/2023 (top), and 07/05/2024 (bottom). Top images show the TSF in red band B4 (left), in which boundaries of the tailings pond are clear, and the same image binary processed for the condition  $NDWI > 0.2$  to identify presence of water at the surface of the TSF. The bottom image shows the TSF in blue band (B2) in which 7 circular structures on the West Dam crest/downstream slope of approximate diameter 60m and 3 circular structures on the East Dam downstream slope of approximate diameter 100m are visible, and distinguishable from dam downstream slope, beach, and tailings pond materials by their reflectance in blue, red, and infrared bands.

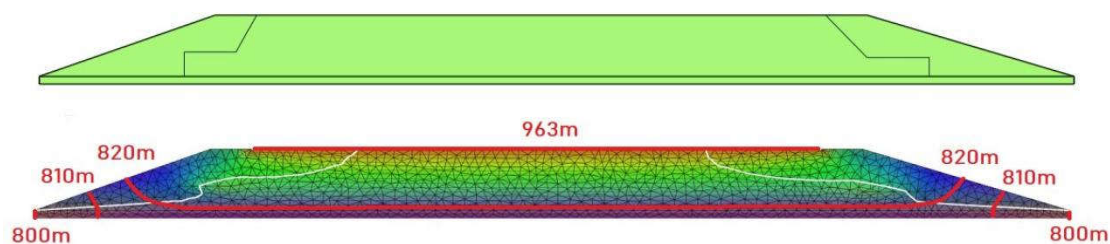
Figure 4 shows the FEFLOW computed 2023 phreatic surface level and hydraulic head isolines for the entire TSF and its foundation analyzed as a simplified 2 dam system in which drainage systems are ignored, beach lengths are 0m, and the material permeabilities listed in Table 5 have been used. This analysis indicates the 2023 hydraulic head in TSF foundation upstream of West and East starter dams is approximately constant at 810m. The total seepage flows out of the West and East Dams are computed to be 1.4L/s/m and 1.2L/s/m, and in both cases more than 90 percent of this flow passes through the foundation. These seepage analysis results are in contrast to 2014 piezometer readings of VWP10-05W-3/VWP10-01E-3 in West/East Dam upstream foundations in excess of 835m/845m, pointing to the importance of considering the effect of 3D TSF geometry on seepage flow, and accounting for any low permeability path from the TSF pond through the TSF abutments into the foundation as previously reported to be of concern [Klohn Crippen, 1998].

**Figure 4.** West/East Dam FEFLOW analysis of 2023 2 dam system indicates hydraulic head in TSF foundation upstream of West and East starter dams is approximately constant at 810m, in contrast to 2014 piezometer readings of VWP10-05W-3/VWP10-01E-3 in West/East Dam upstream foundations in excess of 835m/845m.

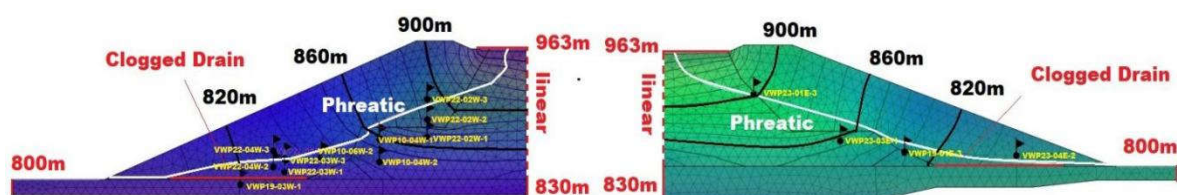
Figure 5 shows West/East Dam FEFLOW steady state seepage analyses with drain function and boundary conditions adjusted to obtain approximate agreement of hydraulic heads with 2023 readings of West/East Dam piezometer readings. For both dams, an upstream foundation total head of 830m was assigned based on readings of piezometer VWP12-01E-2 and results of analyzing the 2 dam system. For the West Dam, to obtain agreement with downstream piezometer VWP22-04W-1 and VWP22-03W-3 readings of 811m and 827.5m, it was necessary to assume 100m of the blanket/finger drain system downstream of the starter dam has been clogged, and to obtain agreement with piezometer VWP10-04W-1 and VWP22-02W-3 readings of 859.5m and 900m it was necessary to assume a beach length of 0m. For the East Dam, to obtain agreement with downstream

piezometer VWP23-04E-2 and VWP19-01E-3 readings of 815.3m and 834m, it was necessary to assume 200m of the blanket/finger drain system downstream of the starter dam has been clogged, and to obtain agreement with piezometer VWP23-03E-2 and VWP23-01E-3 readings of 855m and 911.5m it was necessary to assume a beach length of 0m. After this initial adjustment of drain permeability and seepage flow boundary conditions, material and drain permeabilities were calibrated to 2023 piezometer readings using FePEST. For both West/East Dam FePEST permeability calibrations, the effect on phreatic surface position was not substantial, but returned cycloned sand permeability  $5e^{-7}m/s$  was two orders of magnitude lower than reported in the 2021 DSR, and permeabilities ranging from  $3.3e^{-5}m/s$  to  $5.8e^{-3}m/s$  for sections of drain 0-100 and 100-200 meters downstream of the starter dams were returned. The low value of cycloned sand permeability is attributed to the presence of a structural zone intermediate between tailings and cycloned sand downstream slopes in which tailings and sand materials by 2 percent of waves are 1.7m and 1.3m. The setups for these waves, defined by the formula:

**Figure 5.** West/East Dam FEFLOW 2023 steady state seepage analysis with drain function, boundary conditions, and material permeabilities adjusted so the analysis hydraulic heads are in approximate agreement with 2023 piezometer readings.

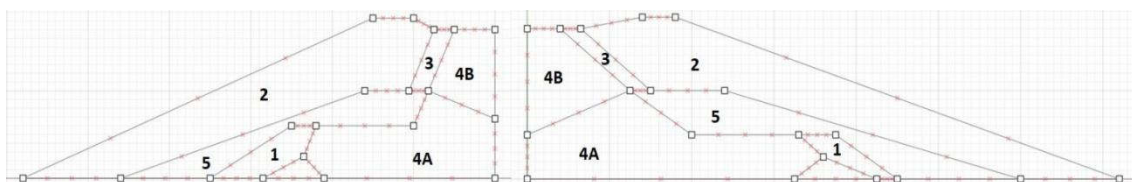
2019 CPT tests of the West Dam at 4 different locations at the crest and downstream slope indicate that for conservative assignment of the state parameter  $\psi$  to different parts of the dam, tailings/cycloned sand material above elevation 880m in the vicinity of the dam crest should be assigned a value of  $\psi$  between 0 and 0.1, while water saturated cycloned sand above and downstream of the West starter dam should be assigned a value of  $\psi$  between -0.05 and 0. Based on these 2019 CPT test results, the West Dam has been divided into 5 zones as shown in Figure 8, in which a liquefaction susceptible fifth zone consisting of water saturated cycloned sand has been added to the 1989 TSF Design Review zone division. In this figure, a similar zone division of the East Dam based on the 1989 TSF Design Review and 2019 CPT test results is also shown.

**Figure 8.** FLAC2D sketch of above foundation tailings/cycloned sand material in 2025 West/East Dam cross sections B2/A1 divided into zones 1:compacted cycloned sand, 2:uncompacted cycloned sand, 3:cyclone overflow+tailings, 4:tailings, 5:water saturated cycloned sand based on the 1989 TSF Design Review, and the 2014 and 2023 ADSI reports. Zone 5 in each dam is distinguished from Zone 2 based on the results of 2019 CPT tests and 2023 piezometer data.

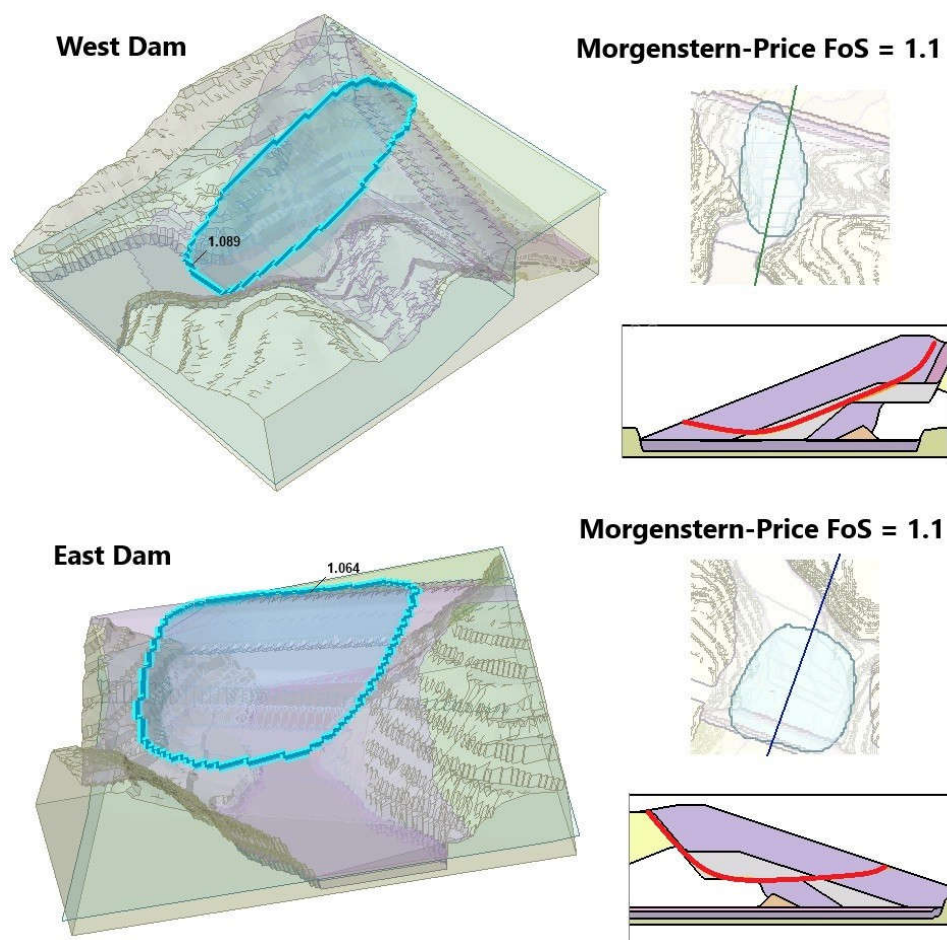
overly conservative based on 2019 CPT data, it is not known what post-2023 CPT data would show in regards to the current extent of water saturated cycloned sand and its liquefaction susceptibility [Robertson, 2010]. Moreover, it is not guaranteed Slide3 FoS computation is finding West/East Dam critical slip surfaces, although both intelligent search and addition of weak layers were attempted without lowering the returned Morgenstern-Price FoS. Slide3 allowance for tension cracking of the cycloned sand dam crests was not observed to have any effect on FoS or slip surface results.

**Figure 9.** Post-liquefaction FoS computation Slide3 results. Slip surfaces returned by classic ellipsoidal search with assignment of residual undrained shear strength ratios 0.22 to zone 4A, 0.07 to zone 4B, and 0.055 to zones 3 and 5.
