# Micro and Macroscopic Analysis of Fatigue Wear of Gear Wheel Top Layer – an Impact Analysis of Thermochemical Treatment

**Abstract:** The main purpose of this work was to tests of form and size of fatigue wear of the top layer of oil gear pump wheel (3PW-BPF-24). The object of tests was operated during a determined number of hours at strictly controlled operational and environmental parameters. A microscope of focal differentiation by Alicona InfiniteFocus G4 (with Focus-Variation optical measuring technology) was used for an identification, measurement and description of noticed superficial defects, which resulted from the fatigue process of the top layer and an earlier thermochemical treatment. The work was finished with an analysis of obtained results (based on the analysis of 3D scans) and conclusions concerning about optimization of the thermal treatment. Taking into consideration the presented results (suggestions) in the technology of improving strength properties of gear wheels (of this type oil pumps) may render it possible to obtain an appropriate fatigue endurance of the top layer, i.e. a minimization of observed superficial defects.

The analysis results of fatigue w

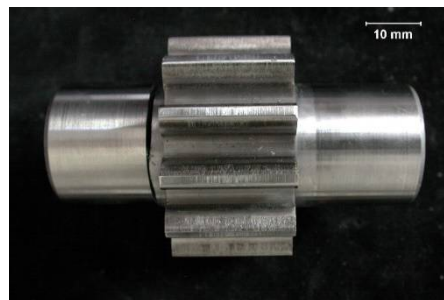
**Figure 1.** General view of gear wheel [46].

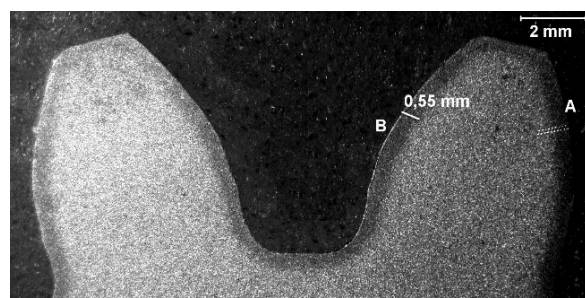
The values given above were not fully reached due to high contents of residual austenite (which is described in a further part of this elaboration).

**Figure 2.** Tooth cross-section (visible changes of macrostructure resulting from the applied thermochemical treatment) [46].

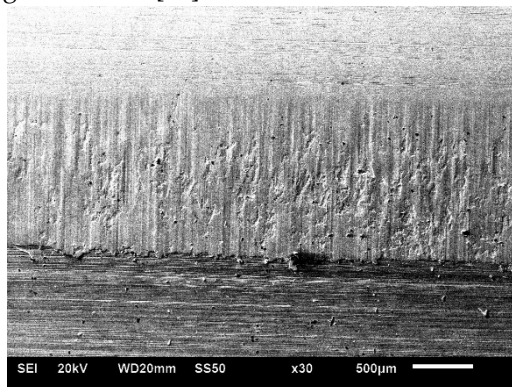
On the external surface of teeth both sides, the traces of exploitation in a form of chippings and of working surfaces wear - Figure 3 and 4 [46] were seen.

**Figure 3.** Macroscopic view of the tooth surface from the A side (scanning microscope Hitachi S3400N) [46].

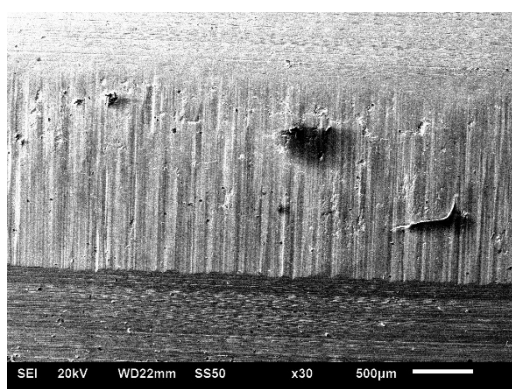
**Figure 4.** Macroscopic view of the tooth surface from the B side (scanning microscope Hitachi S3400N) [46].

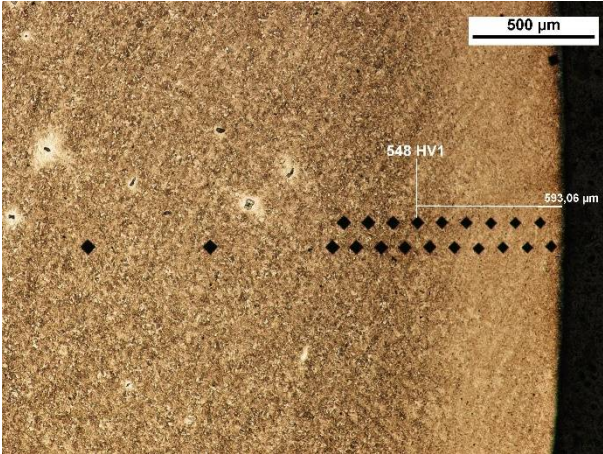
The depth of the tooth carbonized zone from side A is about 593 μm - Figure 5. The course of the hardening curve is shown in Figure 6. An occurrence of about 30% residual austenite and then low-temperature tempered, fine acicular martensite of gradually decreasing carbon contents were detected - Figure 7. A cracked, strongly deformed layer of the thickness about 9 μm was seen on the tooth surface - Figure 8 [46].

**Figure 5.** View of carbonized and hardened layer on the specimen cross-section from the A side with hardness distribution measurement markers (light microscopy, Mi1Fe pickling) [46].

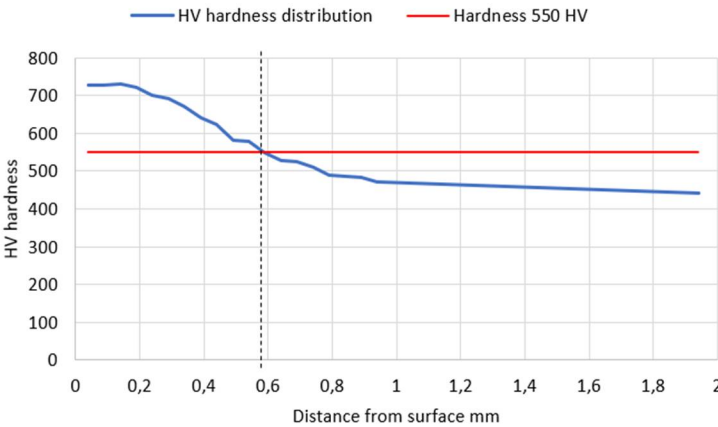
**Figure 6.** Hardness distribution along the normal to the carburized surface - from the A side (in the direction from the tooth surface into the material). Hardness 550 HV occurs to a depth of approximately 0.58 mm.

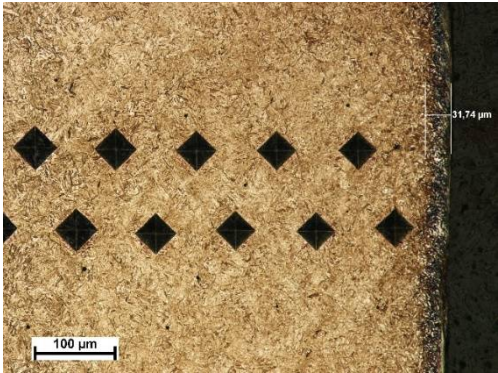
**Figure 7.** View of carbonized and hardened layer on the specimen cross-section from the A side with indentations of hardness distribution measurements and the layer of residual austenite (light microscopy, Mi1Fe pickling) [46].

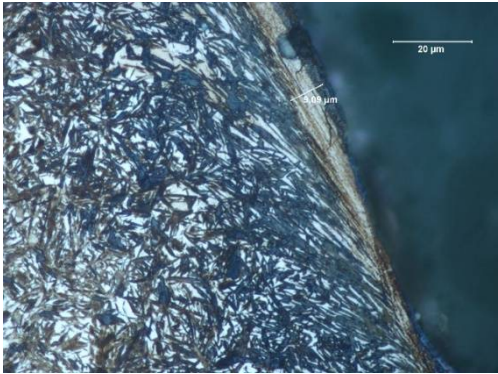
**Figure 8.** View of carbonized and hardened layer on the cross-section of the specimen from the A side - martensite with residual austenite with strongly deformed and cracked layer of the thickness about 9 μm (light microscopy, Mi1Fe pickling) [46].

An occurrence of residual austenite causes a reduction of the tooth surface hardness, an initiation of brittle fractures, a rapid reduction of fatigue strength and an increase of brittleness, in particular it can indicate a trend of generating fractures of the superficial layer during an exploitation [46].

In relation to the information given above, it is recommended to apply additional heat treatment, in a form of sub-zero treatment which will enable an efficient minimization of the residual austenite contents, an improvement of hardness and a dimensional stabilization which will contribute towards an extension of the pinion life and an improvement of its useful properties.

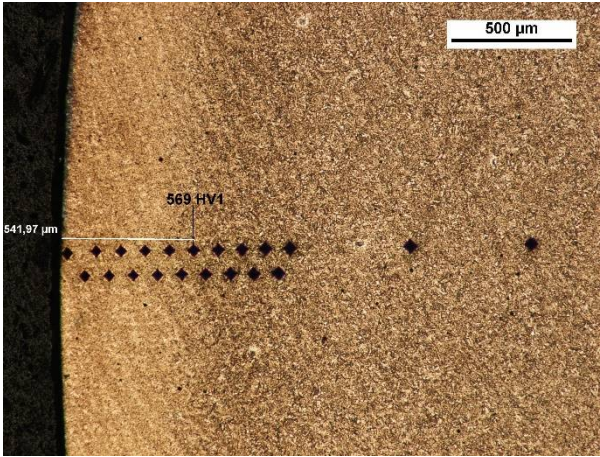
**Figure 9.** View of carbonized and hardened layer on the specimen cross-section from the B side with hardness distribution measurement markers (light microscopy, Mi1Fe pickling) [46].

The depth of the tooth carbonized zone from the B side is about 542  $\mu\text{m}$  - Figure 9. The course of the hardening curve is shown in Figure 10. In the close-to-the-surface zone from the B side to the depth of about 43.29  $\mu\text{m}$  an occurrence of about 30% residual austenite and then low-temperature tempered, fine acicular martensite of gradually decreasing carbon contents were seen - Figure 11. A cracked, strongly deformed layer of the thickness about 7  $\mu\text{m}$  was detected on the tooth surface - Figure 12 [46].

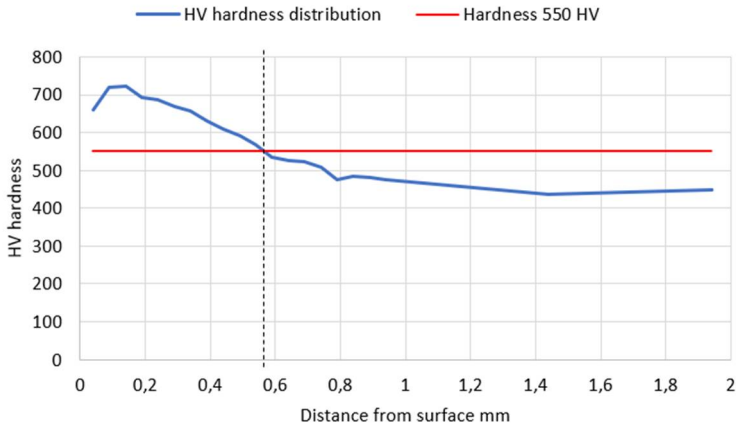
**Figure 10.** Hardness distribution along the normal to the carburized surface - from the B side (in the direction from the tooth surface into the material). Hardness 550 HV occurs to a depth of approximately 0.56 mm.

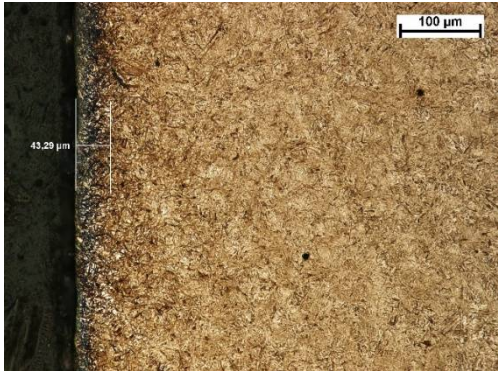
**Figure 11.** View of carbonized and hardened layer on the specimen cross-section from the B side with indentions of the hardness distribution measurements and the layer of residual austenite (light microscopy, Mi1Fe pickling) [46].

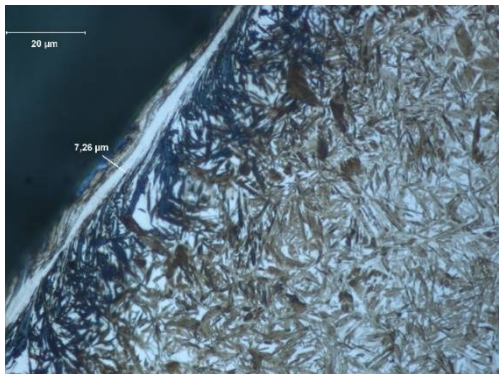
**Figure 12.** View of carbonized and hardened layer on the specimen cross-section from the B side-martensite with residual austenite with strongly deformed and cracked layer of the thickness about 7.3 μm (light microscopy, Mi1Fe pickling) [46].

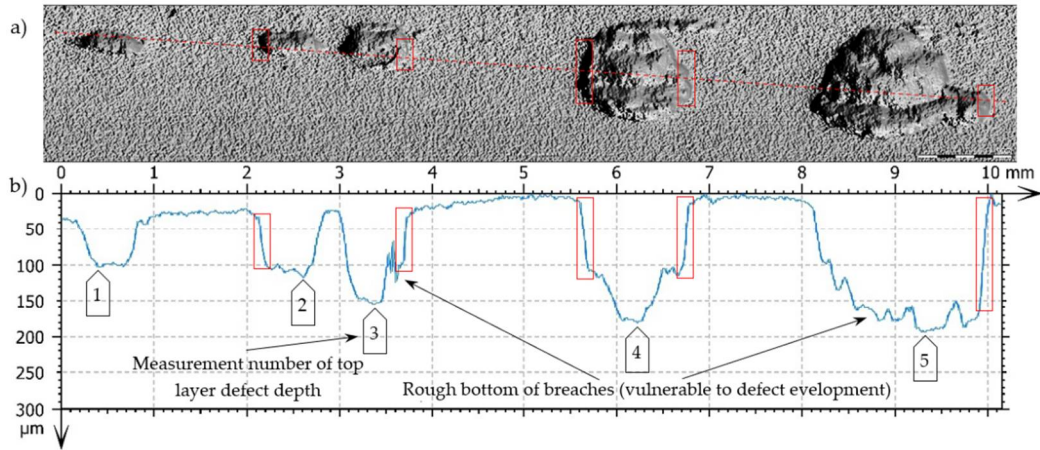
In the result of taking superficial scans 3D superficial fatigue damages (characterized by breaches of oval shapes and sharp edges, inclined perpendicularly to the surface of the teeth under analysis) - Figure 14, were diagnosed.

**Figure 14.** Fatigue pits (pitting) on the tooth working surface - magnification 5x; a) photo simulation, b) profile curve, ---- - line of cross - section, □ - indication of breaches edges inclined to the surfaces, subject to analysis at the angle close to 90° on the cross-section.

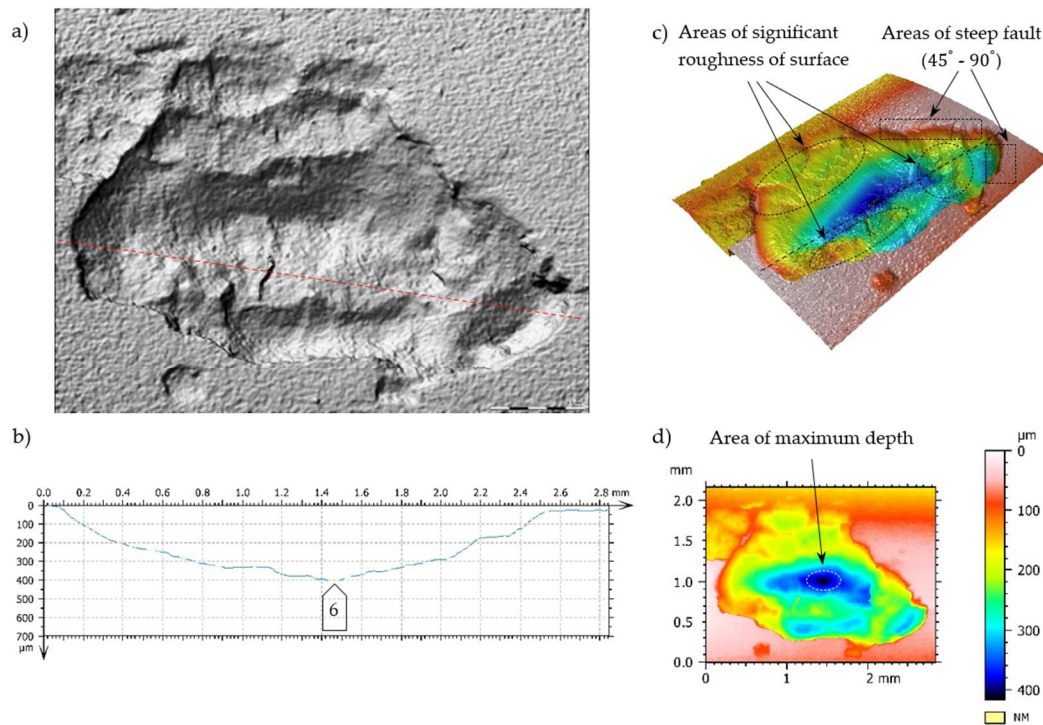
The observed breaches, generated in the result of the material chipping, have different dimensions, rough bottom and they occur locally or on a much smaller scale but on a bigger tooth surface (micropitting) - in particular below the pitch diameter of pinion. A linear arrangement of described defects was observed in some places - Figure 15.

**Figure 15.** Fatigue pit (pitting) on the tooth working surface - magnitude 5x. a) photo simulation, b) profile curve, c) and d) 3D superficial view - pseudocolour of surface with the depth visualization, ---, ----- lines of cross-section.

An advancing chipping of the material particles, which is presented in Figure 15 can lead, in extreme conditions, to a reduction of the teeth working surface to a degree which will make a further transmission of loads (in the case of gears) impossible. In some situations teeth of carbonized wheels can change their shape to the degree leading to their significant wear or even fracture in the result of pitting. Carbonized and hardened teeth of wheels, which were subject to pitting in the area of the tooth root connected with a significant wear, are vulnerable to fracture. The reason is an initiation and a development of fatigue cracks in the pits generated where the crumbled away material was. A significant noise accompanies an operation of gear wheels with considerable pitting [47].

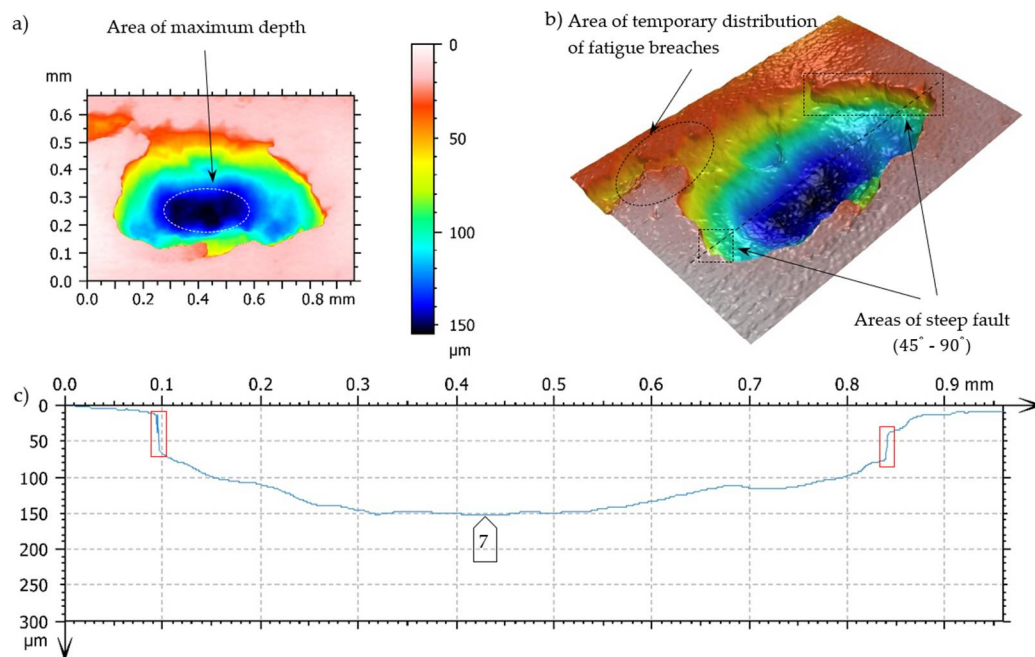
**Figure 16.** Fatigue pit (pitting) on the tooth working surface - magnitude 10x a) and b) superficial 3D view - pseudocolour of surface with visualization of depth, c) profile curve,----- cross-section line, □ - indication of breaches edges, inclined at the angle close to 90° to the surfaces under analysis, on the cross-section.

A surface increase of pitting cavities is caused very often by their mutual connecting. In Figure 16 and 17 the limiting state before a connection of two fatigue breaches is presented.

The main reason of generating this type of breaches includes exceeding of limiting contact stresses of the teeth collaborating surfaces. The degree of tolerating this kind of defects (their number, size and arrangements) depends mainly on the application area. In this case (at an assumption of the forecasted pump life due to a degradation development of the top layer of collaborating teeth), it does not have any big significance. Pitting breaches in the scope of dimensions 0.1-1.5 mm (Figure 14) and even to 2.5 mm (Figure 15) do not exclude the pinion from its further (but temporary) exploitation. It should be borne in mind that correct filtration should be ensured. In this case a high pressure filter of exact purification should be installed directly after the pump to prevent against a failure of valves and receivers situated in the hydraulic line between the pump and the tank, caused by solid impurities.

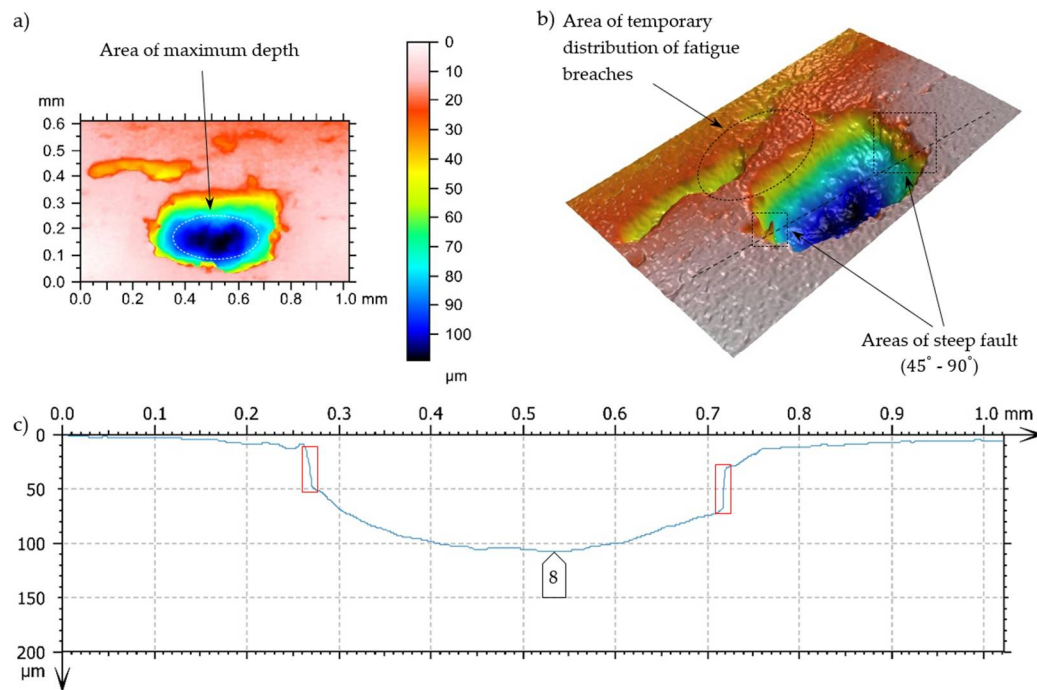
**Figure 17.** Fatigue pit (pitting) on the tooth working surface - magnitude 10x a) and b) superficial view 3D - pseudocolour of surface with visualization of depth, c) profile curve, ---- - line of cross-section, □ - indication of breaches edges, inclined at the angle close to 90° to the surfaces under analysis, on the cross - section.

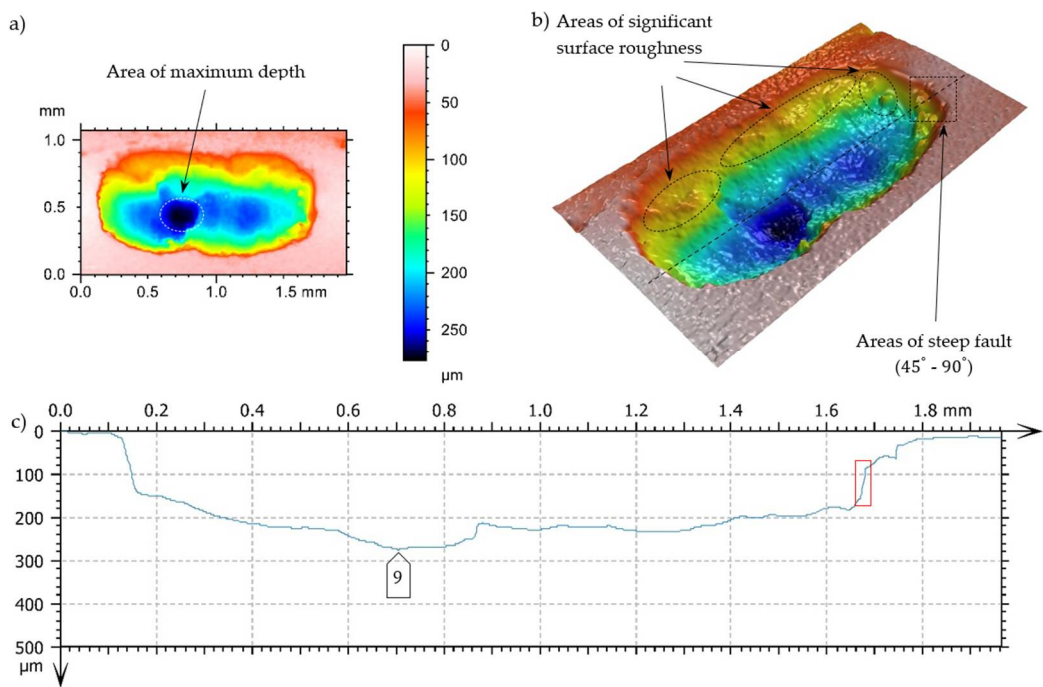
Additionally, it should be taken into an account that a breach of 1 mm dia. close to the fillet of the tooth heat treated or superficially hardened, may begin a crack, which can finally lead to a tooth break; and that is why in some cases this kind of breach should be treated as inadmissible (e.g. in air applications) [47].

**Figure 18.** Fatigue pit (pitting) on the tooth working surface - magnitude 10x a) and b) superficial view 3D - pseudocolour of surface with visualization of depth, c) profile curve, ---- - line of cross - section, □ - indication of breaches edges, inclined at the angle close to 90° to the surfaces under analysis, on the cross-section.

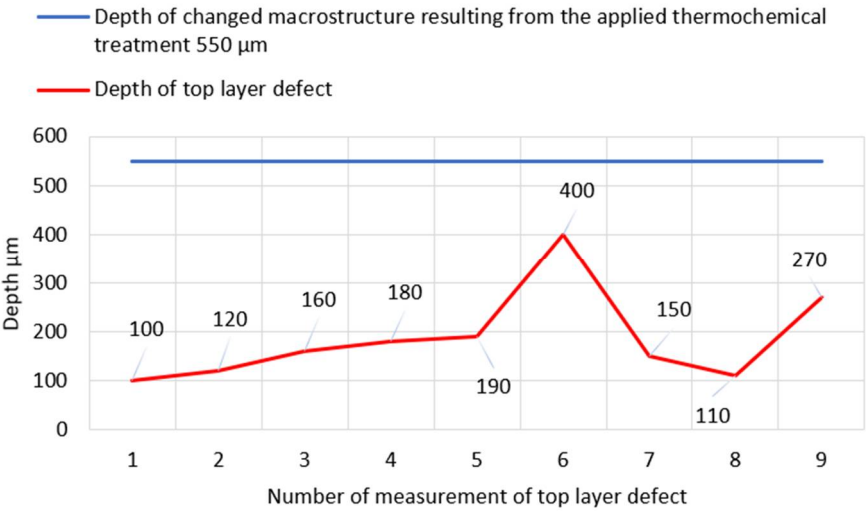
In the cases under analysis the defect depth of the top layer did not exceed the depth of layer subject to thermochemical treatment. A location of all the chippings is enclosed in the scope of the zone, having the structure of low-temperature tempering, fine-acicular martensite of comparatively decreasing carbon contents. The measurement data from Table 4 are graphically presented in Figure 19.

Figure 19. Graphical presentation of the data from Table 4.

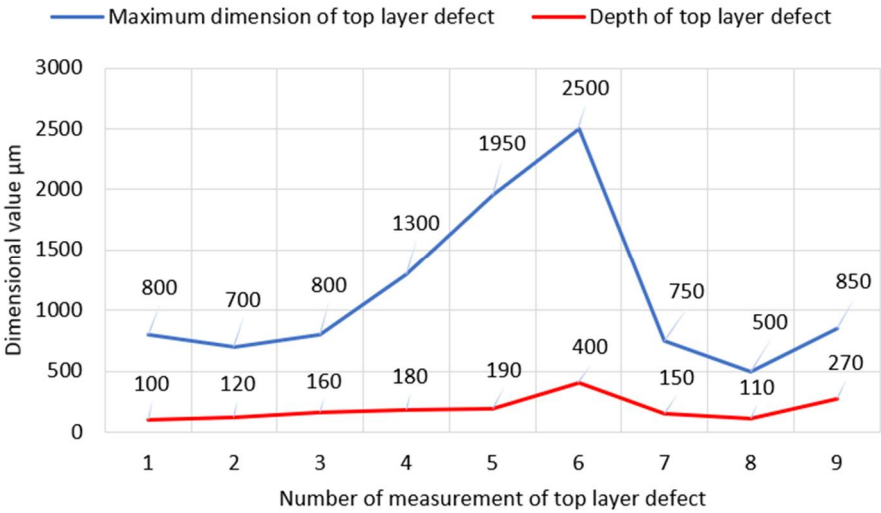
In most cases - Figure 20, the correlation between an increase of the maximum dimensional value of the defect (measured at the level of the surface layer) and the adequate deeper chipping was confirmed.

Figure 20. Graphical presentation of the data from Table 5.
