# On the Mechanisms of Marble Deterioration of Antonio Canova cenotaph in Santa Maria Gloriosa dei Frari Basilica in Venice

Vasco Fassina

## Abstract

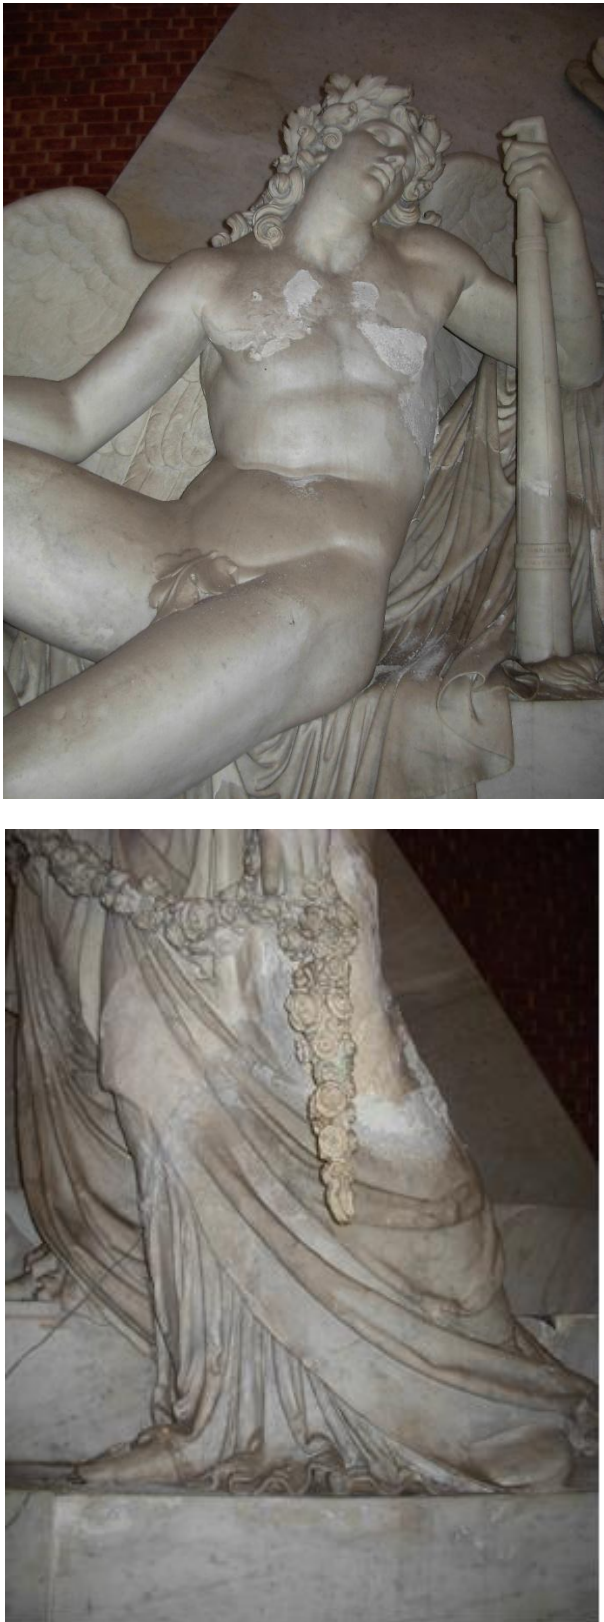
Almost two decades after the aforementioned restoration, the situation had further worsened (Figure 2, a, b) and the Superintendence for Architectural and Landscape Heritage of Venice had planned to intervene with a conservation project that would be preceded by a diagnostic investigation aimed at understanding the causes that had significantly accelerated the further loss of marble surface portions.

**Figure 2.** a) Detail of marble exfoliation on the chest of the *Sleeping Genius* showing the underlying whitish salt crystal. b) Detail of the marble exfoliation of the garments of *Painting* and *Architecture*.

A third stage of deterioration is characterized by the complete missing of marble portions as it is visible on the *Sleeping Genius* (Figure 2a) and *Painting and Architecture* statues (Figure 2b). These more damaged areas are corresponding to the maximum capillary rise front (between 150 and 250 cm) which present the highest salt crystallization pressure.

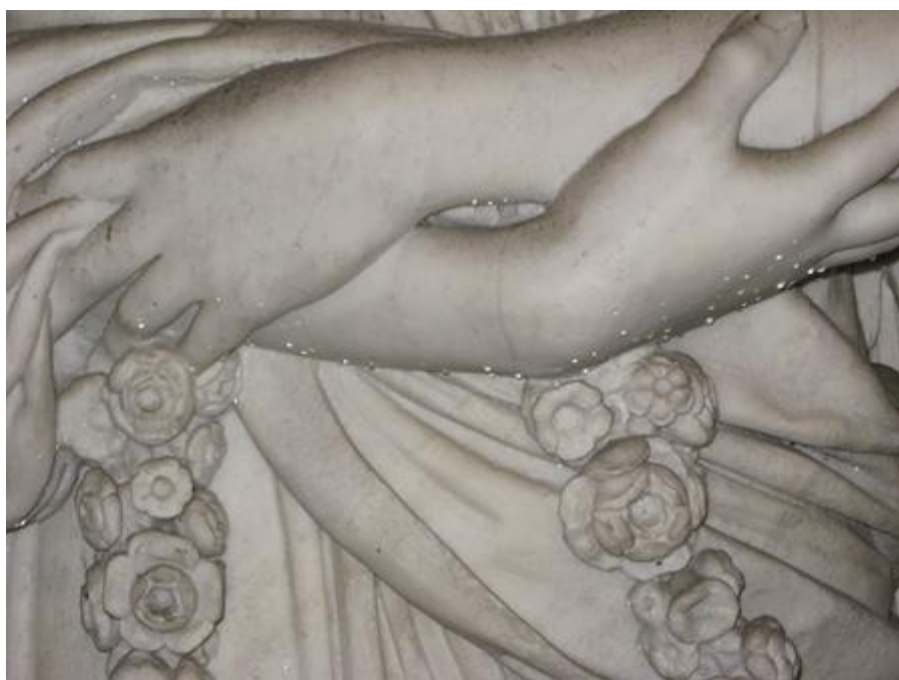
Macroscopic observation of the frequent formation of droplets [8,9] on some areas of the group of sculptures led the authorities responsible for their conservation to plan a survey to investigate the microclimatic conditions that could be responsible of the phenomena observed (Figure 3).

**Figure 3.** Droplet formation on the arm of the statue due to water vapour condensation.

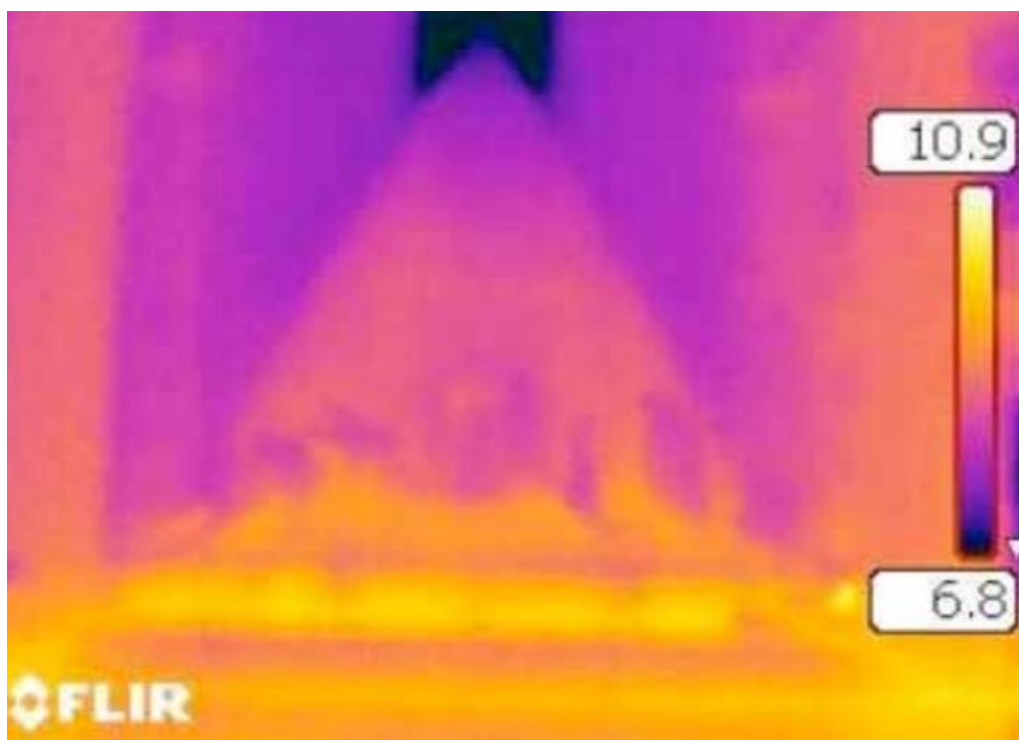
The thermal behaviour of the cenotaph was also investigated using a thermographic survey [11]. Measurements of the pyramid basement and of the lower steps showed a higher temperature than the other areas and in particular the temperature decreased progressively with elevation from the church floor (Figure 4).

**Figure 4.** Thermographic image of the cenotaph. Basement is warmer than statues.

This temperature decrease seems to be in relation with the reduction of the thickness of the monument structure. The higher temperature measured in correspondence to the pyramid basement (greater thickness) in contact with the church floor indicates that the heat source could be attributed to the presence of higher moisture content.

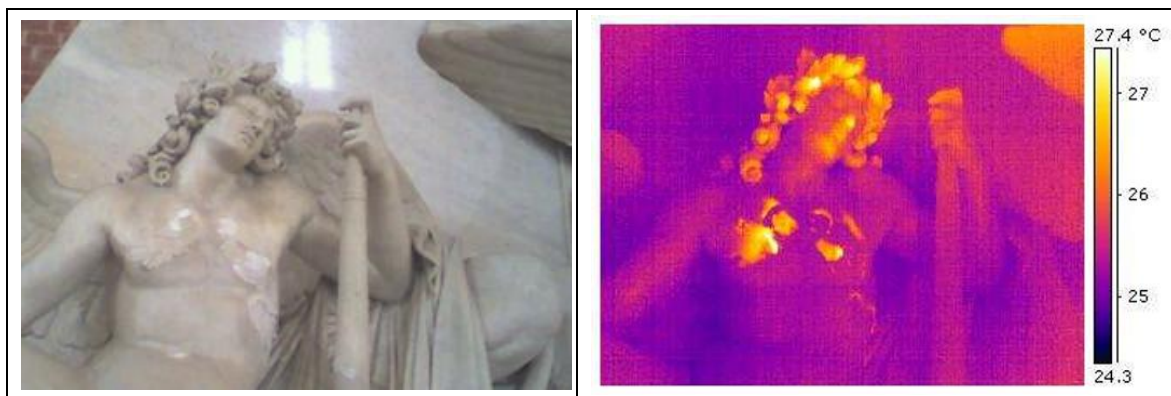
The most important finding from the above investigations was the monitoring of detachment areas which have a greater extension than those visually perceived, i.e., in some areas of the *Sleeping Genius's* head (Figures 5 a, 5 b). These areas are characterised by a pronounced convexity (strongly curved surfaces) in which the more frequent evaporative cycles are taking place and they are responsible for a heavier deterioration process compared to the nearby flat areas or areas with a lesser degree of curvature [2].

**Figure 5.** a) The Sleeping Genius. b) The hairs of the Sleeping Genius appear yellow at IR observation: this indicates some not visible detachments of marble surface (Courtesy of Camuffo).

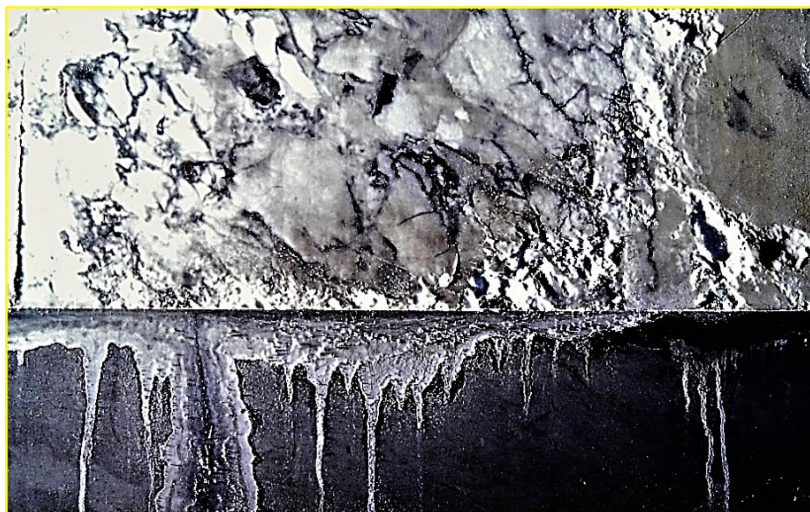
**Figure 6.** Santa Maria dei Miracoli Church. On the lower part salt efflorescence are visible; on the upper part sub-efflorescence are detaching small flakes of marble.

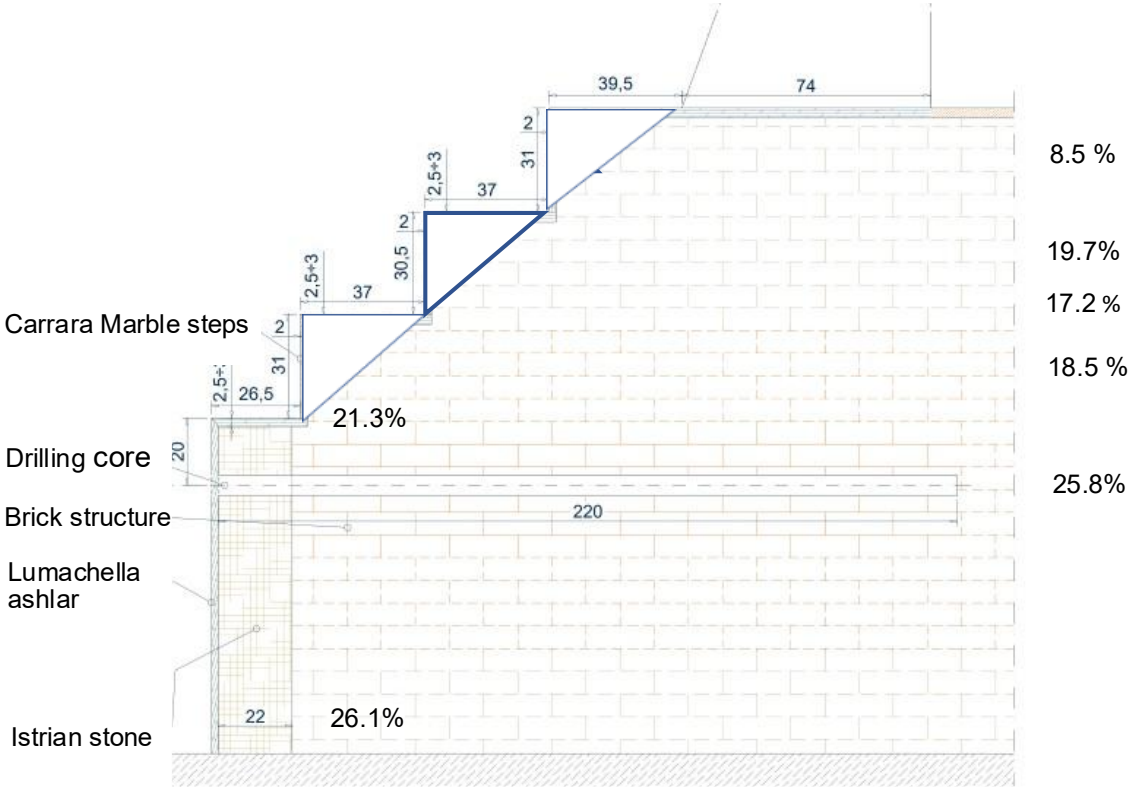
As there were no information in the archives regarding the construction typology of the masonry structure it was necessary to make an inspection by removing the lumachella ashlar (Figure 7) and by drilling the compact Istrian stone (thickness 22 cm) supporting the first marble step. The supporting structure of the marble monument is in direct contact with the foundations which in turn are in contact with the lagoon water (Figure 7).

**Figure 7.** The supporting structure is formed by a rather regular brick structure. Carrara marble steps having a triangular section are in close contact with the underlying brick. The moisture in the brick structure has a water content near the saturation of brick porosity and it is easily transmitted to the Carrara marble steps.

The brick structure should be dehumidified and desalinated by using poultices according to EN 17891 [22]. Successively, the brick structure should be insulated to stop the transmission of moisture from the foundations to the marble elements.

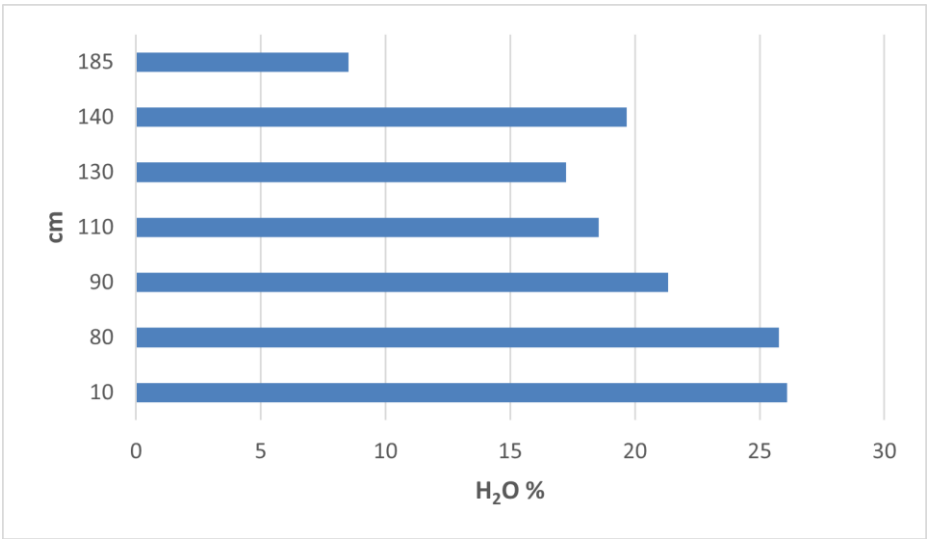
**At the church floor** bricks are completely saturated with a moisture content around 26%. This high-water content is maintaining constant up to 90 cm of elevation. Above this height, moisture content is decreasing slowly up to 140 cm of elevation. Above this eight, the water content is decreasing more rapidly and at the pyramid base (200 cm) it is reduced to 8.5%. Above pyramid base, at 235 cm of elevation, the moisture drops furtherly to 2-3%, that is corresponding to the maximum height of the capillary rise front (Figure 8).

The data obtained indicated that the brick supporting structure is completely water saturated and as there are no discontinuity between the brick structure and the marble blocks or statues the capillary rising damp process is causing the migration of salts from brick structure towards the external marble surfaces.

**Figure 8.** Percentage of water content at different heights. Up to 90 cm the water content is close to the brick saturation. Increasing elevation from the church floor, the moisture content is decreasing. This behaviour is present when the rising damp is active.

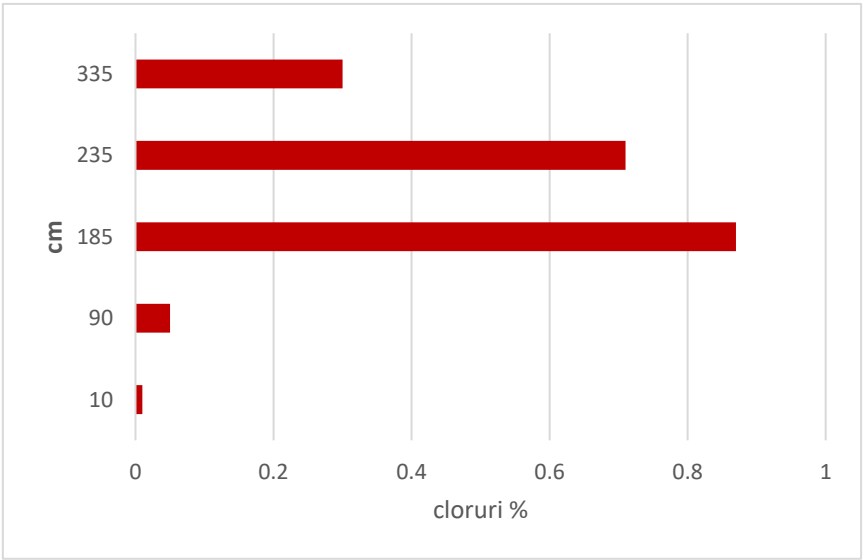
Regarding the salt content, chlorides and nitrates are present in higher quantities than sulphates and migrate vertically to higher heights than sulphates, due to their higher mobility and thus confirming the results obtained in other cases studied [7]. Furthermore, there is an increasing concentration of chlorides towards the external surface in accordance with the lower moisture content measured (Figure 9). From the data the capillary rise phenomenon is active up to an elevation of approximately 180-250 cm where the solution is enriched in chlorides near the surface and sodium chloride crystallizing is causing exfoliation and disintegration of surface marble layer.

**Figure 9.** Percentage of chlorides versus elevation in the brick structure. Higher chloride content is from 185 and 235 cm. .

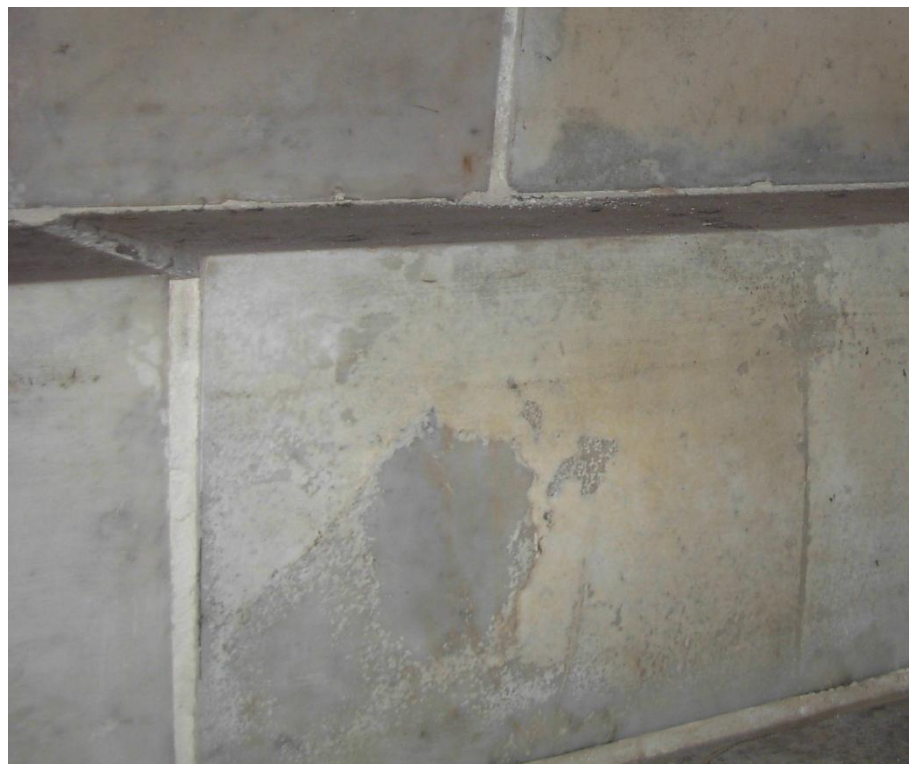
- a) *Rough whitish areas.* The surface of the marble is rough, opaque and generally the white-grey marble surface is turning to whitish due to the change of refractive index consequent to the formation of exogeneous crystals responsible of the detachment of thin marble layers. These alteration features are present quite widely on the marble steps and on some areas of the sculptures (Figure 10).

**Figure 10.** Whitish surface areas, slightly eroded. The explanation of this feature is discussed by optical and SEM microscope analyses. The pale yellowing areas are ascribed to iron oxides formation due to oxidation of small particle of pyrite ( $\text{FeS}_2$ ). The yellowing is a natural weathering alteration due to the presence of this small iron impurities in the Carrara marble.

The first stage of deterioration is characterized by rough and whitish surface due to the accumulation of sodium chloride nearby the external surface (less dense substrate). In these areas the whitish colour is ascribed to a change of refractive index. These areas are quite widely present on the marble steps and in some parts of the sculptures (Figures 10, 14).

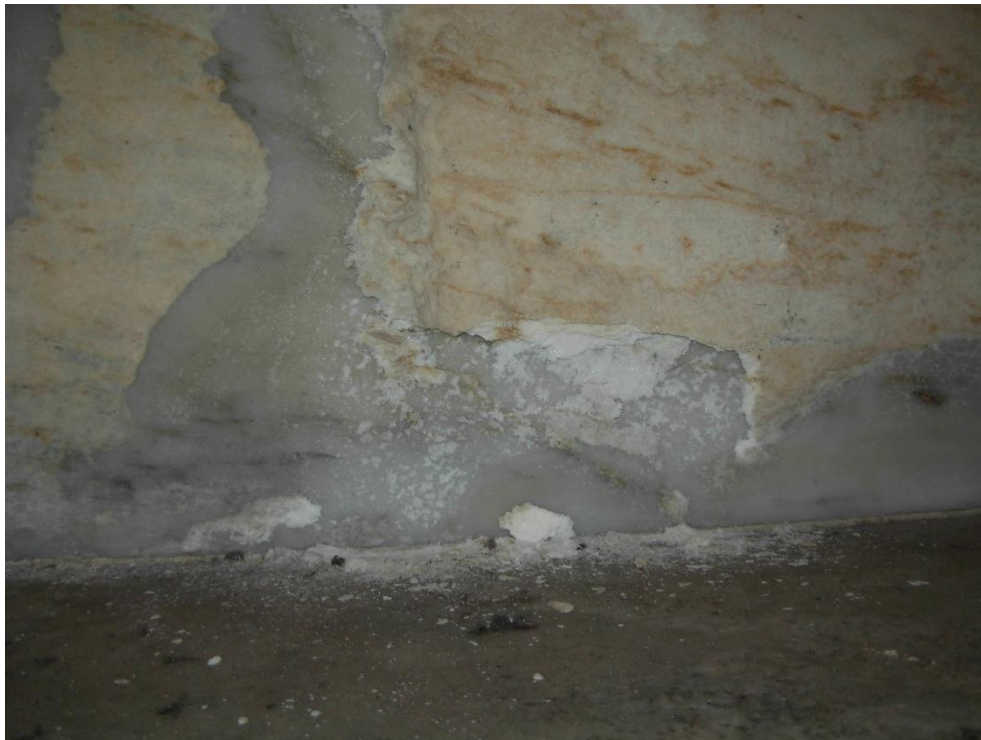
- b) *Areas with exfoliation of superficial marble scales.* The alteration process is more advanced than the above described and exfoliation of superficial marble layers is detaching from the substrate (Figure 11).

**Figure 11.** Exfoliation of thin marble layers due to salt crystallization at sub-surface level.

A second stage of deterioration is characterized by partially detached marble flakes (multilayer exfoliation) from the substrate. Crystallization initially occurs near the external surface and continues towards the internal layers, separating marble flakes mostly in parallel layers (Figures 11, 16, 17).

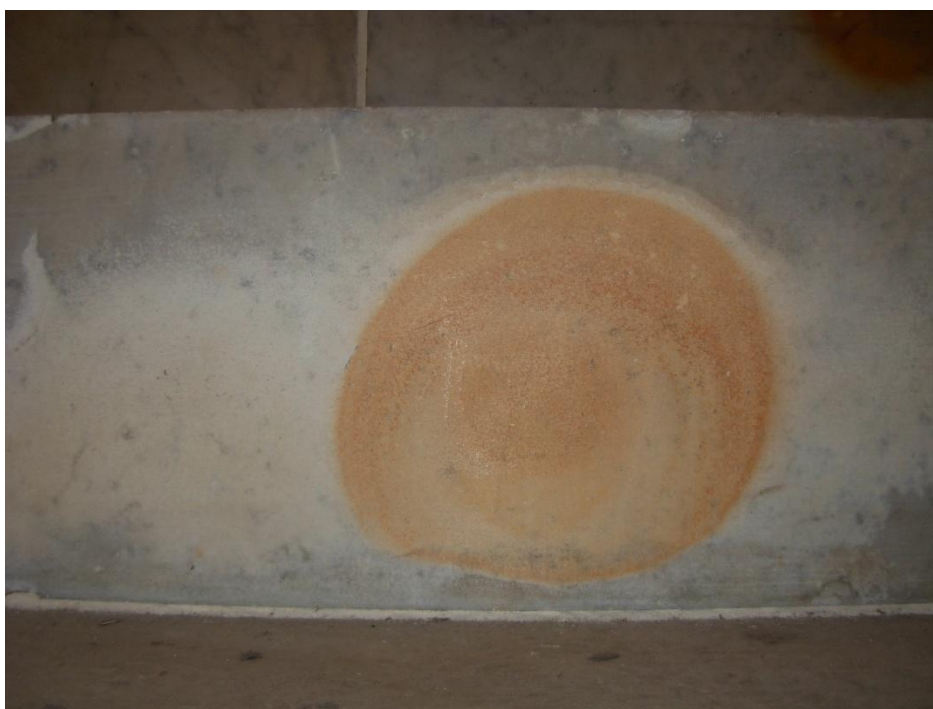
**Figure 12.** Red spots formation due to colloidal iron oxide radial diffusion.

A specific alteration feature is represented by the *formation of reddish circular spots* which are localized in some areas and the surface is rough and opaque similar to the whitish areas before described (Figure 10). These alterations are ascribed to linchpin oxidation to colloidal iron oxides which slowly diffuse through the porosity of marble.

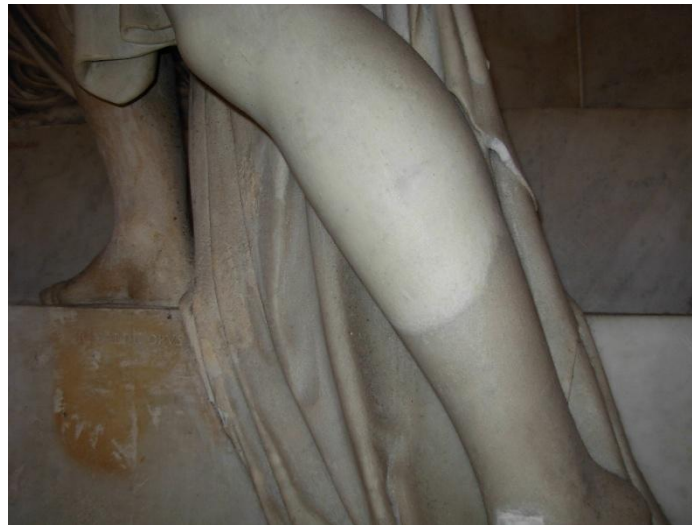
- e) Areas of surface turning to greyish characterized by marble smooth surface without any evident alteration (Figure 13).

**Figure 13.** Marble of the lower left leg of the statue has darkened. This chromatic alteration is ascribed to a colour change of past wax maintenance treatment (see figure 20).

Last observation is related to the observed turning of white-grey marble toward greyish ascribed to a chromatic alteration of the wax-based treatments. Wax application most likely dates back to the final phase of the construction of the cenotaph and may have been periodically repeated as a maintenance practice in use in subsequent periods.

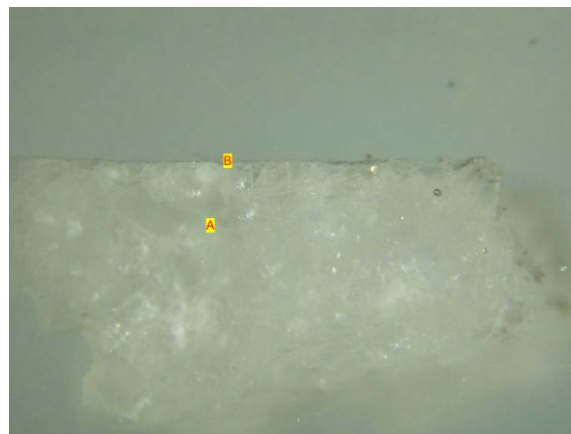
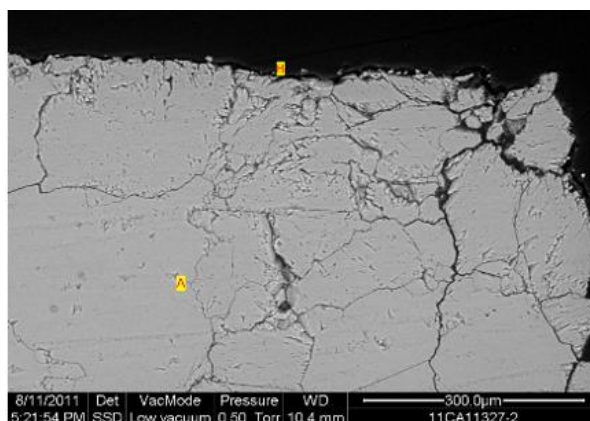
*Type a) Rough and whitish areas* (Figure 10). Cross-sections analyses show a fair amount of interstitial micro-cracks caused by the sodium chloride crystallization. This is the initial stage of deterioration in which calcite crystals detach from each other and the structure becomes less compact and the marble appearance change from white-grey to whitish colour (Figures 14 a, b).

**Figure 14.** a) Cross-section at the optical microscope (80 x enlargements). Interstitial detachment of calcite crystals is visible; b) The same sample at SEM shows a clearly separation of calcite crystals. The lower density of surface layer is responsible of the whitish aspect visually observed. In this area the whitish surface is representing the initial stage of marble deterioration.

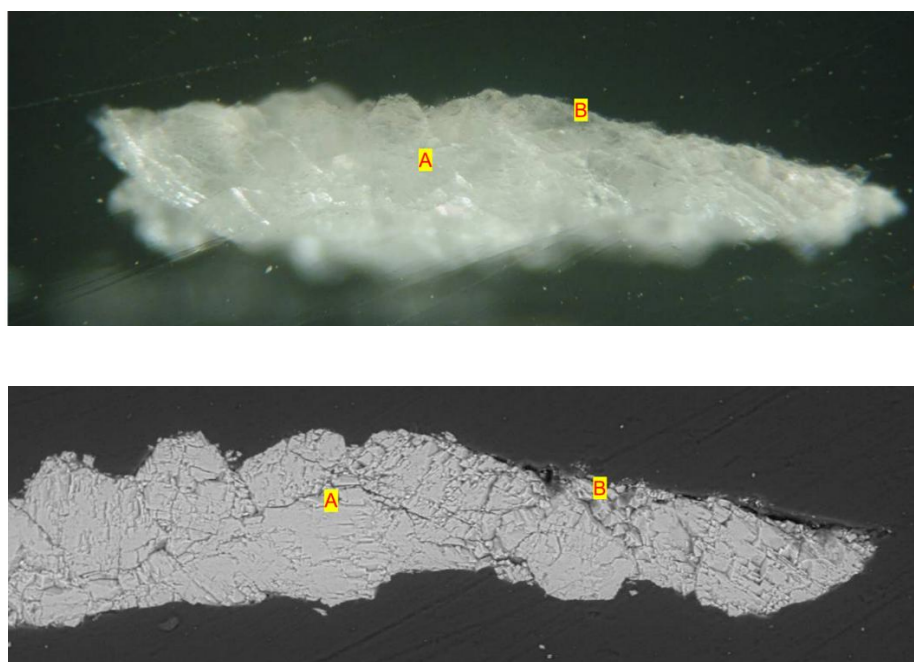
In some areas the intergranular interstices had extended longitudinally to form a line of discontinuity almost parallel to the external surface (Figure 15). This stage represents a level that precedes exfoliation of thin marble layers.

**Figure 15.** a) Cross-section at optical microscope shows interstitial calcite crystals detachment (layer a) as before observed. The thin grey layer B is the wax treatment. Enlargement 80x. b) At SEM the interstitial spaces are increased with respect to Figure 14. This is a more advanced stage of deterioration. The black layer B on the upper part is a remaining of wax maintenance treatment.

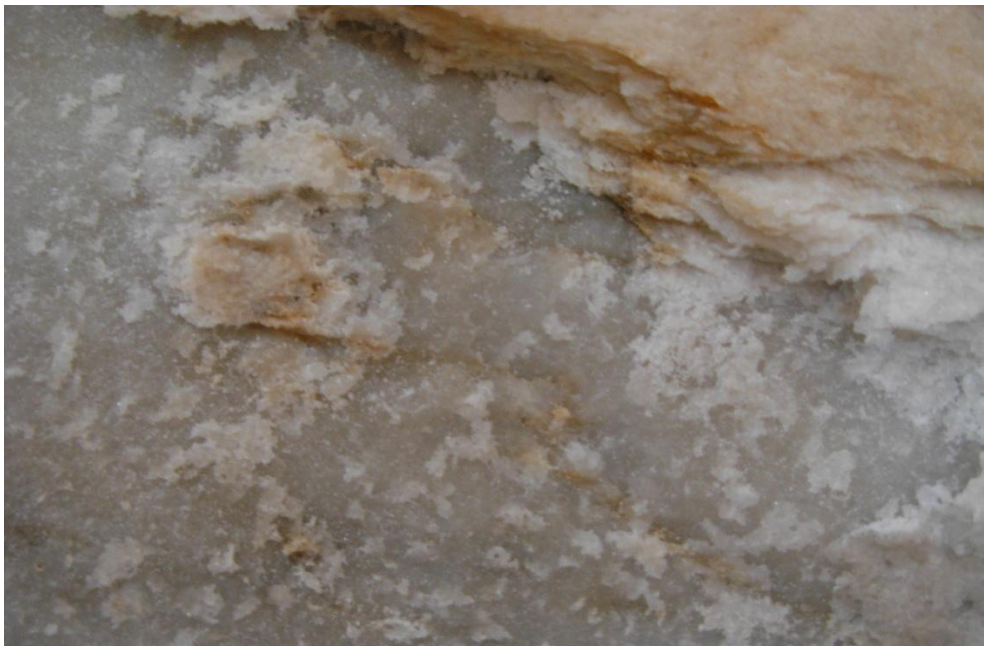
*Type b) Areas with exfoliation of superficial marble scales (multilayer).* A progressive marble detachment flakes is observed (Figures 11, 16). Examination of a cross-section of a multilayer exfoliation scale shows eleven flake layers (Figure 16). Among the various layers sodium chloride crystals were detected and they are responsible for the scale's detachment. Microanalysis also emphasize the presence of potassium chloride and gypsum.

**Figure 16.** Multilayer exfoliation of marble. Enlargement of Figure 11.

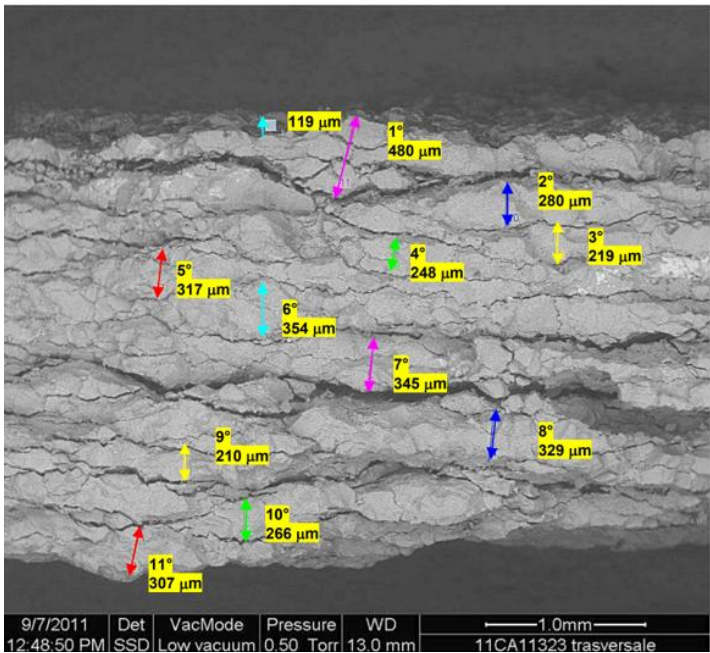
**Figure 17.** Cross-section at SEM. Eleven layers were observed. The black layer on the top is ascribed to a wax treatment, the first layer is 480 μm thick and all the subsequent layers are about 300 μm each one. The total thickness is about 3 mm. .

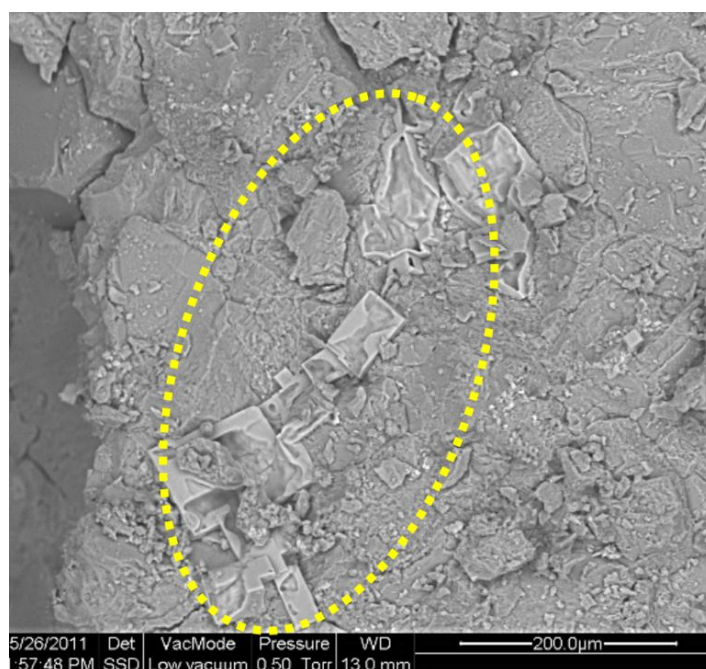
Sodium chloride crystals were observed in between the exfoliation layer (Figures 18, 19). They are responsible of detachment of thin marble layer.

**Figure 18.** SEM analysis of the surface. Sodium chloride crystals, inside the yellow circle, are visible.

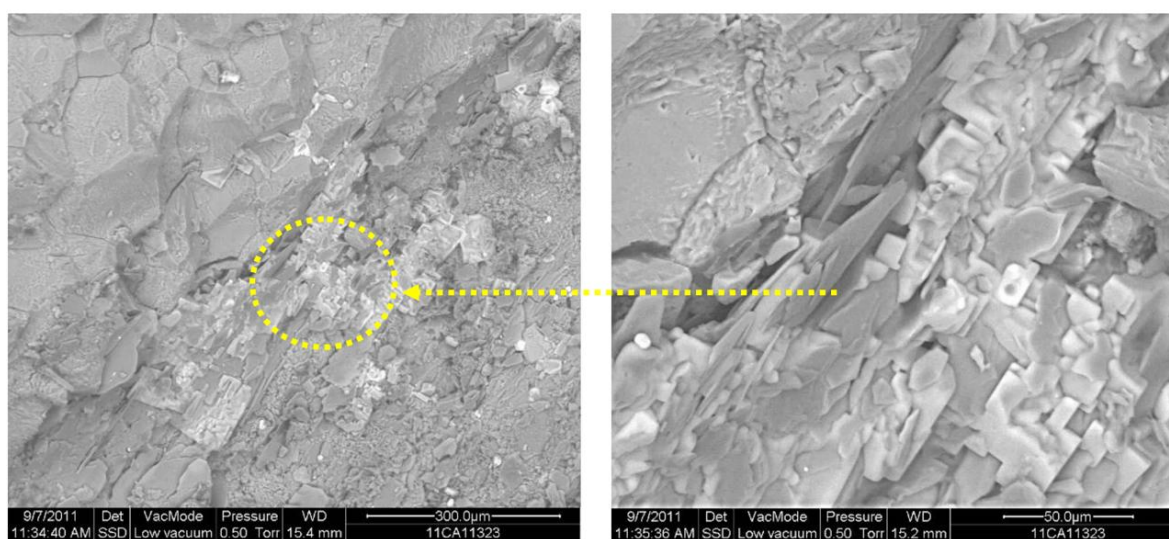
**Figure 19.** a) SEM observation of cross-section exfoliation scale. In the yellow circle sodium chloride crystals growing in between the exfoliation layers; b) The same crystals at higher enlargement. The crystal growing is responsible of the scale detachment.

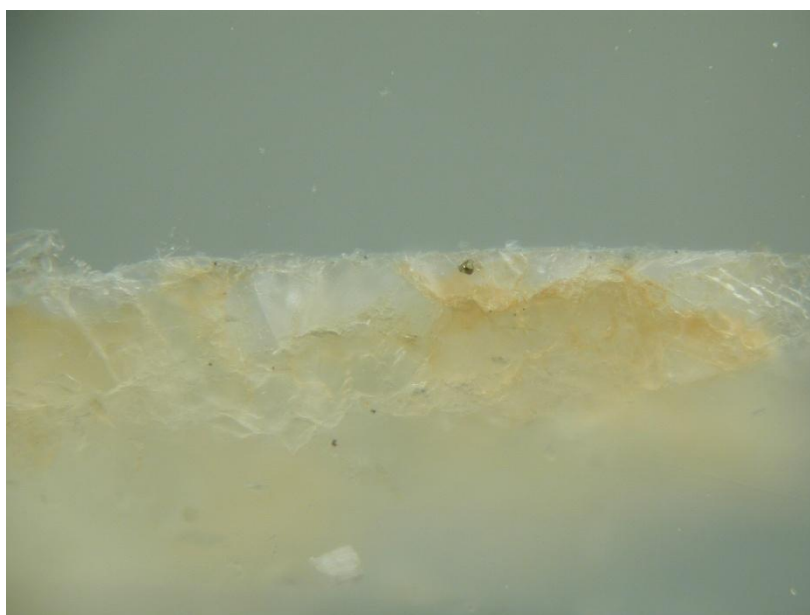
*Type d) Areas with reddish circular spots* (Figure 12). The presence of hydrated iron oxides was identified, most likely generated by oxidation of iron linchpin that were used to fix the marble blocks. According to some authors iron is firstly oxidized to ferrous ion (Fe II), which in presence of moisture is forming a mixture of ferrous and ferric hydroxide. The hydrated iron oxide migrating in the carbonate substrate reacts with carbonate anions of the matrix forming colloidal oxy-hydroxy ferric carbonate  $\text{Fe}^{(\text{III})}_6 \text{O}_{(2+\text{x})} (\text{OH})_{(12+2\text{x})} \cdot (\text{H}_2\text{O})_{\text{x}} (\text{CO}_3)$ , which in turn diffuses through the carbonate matrix and when it reaches to saturation condition a red precipitate of lepidocrocite ( $\gamma\text{FeOOH}$ ) takes place (18-20). A radial diffusion of these colloidal solution give the red-orange circular spots (Figure 12), often with particular shapes, such as Liesegang rings [21]. The formation of Liesegang rings represent a phenomenon of periodic precipitation, observed both in simulated chemical systems constituted by ions scattered in a colloidal medium in gel state, and in natural systems (sedimentary rocks). Such

phenomenon causes the formation of colored ring bands more or less regular. At the optical microscope the colloidal iron oxides is diffusing in the crystal interstices and covering calcite crystal (Figure. 20).

**Figure 20.** Iron oxide colloidal compounds are responsible of the red-orange colour visible.

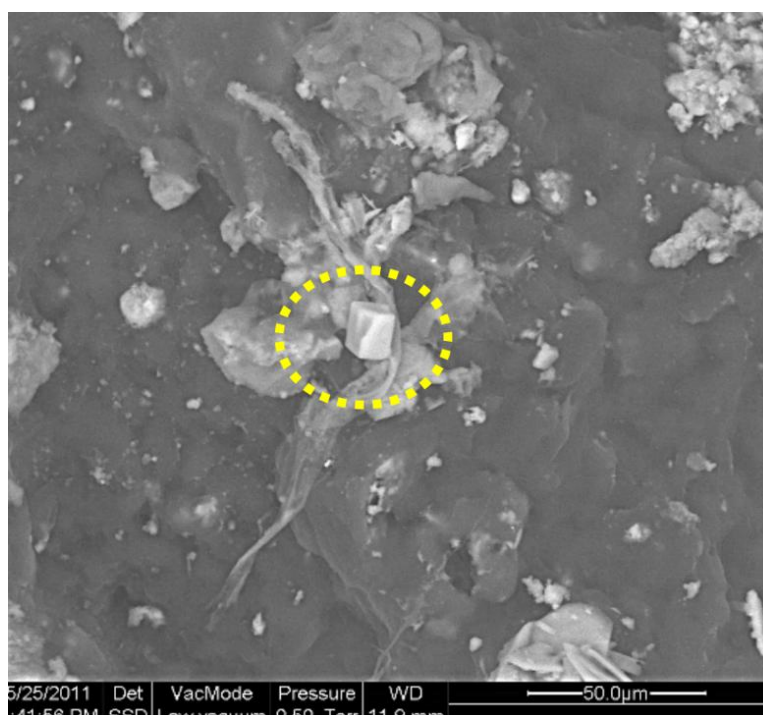
*Type e) Areas of surface turning to greyish* (Figure 13). The cross-section optical microscopic observation shows a compact internal structure which indicates a good state of conservation. On the surface, the presence of wax (Figure 21) and traces of acrylic and siloxane compounds was found (Figure 22). The wax is probably ascribed to ancient treatments, while the synthetic products are ascribed to the 1993 intervention and to some maintenance not present in the archive documents.

**Figure 21.** SEM observation of the surface. A grey dark non-crystalline organic-based layer is covering the marble surface. In the yellow circle a sodium chloride crystal has broken the organic-based layer. .

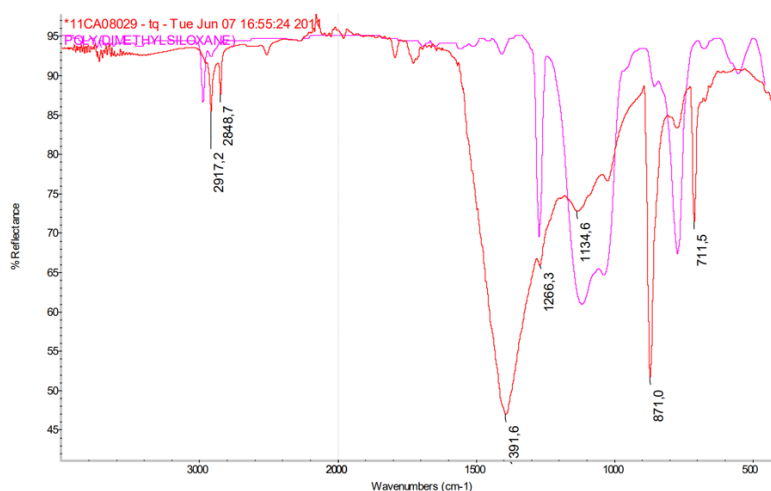
**Figure 22.** FTIR spectrum of the greyish surface layer showing the presence of siloxane.

In the 1993 intervention, acrylic or acryl-siloxane resins were applied, which were identified by our survey and by the previous 2009 survey. This intervention together with the initial wax treatment exacerbated the phenomena of sub-surface crystallization, accelerating the decay processes.
