# Copper Mountain Mine Tailings Dam Safety Review Supplement

**Abstract:** Copper Mountain Mine tailings dam slope stability research based on recommendations of the 2021 Tetra Tech Dam Safety Review, including computation of tailings dam factors of safety, satellite imagery, steady state and transient seepage analyses, and assessment of internal erosion risk. 3D dam factors of safety satisfy BC's normal operating legal requirement of 1.5 but are in possible violation of the post-seismic legal requirement of 1.2.

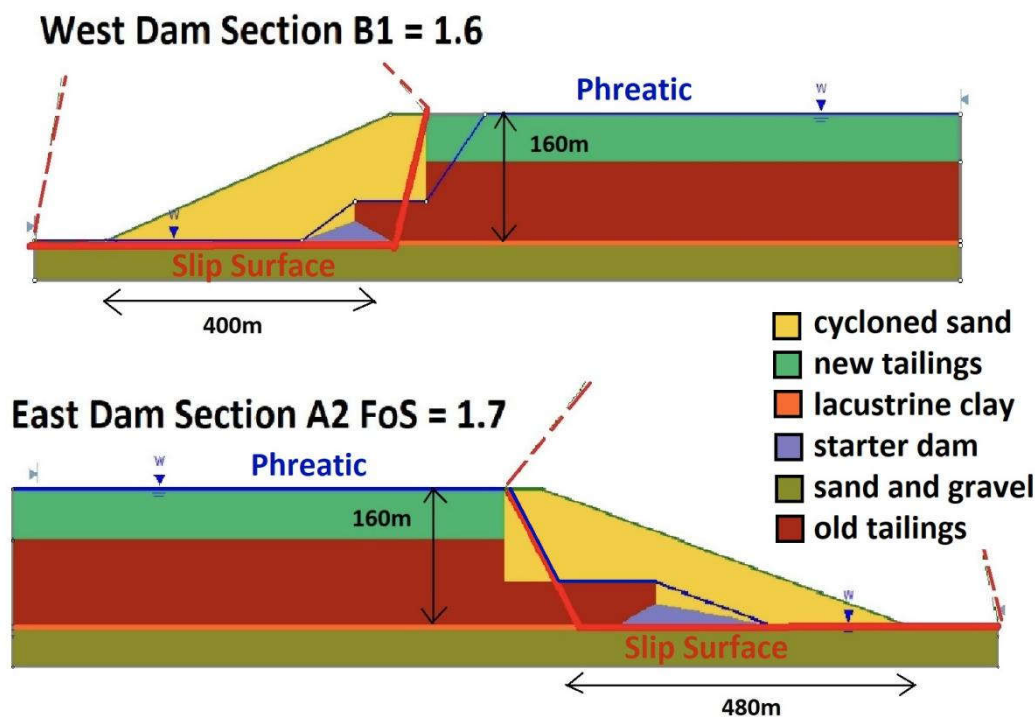
**Figure 1-left** shows the  $\text{FoS}=1.6$  result of applying the 2D Morgenstern-Price limit equilibrium method in Rocscience Slide2 to compute the FoS of West Dam cross section B1 using an approximation of the 2020 KCB model, including the reported phreatic surface level, assignment of drained Mohr-Coulomb material shear strengths to dam construction and sand/gravel foundation materials, assignment of undrained SHANSEP material shear strength to lacustrine clay foundation material, and the reported critical slip surface. Material models/parameters used are listed in **Table 1**, in which the Mohr-Coulomb and SHANSEP models are abbreviated as MC and S. In this table, the densities of the sand and gravel foundation, lacustrine clay, starter dam, and old/new tailings are water saturated densities, while the density of cycloned sand is an unsaturated wet density.

**Figure 1.** Morgenstern-Price computed FoS for West and East Dam 2D cross sections B1 and A2.

**Figure 1-right** shows the  $FoS=1.7$  result of applying the 2D Morgenstern-Price limit equilibrium method to compute the FoS of East Dam cross section A2 using a model approximating the 2020 KCB model, including the reported phreatic surface level, assignment of drained Mohr-Coulomb material shear strengths to dam construction and sand/gravel foundation materials, assignment of undrained SHANSEP material shear strength to lacustrine clay foundation material, and the reported critical slip surface. It is important to note that neither the West nor East Dam 2D FoS computations reported here used a computer search algorithm to determine the dam critical slip surface, implying these 2D FoS values are overreported. It is also noted that in 2016, AMEC reported an end-of-construction FoS of 1.3 for a model of East Dam cross section A2 in which a continuous lacustrine clay layer was present in the foundation, while in 2020, KCB reported an FoS of 1.9 for the same cross section at time-of-construction.

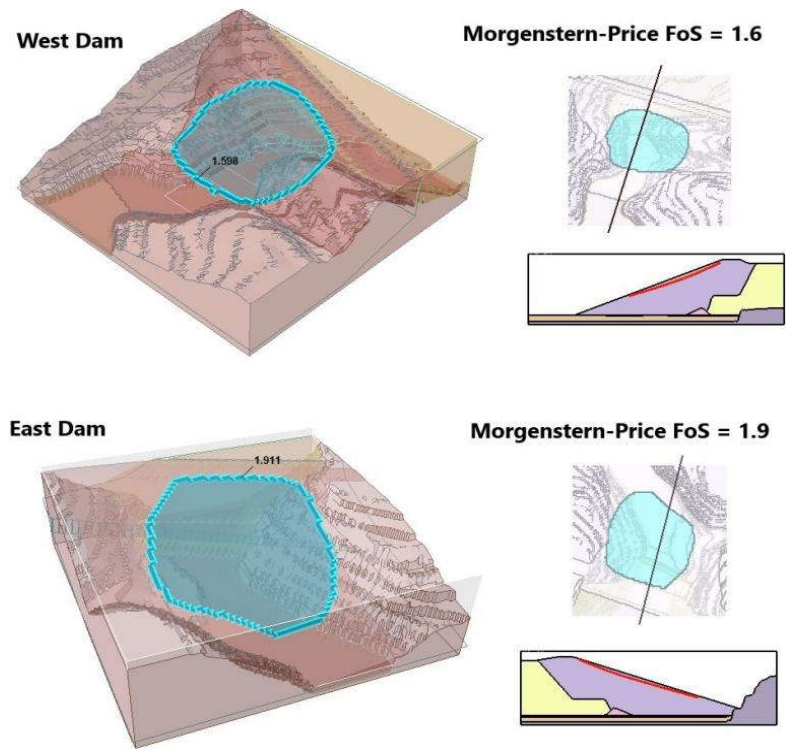
**Figure 2** shows the result of computing 3D FoS values for the West Dam and East Dam in 2025 using Rocscience Slide3. The 3D models are based on valley topographic data provided by the foundation investigation documentation and 2016/2023 ADSI reports, and dam construction projections based on the 2023 ADSI report. Because the foundation investigation documentation showed boreholes in the vicinity of the West and East starter dams having average surface/bedrock elevations of 810.4m/795.4m and 811.8m/781.6m, while the 2023 ADSI specifies the West and East starter dam base elevations for sections B1 and A2 as being 800m, foundation topography was simplified by assuming uniform surface/bedrock elevations of 800m/780m, noting that the sand and gravel material in the foundation below the elevation of the surface lacustrine clay layers is not anticipated to affect failure dynamics. Model phreatic surfaces are based on calibration of FEFLOW 2D 2025 seepage analyses to 2023 piezometer data, assuming water is ponded against the dam crests during a probable maximum flood event. For critical slip surfaces determined by the Slide3 classic ellipsoidal particle swarm search, the Morgenstern-Price FoS value is 1.6 for the West Dam, and 1.9 for the East Dam. The fact that neither 3D slip surface passes through the tailings and clay foundation demonstrates the importance of the narrowness of the TSF valley to enhancing stability of the dam slopes.

**Figure 2.** West Dam and East Dam 2025 3D Morgenstern-Price FoS values computed for critical slip surfaces determined by Rocscience Slide3 classic ellipsoidal particle swarm search. Phreatic surface levels are based on 2D FEFLOW seepage analysis of probable maximum flood conditions.

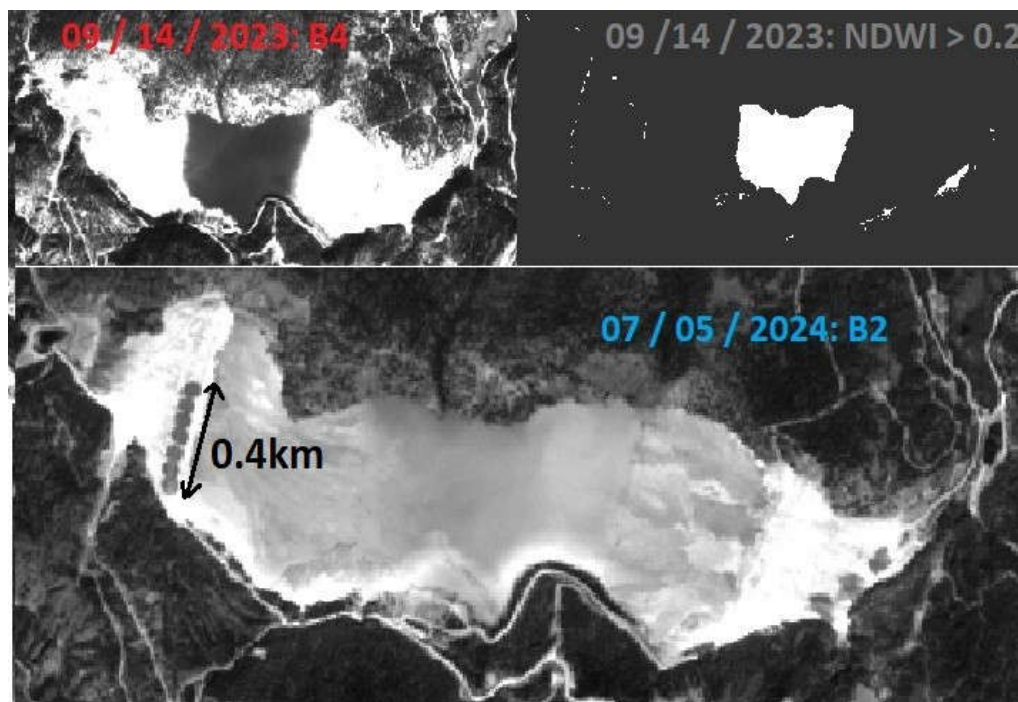
to detect presence of surface water, where B3 and B8 are the satellite measured reflectances in the green and near-infrared bands [Du, 2016, O'Donovan, 2022]. **Figure 3-top** shows images of the Copper Mountain Mine TSF on September 14, 2023, filtered in the red band B4 (left) and binary processed to display  $NDWI > 0.2$  (right) to identify presence of surface water. **Figure 3-bottom** shows an image of the TSF on July 5, 2024, filtered through band B2 (blue-490nm), in which circular surface structures of approximate diameter 60m and 100m with optical reflectivity less than surrounding dam material are visible on the West and East dam downstream slopes. This difference in reflectivity of blue light suggests the structures were not formed by a sprinkler system.

**Figure 3.** Sentinel-2 images Copper Mountain Mine TSF, dated 09/14/2023 (top), and 07/05/2024 (bottom). Top images show the TSF in red band B4 (left), in which boundaries of the tailings pond are clear, and the same image binary processed for the condition  $NDWI > 0.2$  (right) to identify presence of water at the surface of the TSF. The bottom image shows the TSF in blue band (B2) in which 7 circular structures on the West Dam crest/downstream slope of approximate diameter 60m and 3 circular structures on the East Dam downstream slope of approximate diameter 100m are visible, and distinguishable from dam downstream slope, beach, and tailings pond materials by their reflectance in blue, red, and infrared bands.

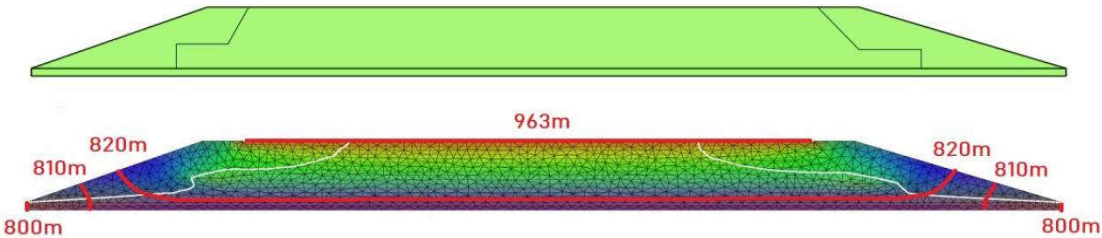
**Figure 4** shows the FEFLOW computed 2023 steady state phreatic surface level and hydraulic head isolines for the entire TSF and its foundation analyzed as a simplified 2 dam system in which constructed drains are omitted, beach lengths are 0m, and the material permeabilities listed in **Table 5** have been used. This analysis indicates the 2023 hydraulic head in TSF foundation upstream of West and East starter dams is approximately constant at 810m. The total seepage flows out of the West and East Dams are computed to be 1.4L/s/m and 1.2L/s/m, and in both cases more than 90 percent of this flow passes through the foundation. These seepage analysis results are in contrast to 2014 piezometer readings of VWP10-05W-3/VWP10-01E-3 in West/East Dam upstream foundations in excess of 835m/845m, pointing to the importance of accounting for transient seepage conditions and the effect of 3D TSF geometry on seepage flow, including any low permeability path from the TSF pond through the TSF abutments into the foundation [Klohn Crippen, 1998].

**Figure 4.** West/East Dam FEFLOW steady state analysis of 2023 2 dam system indicates hydraulic head in TSF foundation upstream of West and East starter dams is approximately constant at 810m.

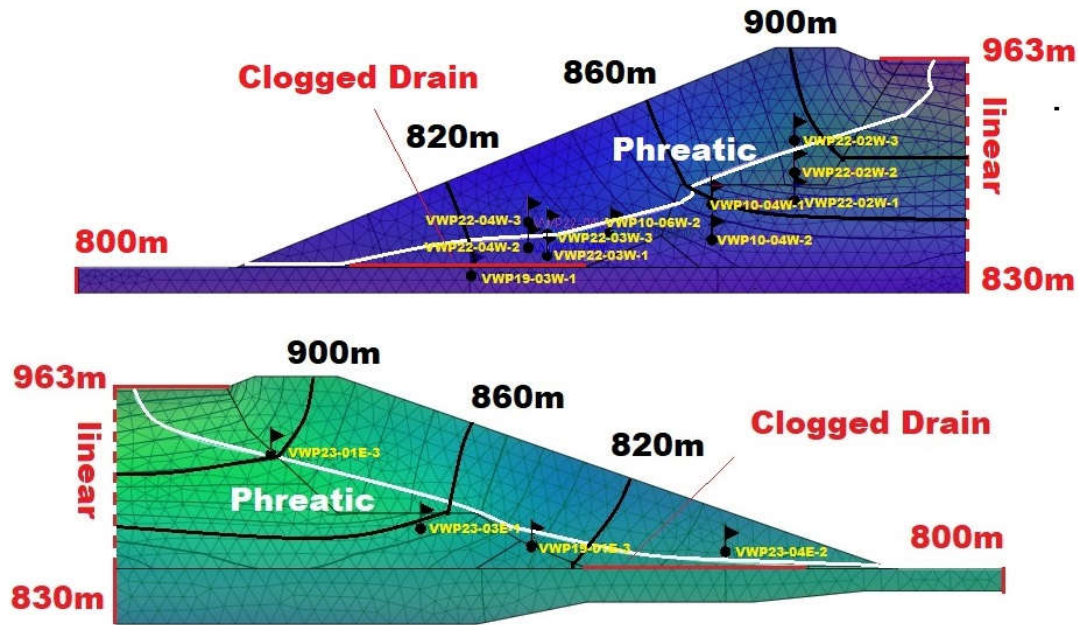
**Figure 5** shows West/East Dam FEFLOW steady state seepage analyses with drain function and boundary conditions adjusted to obtain approximate agreement of hydraulic heads with 2023 readings of West/East Dam piezometer readings. For both dams, an upstream foundation total head of 830m was assigned based on readings of piezometer VWP12-01E-2 and results of analyzing the 2 dam system. For the West Dam, to obtain agreement with downstream piezometer VWP22-04W-1 and VWP22-03W-3 readings of 811m and 827.5m, it was necessary to assume 100m of the blanket/finger drain system downstream of the starter dam has been clogged, and to obtain agreement with piezometer VWP10-04W-1 and VWP22-02W-3 readings of 859.5m and 900m it was necessary to assume a beach length of 0m. For the East Dam, to obtain agreement with downstream piezometer VWP23-04E-2 and VWP19-01E-3 readings of 815.3m and 834m, it was necessary to assume 200m of the blanket/finger drain system downstream of the starter dam has been clogged, and to obtain agreement with piezometer VWP23-03E-2 and VWP23-01E-3 readings of 855m and 911.5m it was necessary to assume a beach length of 0m. After this initial adjustment of drain permeability and seepage flow boundary conditions, material and drain permeabilities were calibrated to 2023 piezometer readings using FePEST. For both West/East Dam FePEST permeability calibrations, the effect on phreatic surface position was not substantial, but calibrated cycloned sand permeability  $5e^{-7}$ m/s was two orders of magnitude lower than reported in the 2021 DSR, and calibrated permeabilities ranged from  $3.3e^{-5}$ m/s to  $5.8e^{-3}$ m/s for sections of drain 0-100 and 100-200 meters downstream of the starter dams. Inclusion of daintube crest drainage in West and East Dam steady state seepage analyses as FEFLOW fluid transfer boundary conditions was not observed to have any effect on phreatic surface level of pore water pressure due to location of the drains above the phreatic surface.

**Figure 5.** West/East Dam FEFLOW 2023 steady state seepage analysis with drain function, boundary conditions, and material permeabilities calibrated to 2023 piezometer readings.

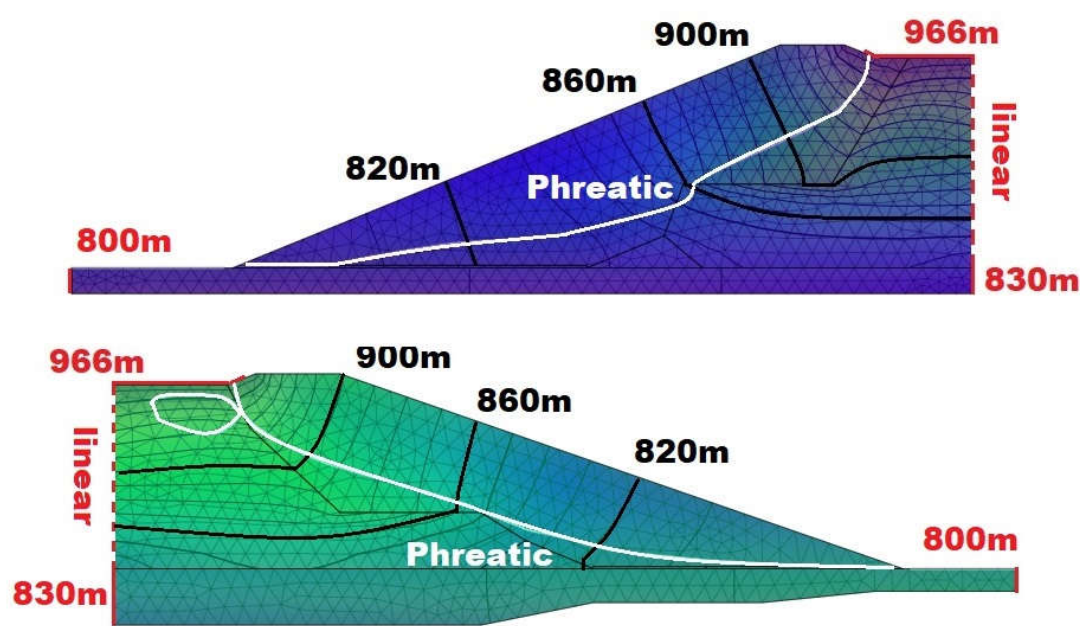
The design minimum freeboard of 2m assumes an initial freeboard of 5m is decreased by occurrence of a probable maximum flood. Because the 2023 ADSI reports a freeboard of 10m, transient seepage analysis has been performed assuming an increase in water level of 3m takes place with occurrence of a probable maximum flood of duration 72 hours, and that a month is required to pump the flood water out of the reservoir to return the pond height to its original level. **Figure 6** shows the West/East Dam transient seepage analysis in which phreatic surfaces are not significantly changed from steady state levels, but the hydraulic head of water saturated cycloned sand and tailings beneath the dam crests is increased by 10-20m.

**Figure 6.** West/East Dam FEFLOW 2023 transient seepage analysis results 30 days after 72 hour probable maximum flood decreases dam freeboard by 3m.

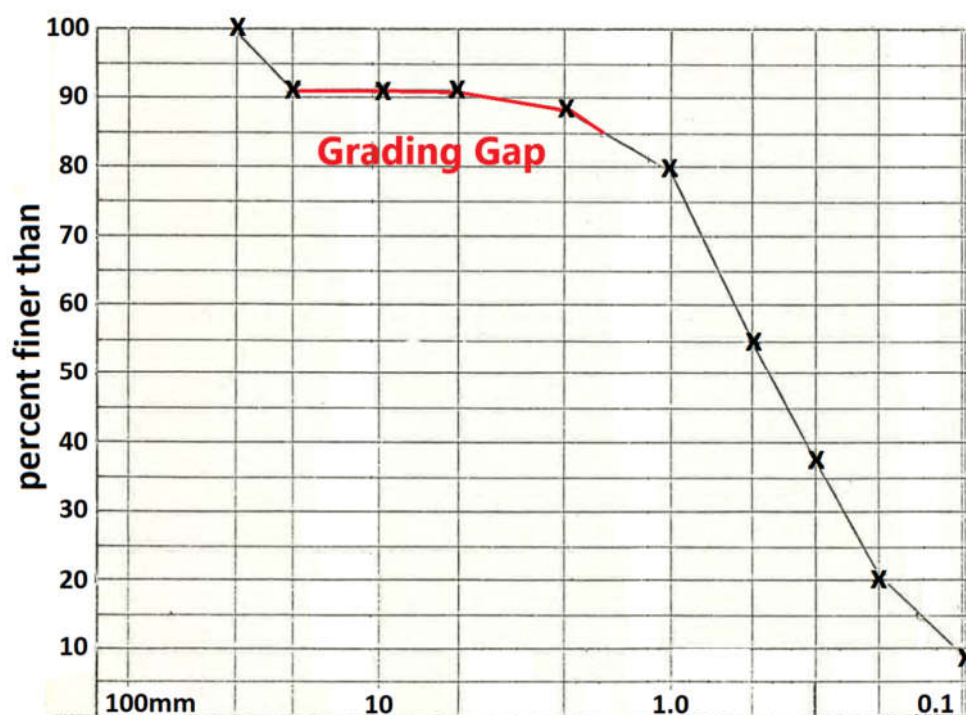
A condition on grain size distribution of a material indicating initiation of suffusion is the Kezdi criterion, which states suffusion may initiate if the difference in percent fines content between grain sizes  $D$  and  $4D$  is less than 15 percent [Kezdi, 1979]. Based on the grain size distribution curve for silty gravelly sand recovered from borehole SL-9 in the East Dam foundation, shown in **Figure 7**, and the Kezdi criterion, the foundation material is susceptible to suffusion because of a gap in grading between 2 and 20mm grain sizes [Bechtel Ltd, 1971]. In principle, this suffusion could result in transport of fine grained sand and and/or clay material through the foundation contributing to West and/or East Dam drainage blanket and finger drain clogging [Fry, 2016].

**Figure 7.** Grain size distribution curve for silty gravelly sand 17.2 to 18.7 feet deep in borehole SL-9 in the East Dam foundation.

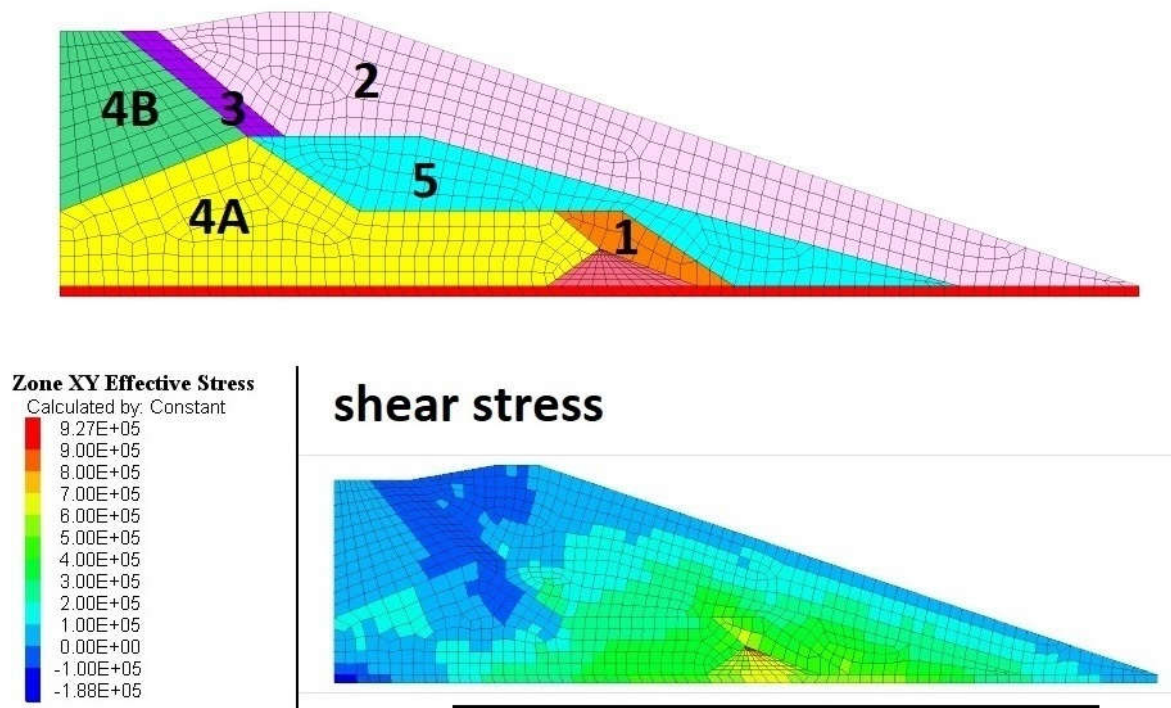
changed from approximately 30mm/15m to 35mm/15m, equating to a strain rate of  $6.8e^{-11}s^{-1}$ , which for a clay Maxwell viscosity of  $2e^{12}kPa \cdot s$  requires a shear stress of 136kPa to sustain [Bancroft, 2024]. As shown in **Figure 8** in which results of FLAC2D shear stress computation for 2025 East Dam cross section A1 are displayed, this level of shear stress is attained in the vicinity of the starter dam and its foundation. InSAR and/or ground-based radar measurement of East Dam motion might be used to identify the spatial extent of dam motion.

**Figure 8.** FLAC2D computation of shear stress in 2025 East Dam cross section A1 shows the shear stress in the vicinity of the starter dam and its foundation exceeds 100kPa. Dam zone labels 1:compacted cycloned sand, 2:uncompacted cycloned sand, 3:tailings sand + cyclone overflow, 4:tailings slimes, 5:water saturated cycloned sand.

- Chapter 7 - FLAC2D computation of shear stress in the East Dam suggests inclinometer displacements can be attributed to secondary creep of water saturated material in the vicinity of the starter dam and its foundation.

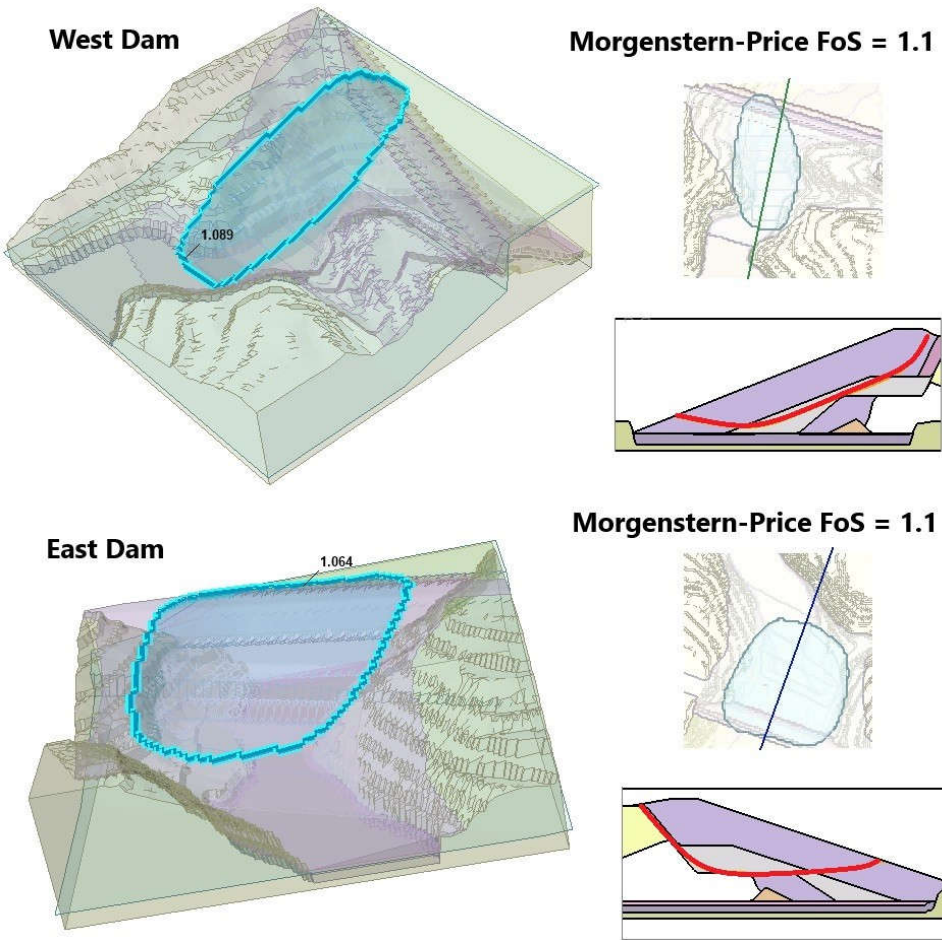
Figure 9. Post-liquefaction Morgenstern-Price FoS computation results in Slide3.

If liquefaction triggered slope instability is identified by direct measurement as an ongoing threat to dam stability, wick drainage of excess pore water pressure in the tailings beaches and/or relief well drilling down into the foundation may be necessary. To avoid the complication of correctly predicting liquefaction triggers, it is noted that current best practice is to assume liquefaction could be triggered and design/construct dams to a post-seismic stability standard  $FoS > 1.1$  [International Commission on Large Dams, 2019, O'Brien, 2020].
