Development of a GIS Tool for a High Precision PV Degradation Monitoring and Supervision: Feasibility Analysis in Large and Small PV Plants

Abstract: It is well known that working PV plants show several maintenance needs due to wiring and modules degradation, mismatches, dust and PV cells defects and faults. There are a wide range of studies that show the theoretical and some laboratory tests of how these circumstances may affect the PV production. Thus, it results mandatory to evaluate the whole PV plant performance and, then, it's payback time, profitability and environmental impact or carbon footprint. However, very few studies include a systematic procedure to quantify and supervise the real degradation effects and faults impacts on the field. In this paper, the authors first conduct a brief review of the most frequent PV faults and degradation that can be found on real conditions operative PV Plants. Then, they propose and develop an innovative Geographic Information System application to locate and supervise them. The designed tool has been applied to either a large PV plant of 108 kWp and a small PV plant of just 9 kWp installed on a home rooftop. For the large PV plant, 24

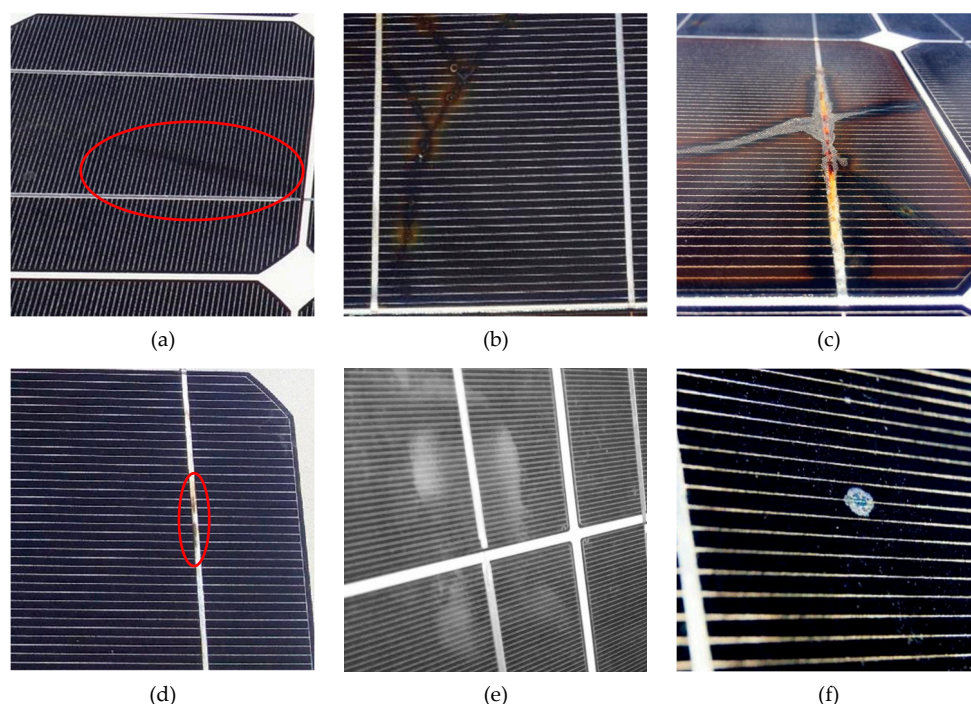
Figure 1 – Defects identification examples. (a) Snail track. (b) Cell crack. (c) Hot spot. (d) Busbar discoloration. (e) EVA discoloration. (f) Bubble formation.

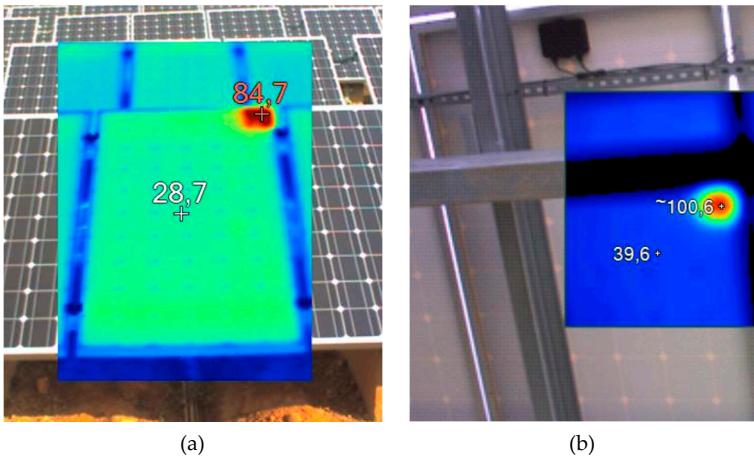
Figure 6 - Hot spot detection in (a) frontal and (b) rear taken thermographies.

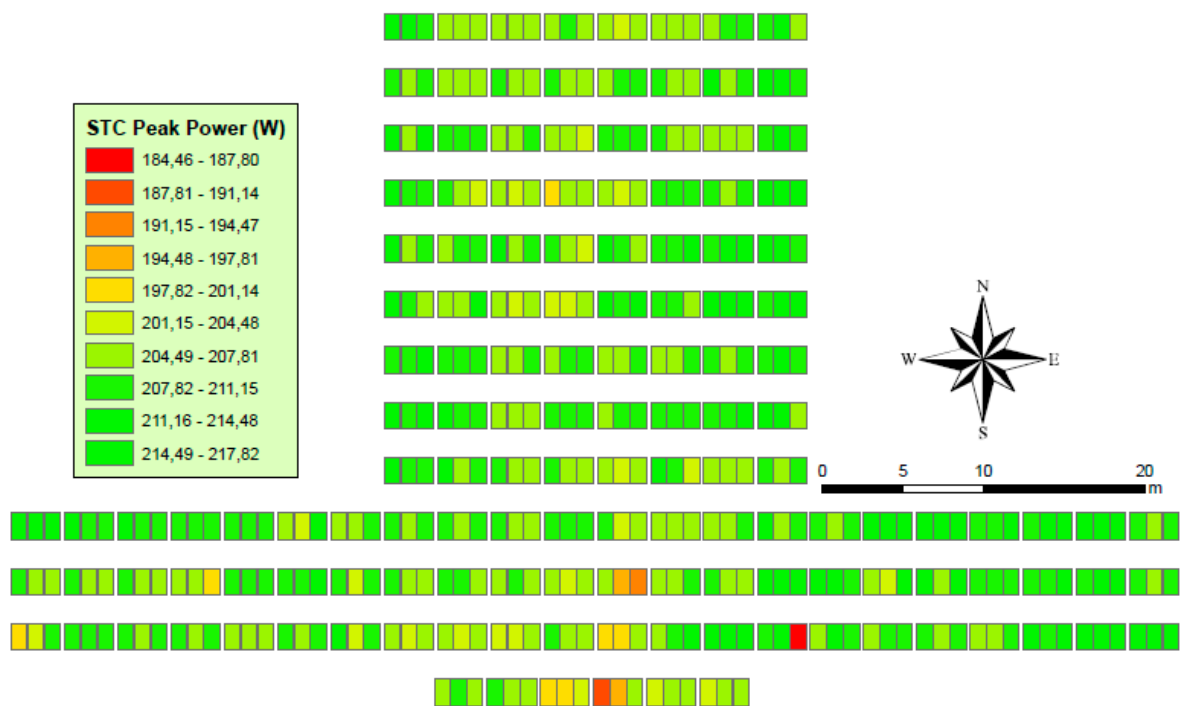
Figure 8 – STC peak power distribution analysis (108 kWp PV plant).

Figure 8 shows lower peak power values for STC conditions in the center of the lower part of the installation, whereas the extremes show significantly higher values. This effect may be caused by the temperature distribution through the PV modules and the refrigeration by air convection conditions. The lowest STC peak power was 184.46 W, where the highest value was 217.82 W (18.09% difference). Sub-figure 18.a shows the distribution of the peak power values, where it can be noticed that more than the 70% of the modules are in the 205–211 Wp range.

By analyzing Figures 8 and 16, it is observed that snail tracks may affect substantially to the power generation. Some modules with a high number of snail tracks show lower peak power values on STC. However, the thermographies did not detect significant variations on the PV module performance.

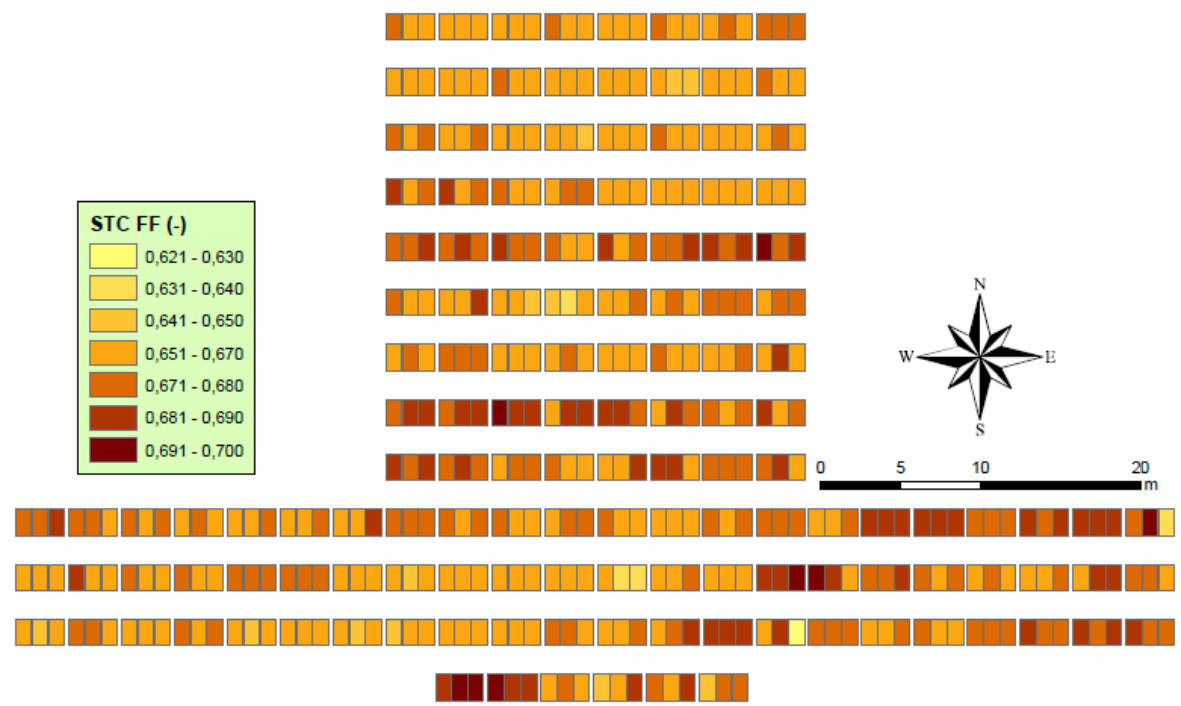
Figure 9 – STC fill factor distribution analysis (108 kWp PV plant).

In a similar way, figure 9 shows the fill factor of the PV modules transformed to the reference STC. Sub-figure 18.b shows the histogram for these values. It can be noticed that the PV modules are affected by a significant rate of degradation where 80% of the modules are in the range 0.66–0.68, when the nominal FF given by the manufacturer achieves 0.8018 (see table 3). Less than 1% of the PV modules present a $FF > 0.695$. Moreover, it can be observed that those modules with lower values for peak power in figure 8 show also lower values of FF in figure 9. However, higher variations of the FF can be noticed in this late figure rather than on the peak power analysis. The fill factor distribution shows not to be homogeneous in the installation and, thus, modules with high values of fill factor

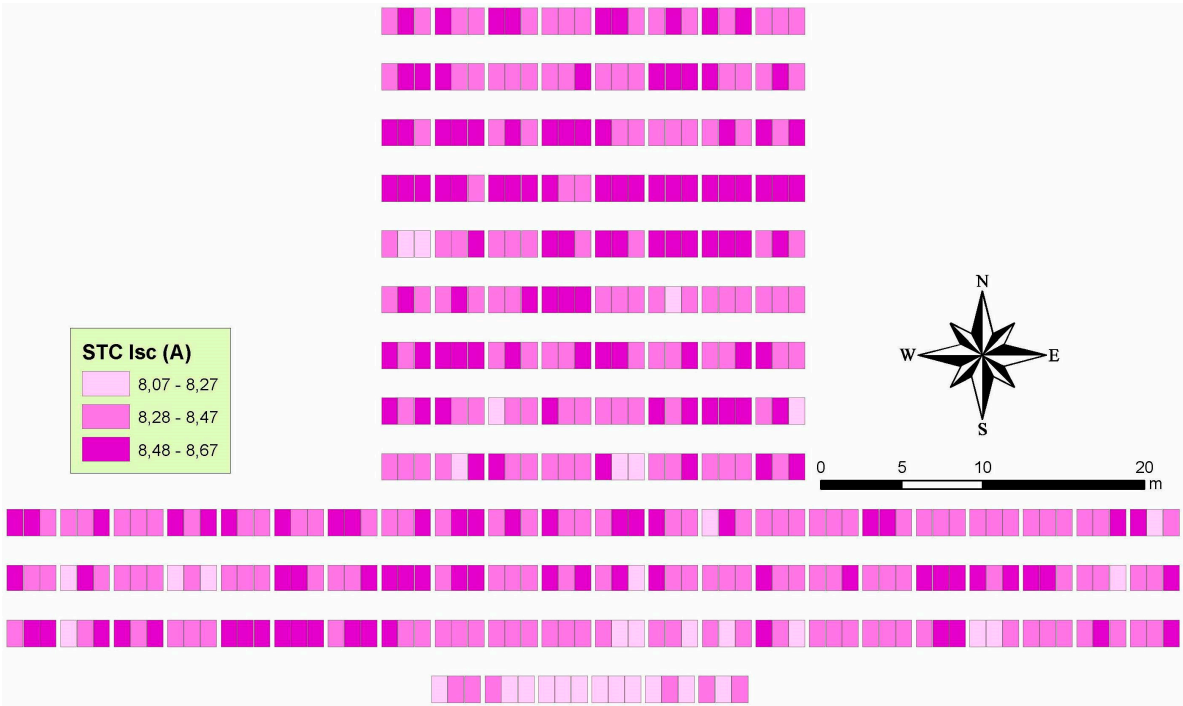
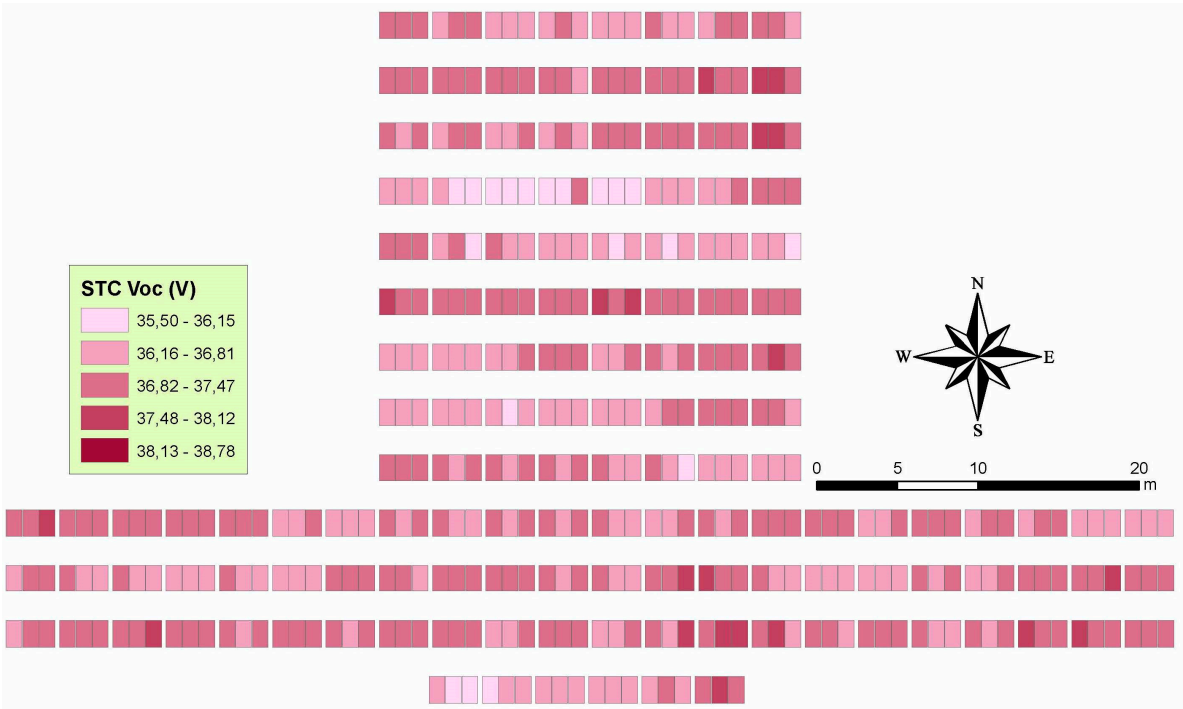
Figure 10 – STC short circuit current distribution analysis (108 kWp PV plant).

Figure 11 – STC open circuit voltage distribution analysis (108 kWp PV plant).

Figures 10 and 11 show the STC short circuit current and STC open circuit voltage distributions respectively. Moreover, Sub-figures 18.c and 18.d show their histograms. From that figures it can be observed that there exist very slight variations on the short circuit distribution (0.6 A max), but significant variations (up to 3.28 V) in the open circuit voltages. Both distributions in the spatial field are absolutely not homogeneous.

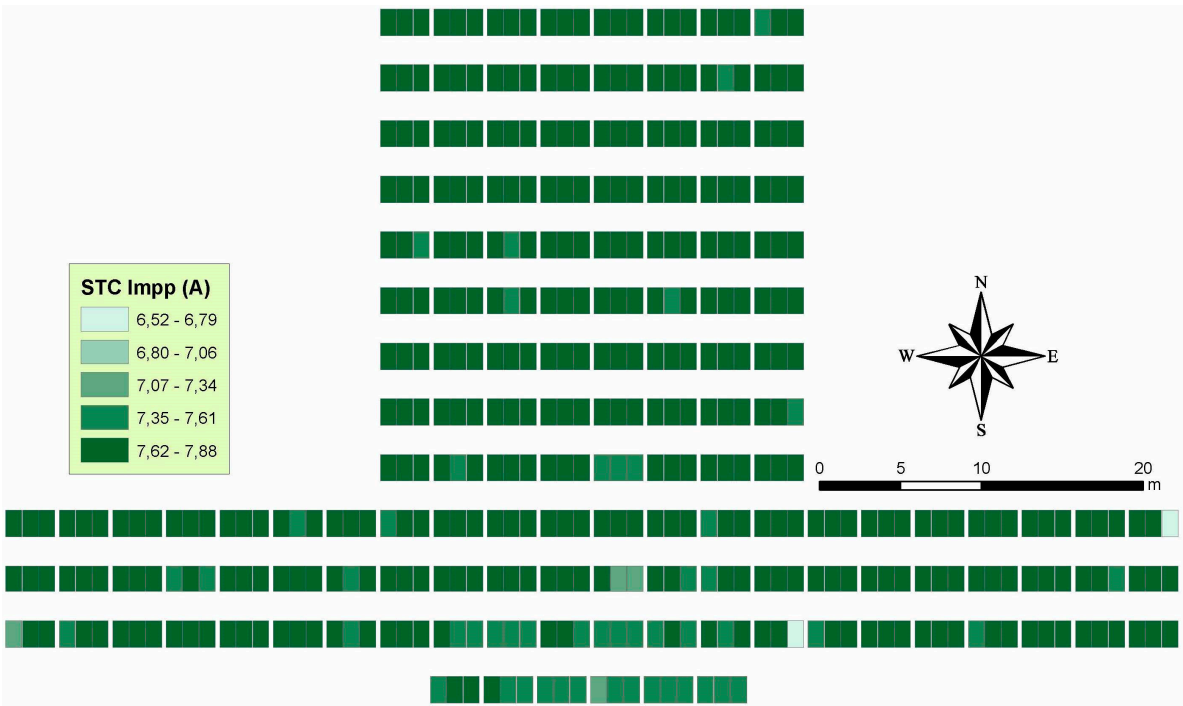
Figure 12 – STC maximum power current distribution analysis (108 kWp PV plant).

In Figure 12 it can be easily distinguished groups of PV modules with high values for the STC maximum power current. Distribution on the PV field of this electrical value is not uniform and low values can be correlated with low values of the STC maximum power voltage in Figure 13. Undoubtedly, those PV panels must be inspected with caution. Let's notice that higher differences on this value between close located PV modules can be found than when analyzing the maximum power voltage distribution.

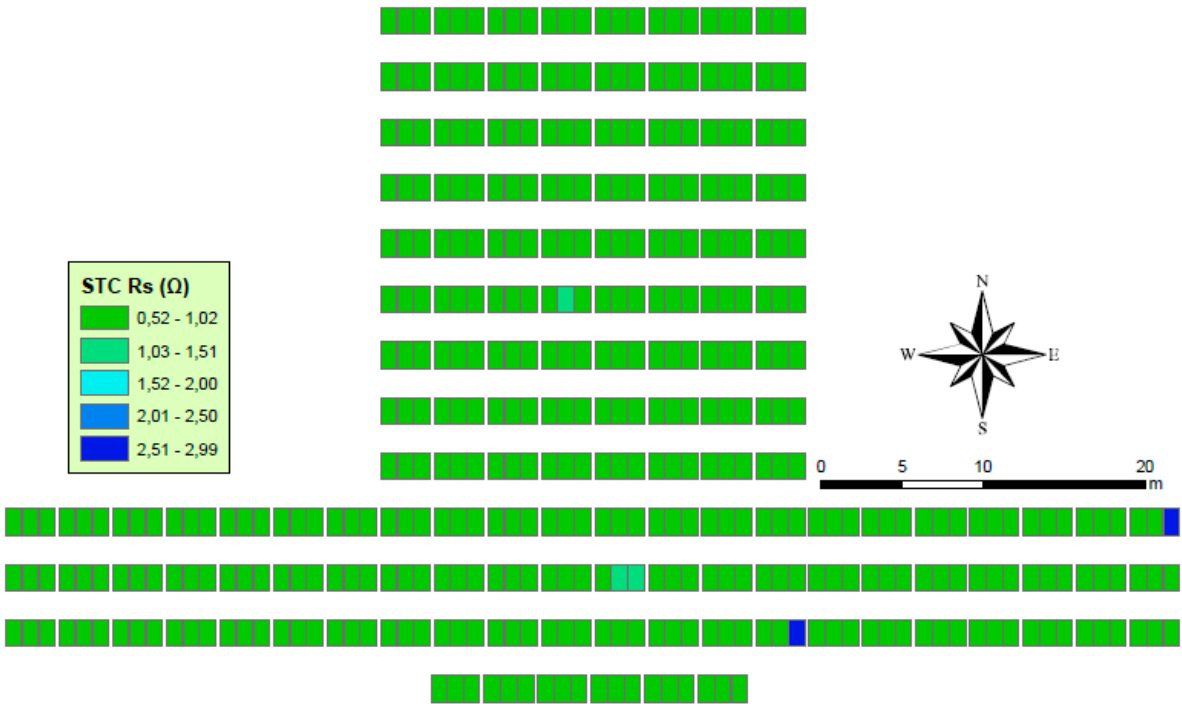
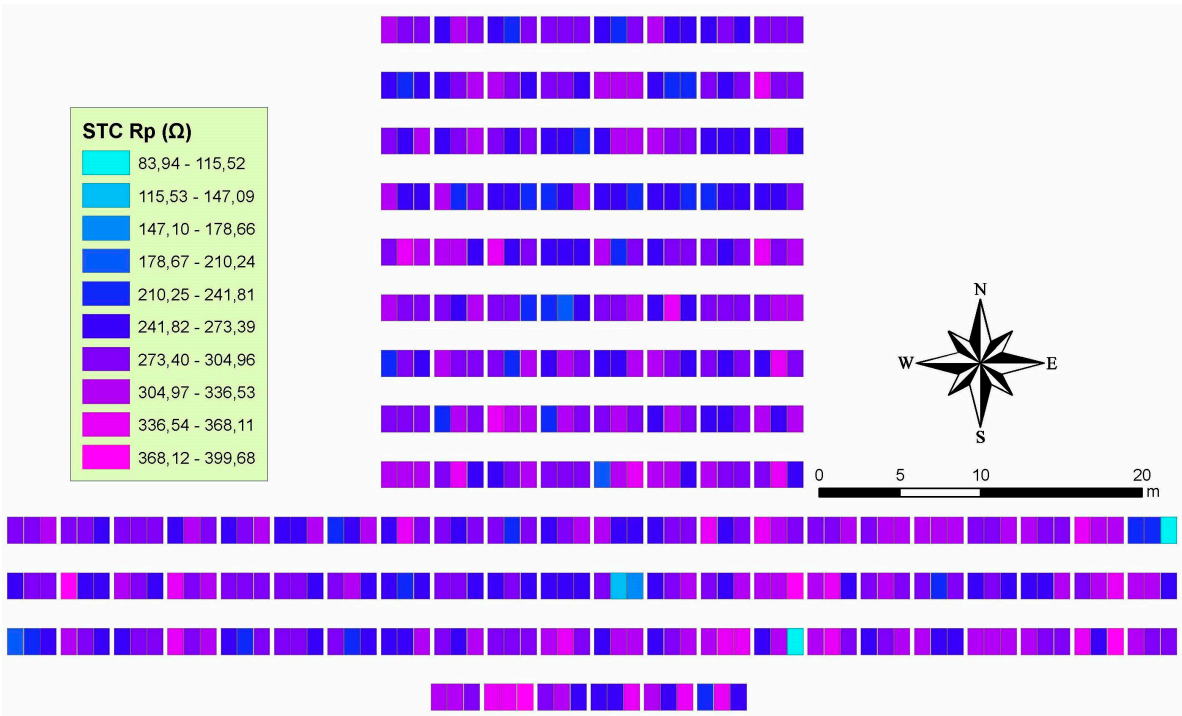
Figure 14 – Series resistance distribution analysis (108 kWp PV plant).

Figure 15 – Parallel resistance distribution analysis (108 kWp PV plant).

Figures 14 and 15 show the distributions of the series resistance and parallel resistance of the PV modules respectively. Although both distributions are not the same, extreme values are located on the same PV modules. As it can be verified in Figure 15, these modules which have high values of series resistance and abnormally low values of parallel resistance, also present a significant high number of hot spots and burn marks (between 1 and 8). Moreover, according to Figure 8, those modules have very low power output. Thus, the whole string series production is affected. These PV panels must be replaced immediately. Fortunately, the rest of the series seem not to have been affected seriously. Sub-figures 18.g and 18.h show the histograms for both electrical parameters. The average for the series resistance is 0.7515 Ohm, while for the parallel resistance is 286.1831 Ohm. Both values are significantly different (higher in the case of the series resistance and lower for the parallel resistance) from the nominal ones, conducting to a considerable degradation rate.

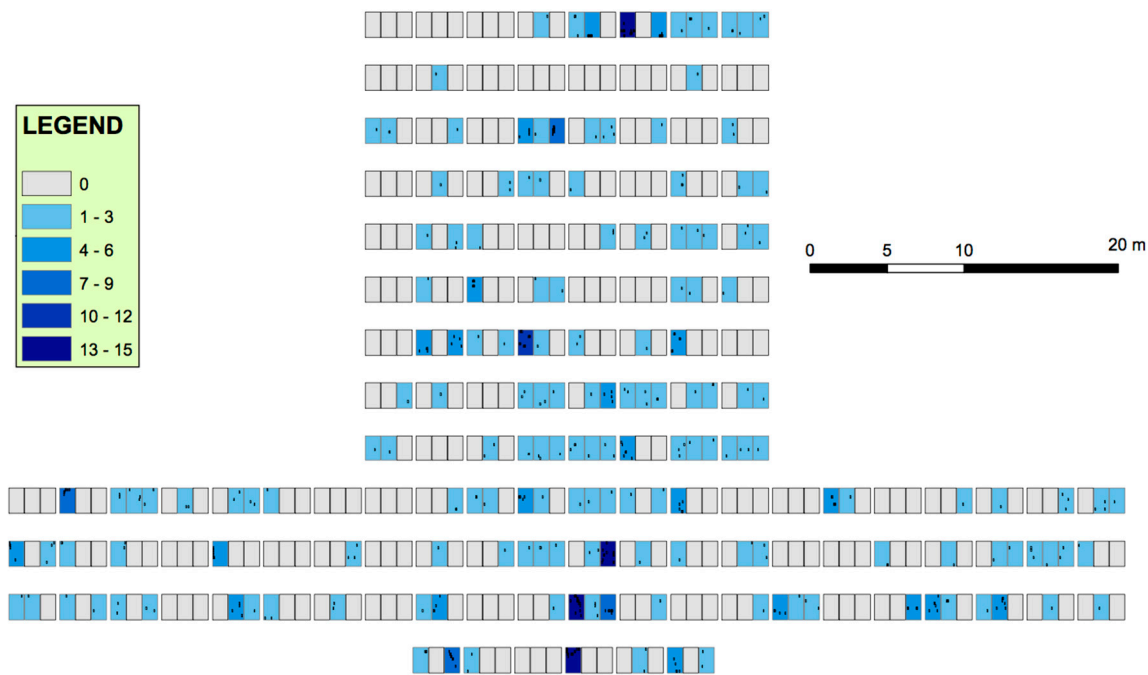
Figure 16 – Snail tracks distribution analysis (108 kWp PV plant).

Figures 16 and 17 include the most relevant PV defects on the installation: snail tracks and hot spots and burn marks. The snail tracks distribution in the power field seems not to be homogeneous but we cannot also infer a clear high density zone. PV modules affected by this PV fault seem to have from 1 to 3 defects. However, 15 defects of this type can be found on single modules. No significant correlations with electrical measurements are detected in this case.

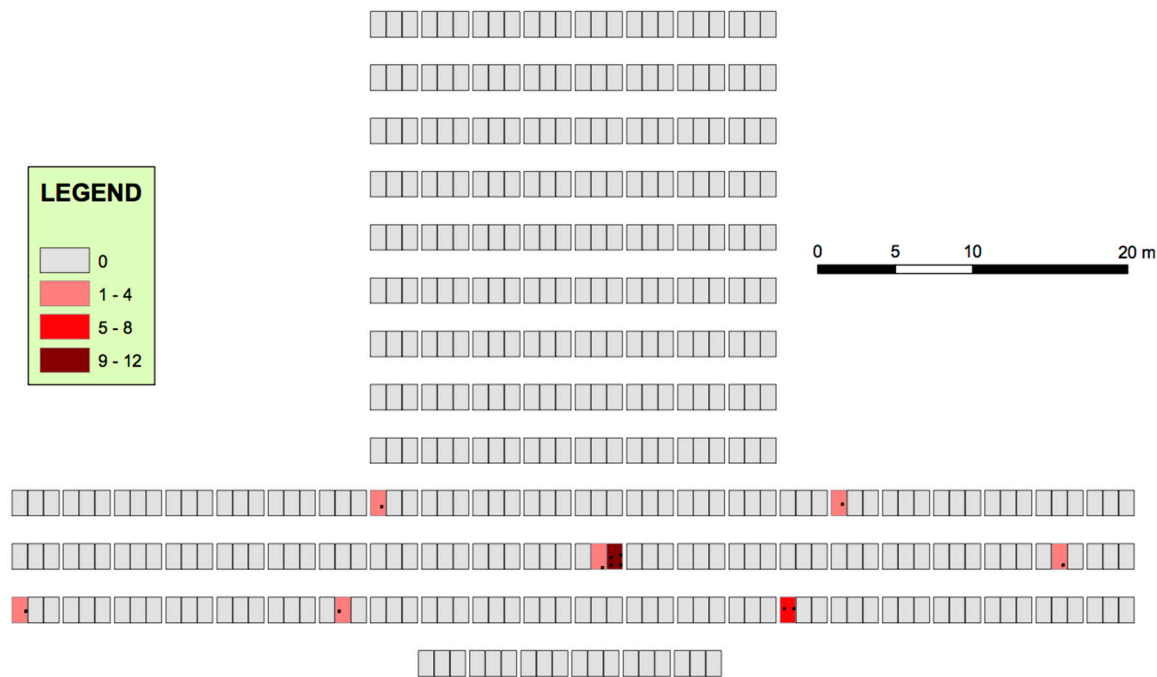
Figure 17 – Hot spots and burn marks distribution (108 kWp PV plant).

Figure 17 show the hot spots and burn marks found on the PV modules. Fortunately, very few of these defects have been found in the installation. In this case, its distribution is clearly concentrated in the lowest part. Moreover, it results remarkable that the module with the highest number of hot spots and burn marks is also one with the highest number of snail tracks. Its STC peak power output is also lower than the average.

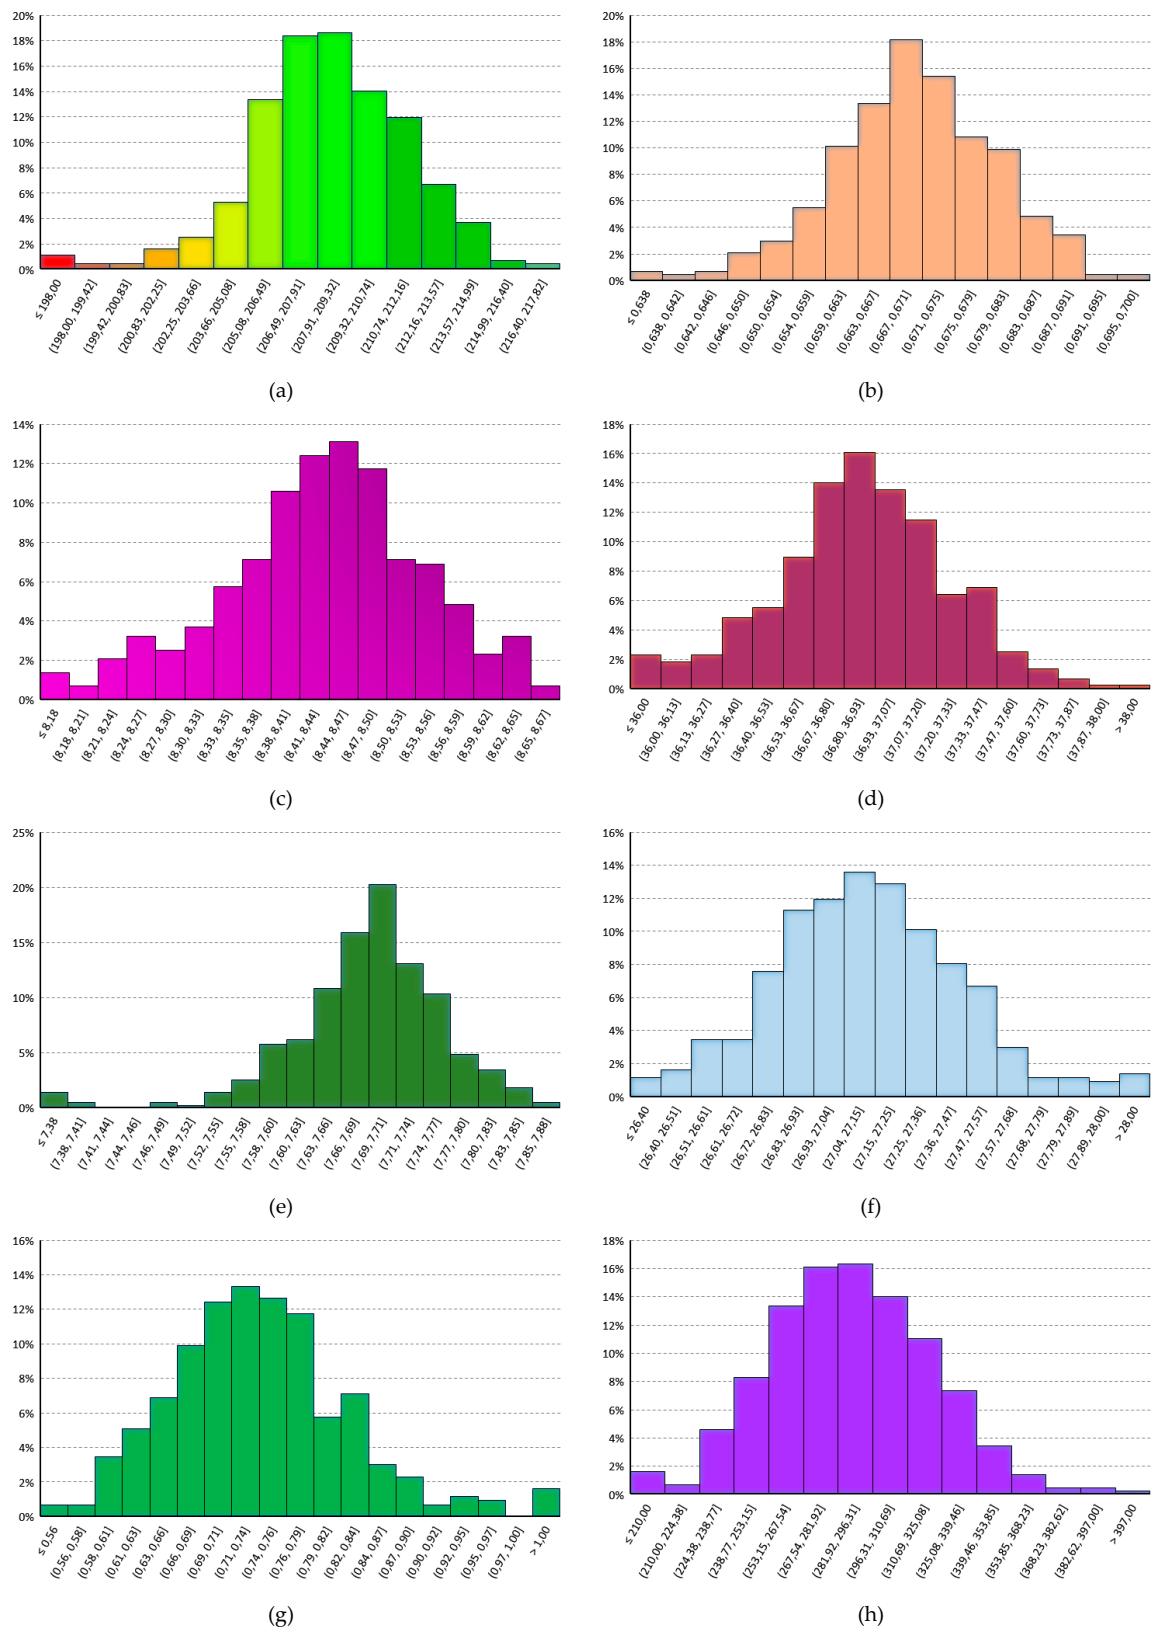
Figure 18 – Histograms of the measured parameters in STC conditions for the 108 kWp PV plant: (a) peak power, (b) fill factor, (c) short circuit current, (d) open circuit voltage, (e) maximum power current, (f) maximum power voltage, (g) series resistance and (h) parallel resistance.

The developed GIS tool allows the analysis of the spatial PV degradation and defects location in an easier way than a traditional statistical analysis. Figure 18 shows the histograms of the measured parameters transformed to STC conditions.

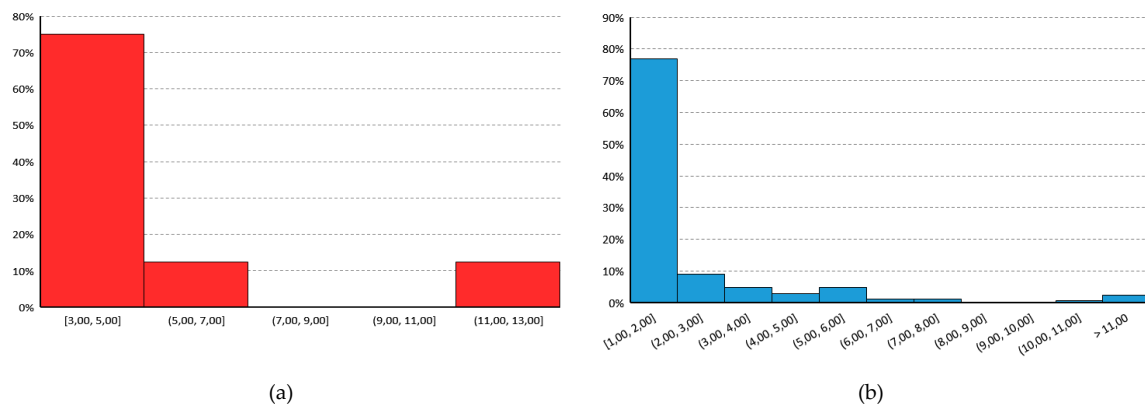
Figure 19 – Histograms of the main PV faults found at the 108 kWp PV plant: (a) hot spots and burn marks and (b) snail tracks.

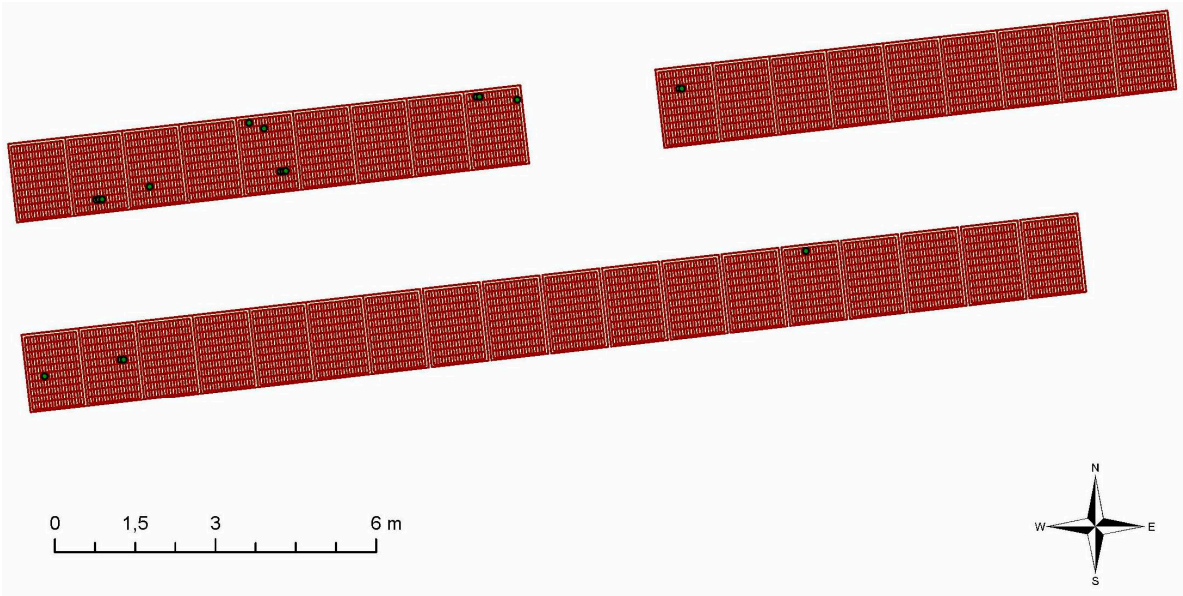
Figure 20 – Snail tracks distribution (9 kWp PV plant).

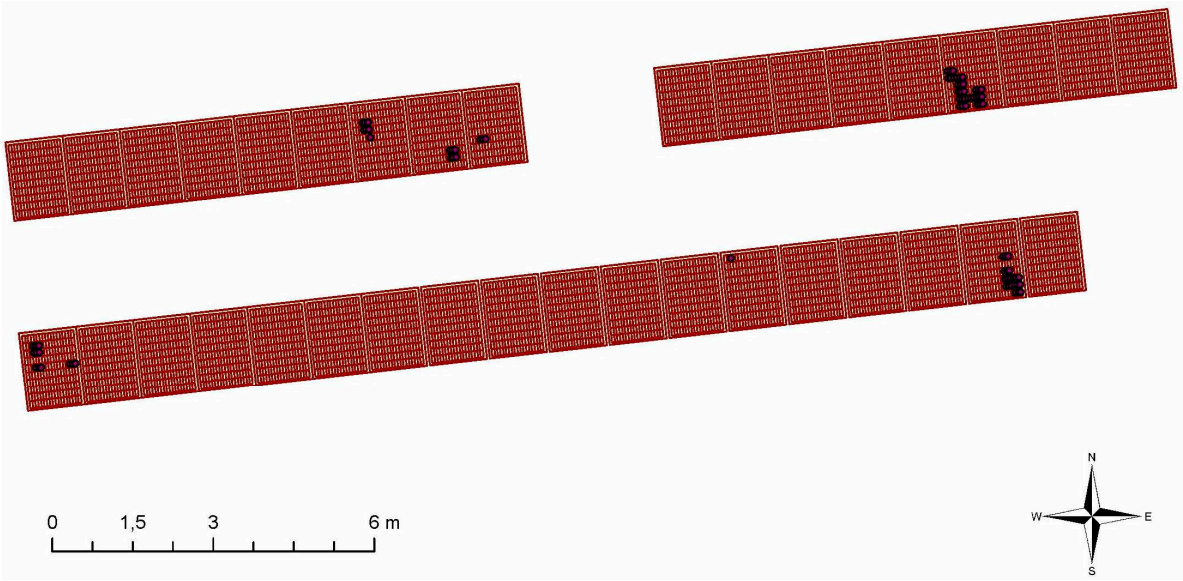
Figure 21 – Cells discoloration distribution (9 kWp PV plant).
