Case Report

Multi-analytical investigation of stains on dimension stones in Master Valentim's Fountain, Brazil

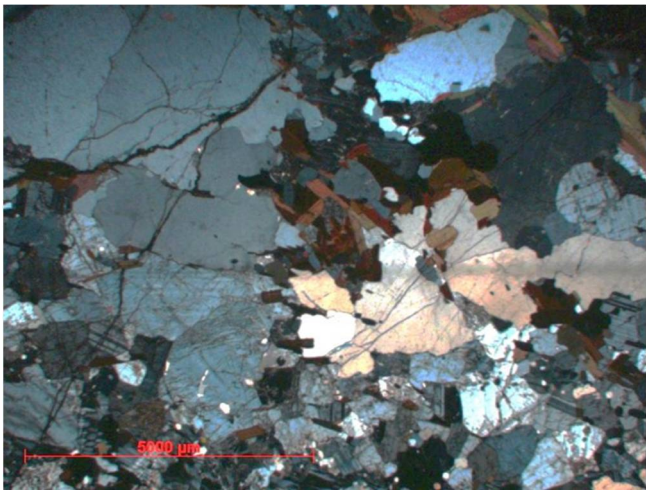
Microscopically, the sample is characterized by granoblastic and porphyroblastic textures, and medium to coarse, inequant grains, highlighting well-developed microcline and plagioclase crystals. The stone sample exhibited significant alterations and microcracks, which are often occupied by recrystallized quartz grains (Figure 4). The mineralogical composition is mainly quartz, K-feldspar, plagioclase, and biotite. The accessory minerals are muscovite, garnet, and opaque minerals ($\approx 1\%$). Sericite appears as an alteration mineral.

Figure 4. General Stone texture (crossed Nicols).

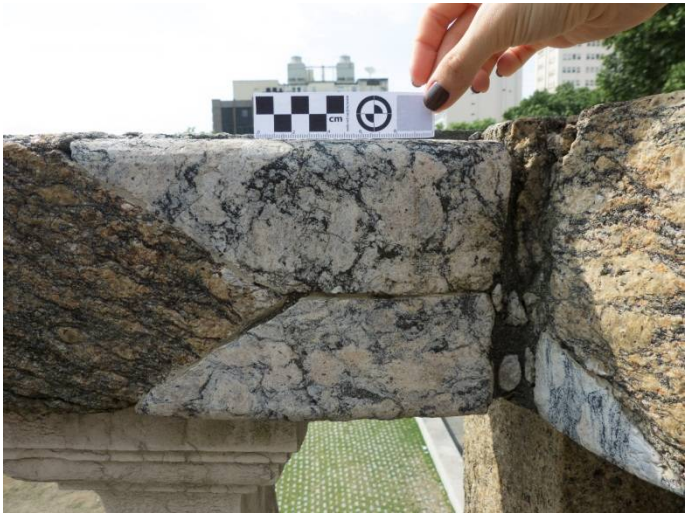
Colorimetric tests were performed to evaluate the replacement parts in previous restorations. It was easy to discern the original Gneiss stones from the replacement parts with the naked eye, since the latter were in better polishing state and with different colors (Figure 5). In the case of the restoration carried out on Lioz limestone balustrade and torches (Figure 6), although the difference was more subtle, it was still perceptible. Regarding the gloss, the new pieces exhibited an increase in the values, but without relevance.

Figure 5. Substitute piece on a Gneiss block.

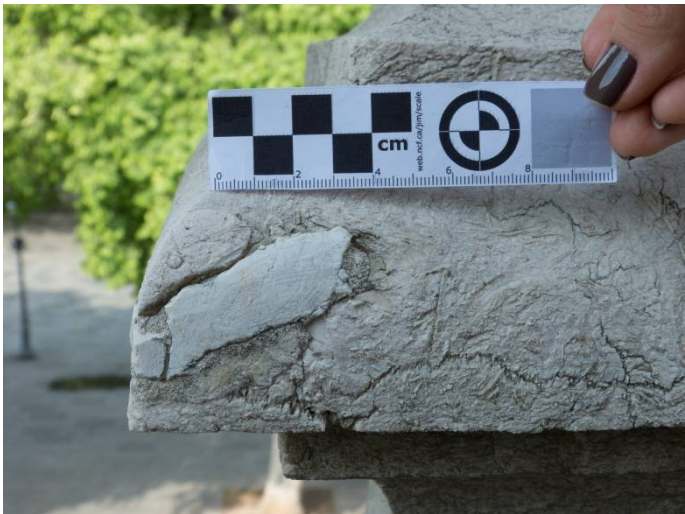
Figure 6. Lioz limestone area with restored part.

The analyses showed that Lioz limestone is light faded brown, slightly orange, possibly due to the weathering effects. Nevertheless, there is chromatic compatibility between the new parts and a sound Lioz limestone. On the other hand, Gneiss showed a tendency to brown, with a more intense orange. The substitute stones to the Gneiss showed grey color slightly orange.

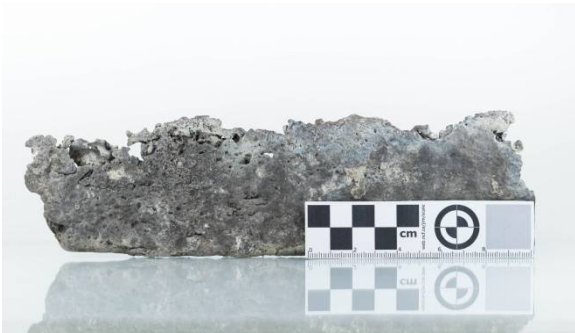
XRF analyses were performed at three different points on the connection plate (Figure 7) and the results indicated lead (Pb) as the major element. Such result was expected, since Pb was widely used by Master Valentim in his works. Furthermore, smaller levels of aluminum (Al) and silicon (Si) were verified, as well as traces of other elements. The values derived from the analyses ranged from 77.8 to 88.9% for lead oxide (PbO), 4.4 to 10.0% for silicon oxide (SiO₂) and 1.9 to 3.7% for aluminum oxide (Al₂O₃).

Figure 7. Lead plate used to connect the stone blocks of the monument.

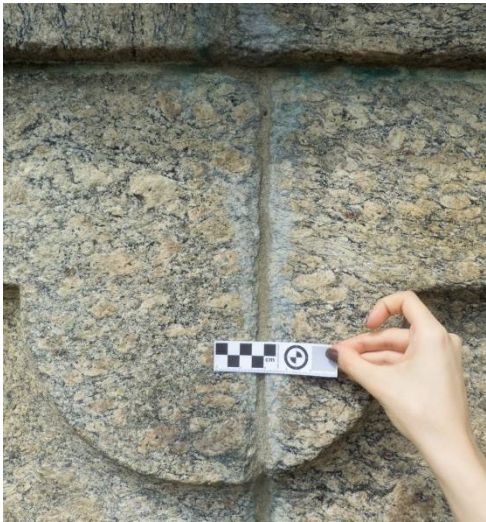
The XRF analysis performed on the light stains (Figure 8) indicated high content of lead (Pb) and silicon (Si).

Figure 8. Light staining area on a Gneiss block.

The levels observed were approximately 50% of Pb, 38% of Si and 8% of Al, besides other elements. These results suggest that these stains may have been originated from the association of the lead of the plates used to connect the blocks with other elements such as sulfur (from the pollution present in the environment of high urban movement), forming an insoluble salt of white coloration.

The XRD analysis demonstrated presence of quartz, plagioclase, K-feldspar, and mica as expected for Gneiss stones. However, such analysis also showed peaks of cerussite (PbCO_3), and anglesite (PbSO_4), which are the probable cause of the light stains, as well as insignificant peaks of cotunnite (PbCl_2).

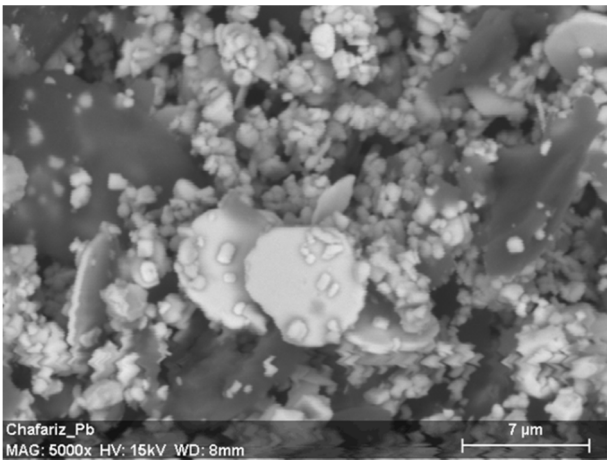
Figure 9 shows the SEM image zoom of staining area of the analyzed samples. The SEM-EDX results identified peaks of chlorine (Cl), potassium (K), carbon (C), sulfur (S), calcium (Ca), oxygen (O), iron (Fe), sodium (Na), magnesium (Mg), silicon (Si), and lead (Pb). Quantitative analysis indicated about 65% of Pb. In order to verify the possible elements related to Pb in the light staining area analyzed, elemental mapping of Pb, S, C and Si were performed as verified in Figure 10.

Figure 9. SEM image zoom of the staining area.

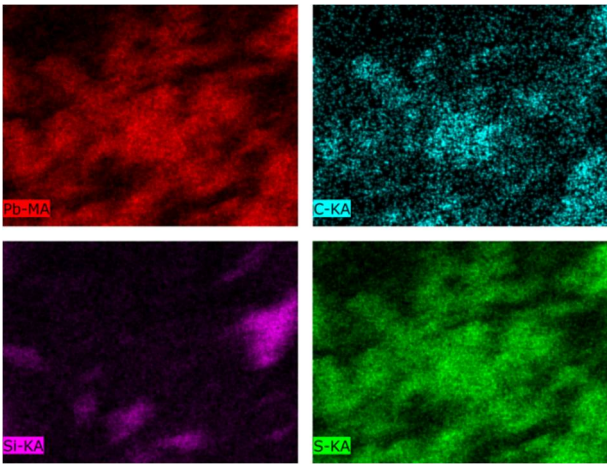
Figure 10. Elemental mapping of Pb, C, Si, and S individually.

Such results suggest that sulfur is the main element associated to lead. It is also possible to observe association between Pb and C, but occurring to a lesser extent when compared to S.

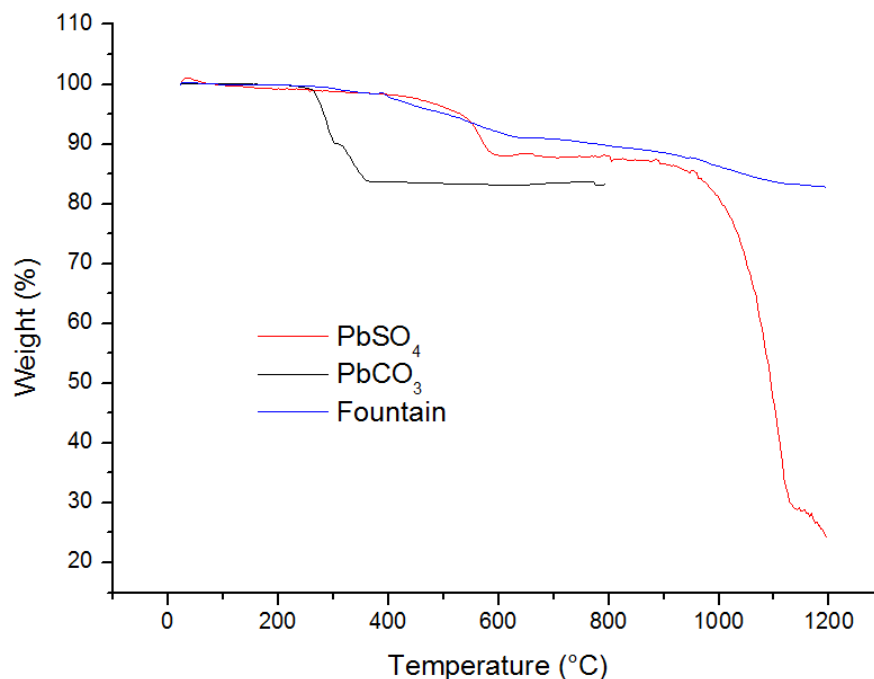
The results of ATG (Figure 11) indicated that the sample concerning change in the fountain is related to PbSO_4 formation since the thermal degradation curve is similar to this pure salt. Thus, it was believed that the sulfur pollution emanating from the vehicles was deposited on the surface of

the fountain and that this element was associated with the lead used as a grout, forming the stable salt of lead sulphate.

Figure 11: Thermal degradation curve showing the losses in each step with a rate of 10°C/min.
