**Failure Analysis of fractured Fixing Bolts of a Mobile Elevating Work Platform
using Finite Element Methods**

Keywords: Fatigue Analysis, Finite Element Analysis(FEA), Mobile Elevating Work Platforms(MEWPs), Fixing bolt

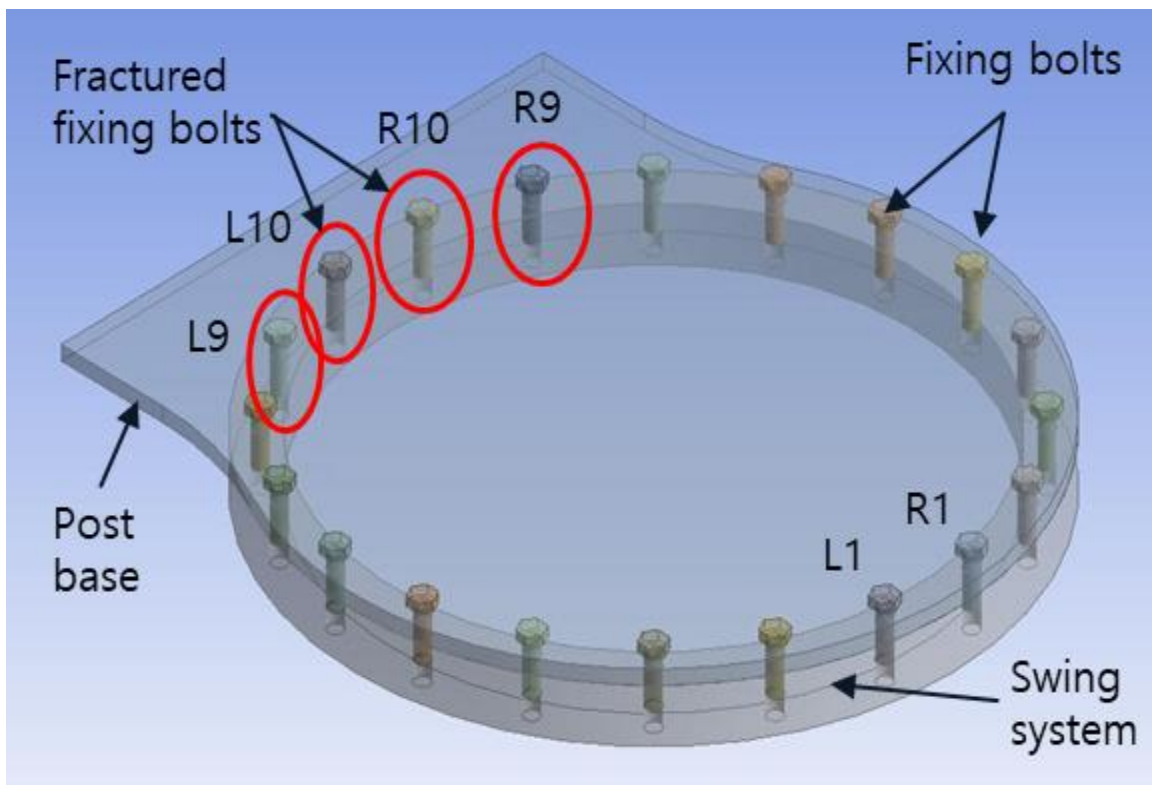
Out of these 20 bolts, 4 bolts were fractured [Fig. 2]. According to the information from the customer, this MEWP failed after 40 months of service [Fig. 3]. Notably, none of the four fractured bolts were accessible, and only one bolt (R10), which received the most loading, was studied.

Fig. 2. The set of 20 turntable fixing bolts and 4 fractured bolts

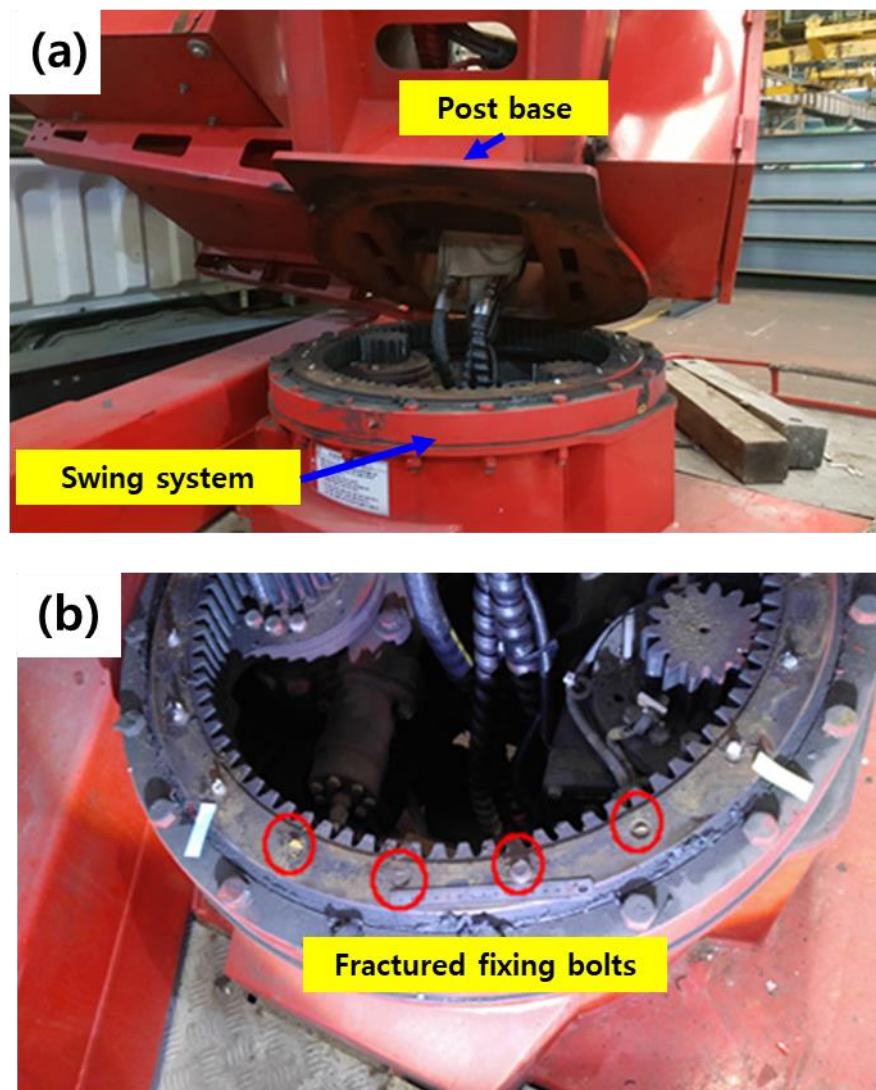
Fig. 3. Failure scene of the fractured turntable fixing bolts: (a) turntable and boom after the accident and (b) fractured fixing bolts

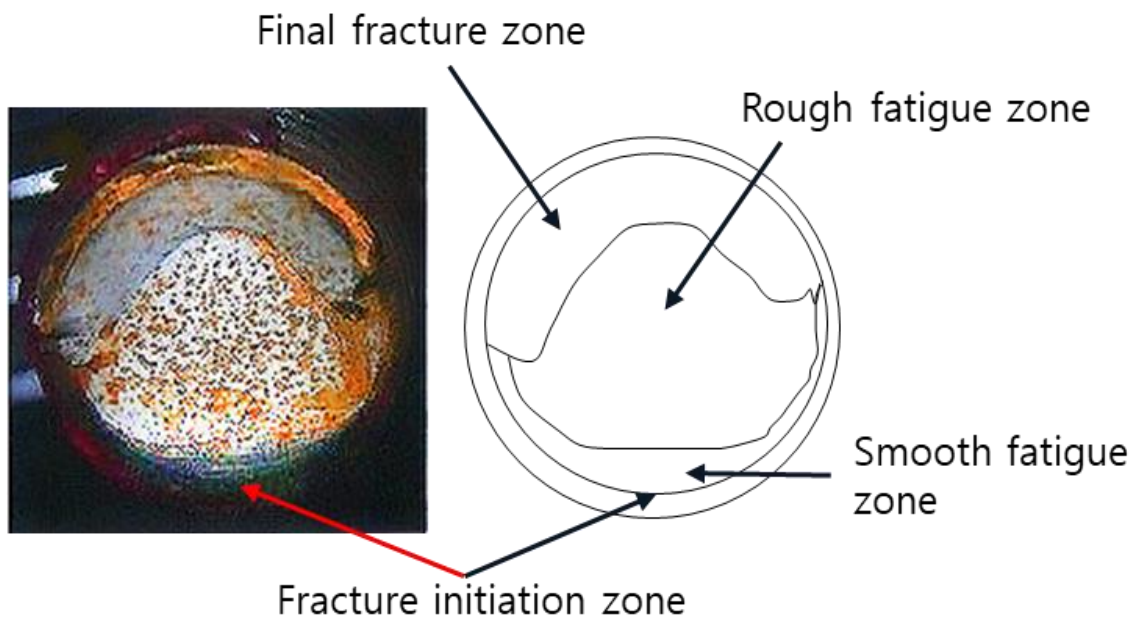
A visual inspection of the fractured section of the fixing bolt (R10) in the turntable revealed characteristics of a fracture at the bolt thread near the contact part of the post base and swing system. The fatigue crack appears to have propagated to the center of the bolt starting from the thread, revealing three typical characteristics of fatigue failure—a smooth fatigue zone, rough fatigue zone, and overload or final fracture zone at the fracture plane [5-7]. A schematic of the fractured fixing bolt with specific zones is illustrated in Fig. 4.

Fig. 4. Macrograph and schematic of fracture surface of one of the fixing bolts (R10)

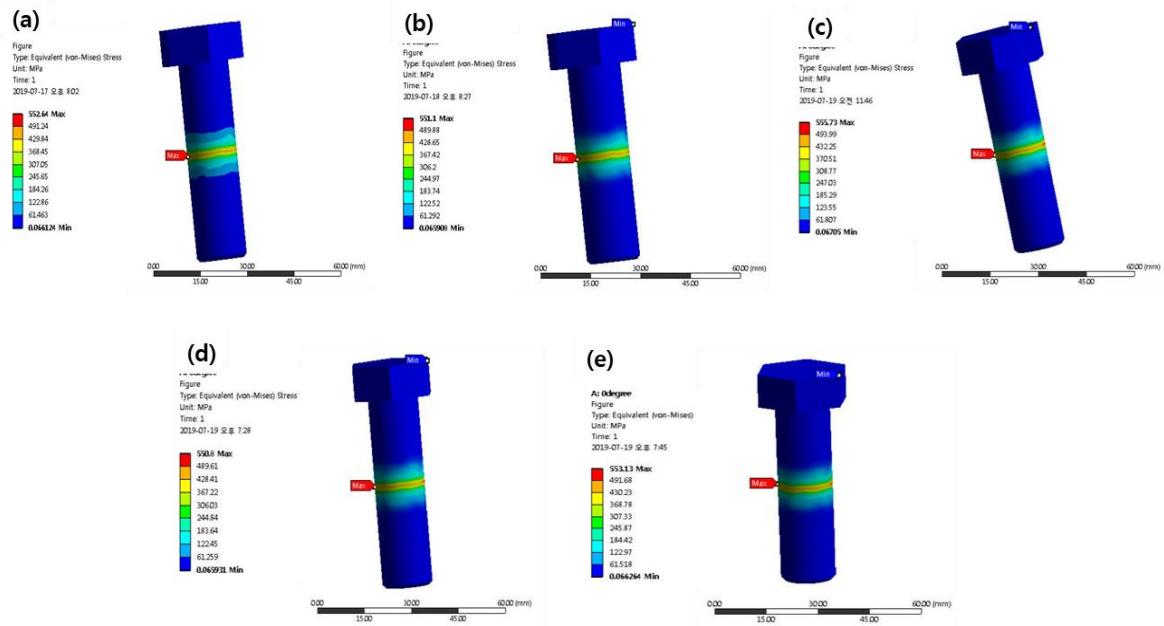
The maximum von-Mises equivalent stress acting on the fixing bolt (R10) was obtained by increasing the boom angle from 0° to 80° by 20° intervals according to the maximum work radius of MEWP. The results of the structural analysis are shown in Fig. 8. The maximum von-Mises equivalent stress is between 550.8 MPa and 553.35 MPa. These values are less than the

yield strength of fixing bolt, 1132 MPa, and the safety factor is 2.05, which is greater than the MEWP design safety factor of 1.48 [25], confirming that the fixing bolt was designed safely.

Fig. 8. Von Mises equivalent stress distribution on the fixing bolt according to boom angle from 0° to 80°: (a) 0°, (b) 20°, (c) 40°, (d) 60°, (e) 80°

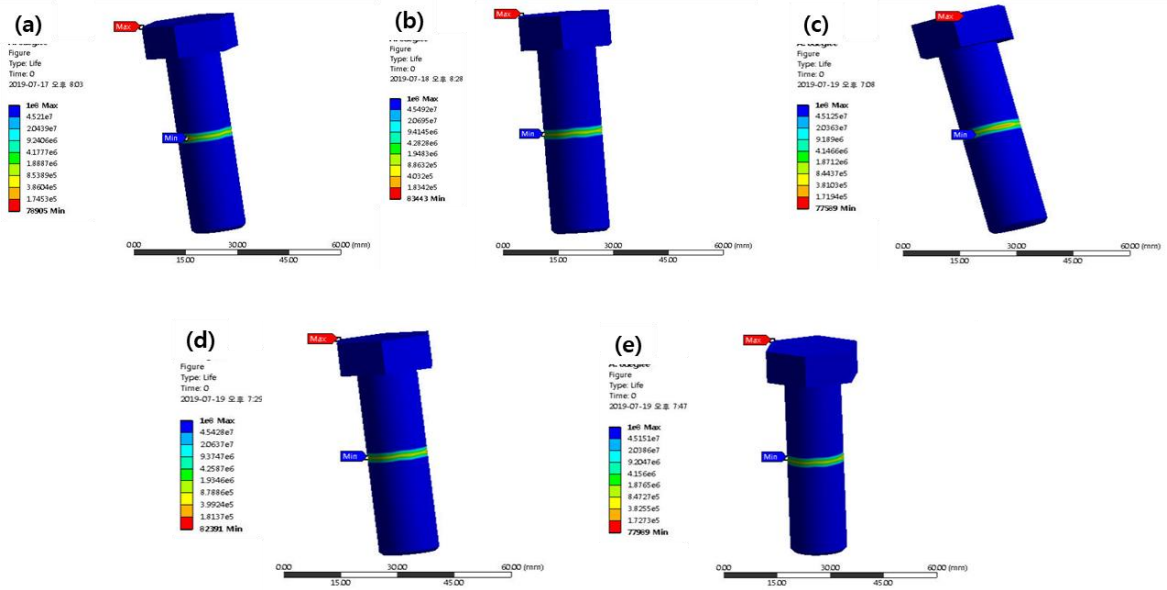
Fig. 9 represents the available life (number of cycles under constant loading conditions before the fixing bolt fails owing to fatigue) for the given fatigue analysis. As the figure shows, the minimum life (between 77,589 cycles and 83,443 cycles) has been determined for the zone with the maximum von-Mises equivalent stress of the fixing bolt.

Fig. 9. Fatigue life simulations of the fixing bolt according to boom angle from 0° to 80°: (a)

0°, (b) 20°, (c) 40°, (d) 60°, (e) 80°

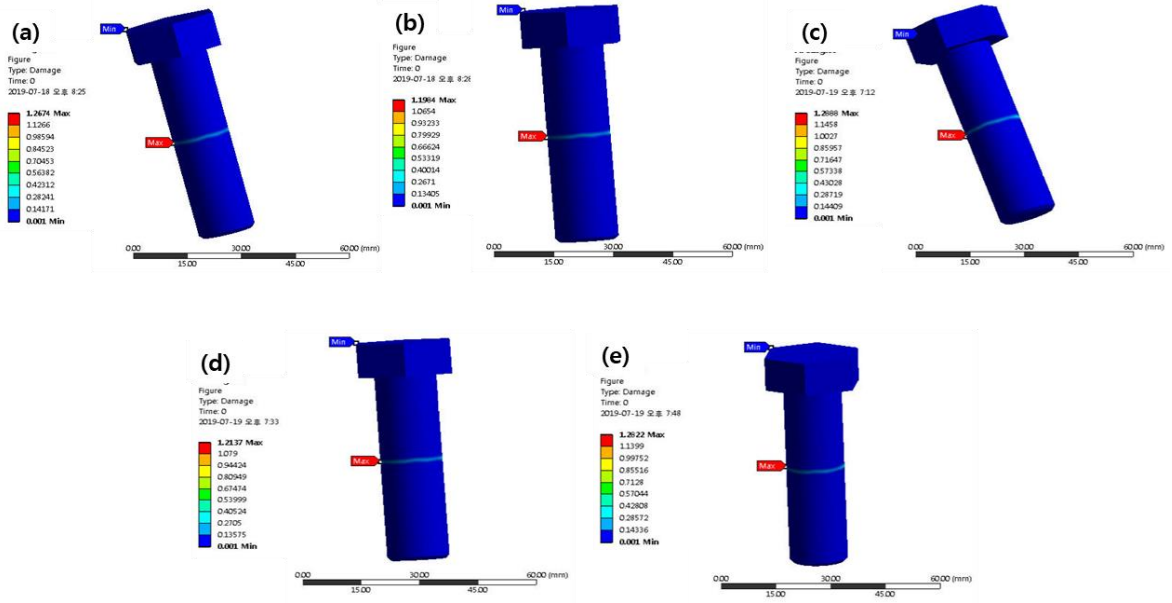
Fig. 10 indicates the fatigue damage, which is defined as the design life divided by the available life. As this figure shows, the maximum damage (between 1.19 and 1.29) occurs at the critical zones (a value greater than 1 indicates that the fixing bolt will fail from fatigue before the design life is reached).

Fig. 10. Fatigue damage contours of the fixing bolt according to boom angle from 0° to 80°:

(a) 0°, (b) 20°, (c) 40°, (d) 60°, (e) 80°

The results of the fatigue analysis show that the fixing bolt may be damaged by fatigue if MEWP is performed repeatedly for a long time. Therefore, we propose a method to prevent the failure of the fixing bolt of the MEWP from four different standpoints— the manufacturer, safety certification authority, safety inspection agency, and owner. The manufacturer should design not only a structural analysis but also a fatigue analysis, and the safety certification

authority should check the results of the fatigue analysis. In addition, the safety inspection agency should inspect the crack through non-destructive means, and the owners should replace the cracked fixing bolts and replace the entire fixing bolt set at regular intervals (e.g., 5 or 10 years).

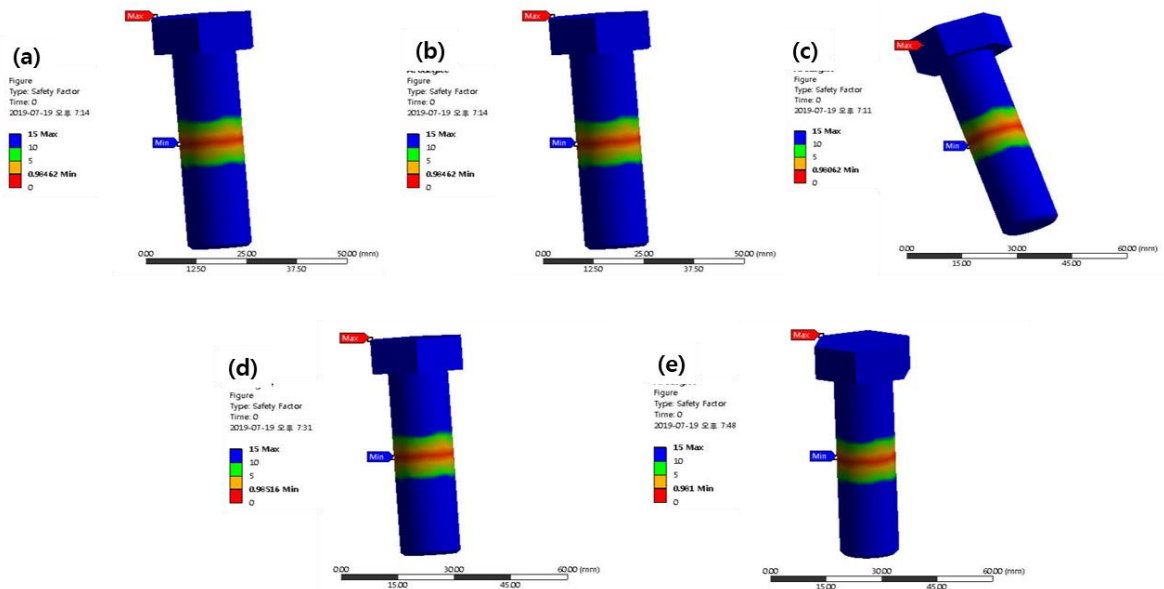
Fig. 11 represents the factor of safety (FS) with respect to fatigue failure at a given design life. This value is valid between the minimum safe zones (0) and maximum safe zones (15). As this figure shows, the minimum safety of the design (between 0.98 and 0.98516) designates the critical zones.

Fig. 11. Minimum safety areas on the fixing bolt according to boom angle from 0° to 80° :

(a) 0° , (b) 20° , (c) 40° , (d) 60° , (e) 80°
