# Maintenance Management in an Un-renovated Building

#### 4. Case study: a neo gothic palace

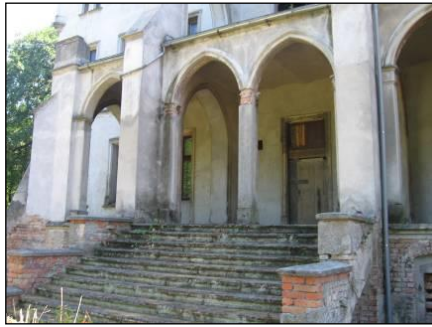
**Fig. 4.** Fragment of the northern elevation. Numerous damp stains on the terrace, destroyed steps, missing areas of plaster. Destroyed column caps.

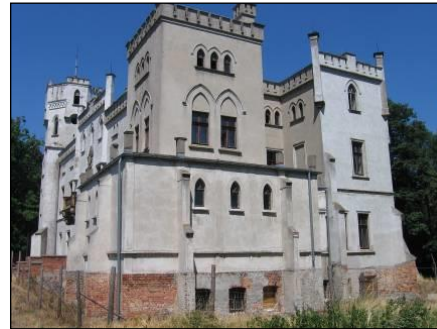
**Fig. 5.** Southern elevation. View from the south-western side. Walls covered by a cement-lime plaster applied in the 80s of the 20<sup>th</sup> century. Lack of balustrade on the tower terrace. Lack of plaster on the foundation plinth

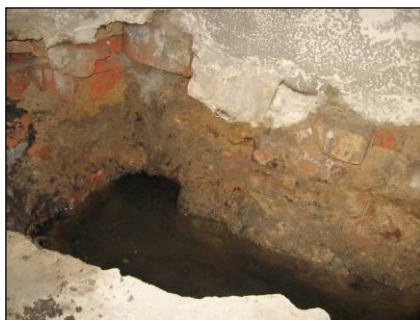
**Fig. 6.** Basement in the middle part of the building, fragment. Foundation uncover. High level of groundwater, severely damp wall

The walls of the basements are severely damp. From the outside, large amounts of efflorescence, including salt efflorescence, and discolorations are visible from the inside on the plasters. In the east part of the building, on the ground floor, the walls are severely damp due to water entering from the ground by capillary rise. The walls of the room under the terraces are damp from rainwater.

The bad technical condition of the roof structure indicates the necessity of immediate repairs of the framework. A new roof cover and thermal insulation of the roof ought to be carried out, replacing all flashing, gutters and downpipes. The foundation needs to be dried, equipping the building with drainage.

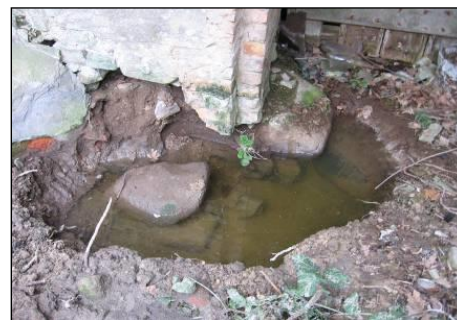
The foundation of the building are strip foundations of various dimensions with an offset of 15 cm, made from boulders on lime mortar with an addition of clay; the average diameter of the boulders is approx. 60-70 cm. The depth of the strip foundation is approximately 80-120 cm below the level of the basement floors. Uncovers of the foundations in the north-eastern and south-western part of the building were carried out. Severe damp of surfaces from the groundwater was determined. The soil in areas of the foundation uncovers is loamy sand. The level of groundwater is above the level of the foundation. There is a lack of vertical and horizontal damp insulation.

**Fig. 7.** Wall of northern elevation, fragment. Foundation uncover. Foundation from boulders. Visible groundwater table

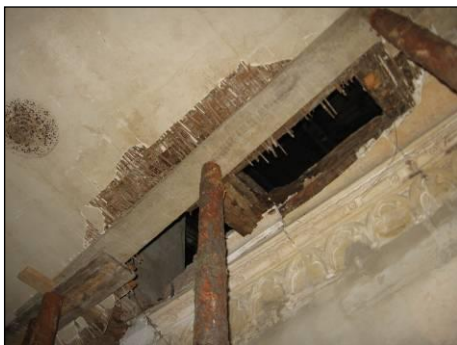
**Fig. 8.** Upstairs, fragment of ceiling above the room in the eastern part. Bad condition of the ceiling. Ceiling temporarily shored

The wooden ceilings over the ground floor and first floor do not fulfill the specified ultimate limit states of load-bearing capacity, and the immediate renovation of the ceilings in a manner that allows for preserving as much of the historic substance as possible in an unchanged form is recommended.

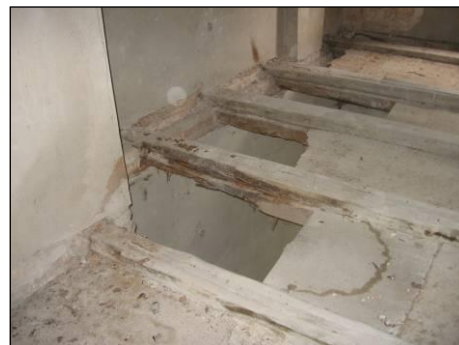
**Fig. 9.** Attic, fragment of the floor in the central part. Corroded ends of floor beams. Lack of flooring and ceiling
