Non-Destructive Test to Diagnosing Wear of Marine Gas Turbine Blades

In this paper, a non-destructive test to diagnose wear of blade's compressor of a gas turbine is reported. Gas turbine was operating in Campeche City, Mexico, in a very aggressive environment, where the entry of solid particles is unavoidable. The objective was to reduce cost of maintenance in this equipment. Analysis on a blade of gas turbine was performed, which was in operation on an offshore platform. Compressor blade was exposed to a severe damage by the impact of particles and environmental pollutants such as salts, sands and sulphurs.

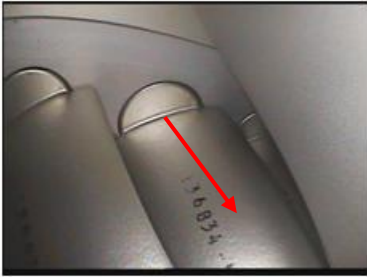
First stage of variable inlet guide vanes (IGV)	Erosion, corrosion, pitting and impact for foreign object damage (F.O.D.)
Inlet air A2

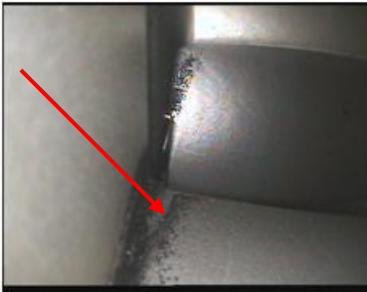
First stage of compressor's blades.	Defected surface, corrosion, pitting and impact for foreign object damage (F.O.D.)
Inlet air A3

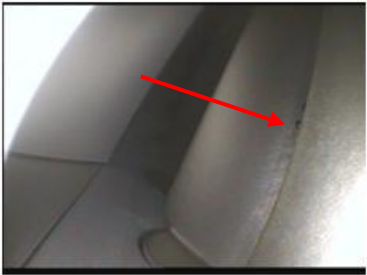
Second stage of variable inlet guide vanes (IGV)	Defected surface, corrosion, pitting and impact for foreign object damage (F.O.D.)
Inlet air A4		Second stage of compressor blades.	Several dent and wear in tip blade.

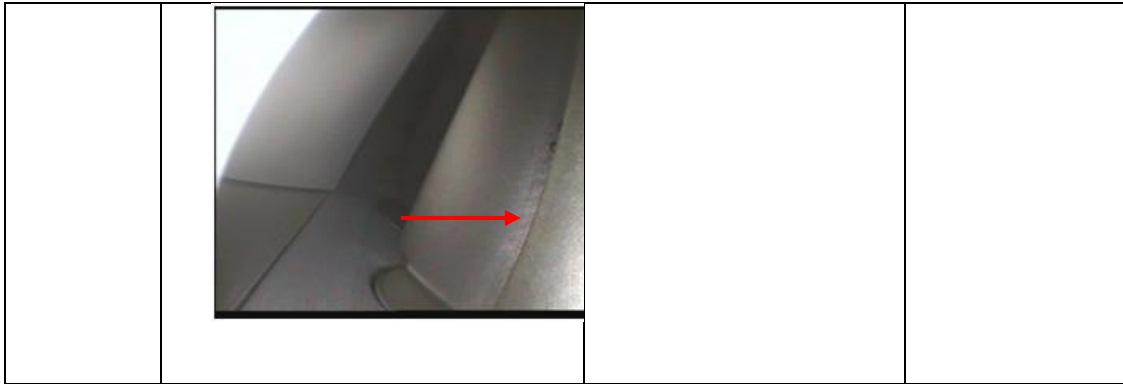
Figure (6). Borescope test of C40 gas turbine (24,000 hours).

In Borescope analysis, contamination in first stage of axial compressor was observed, it is a mixture of oil vapours that can prevent variable blades from opening or closing, which can lead to a low turbine performance and, even serious damage to turbines. The stage seventh of axial compressor has impregnated with dirt and debris, which is usually detergent and water used for washing of axial compressor's rotor (Figure 6), but this routine activity of maintenance is annual and technical engineer only carries out chemical analyses of water to detect metals in samples. In fact, his drag of solid particles by gas flow is another major problem during the operation of turbines. These foreign particles can either be deposited over turbine trail and blades (see Figure 1), causing wear and reducing efficiency of the turbine, or be launched at high velocities against blade surfaces, promoting formation of erosion pits in preferential areas, which can act as stress raisers [9–10].

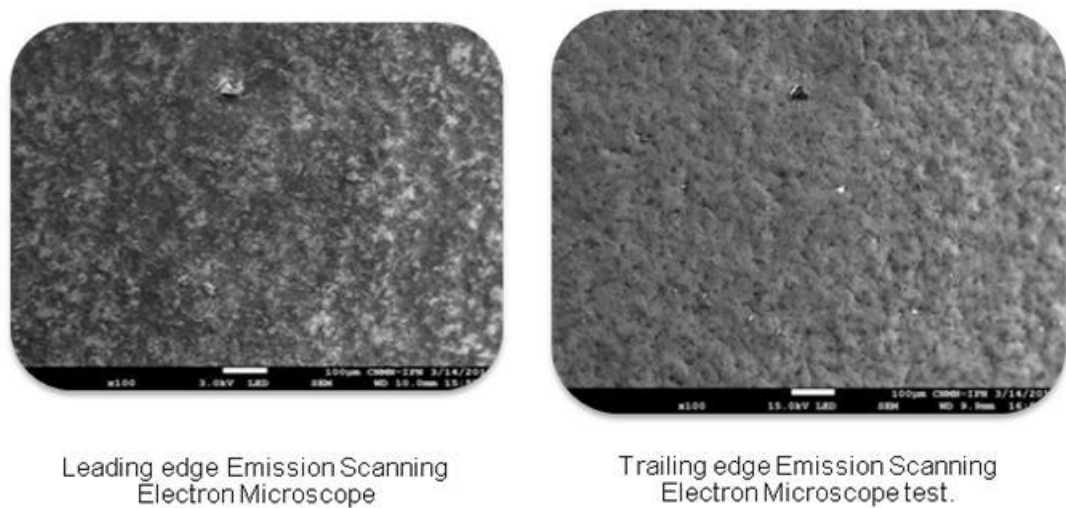
Figure (12). Worn region with 3KV and 15 KV (JEOL JSM-7600 SEM).

In worn regions with 3KV and 15 KV (Figure 12) showed different elements than those observed in worn surface. In zones 1 and 2 (Figure 13), new chemical elements appeared in EDS analysis such as carbon (C), oxygen (O), aluminium (Al), silicon (Si), niobium (Ni), molybdenum (Mo), chromium (Cr), iron (Fe), cobalt (Co) and nickel (Ni) and when applying 15 KV new chemical elements appeared in EDS analysis such as carbon (C), oxygen (O), aluminium (Al), silicon (Si), potassium (K), calcium (Ca), titanium (Ti) chromium (Cr), manganese (Mn), iron (Fe), cobalt (Co), nickel (Ni), Tungsten (W), niobium (Ni) and molybdenum (Mo), which could be due to introduced particles (contaminants) travelling in air intake or from hot corrosion (accelerated oxidation damage) due to corrosive deposits. There is evidence of aluminium,

chromium and iron oxides in this region [12–13].

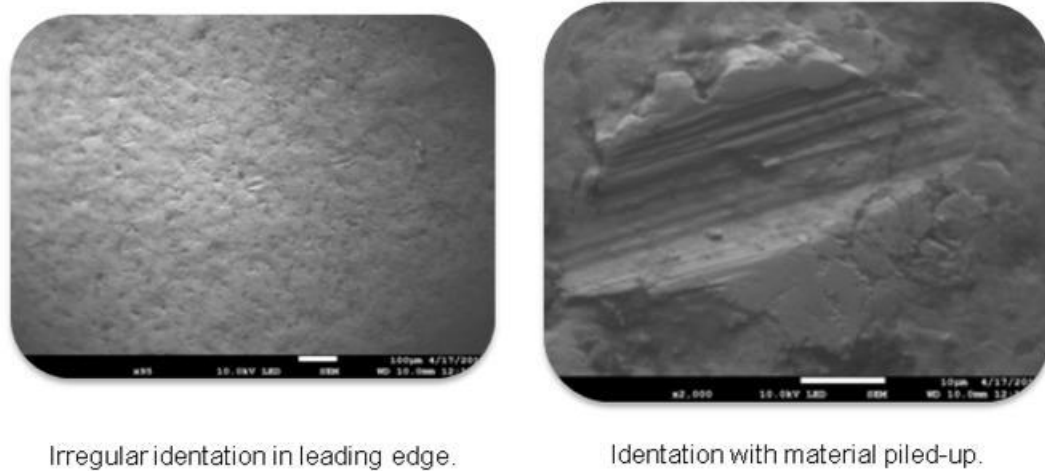
Fig. (14). Irregular indentation and material piled-up (trailing edge).

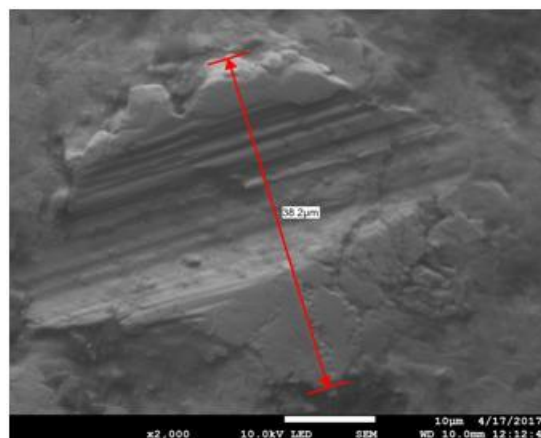
Figure (15). Cavity around 38.2 µm

Figure 16 in trailing edge, present irregular indentations were identified on surfaces around 176–268 µm length with material piled-up (lips) at sides and cavity around 38.2 µm (see Figure 15), the result of subsequent particle impacts, which caused detachment of lips with trajectory around 408–648 µm.

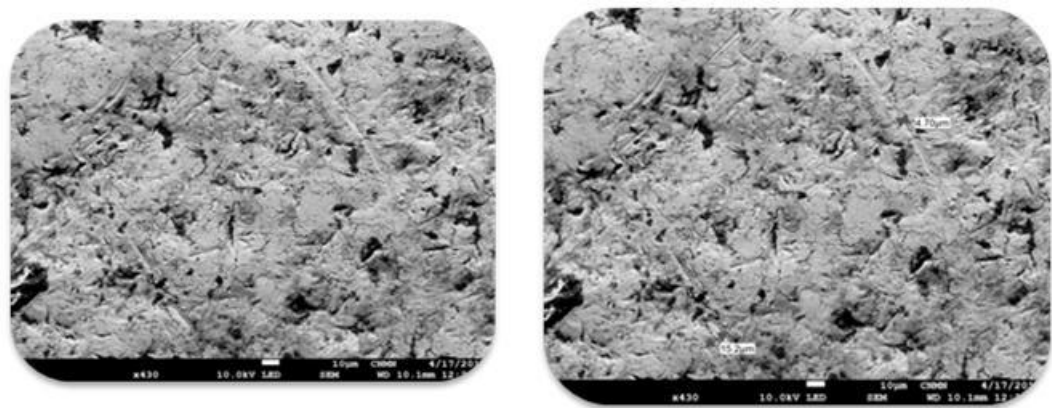
Large craters and grove (ploughing action) in trailing edge.

Ploughing action with material piled-up.

Figure (17). Craters, grove and piled-up material (leading edge).

Images in Figures 17 and 18 in leading edge, which are characterized by large craters and grooves (ploughing action) of around 125–150 μm length with material piled-up (lips) at sides around 4.7–15.2 μm length and in front of cavities, which is common in solid particle erosion, as specimens are impacted at oblique incident angles ($\alpha \leq 45^\circ$) [14].
