Analyses and the Cause of Corrosion and Materials Loss at the Base of a Three-Phase Separator in Petroleum-Based Processing

Abstract: The three-phase separator was perforated after four years' service. The perforation position is at the bottom of the vessel under the baffle plate in an oil transfer station. In order to find out the causes of corrosion and perforation of the vessel, it was investigated by chemical analysis using a direct-reading spectrometer, microstructure examined by optical microscope(OM), and lab simulated corrosion experiments by electrochemical workstation, and the corrosion products examined with scanning electron microscopy(SEM), energy dispersive spectrometer(EDS) in this paper. The analyses indicated that the coating at the base of the pressure vessel failed and this led to the direct exposure of the carbon steel plate to the corrosive medium. The reason for the corrosion and perforation is that base material in the concealed place of the vessel contacts with the medium directly and corrodes due to coating failure. If the vessel carbon steel connects with the baffle plate stainless steel to form a hetero-metallic couple in the corrosive medium, the vessel

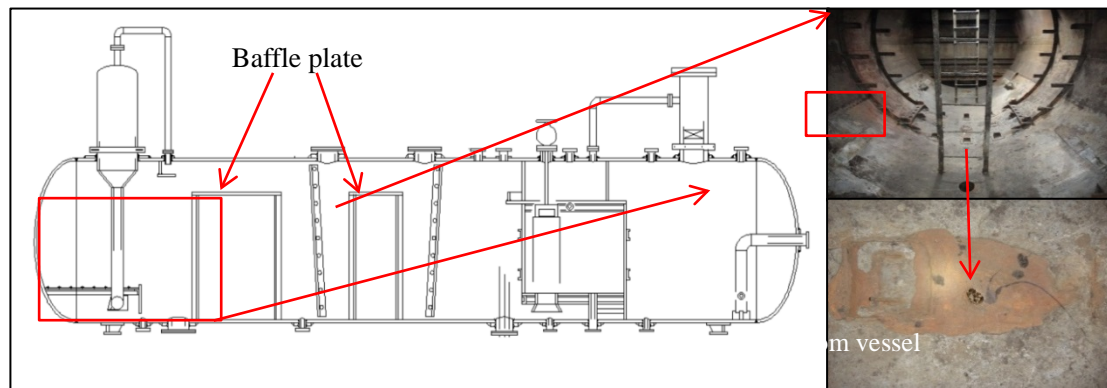
Figure 1. The perforating position of three-phase separator.

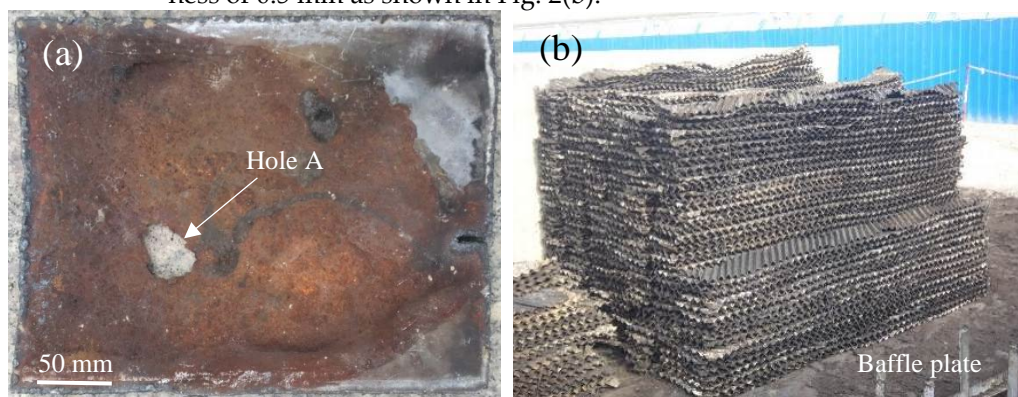
The plate of the vessel is made of Q245R carbon steel with a thickness of 12 mm. Samples were taken from the etched and perforated bottom plate of the vessel as shown in Fig. 2(a), marked as hole A. The baffle plates made by 316L stainless steel with a thickness of 0.5 mm as shown in Fig. 2(b).

Figure 2. Failure samples of three-phase separator. (a) The perforated bottom plate of the vessel; (b) The 316L stainless steel baffle plates.

During the four years of service, the sacrificial anode of the three-phase separator was replaced twice in the process of maintenance, and the perforation occurred at the bottom of the vessel under the baffle plate, which is a hidden place and not easy to find. The enormous consumption of sacrificial anode indicates that the coating has fallen off or the inner wall of the vessel has been directly contacted with the medium. When the sacrificial anode is exhausted, the vessel inner wall which protected by the sacrificial anode will be failed. Combining with the above test results, it is shown that serious corrosion will occur on the inner plate of the vessel when the substrate contacts with the medium directly, the Q245R carbon steel and baffle plate 316L stainless steel coupled form galvanic corrosion[22-24], the corrosion will accelerate significantly.

It is suggested to strengthen the inspection of corrosion risk in hidden parts of containers in the process of reconditioning, without leaving dead corners, especially for vessels with obvious consumption of sacrificial anodes. Perfect insulation measures between the baffle plate and support to prevent direct contact of dissimilar metals and galvanic corrosion.

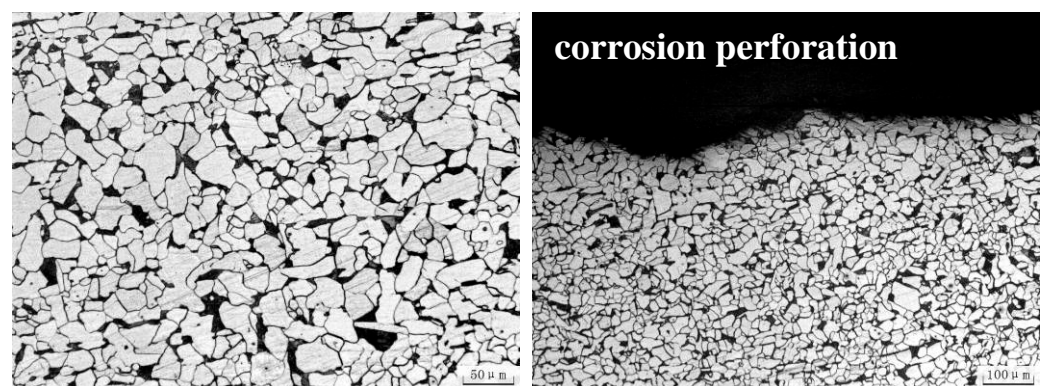
The metallurgical structure of the perforated vessel bottom plate sample is Ferrite+Pearlite (F+P) with a grain size of 8.0 and no abnormal structure was found around the corrosion perforation area, as shown in Fig. 4. The grain size is a kind of characterization of the metallurgical, the larger the grain size, the smaller the crystal shape, the better the strength, toughness and plasticity.

Figure 4. (a) Metallographic structure of the base material; (b) Metallographic structure around the corrosion perforation.

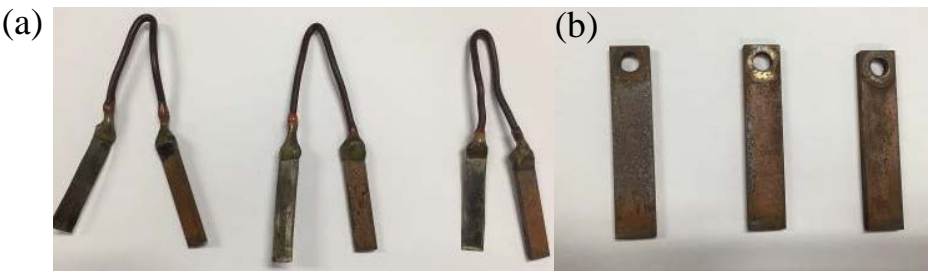
The corrosion rate results are shown in Table 5. The average corrosion rate of carbon steel is 0.5347 mm/a which connected with stainless steel, and that of carbon steel samples without connection with stainless steel is 0.3744 mm/a. The macroscopic morphology of the specimens before film removal is shown in Fig. 5, and the macroscopic morphology

after film removal is shown in Fig. 6. According to the corrosion degree specified in NACE RP-0775-2005[21], the test results are classified as severe corrosion ($>0.25\text{mm/a}$).

Figure 5. The macroscopic morphology of the sample before film removal (a) Carbon steel connected to the stainless steel; (b) Carbon steel.

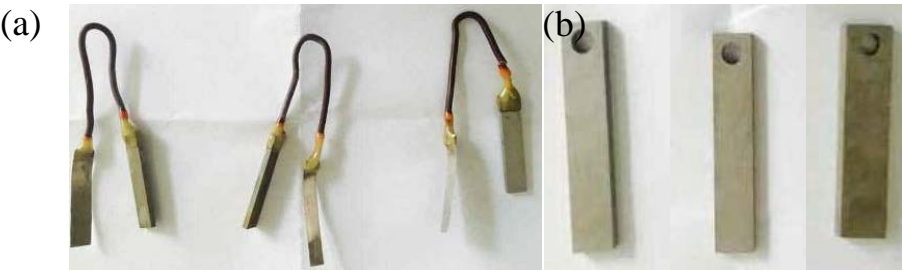
Figure 6. The macroscopic morphology of the sample after film removal (a) Carbon steel connected to the stainless steel; (b) Carbon steel.

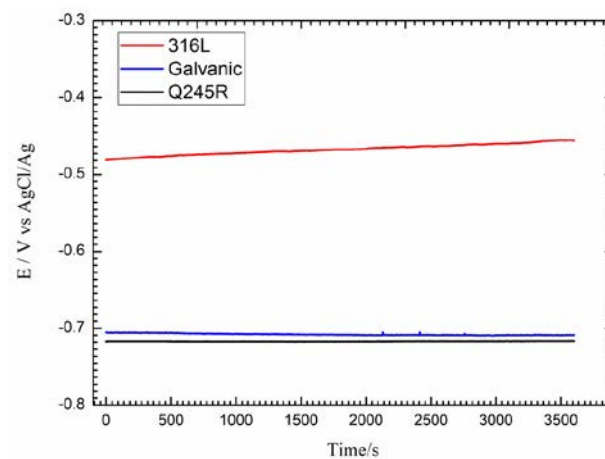
The OCP curve of different materials over time is shown in Fig. 7. It can be observed that the OCP of Q245R carbon steel alone is about -0.717 V vs AgCl/Ag, and that of 316L stainless steel alone is about -0.45 V vs AgCl/Ag. The coupling potential (CP) of Q245R carbon steel and 316L stainless steel is -0.706 V vs AgCl/Ag.

Figure 7. Curves of OCP of different materials with time.

The OCP of Q245R carbon steel is negative 240 mV compared with that of 316L stainless steel as shown in Fig. 7, and the corrosion potential of Q245R carbon steel is also significantly lower than that of 316L stainless steel as shown in Fig. 7. Therefore, when they are coupled, the Q245R carbon steel is the anode, the positive potential shift, the anode reaction rate increases, the cathode reaction is inhibited. 316L stainless steel is the cathode, the negative potential shift, the cathode reaction rate increases, the anode reaction is inhibited. On the other hand, the corrosion current of Q245R carbon steel is $1.48 \times 10^{-4} \text{ A/cm}^2$, much greater than the corrosion current of 316L stainless steel. Therefore, the coupling potential of Q245R carbon steel and 316L stainless steel is only slightly positive than that of Q245R carbon steel. However, according to the polarization curve, the current of Q245R carbon steel increases rapidly with the positive shift of the potential, so the coupling current will greatly increase, the anode of Q245R carbon steel is significantly promoted, that is, the corrosion accelerates.

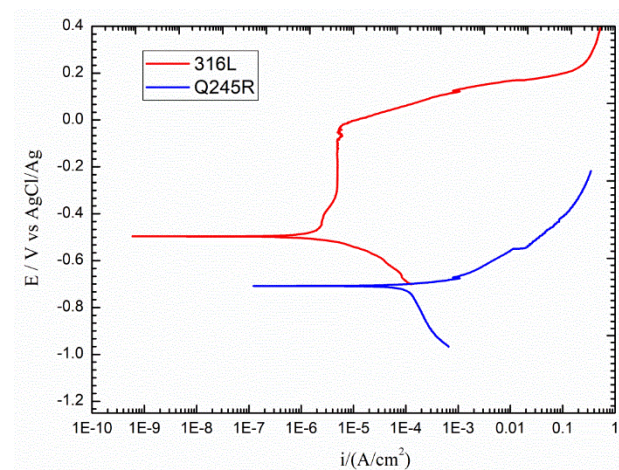
Fig. 8 shows the dynamic potential polarization curves of Q245R carbon steel and 316L stainless steel. The corrosion of Q245R carbon steel is active dissolution, and the corrosion potential is -0.7661 V vs AgCl/Ag, the corrosion current is $1.48\times10^{-4}\text{ A/cm}^2$. The current of anodic polarization curve increases rapidly with a positive shift of potential. The 316L stainless steel is passivated, and the passivation current density is about $5\times10^{-6}\text{ A/cm}^2$, the pitting potential is about 0.1 V vs AgCl/Ag.

Figure 8. The dynamic potential polarization curve in the simulated liquid.

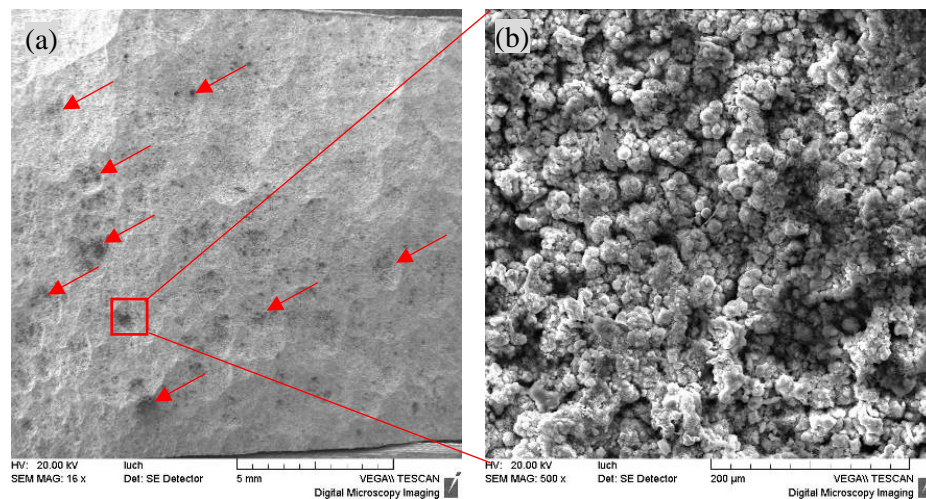
The SEM image of the sample near the perforated hole A in Fig. 2 as shown in Fig. 9(a). The surface is relatively concave and convex with a lot of pitting pits. The pits local magnification is showed in Fig. 9(b), indicating that corrosion products are loose.

Figure 9. (a) SEM image near the perforated hole A; (b) Corrosion products in the pitting pits.

The SEM analysis of the failed vessel showed that near the perforation site surface is relatively concave and convex with a lot of pitting pits as shown in Fig. 9(a,) and there were abundant loose corrosion products on the surface as shown in Fig. 9(b), which indicated that serious pitting corrosion occurred in and around the perforation site of the vessel. Other micro corrosion perforations were found besides the hole A in Fig. 2, one of those SEM image as shown in Fig. 10(a), the micro corrosion perforation is elliptic, with a diameter of 1.7 mm. EDS analysis result of the hole as shown in Fig. 11, the closer to the micro corrosion perforation, the higher the chloride and sulfur content. Therefore, indicating that the chloride ion and sulfur plays a key role in the formation of pitting pits, eventually leading to corrosion perforation.

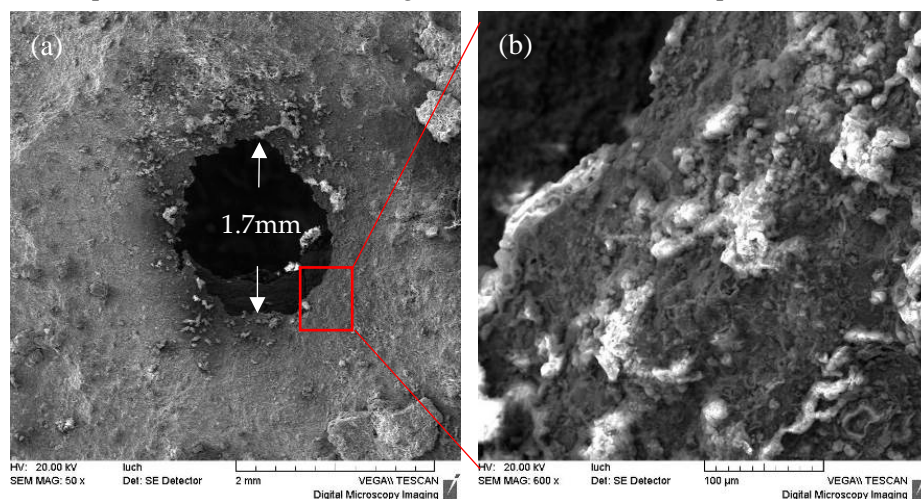
Other micro corrosion perforations were found besides the hole A in Fig. 2, one of those SEM image as shown in Fig. 10(a), the micro corrosion perforation is elliptic, with a diameter of 1.7 mm. The microstructure of corrosion products near the micro corrosion perforation as shown in Fig. 10(b), and the corrosion products are abundant.

Figure 10. (a) SEM image of the micro corrosion perforation; (b) The microstructure of corrosion products near the micro corrosion perforation.

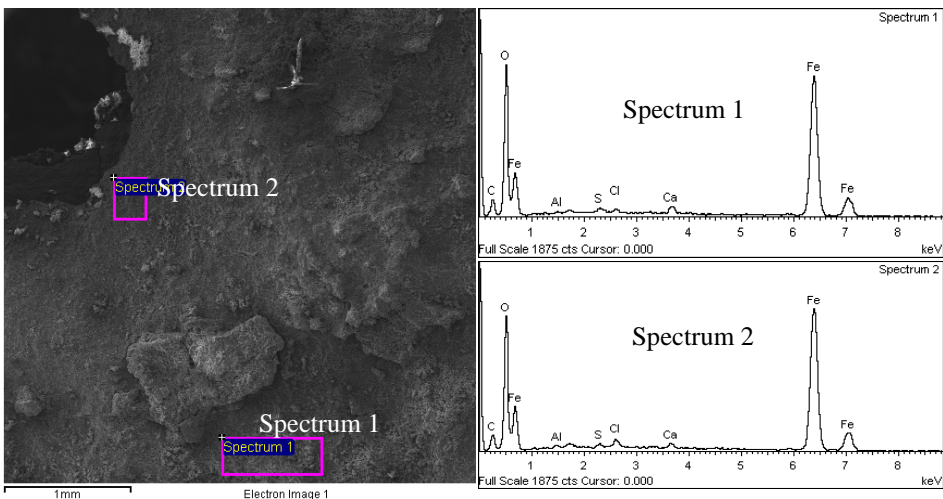
EDS was performed to analyze the distal and proximal ends of the micro corrosion perforation in Fig. 10(a). The specific inspection locations are showed in Fig. 11, and the detection results are presented in Table 6. According to the test results, the Cl and S element content of Spectrum 2 were higher than Spectrum 1, indicating that the chloride ion and Sulfur plays an important role in the formation of corrosion perforation.

Figure 11. EDS analysis of the corrosion perforation.
