Residential Building Damages Related to the Geological Bedrock Variations During M_{ww} 5.6 Earthquake in Cianjur, West Java, on November 21, 2022

Abstract

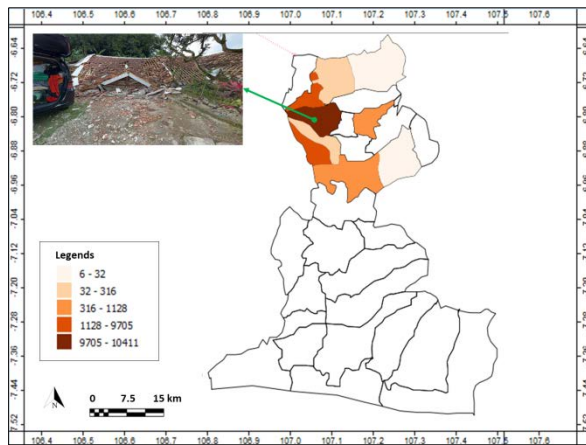
Figure 3 depicts the spatial distributions of damaged buildings based on current available data in subdistricts within Cianjur district, West Java, Java island, Indonesia. It is clear that the majority of damaged buildings were concentrated in the district's northern and western parts, which were cut off from the mountainous areas. A high concentration of damaged buildings with a range of 9,705–10,411 houses was also observed in the

northwest. This area was surrounded by areas that experienced quite high numbers of damaged buildings, ranging from 1,128 to 9,705 houses. The number of damaged buildings was decreasing in the east. Then, the north and west sides experienced more earthquakes in comparison to the south and east sides.

Fig 3 Damaged residential buildings in subdistricts within Cianjur district, West Java, Java island, Indonesia (Insert photo: damaged house).

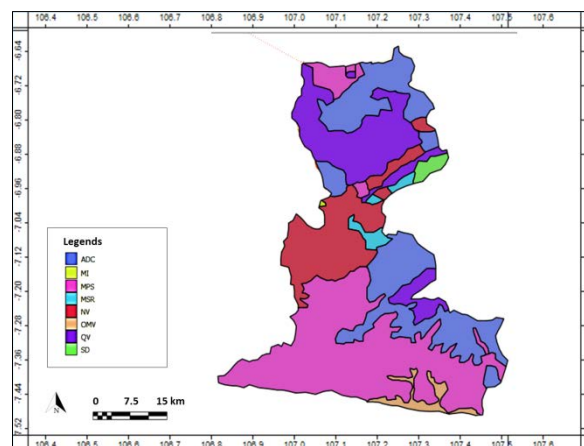
Fig 4 Geological bedrocks in subdistricts within Cianjur district, West Java, Java island, Indonesia (ADC: Andesitic Dacitic, MI: Miocene Intrusive, MPS: Miocene Pliocene Sediment, MSR: Miocene Sedimentary Rocks, NV: Neogene Volcanic, OMV: Oligo-Miocene Volcanic, QV: Quaternary Volcanic, SD: Superficial Deposits).

Geological bedrock in Cianjur, where the earthquake was present, varied (Figure 4). At least there were eight types of geological bedrock. The bedrocks in the north were different from the bedrocks in the central and southern parts. The northern parts, where the most damaged buildings were recorded, were dominated by quaternary volcanic bedrocks. This bedrock covers almost 7 subdistricts that have high numbers of damaged houses (Figure 5). The northern parts were bordered by Andesitic Dacitic bedrocks. In contrast, the central parts of Cianjur were dominated by Neogene volcanic bedrocks. Miocene-Pliocene sediments dominated the lowland southern parts of Cianjur. The results (Figure 6) confirm that majority of building damages account for 54.67% of the total building was associated with quaternary volcanic bedrocks. The second massive building damages were observed for Andesitic Dacitic volcanic rocks accounted for 32.07%.

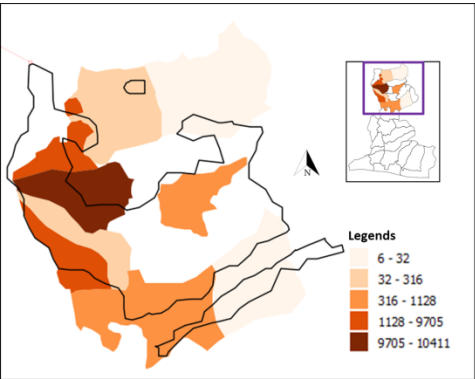
Fig 5 Overlaid of Quarternary Volcanic geological bedrocks with damaged houses in subdistricts within Cianjur district, West Java, Java island, Indonesia.

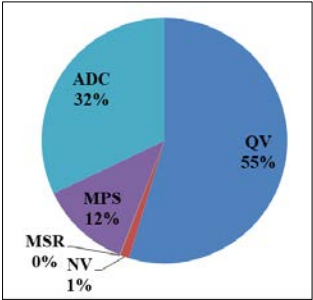
Fig 6 Compositions of damaged houses in every geological bedrocks (ADC: Andesitic Dacitic, MPS: Miocene Pliocene Sediment, MSR: Miocene Sedimentary Rocks, NV: Neogene Volcanic, QV: Quarternary Volcanic) in subdistricts within Cianjur district, West Java, Java island, Indonesia.
