Characteristics of Corrosion Products of Friction-type High-Strength Bolted Joints of Steel Bridge: A Case Study

Therefore, this paper first analyzed the main diseases of the FHSB connection nodes of the Dongying Shengli Yellow River Bridge, which has been in operation for 33 years. Then after selecting seven representative FHSB connection sub-samples and eight steel plate samples, the SEM, the EDS and the XRD were used to analyze the microscopic morphology and chemical composition of corrosion products on the sample surface. Finally this paper discussed the relationship between the corroded sample surface and environmental corrosion in order to provide reference for scientific anti-corrosion protection measures for the nodes in aging steel bridges in the future.

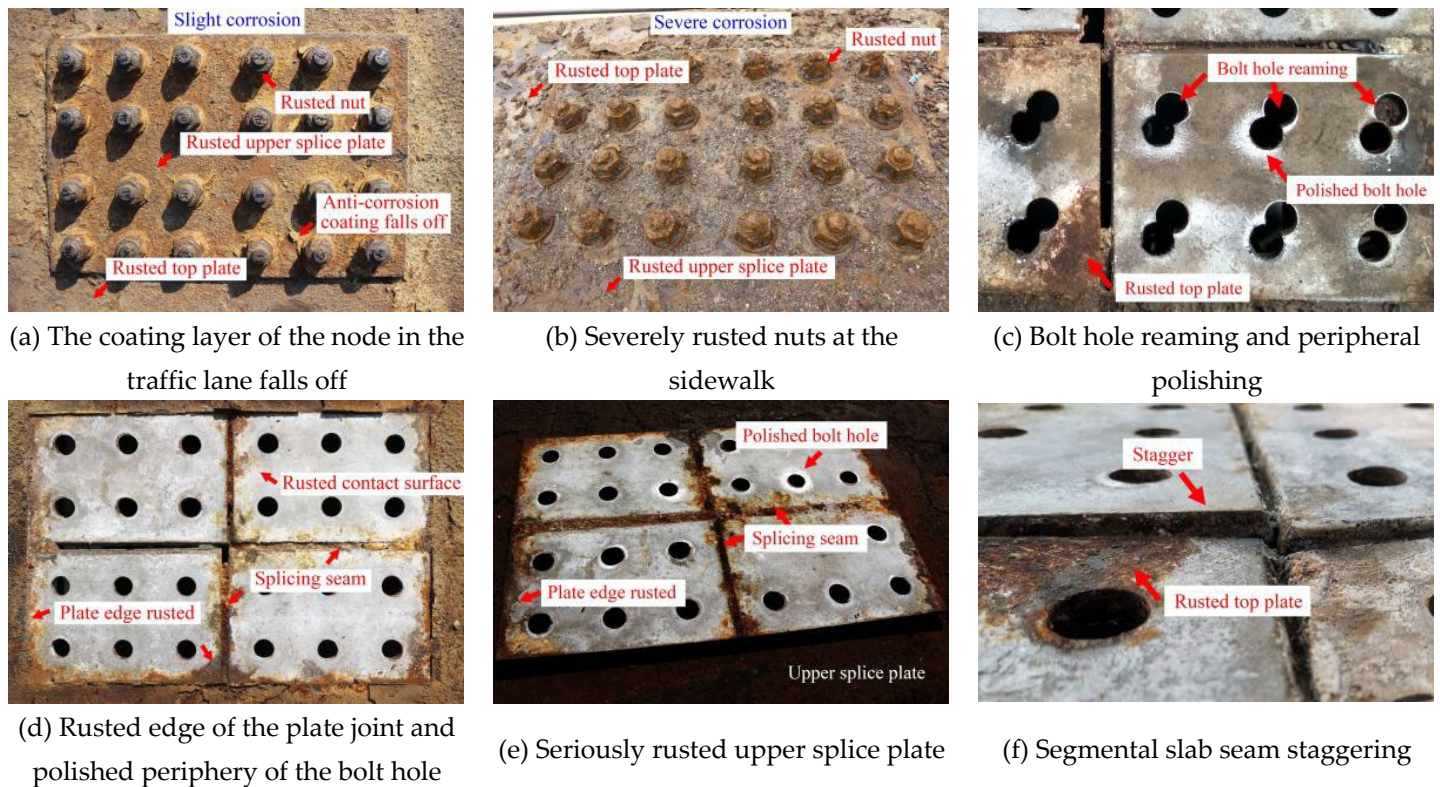
Figure 3 shows some typical diseases of the transverse joint FHSB connection node. Due to exposure of the top plate of the box girder at the lower-part sidewalk and cracking of the pavement, the nodes were corroded by rain and corrosive gas all year round, resulting in serious corrosion of the nodes, with some nuts losing up to 65% thickness. In addition, the longitudinal ribs of the top and bottom plates at the FHSB nodes of the transverse joints had open butt welds, and the rigidity of the bridge deck was seriously weakened, resulting in different polishing degrees among the joint connecting components. The main diseases of FHSB connection nodes of transverse joints included coating peeling, corrosion of connection components, and polishing of section plate joints and bolt holes. Investigation and analysis showed that the number of bolt holes not expanded according to the specifications accounted for 9.62% of the total. Some gusset plate bolt holes were polished around and the polished shape was generally a circle with different areas, with an average 11 mm diameter. The number of polished bolt holes accounted for 15.22% of the total. Construction quality problems, such as nonstandard hole expansion, staggered slab joints and contact surface pollution, led to poor tightness of FHSB connection joint contact surface and accelerated corrosion of joint contact surface.

Figure 3. Typical diseases of transverse joint FHSB connection nodes.

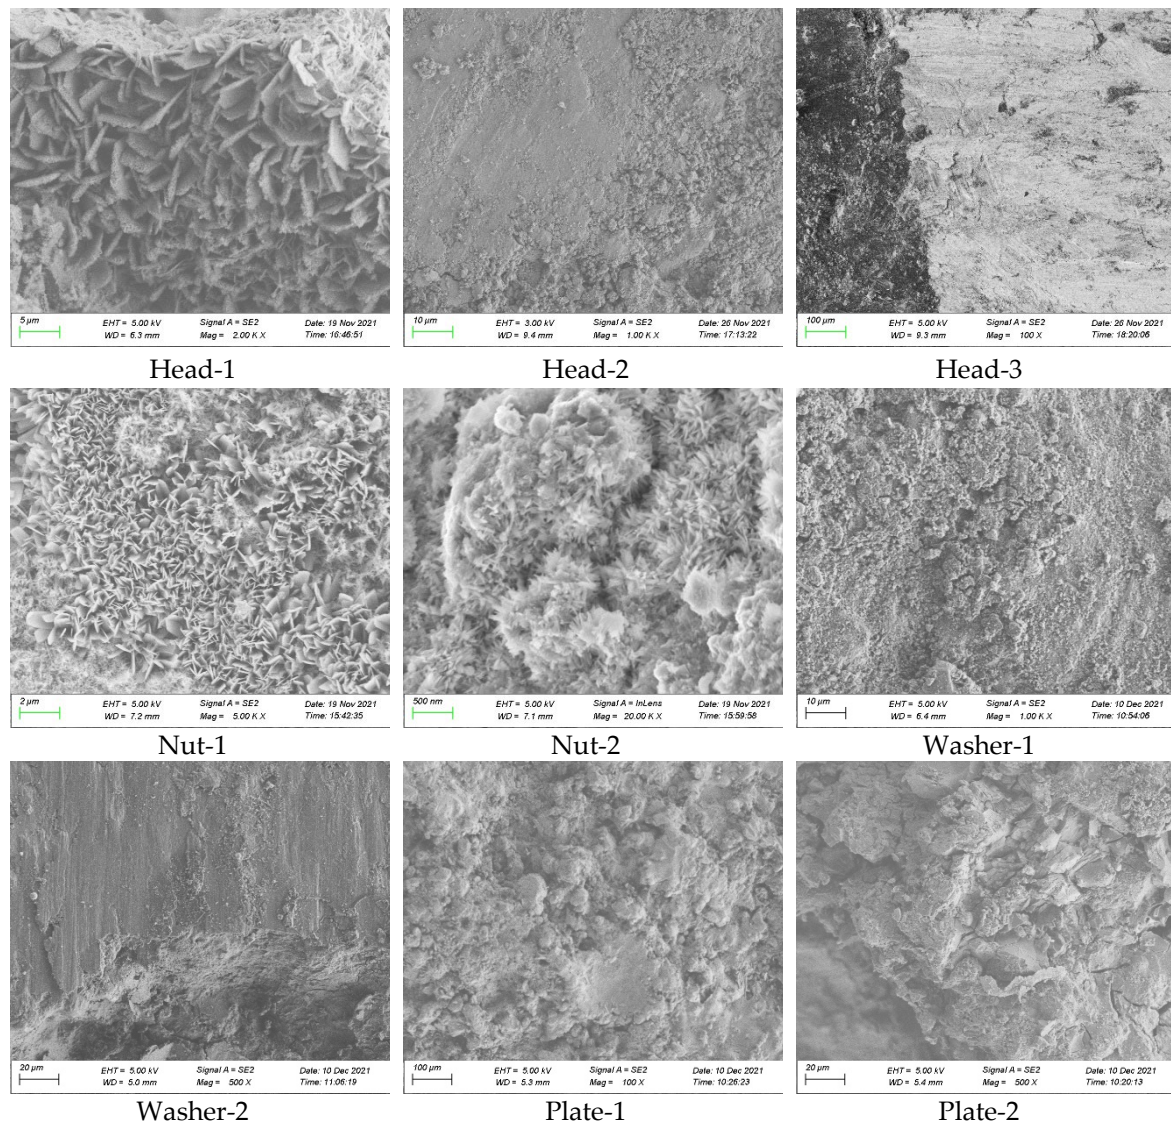
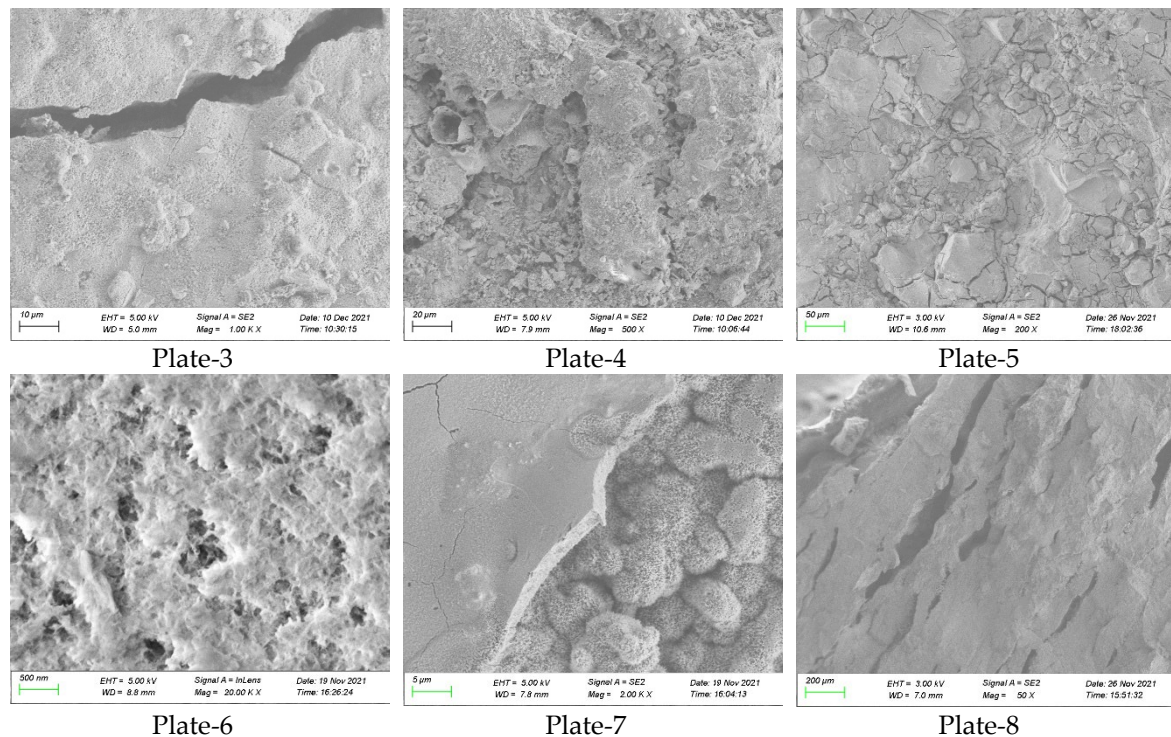
Figure 5 shows the microscopic morphology of the sample surface. The SEM analysis results showed that the corrosion products on the surface of the bolt head (Head-1) are mostly scaly and loose. The corrosion products on the surface of Head-2 were mostly clastic, with loose structure, smooth local area and obvious boundary. Head-3 had compact structure, smooth local area and obvious boundary. The corrosion products of Nut-1 and Nut-2 were mainly needle shaped, and were also scaly and spiky. The micromorphology of gasket surface was basically similar to that of Head-2 and Head-3. The surface of Plate-1 aluminum spraying layer was uneven and in dense granular shape and was not rusted by naked eye. The surface of Plate-2 and Plate-5 aluminum spray coating was slightly rusted and dark gray, and its corrosion products were layered and cracked. Plate-6 aluminum spraying layer was seriously rusted, smooth and porous, and had white powder and loose surface structure. After the aluminum coating on the contact surface was completely corroded and the steel plate substrate gradually rusted, the corrosion products of Plate-3 and Plate-4 were reddish brown, with most of them being massive and spherical with obvious cracks. The surface protective layer of Plate-7 and Plate-8 in contact with the atmosphere basically fell off, with cluster corrosion products on the surface of Plate-7, and dense massive corrosion products on the surface of Plate-8, but there were many cracks and obvious delamination.

Figure 5. Micromorphology of sample surface.

In general, the micro-morphology of the corrosion products on the surface of each sample in contact with the atmosphere was relatively rich, which may be related to the complex corrosive environment of the connecting nodes. Debris accumulation occurred near the polished area formed by the contact surface, because sample polishing was mainly caused by the fretting and sliding of the connecting nodes. With the increase of corrosion degree, the contact surface of the aluminum spray coating on the steel plate gradually changed from an uneven and dense state to a smooth porous powder state. After the steel plate substrate gradually rusted, the corrosion product was fluffy and cracked red rust. With the lack of oxygen in the plate seam, the rust gradually turned from red to brown, and the surface was bonded. Therefore, the uneven "biting" state of the aluminum sprayed steel plate contact surface constantly changed. It was deduced that the friction coefficient of the contact surface decreased first and then increased. In addition, the polishing around the bolt hole changed the roughness and bonding state of the uneven contact surface, and also reduced the friction coefficient of the contact surface.

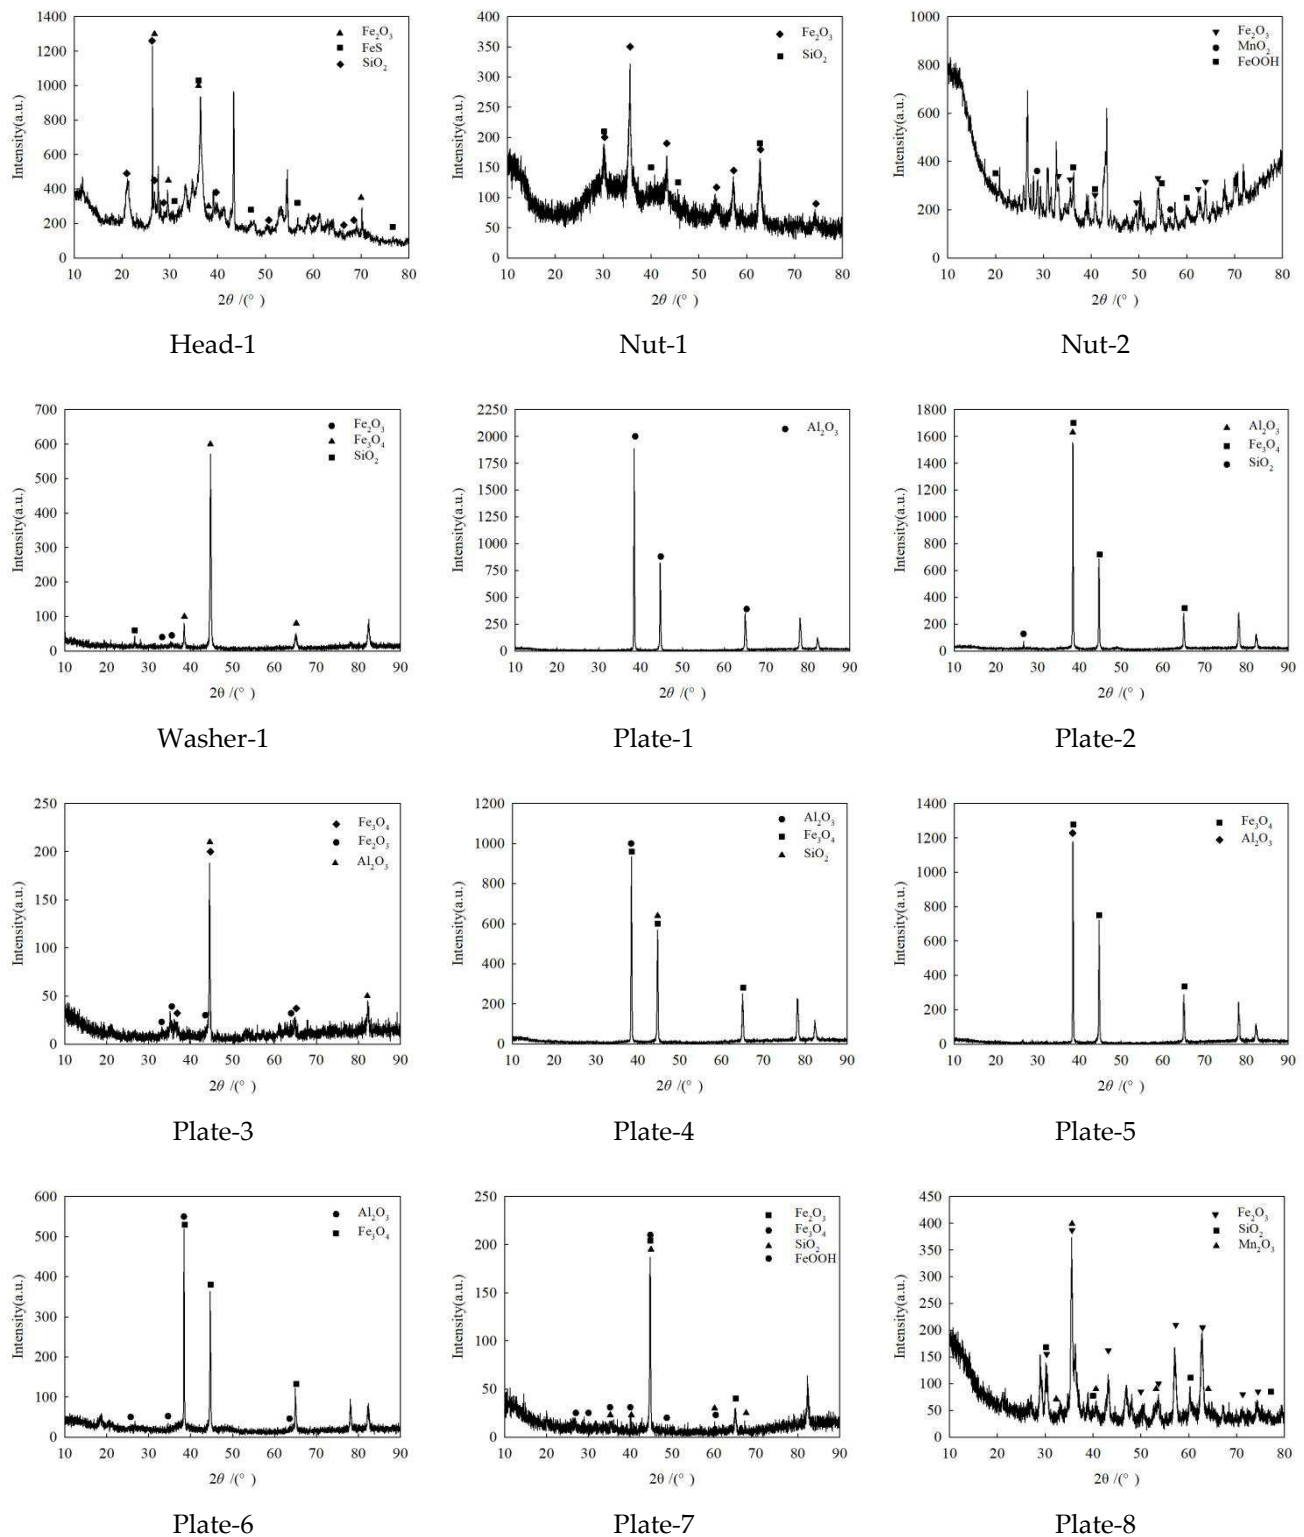
Figure 6 shows the XRD pattern of corrosion products on the sample surface. Analysis results showed that the corrosion products of bolt head, nut, gasket and outer surface of steel plate were mainly Fe and Si oxides. In addition, the corrosion products of Head-1 contained FeS, that of Nut-1 and Nut-2 contained MnO_2 and FeOOH , and that of Plate-7 and Plate-8 contained Mn_2O_3 and FeOOH . The corrosion products of steel plate contact surface samples were mainly Al and Fe oxides, most of which were Al_2O_3 , Fe_2O_3 and Fe_3O_4 .

Figure 6. The XRD pattern of sample.
