# Coating Condition Detection and Assessment on the Steel Girder of a Bridge through Hyperspectral Imaging

**Abstract:** The organic coating of bridge steel girders is subjected to physical scratches, corrosion, and aging in natural weathering. The breakdown of the coating may cause serviceability and safety problems if left unnoticed. A hyperspectral imaging method is proposed to detect the condition of steel coatings based on coating-responsive features in reflectance spectra. A field test was conducted on the real-world bridge which shows obvious signs of degradation. The hyperspectral signature enables an assessment of the coating health and defect severity. The results indicated that the coating scratch can be effectively located in the domain of a hyperspectral image and the scratch depth can be determined by mapping a scratch depth indicator ( $SDI=R532nm / R641nm$ ). Rust sources and products in steel girders can be identified by the unique spectral signatures and the rust stains (and thus stain areas) scattered on the coating can be pinpointed at pixel level by the corrosion rust indicators. The chemical integrity of a topcoat is demonstrated by the short-wave infrared sp

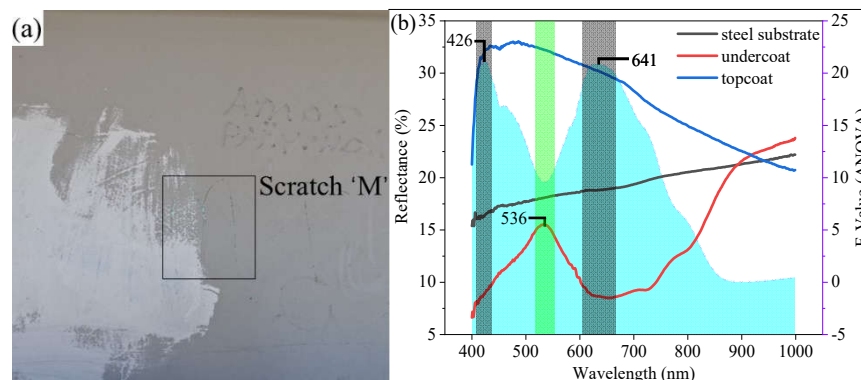
Figure 4a presents the view of the coating scratch on the bridge steel girder. It is observed that the scratch depth varies along the trace as the scratch even reaches the undercoat in some areas. The coating thickness is reduced though the color difference from the original view is not significant. In addition, it is not known whether the substrate steel is exposed due to scratches. Coating is used to protect the steel from corrosive media. Corrosion can initiate at a bare steel spot and the effect gradually propagates concentrically to the local, which progressively damages the health coatings. Figure 4b shows the comparison of the spectral signatures in the range of 400-1000 nm (visible and near-infrared, VNIR) from different objects, topcoat (pigmented alkyd), undercoat (epoxy), and girder steel, in the domain of scratches from the hyperspectral imaging. In view of hyperspectral imaging, those three objects are spectrally different especially for the topcoat and undercoat though both are organic polymers that are characterized by aromatic rings and side chains. As for the substrate, steel does not yield any absorption features in the range of VNIR because the steel is composed of metal ions which do not absorb photons in the current wavelength domain [29].

**Figure 4.** Coating scratch on the steel girder (a) original view, (b) spectral signatures of different coating layers and the corresponding F-values from ANOVA analysis of spectra.

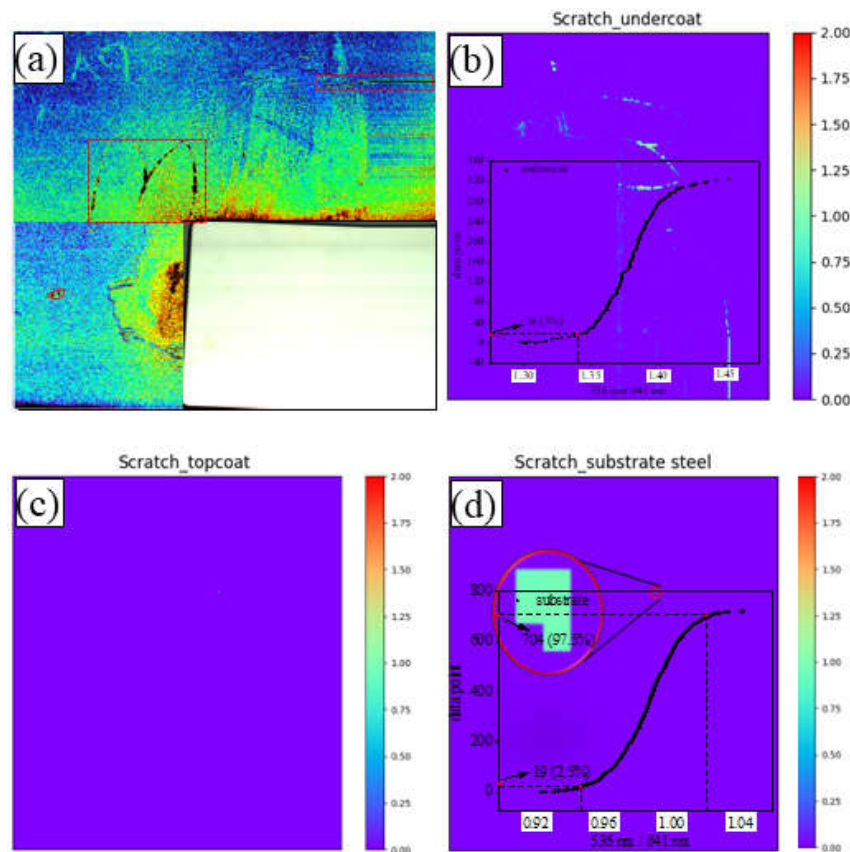
To differentiate different layers of coating, scratch depth indicator (SDI) is developed by the ratio between two bands, 536 nm and 641 nm. Figure 5b displays the F-value results derived from the One-way ANOVA analysis based on the spectra from the three objects. There are two local maxima at 426 nm and 641 nm and one local minimum at 536 nm. According to ANOVA F-value, spectra at wavelength 536 nm yield the least variation ( $p < 0.05$ ) in the range of 400-750 nm. For comparison, 426 nm and 641 nm are more sensitive to the differences between different coating layers because higher close F-values are observed, which is around 21 ( $p < 0.05$ ). To establish a robust indicator, 641 nm is selected as the most sensitive band in this study because 426 nm is located at the beginning of the spectrum which is usually subjected to severe mechanical noises [8]. Figure 5a demonstrates the mapping of SDI (536 nm/641 nm) in hyperspectral imaging. The scratch profile can be easily identified, and the exposed undercoat can be located by the black spots. In order to assess the scratch condition, different layers of the coating are retrieved from the mapping by thresholds to demonstrate the scratch depth. The corresponding SDI threshold for undercoat and steel is obtained from the distribution of the SDI values as illustrated in Figure 5b and Figure 5d. For undercoat epoxy, the critical SDI 1.33 isolates the exposed undercoat though some scattered misidentifications can be observed. Most of the misclassifications of the undercoat are located in the shades of the white reference board. This is because the shade can distort the spectra and thus produce incorrect information, which can be eliminated by the additional external light source in real practices [24]. It is noted that several pixels are distinguished from the undercoat in the heart of scratch 'M', which is the substrate steel. As hyperspectral imaging also enables a high spatial resolution of 0.56 mm in this study, the exposed steel can be spotted by the critical SDI of 0.95. There are in total 5 pixels that can be identified, which makes a 1.57 mm<sup>2</sup> exposure. It is worth noting that hyperspectral imaging can perform a much more accurate inspection by using spectral information compared to the RGB inspection.

**Figure 5.** Different layers of the girder coating with scratches (a) mapping of SDI (536 nm/641 nm) in hyperspectral imaging, (b) scratch of undercoat (SDI > 1.33), (c) scratch of substrate steel (0.95 < SDI < 1.02), (d) topcoat otherwise.

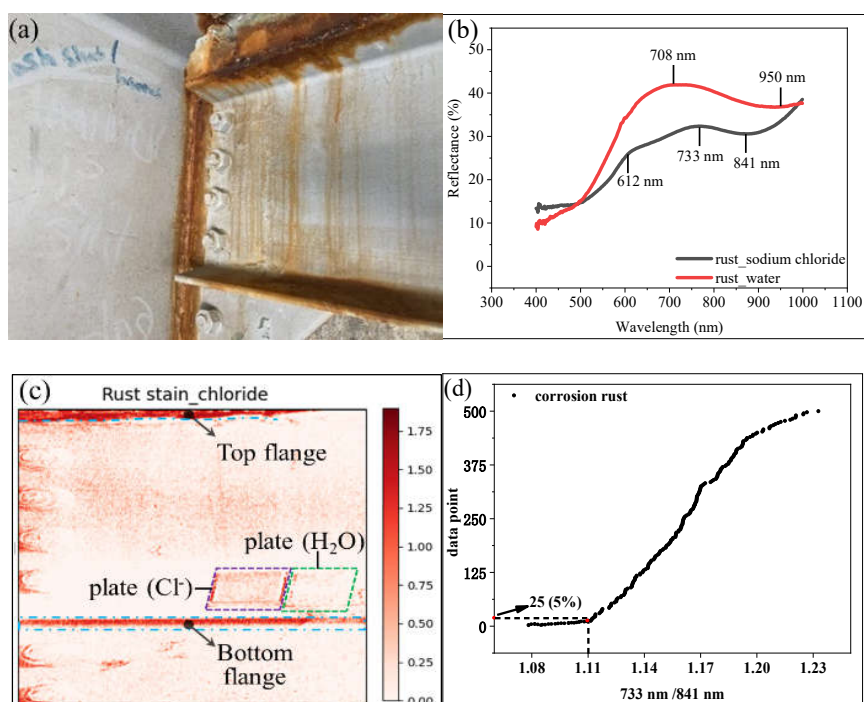
All figures and tables should be cited in the main text as Figure 1, Table 1, etc. Steel rust percentage has been used as an indicator to assess the coating conditions according to ASTM so as for timely remedies [28]. Figure 6 presents the coating surface with steel rust stains as well as the corroded steel girder top flange. Many corrosive media cause rust in the atmospheric environment and the corrosion products may vary. Acidic exposures are prone to produce  $\text{Fe}_3\text{O}_4$  (magnetite),  $\text{FeCl}_2$  (ferrous chloride), and  $\text{FeOOH}$  [30]. For chloride salt ions attack,  $\beta\text{-FeOOH}$  (akageneite) and  $\alpha\text{-FeOOH}$  (goethite) are the main corrosion products [30-31]. Two steel plates with the treatment of sodium chloride and water respectively are prepared and placed in the view of the scanning view. Figure 6b shows the spectral signatures in the VNIR range derived from corrosion spots on two plates. It is noted that the rust products with different exposures differ spectrally. Rust obtained from sodium chloride solution yields three absorption features at 612 nm, 733 nm, and 841 nm and water-based corrosion products have the features at 708 nm and 950 nm which is characterized by the water [8].

As chloride corrosion is more aggressive, it is worth emphasizing its corrosion effect before the pervasive attack on both substrate and organic coatings [14]. The chloride rust (CR) indicator, 733 nm / 841 nm, is constructed to demonstrate the corrosion products. Figure 6c demonstrates the mapping of CR in the domain of hyperspectral imaging with a threshold of 1.11. This critical CR is obtained from the stain pixels in the diaphragm with the same method as illustrated in SDI. The severely rusted steel flanges can be identified in CR mapping as indicated by the dark red areas. Moreover, the rust stain on the coating in the diaphragm is also detected by the CR though the CR values are smaller compared to the rust spots. It is because rust products intermingle with the topcoat in the domain of a pixel. The hyperspectral spectrum is representative of the overall composition of the chemicals in that pixel [8].

**Figure 6.** Girder coating with rust stain (a) the view of the rust spot, (b) spectral signatures of the different rust products in VNIR, (c) rust stain demonstration by CR indicator (>1.11), (d) critical CR for rust stain on topcoat.

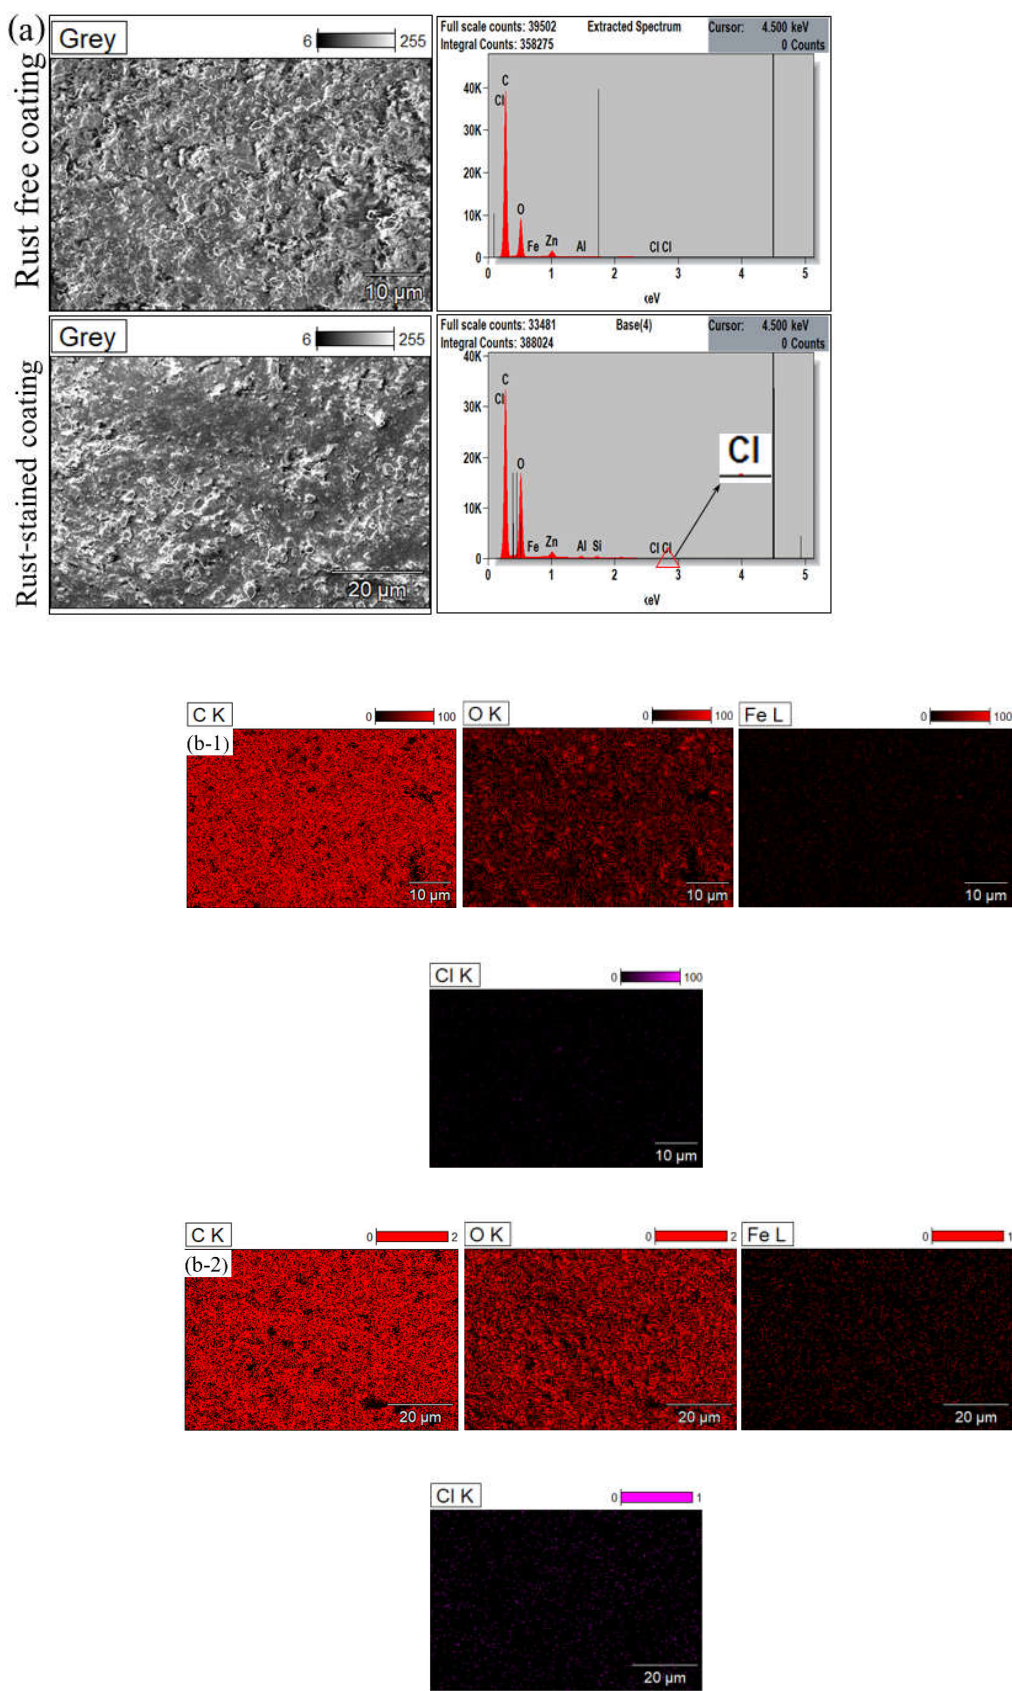
The coating samples with rust stains are analyzed by the energy dispersive X-ray spectroscopy (EDS) as opposed to the normal coating on this girder, Figure 7 shows the comparison of the element mapping results. The EDS spectrum as shown in Figure 7a demonstrates detectable peaks in terms of Cl for the rust-stained coating while the rust-free coating is dominated by the topcoat polymer compositional elements, C and O. The presence of Cl is also reflected by the element mapping result as illustrated in Figure 7b. For elements related to steel rust, Fe and Cl show significant differences in distribution. Oxygen (O) is not considered here to distinguish rust because of its massive existence in alkyd resins and thus cannot be easily impacted. As seen from Figure 7b, Fe is more visible on the coating with rust stains though Fe is also spotted in the rust-free coating samples. For Cl, the contrast is more significant because it almost disappears in rust-free samples. Table 1 shows the element ratio of each detectable element present on the coating surface. C and O occupy, in total, about 90% and N is the third prevailing element that makes up around 7.5% of the coating topology. The element dominance agrees well with the composition of alkyd. Rust-stained coating sees Fe of 1.78% which is higher than the 0.56% in the rust-free coating. As for Cl, it occupies 0.51% of the total detectable elements for the topcoat with rust stains in comparison with the 0% Cl in the stain-free topcoat. Element Cl distinguishes the rust-contaminated coatings from the rust-free sample which shows negligible presence. The result is consistent with the hyperspectral imaging result which shows the rust stain distribution as well as the corrosion source is Cl-related media.

**Figure 7.** Comparison of the element distribution on the coating with and without rust stains by (a) EDS spectra, (b-1) EDS mapping of rust-free topcoat, (b-2) EDS mapping of rust-stained topcoat.

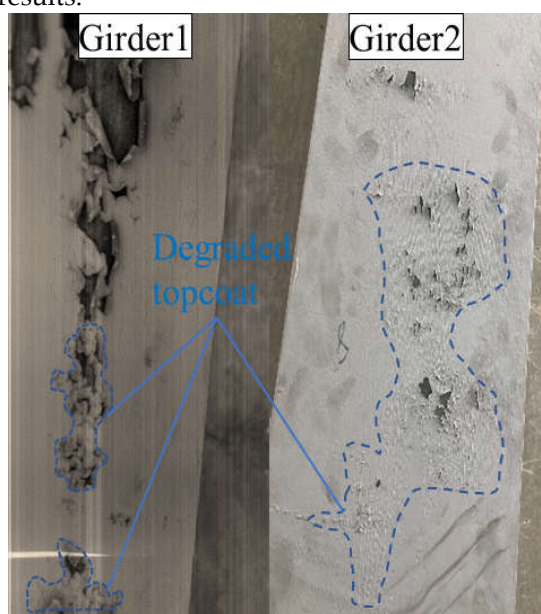
A degraded topcoat can expose the undercoat and thus increases the corrosion probability of the substrate. Early detection can potentially enhance the serviceability of steel girders. Figure 8 shows the deteriorated topcoat on the bottom flange of the steel girders in the proposed field bridge. Those deteriorated topcoats have lost the cling to the undercoat and thus cannot effectively protect the undercoat and substrate. As the degradation is generally characterized by chain breakage due to oxidation, Figure 9 displays the comparison between healthy and degraded topcoats by both FTIR and SWIR spectroscopy from hyperspectral imaging. FTIR is the complementary information for SWIR spectroscopy to interpret the topcoat degradation in view of the binder's chemical connections.

**Figure 8.** Demonstration of the degraded topcoat on the bottom flange of the steel girder.

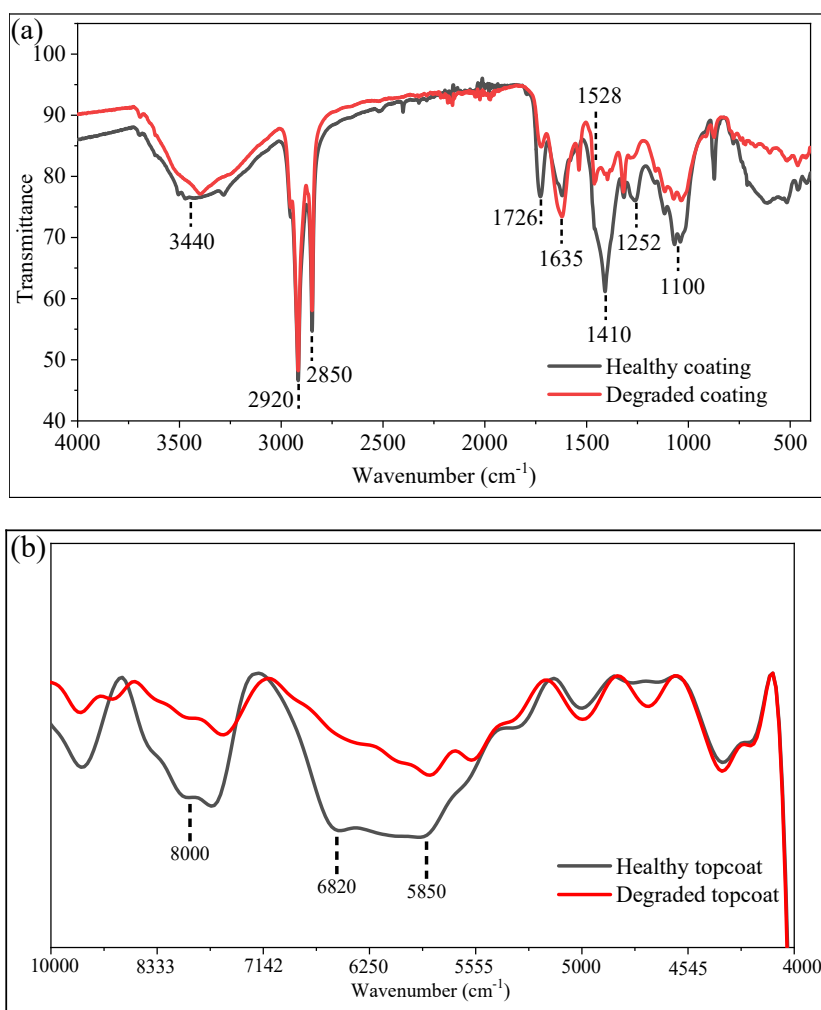
Considering the natural aging and atmospheric exposure effect on the topcoat, the stretching vibration of the C=O at 1726 cm<sup>-1</sup> and C-O-C at 1528 cm<sup>-1</sup> are featured by the bond cleavage in the polyester of the girder topcoat, alkyd resin [32-33]. Table 2 summarizes the band assignment of the alkyd resin. It can be seen that the narrow absorption bands at 1726 cm<sup>-1</sup> and 1528 cm<sup>-1</sup> both significantly decrease for the degraded topcoat in comparison to the healthy, which indicates the chains shortening in the polymer [33]. The chain scission in polyester is also observed by the decreasing absorption at 2920 cm<sup>-1</sup> and 2850 cm<sup>-1</sup> for degraded topcoat, which illustrates the reduced presence of the side chains [34]. In addition, the O-C-O featured band at 1410 cm<sup>-1</sup> almost disappears to demonstrate the reduction side chain [35]. On the contrary, it is noted that 1635 cm<sup>-1</sup> is boosted due to the degradation effect on the topcoat [33, 36]. It is because of the autooxidation of the polymer crosslink. In this process, the degraded alkyd resin releases alcohol and carbonyl species, which thus reduces the molecular weight of the original topcoat component [34]. The decreasing weight of alkyd resin can also be implied by the diminished bands at 1100 cm<sup>-1</sup> and 1252 cm<sup>-1</sup>. The breakage of C-O-C produces volatile species, for example, phthalic acid due to the Norrish Type I reaction [33]. Figure 10 shows the microstructure of the healthy and deteriorated topcoat by SEM. In comparison, the degraded topcoat yields a messier topology, and the topcoat has been degraded into more pieces. Table 3 illustrates the presence of detectable elements on the topcoat derived from the EDS mapping results. C is significantly reduced from the healthy to degraded topcoat due to the oxidation effect, which conforms to the FTIR results.

**Figure 8.** Comparison of the healthy and degraded topcoat in the range of (a) 400-4000  $\text{cm}^{-1}$  (FTIR), (b) 4000-10000  $\text{cm}^{-1}$  (SWIR).

Figure 10b presents the spectra derived from the healthy and the degraded topcoat in the range of 4000-10000  $\text{cm}^{-1}$  after continuum removal processing to facilitate quantitative comparison [37-38]. As illustrated in the FTIR, the main and side chains were greatly shortened due to the degradation effect. The reduction of the C=O in the degraded topcoat can also be detected in SWIR spectroscopy

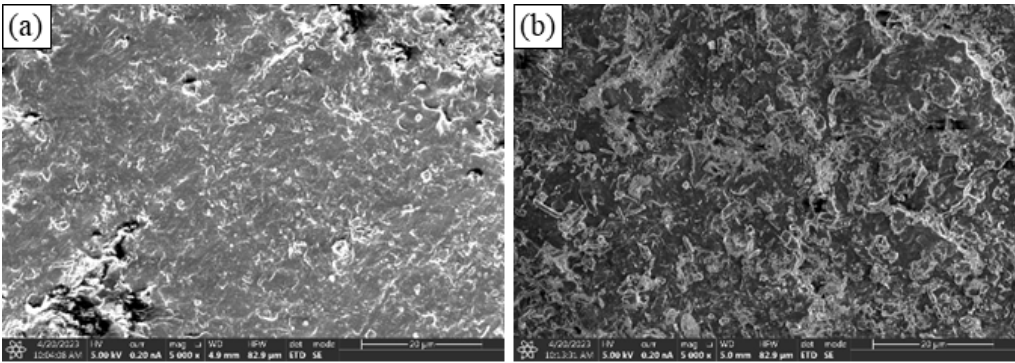
**Figure 10.** Topology by SEM of (a) healthy topcoat, (b) degraded topcoat.
