# Investigation and Improvement Strategies for Mold Fracture: A Study on the Application of a Double-Pulse Electrodeposition Method for Enhancing Mold Lifespan

**Abstract:** We present an investigation on the fracture of a mold, comparing it with a normal part using specific techniques, such as EDX, SEM, and AES. The EDX analysis revealed that the composition of the normal part was consistent with that of low carbon steel, mainly comprising Fe and C. In contrast, the fractured part exhibited cracks due to nonconforming nonmetallic inclusions and reticular carbides, with fractures resulting from microporosity agglomeration and cleavage fracture. The SEM and AES analyses further presented the causes of mold fracture, highlighting the mechanism by which dimples on the specimen edge contributed to the fracture. The EDX analysis confirmed that the mold experienced thermal brittleness during use. To enhance mold durability and extend its lifespan, a double-pulse electrodeposition method was employed to create a NiCo alloy coating as a replacement for the Cr layer on the metal surface. The coating exhibited a smooth and scratch-free surface. The prepared NiCo special coating significantl

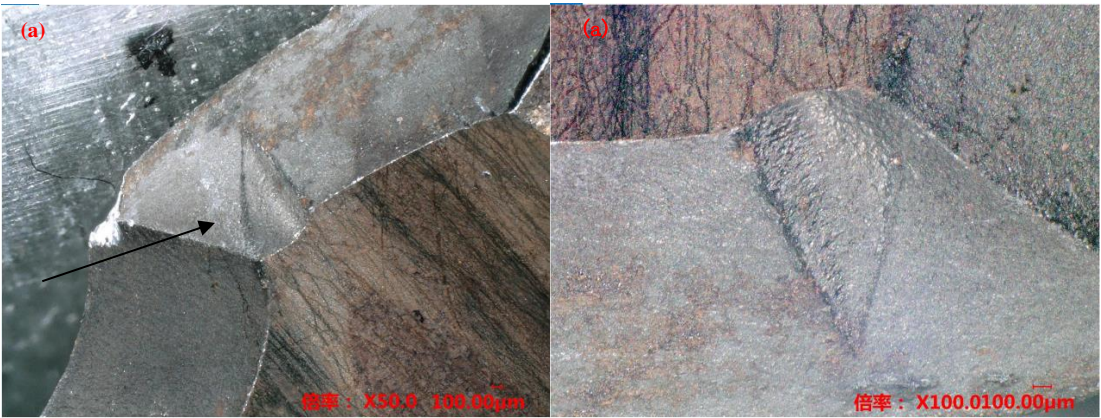
**Figure 1.** Location of the fracture under a high-power microscope: (a) magnified 50 times and (b) magnified 100 times.

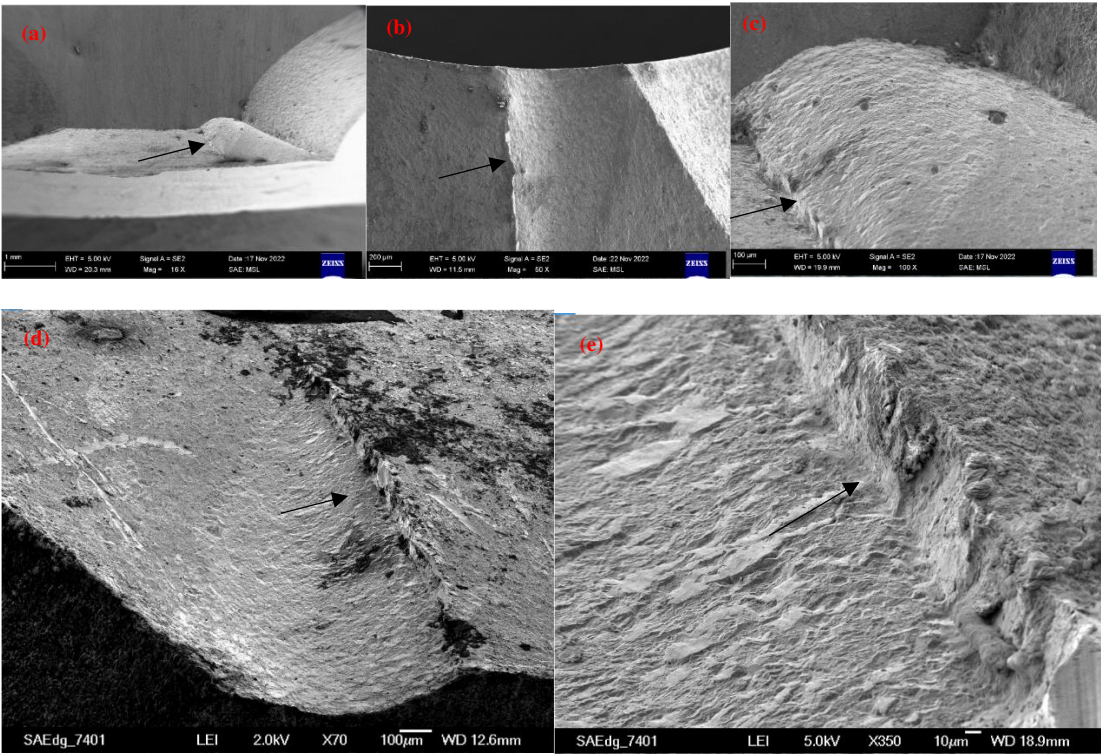
The fracture surface was microscopically inspected using SEM, and the morphology of the fracture was observed at different magnifications, as shown in Figure 2. The SEM images of the fracture surface were magnified at 16 $\times$ , 50 $\times$ , and 100 $\times$ , and they clearly showed fracture steps, indicating intergranular cleavage fracture characteristics. At high magnifications, such as 100  $\mu\text{m}$  and 10  $\mu\text{m}$  in Figure 2(d) and (e), respectively, flat quasicleavage planes, micropores, and tear ridges were observed, indicating a fracture along the original grain boundaries.

**Figure 2.** Location of the fracture under SEM at different magnification times: (a) 16 $\times$ , (b) 50 $\times$ , (c) 100 $\times$ , (d) 70 $\times$ , and (e) 350 $\times$ .

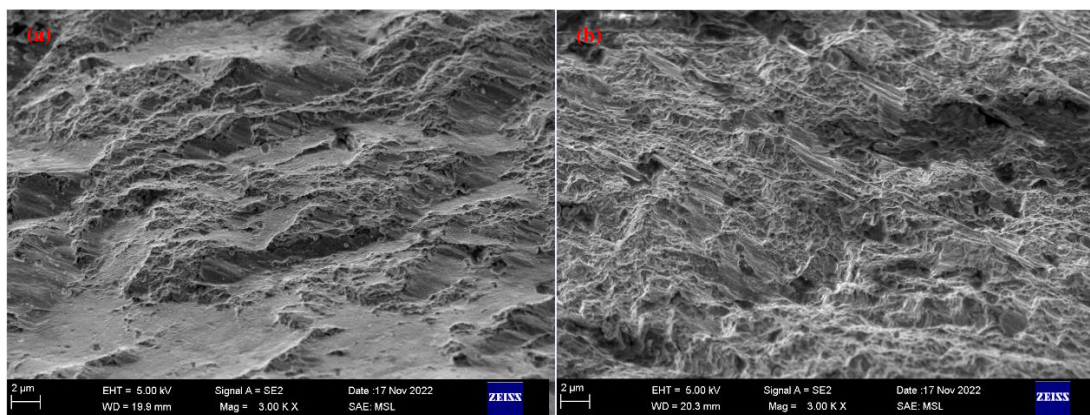
From the high-magnification observations in Figure 3, it was observed that the micromorphology along the grain boundary exhibited ductile dimples. However, local dimples contained additional nonmetallic inclusions and carbide particles, which had significant concentrations at the microscopic crack sites. This phenomenon corresponded to a quasicleavage fracture formed at the concentrations of nonmetallic inclusions and carbides. When comparing the fracture morphology in Figure 3(a) with the normal site shown in Figure 3(b), multiple microcracks were evident, as shown in Figure 3(a), which were distributed along the boundaries of the nonmetallic inclusions and carbide particles. This finding indicated that the fractures were caused by the lack of conformity of the nonmetallic inclusions and reticular carbides.

The fracture site in Figure 3(a) displays microporosity agglomeration and cleavage fracture. Microporosity agglomeration fracture [30,31] is a form of shear fracture, which is a common mode of material toughness fracture. The fracture surface was typically dark gray and fibrous, with numerous dimples distributed on the surface. The process of microporosity agglomeration fracture included micropore nucleation, growth, aggregation, and fracture.

The size and depth values of the dimples on the fracture surface of the martensitic aging steel depend on the quantity and distribution of the second-phase particles and the plastic deformation capability of the matrix. The small and shallow dimples on the fracture surface in Figure 3(a) suggest that the matrix has a strong work hardening ability [34]. These dimples may be generated due to the specimen loading at the edge, resulting in  $\sigma_{max}$  not being uniformly distributed across the cross-section. The stress at the edge was very high, and the crack gradually increased from the surface to the inside, resembling the process of tearing two stuck papers from one end. Therefore, this phenomenon is known as a tensile tearing type of fracture. Notched or cracked samples often showed this type of fracture surface. The tensile tearing elongated dimple was small and shallow, and the cracks propagated quickly over a macroscopic scale, leading to brittle fracture. This result supported the previous conclusion that the fracture had both brittle and cleavage features.

**Figure 3.** Morphologies of the fracture site and the normal site: (a) crack site and (b) normal site.

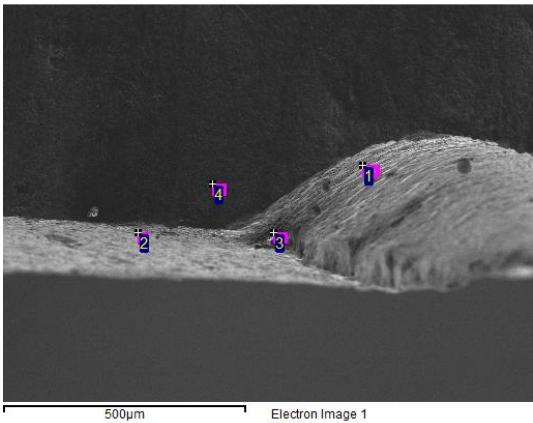
Four sampling locations were selected from the fracture surface and analyzed for their composition, as shown in Figure 4. Figure 5 presents the composition of the fracture surface and

Figure 4. Different positions for the test sample of the crack position.

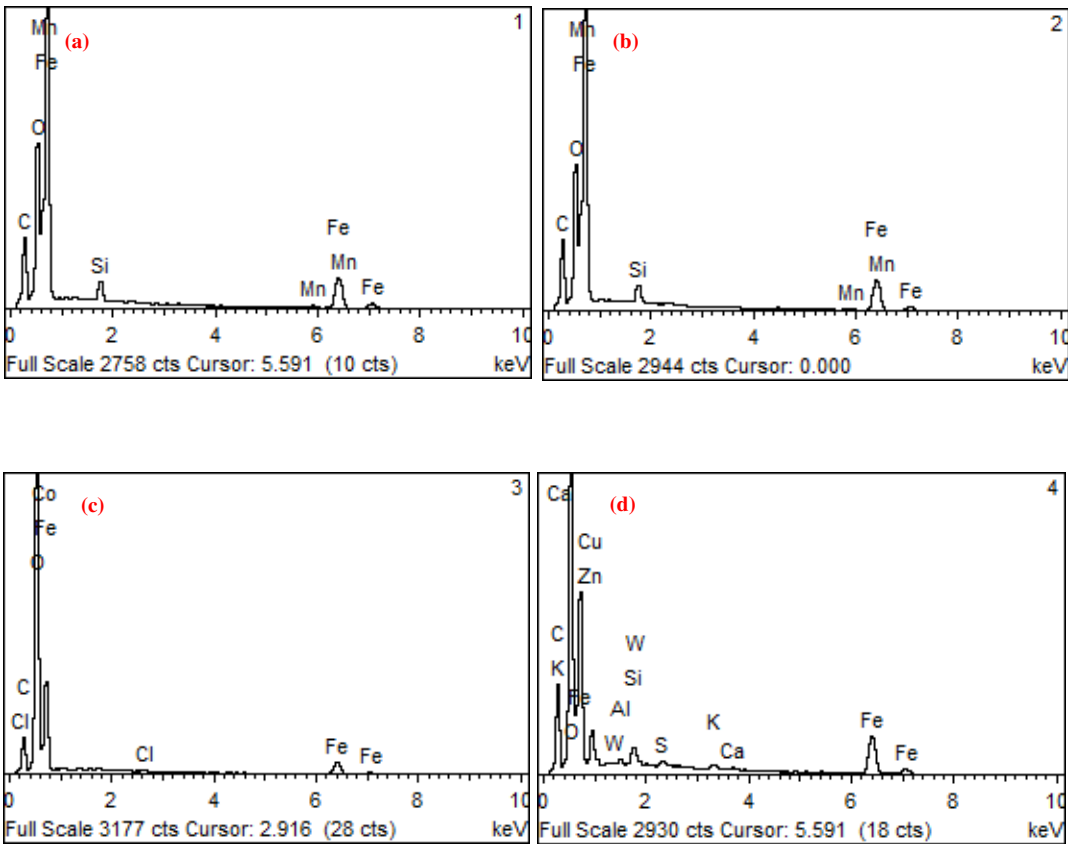
Figure 5. EDX results for different crack positions.

The EDX test results presented in Table 2 indicate that oxygen was detected at all four sampling locations on the fracture surface, with the highest oxygen content being 32.6% at location 3. Since the oxygen content in low carbon steel is typically low, the high oxygen content detected on the fracture surface suggested that the steel surface underwent oxidation or had nonmetallic impurities, such as oxides or manganese oxides, during processing and usage. The mold fabrication, heat treatment, and material selection processes could all contribute to the changes in oxygen content. However, an overly high oxygen content could decrease the steel toughness and ultimately increase the risks of fracture and oxidation. Therefore, the high oxygen content on the fracture surface could have contributed to the fracture.

Manganese was detected at positions 1 and 2, while no relevant element was detected at positions 3 and 4. This result could suggest that the chemical compositions in these areas were not uniform and could have undergone varying heat treatments. Mn is a common alloying element in low carbon steel, improving steel hardness and toughness. However, if the concentration of manganese was too high, it could result in uneven steel strength and increase the susceptibility of these regions to fracture or other damage. These findings could indicate the presence of uneven steel distribution or improper treatment and could have contributed to the mold fracture.

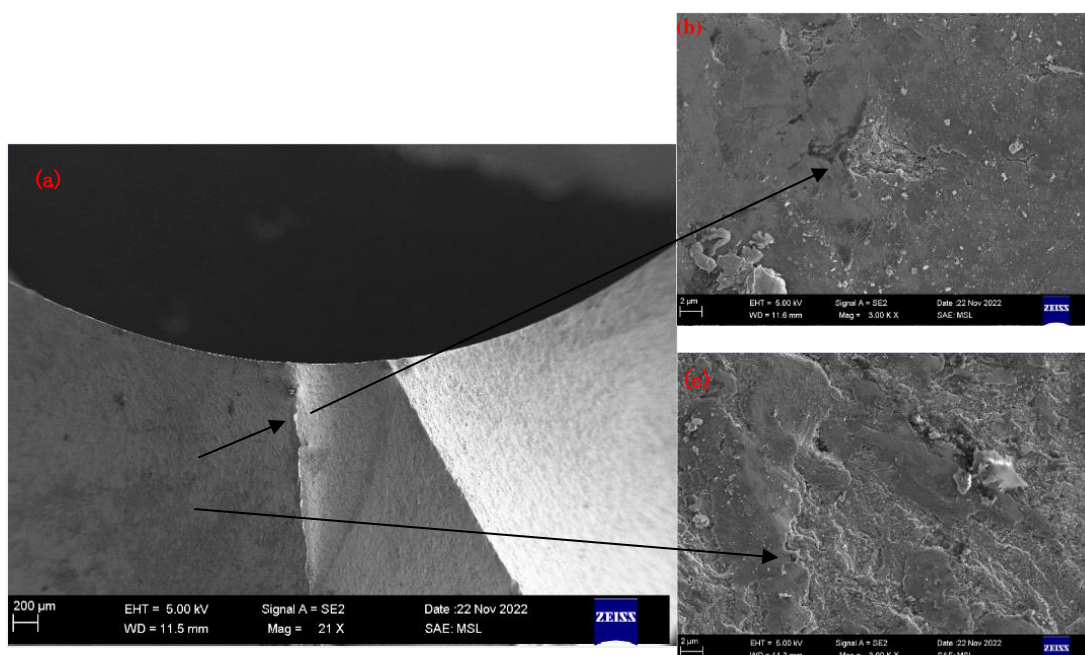
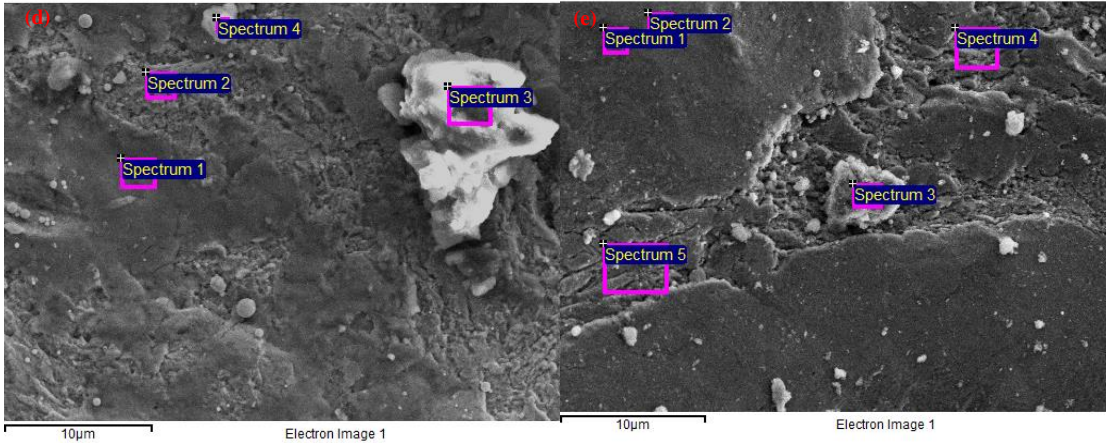
To compare the composition differences between the fracture and normal surfaces, samples were taken from both specimens for composition testing. Figure 6 (a) shows an SEM image that identified the locations corresponding to Figures 6 (b) and 6 (c). Four locations on the fracture surface were sampled for composition testing, as shown in Figure 6 (d), while five locations on the normal surface were sampled, as shown in Figure 6 (e). The EDX spectrum chart for the corresponding location of fracture sampling is shown in Figure 7, while the EDX spectrum chart for the corresponding location of normal sampling is shown in Figure 8. The EDX comparative test results are presented in Table 3 for the fracture samples and Table 4 for the normal samples. These results could enable a comparison of the elemental composition of the fracture surface and normal surface and could provide insights into the causes of mold fracture.

**Figure 6.** (a) SEM images indicating the location of sampling, (b) corresponding fracture locations, (c) normal locations, (d) sampling points of the fracture locations, and (e) sampling points of the normal locations.

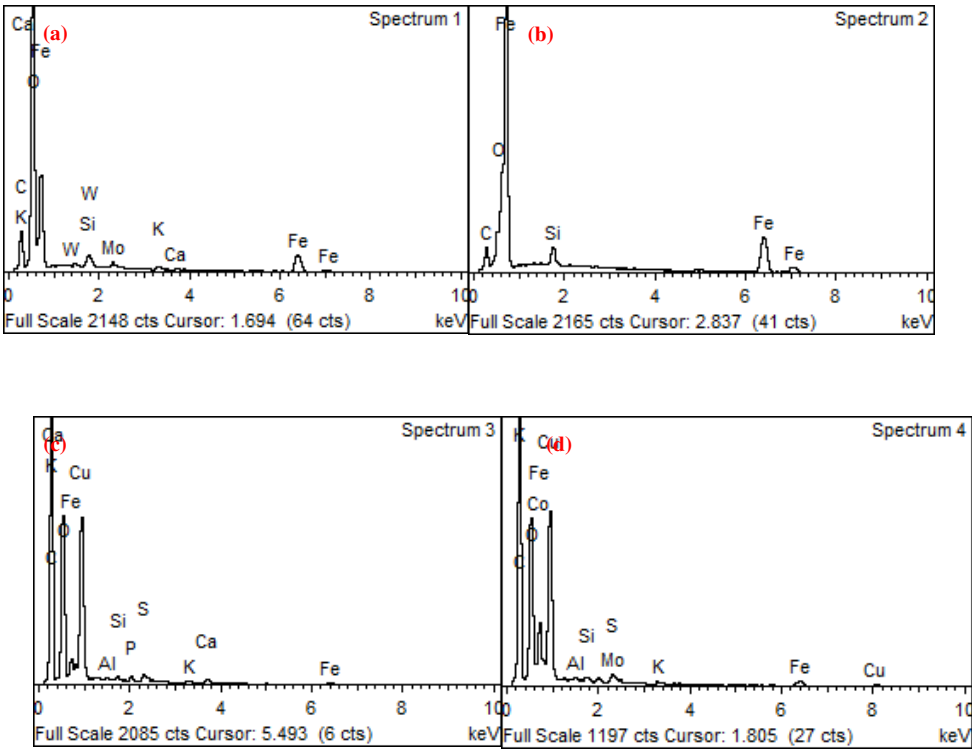
**Figure 7.** EDX spectrum chart for the corresponding location of fracture sampling.

A comparison of the composition data obtained from the EDX analysis of the fracture and normal parts of the mold samples revealed that the normal part contained C, O, Si, Fe, Cu, and Zn, while the fracture part contained C, O, Al, Si, P, S, K, Ca, Fe, Co, Cu, Mo, and W. Interestingly, the percentage of Fe in the fracture part significantly decreased. This finding suggested that the mold underwent thermal brittleness during use. Thermal brittleness is a phenomenon causing materials to break easily at high temperatures. This characteristic is often associated with materials absorbing a large amount of oxygen or other impurity elements at high temperatures, leading to changes in the material internal structure that reduce its toughness and ductility.

Based on the comparison of composition data obtained from EDX analysis of fracture and normal parts of the mold sample, it was observed that the mold experienced thermal stress during use that resulted in serious fracture phenomena and a significant decrease in the content of elements such as Fe. The type of steel material used for the mold was Cu0.25Si1.21Mn0.86Cr0.07, which is a

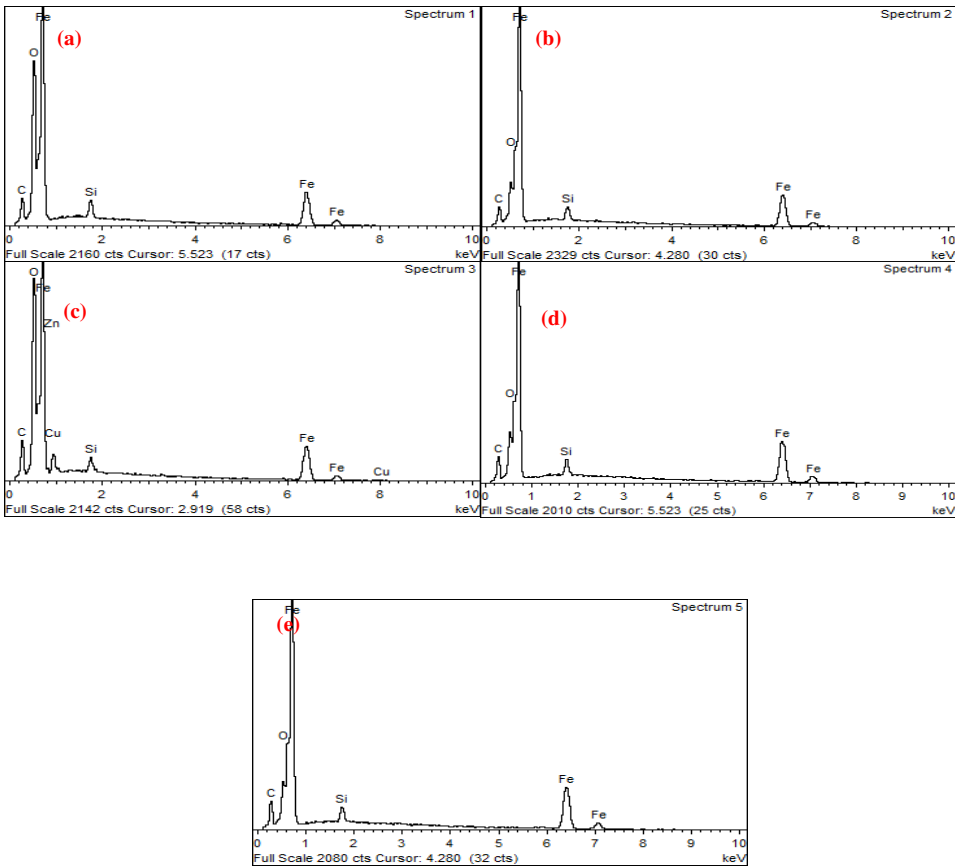
**Figure 8.** EDX spectrum chart for the corresponding location of normal sampling.

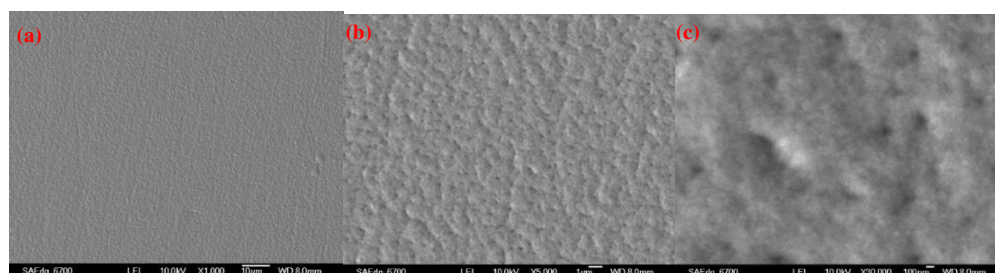
The SEM images of the special NiCo composite coating are presented in Figure 9, with images at 10  $\mu\text{m}$ , 1  $\mu\text{m}$ , and 100 nm scales shown in (a), (b), and (c), respectively. The morphology, roughness, and surface structure of the sample can be observed in Figure 9 (a) at the 10  $\mu\text{m}$  scale, and the surface is found to be very smooth without scratches. Clear details of the coating crystal structure, texture, pores, and spots can be observed in Figure 9 (b) at the 1- $\mu\text{m}$  scale. Details of the morphologies, features, and compositions at the 100-nm scale can be observed in Figure 9 (c). Furthermore, the EDX spectrum chart for the NiCo coating is shown in Figure 10. The results indicate that the coating comprises approximately 77% Ni and 23% Co.

These results demonstrate that the double-pulse power supply technique used in this experiment leads to the formation of a uniform and dense NiCo composite coating, which is smooth and without defects. The use of this technique enables the control of coating quality and helps to avoid problems such as loose coatings and holes. The EDX results indicate that the composition of the coating is well within the expected range, indicating the effectiveness of the electroplating process.

**Figure 9.** SEM image of the special coating. (a) 10  $\mu\text{m}$  (b) 1  $\mu\text{m}$  (c) 100 nm.

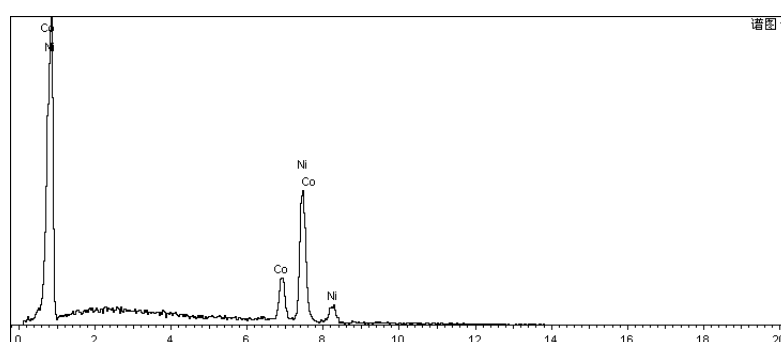
**Figure 10.** EDX spectrum chart for the special coating.

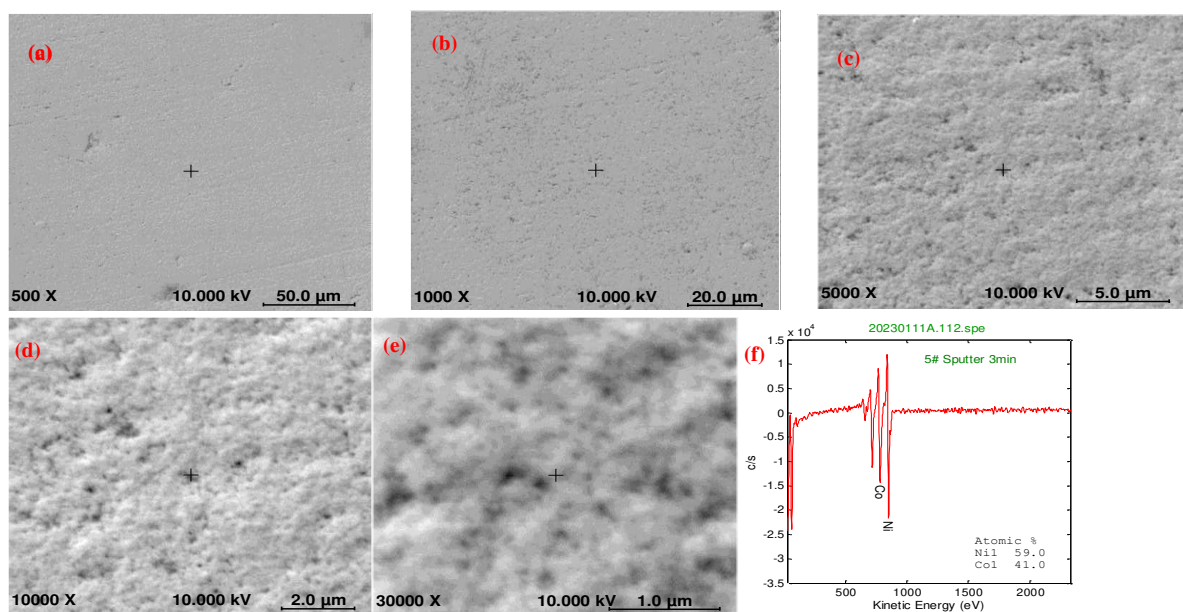
The results of the SEM test are shown in Figure 11, with images captured at various magnifications to reveal different features of the coating. At low magnifications, as shown in Figure 11 (a) (500×) and (b) (1000×), the approximate morphology and surface features of the coating and the roughness of the sample surface can be observed. The coating surface is found to be smooth and flat without scratches. At medium magnifications, as shown in Figure 11 (c) (5000×) and (d) (10000×), the coating surface can be observed to be smooth with good density, and the details of the coating surface morphology can be observed clearly. In addition, microfeatures such as surface defects and particles can be detected. At high magnifications, as shown in Figure 11 (d) (10000×) and (e) (30000×), detailed information about the distributions of coating composition and features can be observed. The results confirm that the use of the double-pulse power supply technique significantly reduces the looseness and holes in the coating. Particular attention is drawn to Figure 11 (e), which magnifies the element distribution and interface structure by 10000 times. The results show that the NiCo composite coating is uniform, and the elemental distribution is highly symmetric. The element mapping indicates that the Ni and Co elements in the coating are evenly distributed, with no significant concentration in any specific area. The analysis suggests that the electroplating process is successful in producing a uniform, dense, and stable NiCo composite coating with good adherence to the metal surface.

**Figure 11.** SEM and AES results of the special coating under different magnification ratios.

The AES test result of Figure 11 (f) provides additional insights into the structure and composition of the NiCo composite coating, and it confirms the effectiveness of the double-pulse power supply technique in achieving the desired electroplating quality.

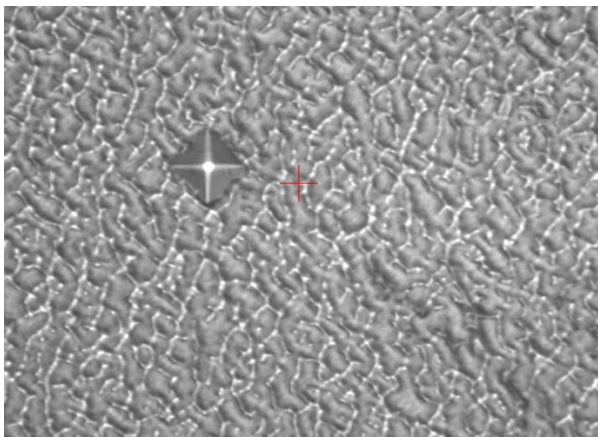
To further investigate the properties of the NiCo composite coating, a hardness test is performed using a SHIMADZU Dynamic Ultramicro Hardness Tester DUH-211S, as shown in Figure 12. The test force range is 0.1–200 gf (0.1–1961 mN), and the measuring range is 0.1–10  $\mu\text{m}$ . The microscope magnification is 500×, and the HV range is 100–900. The maximum permissible percentage errors are 4%–12%. The hardness obtained is 465.257 HV, which is much harder than the raw materials used for the mold. This result confirms that by using the double-pulse power supply technique, the wear resistance is significantly improved. The application of the NiCo composite coating with improved hardness and wear resistance extends the service life of the mold. This hardness test verifies that the electroplating process using the double-pulse power supply technique leads to the formation of a

Figure 12. Hardness test image for the special coating.

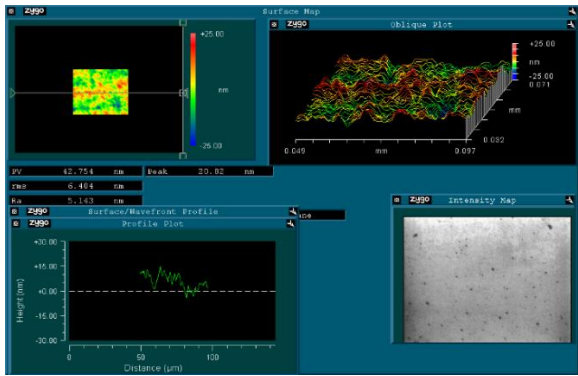
dense and uniform coating with excellent hardness and wear resistance. The surface roughness of the coating shown in Figure 13 is 5.143 nm, which is relatively smooth with few scratches.

Figure 13. Surface test image for the special coating.
