Applying Infrared Thermography to a Latest Residential Building in France: Case Study, Verifying Dwellings National Thermal Regulations RT 2012 Mainly Thermal Bridges Assessment

Harry Ramenah

LCOMS laboratory, University of Lorraine, Metz France; harry.ramenah@univ-lorraine.fr

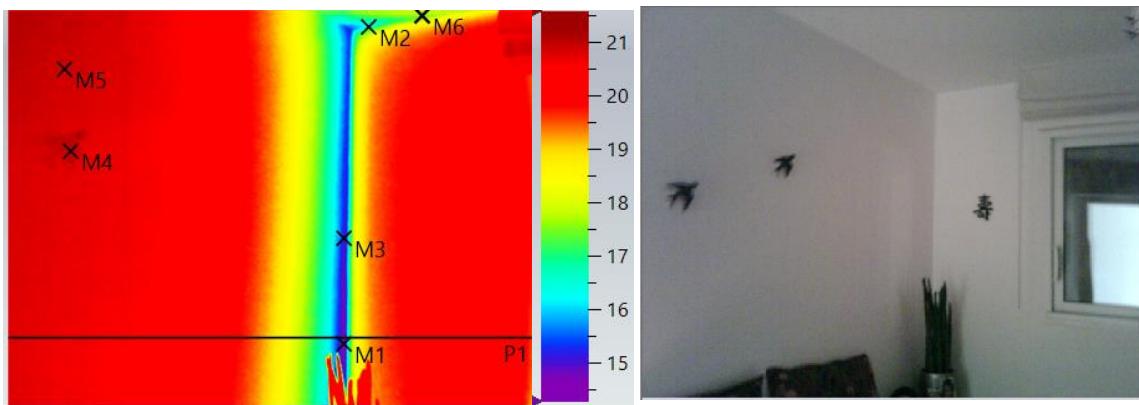
Figure 7. Left is the thermogram of a wall to wall thermal bridge and real image on the right.

The wall containing the window in the real image is an insulated wall facing the outside and is at a junction with an internal load-bearing wall.

The blue color in the IR image indicates the wall to wall thermal bridge. The black bird which is a dark object is considered as the reference (reflection) temperature at 20.9°C and the measured room temperature is 21°C indicating that measurements are done in an optimal condition. M1 to M5 in the thermogram, are measured temperatures by IR camera as indicated in Table 1. The reference temperature is M4 (black object) as indicated by the highlighted blue line in Table 1 and M1 is the lowest temperature at 14.6°C. M5 is a random point showing that the red color is at the reference temperature.

It is also interesting to point out that temperatures M2 & M6 are part of the balcony thermal bridge.

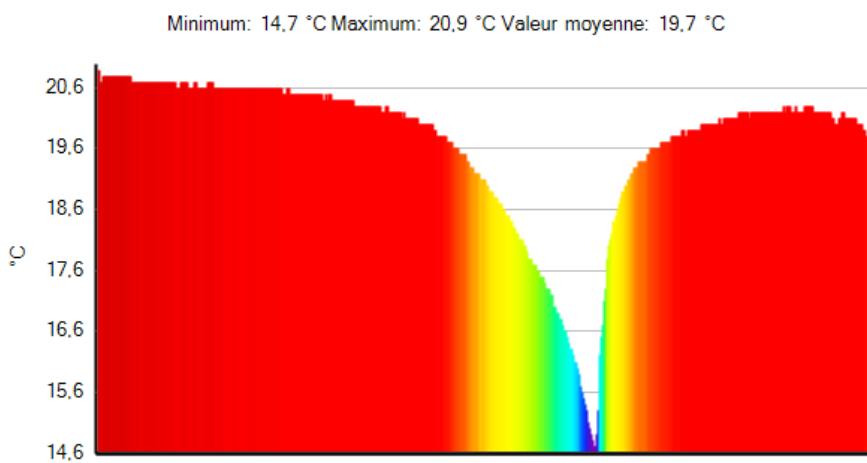
The line P1 in the thermal image is the temperature profile and plotted in Figure 8, showing a substantial temperature drop.

**Figure 8.** Substantial temperature drops due to wall to wall thermal bridge.

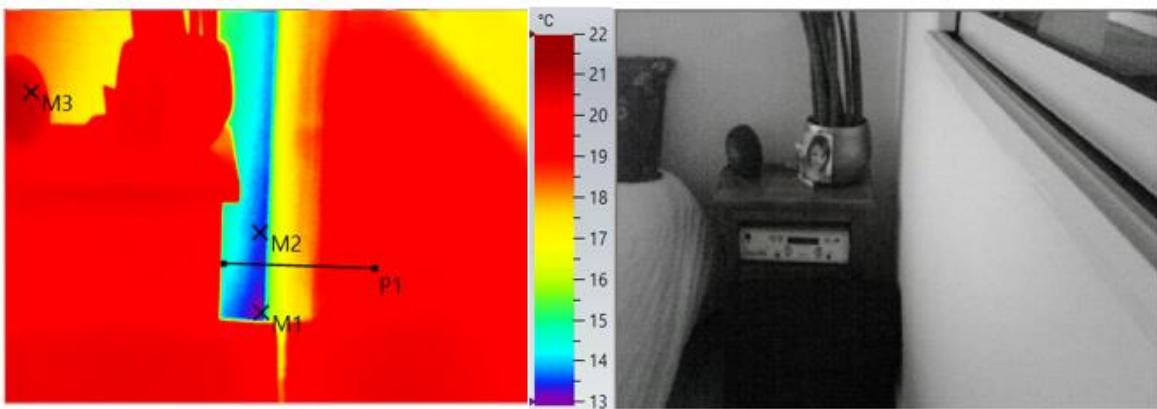
The lower part of this wall to wall thermal bridge is showed in Figure 9 with the corresponding real image. In Table 2, the lowest measured temperature is close to 13°C indicated by M1, for a reference temperature 20.8°C indicated by M3, which is a dark alarm clock in the real image. Line P1 in the thermal image is the profile temperature that is plotted in Figure 10. The difference between the reference temperature and lowest temperature in the thermal bridge is 7.9 °C.

**Figure 9.** Lower part of the wall to wall thermal bridge.

This thermal bridge is caused by a lack of extension of the insulation on the uninsulated wall or a missing of thermal break at the walls junction during construction. The colors in the thermal image have been standardized in the Testo software for a better overview of temperature variation.

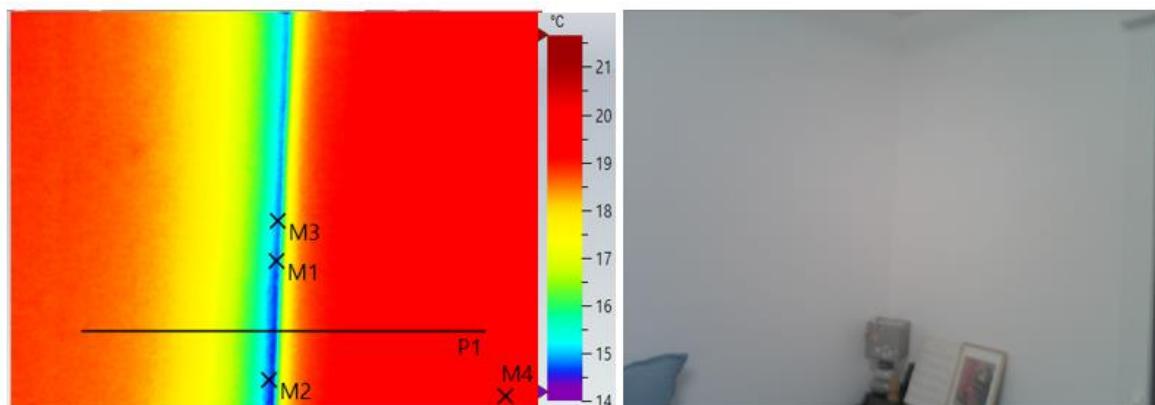
The next wall to wall thermal bridge is in another bed room, the green line in Figure 6. The thermal bridge again is at the junction of the internal bearing wall and an insulated wall facing the outside but in a south orientation. The thermograms and corresponding real image are displayed in Figure 11. Table 3, is indicating temperatures at variant locations in the thermal image. The temperature difference is nearly 5°C between the lowest temperature in the thermal bridge and the room temperature.

**Figure 11.** On the left, another wall to wall thermal bridge and the real image on the right.**Table 3.** Measured temperatures for another wall to wall thermal bridge.

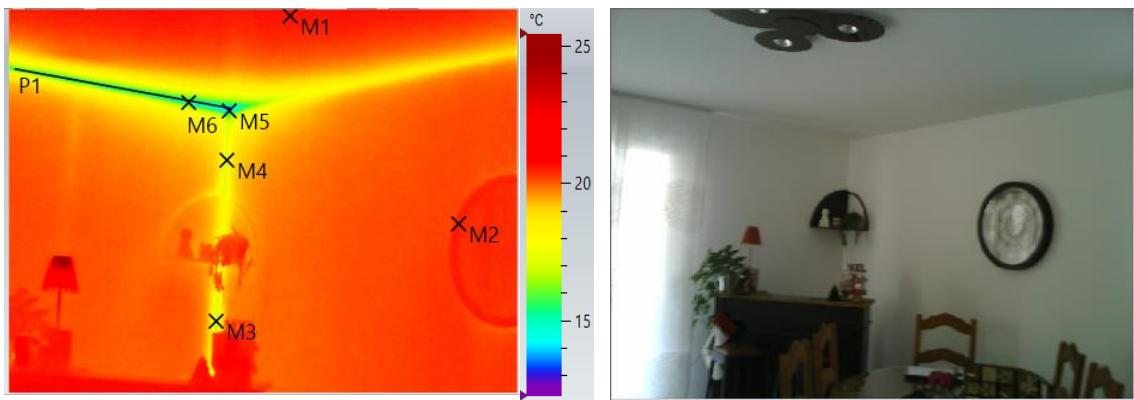
This first type of thermal bridge is along the dark and yellow lines as indicated in Figure 5 including the junction between the two walls. The thermogram and its corresponding real image are displayed in Figure 12.

Figure 12. Balcony wall thermal bridge on the left and real image on the right.

The wall containing the clock in the real image has a north orientation and the perpendicular wall has a north west orientation. The reference temperature is taken as M2 due to the thick dark frame of the clock. It can be concluded that an equilibrium condition is reached as the ceiling temperature M1 is the same as M2. Table 4, gives temperatures at different locations. The least temperature is given at M5 position whereas M3 & M4 are temperatures at the wall to wall junction. Line P1 is temperature profile in the balcony wall thermal bridge and is represented in Figure 13. The ultimate temperature difference is 7.2°C.

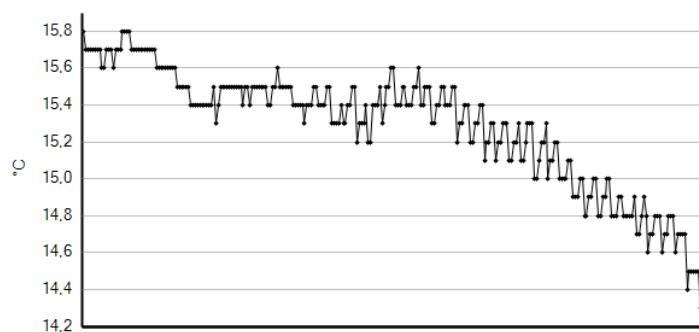
Figure 13. Temperature profile in the thermal bridge in the IR image.

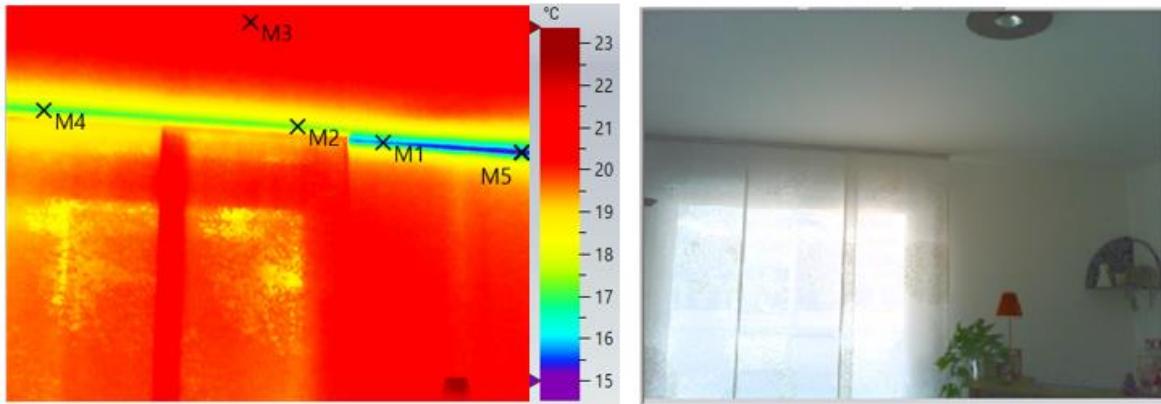
The yellow line in Figure 6 is the bridge in the north west orientation and above the window door. The concerning balcony and window door are also visible in Figure 5. The results are presented in Figure 14 and Table 5. This thermal bridge is substantial as it still appears even behind the curtain rail in a clear blue color. The greatest temperature difference 5,7°C

Figure 14. Left: Balcony thermal bridge along the yellow line. The real image on the right.

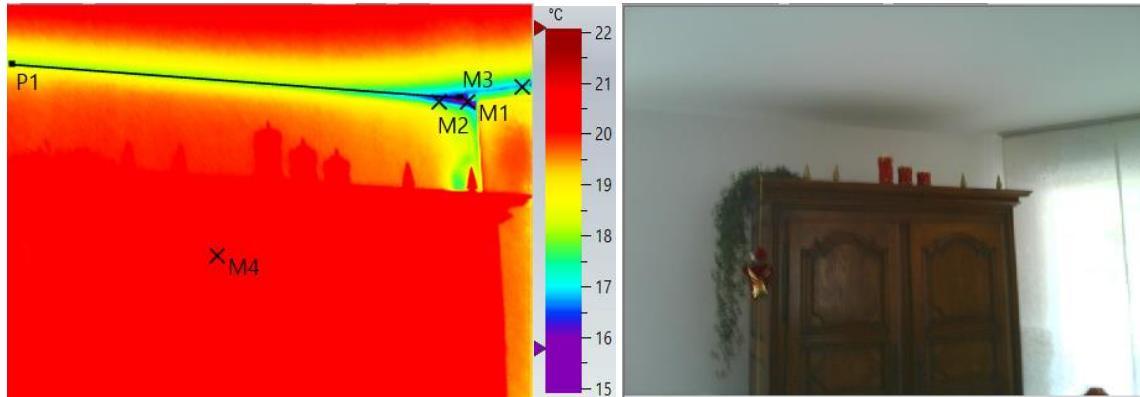
The following results are at the angle between the yellow and clear blue lines, that is between the south and south west orientation. In this case, the line P1 is not very significant as the IR camera in Figure 15 was facing the angular zone. The plot is simply indicating the temperature drop at the corner. Table 6 is the corresponding temperatures at several locations in the IR image.

Figure 15. Left: Thermograms between yellow and clear blue lines. Real image on the right.

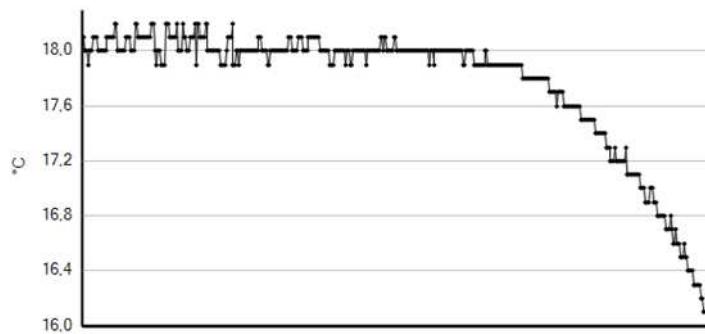
The profile temperature along the balcony thermal bridge facing the south orientation is indicated in Figure 16. The linear part of the graph is not significant due the IR camera position as explained in section 2.3.

Figure 16. Temperature profile of P1 in the IR image.

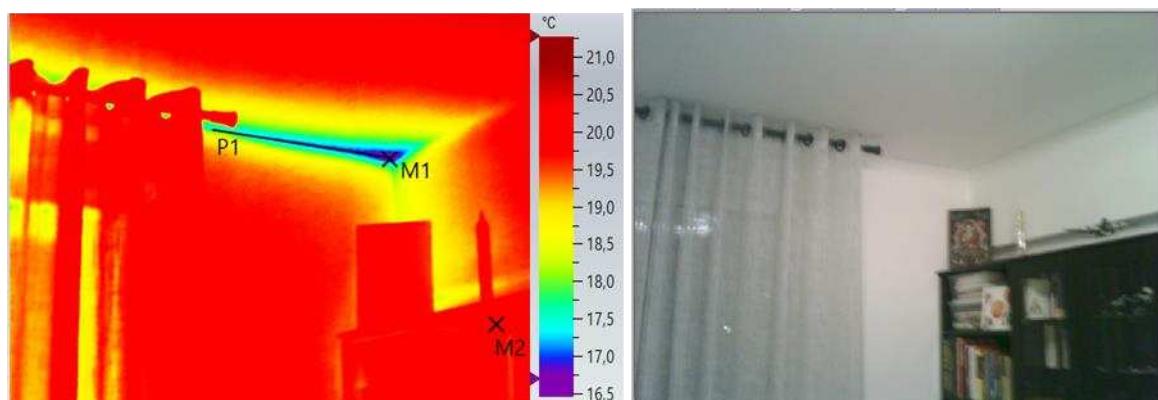
The balcony thermal bridge is all around the building structure and we have chosen to give results for this last junction at the orange line in Figure 6. This zone has a south orientation. The least measured temperature at M1 position in the thermogram of Figure 17 is 16.6°C as indicated in Table 7. The line P1 is the temperature profile along the balcony wall thermal bridge and represented in Figure 18. We retain a temperature difference of 4.4°C for this thermal bridge.

Figure 17. Left: Thermogram of the room at orange line and the corresponding real image on the right.

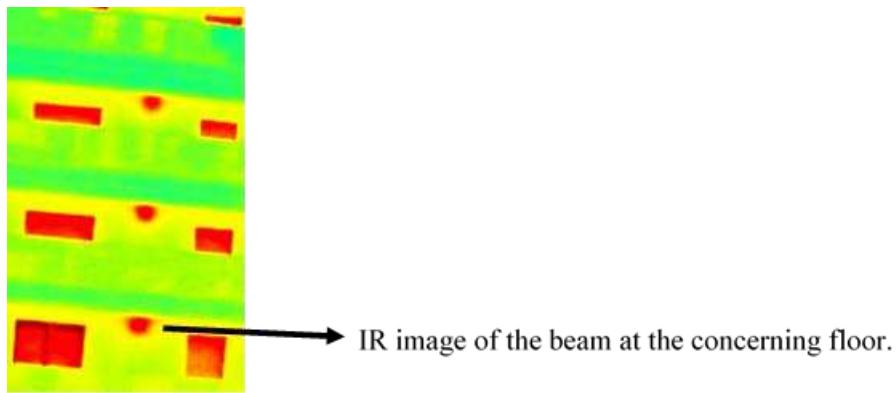
The beam is clearly visible on the outside thermogram at various floor of the building as illustrated in Figure 19. The thermogram of this thermal bridge and the real image are illustrated in Figure 20.

Figure 19. Beam wall thermogram from outside.

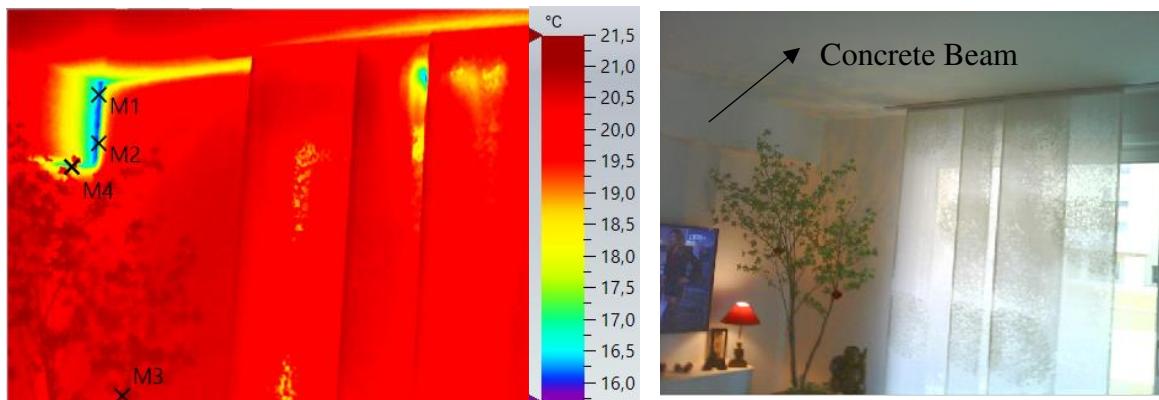
Figure 20. Thermogram and real image of the slab wall junction.

This thermal bridge was caused by the beam itself and the heat flow is imaged in Figure 4 of section 3. The reference temperature is determined by the dark object on a branch of the tree in the real image. The maximum temperature difference is nearly 5°C.

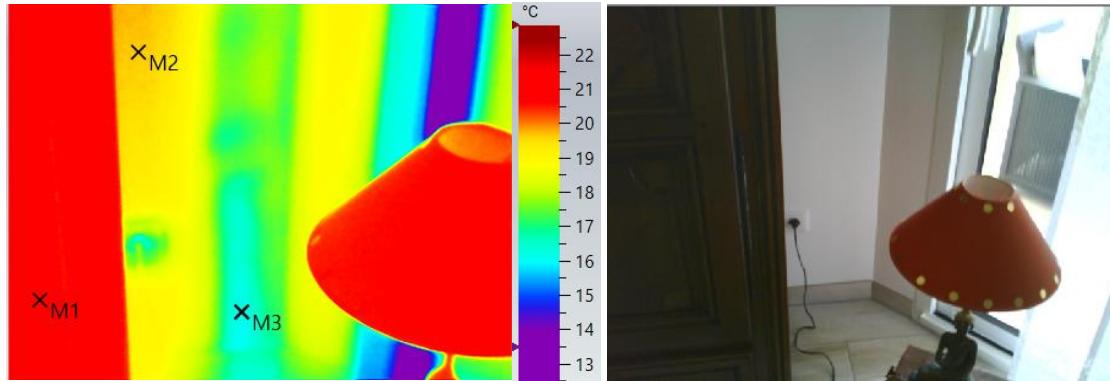
Missing thermal insulator have been listed at few zones of the apartment during the thermal survey. One of the zone is between the yellow and clear blue lines in Figure 6. It seems that there are missing thermal insulator at various area of the wall and only results regarding the lower part of the wall are considered. We should also consider the temperature index for an area on the thermal image as explained in section 2.5. Internal temperatures at different locations of that zone were also measured by a contact temperature sensor PT 100 and are similar to those of the thermal camera. During this survey, the internal ambient temperature, T_i , was 21°C and the external ambient temperature T_0 was 5°C. Various parts of missing thermal insulator are visible on the thermogram of Figure 21 and the corresponding real image on the right of the thermal image. The measured internal surface temperatures are given in Table 9.

**Figure 21.** Thermogram of the zone of missing insulator and the real image on the right.**Table 9.** The corresponding temperature of the thermogram.

M3 is considered as the internal surface temperature T_{si} at 16.1°C for the temperature index determination given by equation 1 in section 2.5 and the other temperatures in this equation are indicated above. The determined TI value is 0.694.

For dwellings the value of TI should not be less than 0.75 as this value matches an internal surface temperature of 13.8 °C when the usual inside temperature is 20°C and outside temperature is -5°C. Consequently, condensation would arise if the outside temperature was below -5°C or the inside air was more saturated with water vapour.

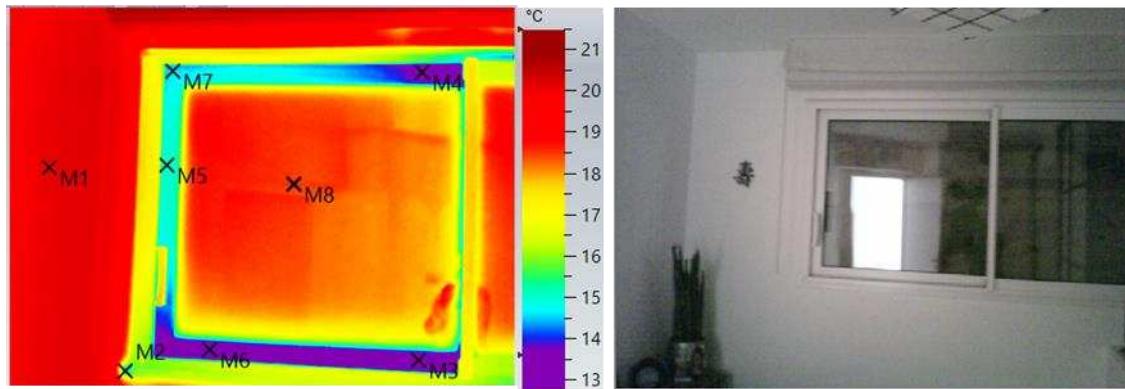
Figure 22. Window thermogram on the left and real image on the right.

Measured temperatures at various positions of the window are given in Table 10. M1 is the reference temperature. The M2 temperature is at 14.8°C indicating a small air leakage due to a poor installation. M3 to M7 are temperatures around the window frame showing low temperatures comparing to the reference temperature. The colder the window frame the greater the conductive current and this great temperature difference is always causing air movement cycle that is felt a lot like a window draft by occupants. The constant cold surface temperatures make the bedroom especially unpleasant and uncomfortable and in end having major effects on quality of life. Moreover, the IR image of Figure 23 is illustrating an air leakage by the purple color at the bottom part of the window sash.

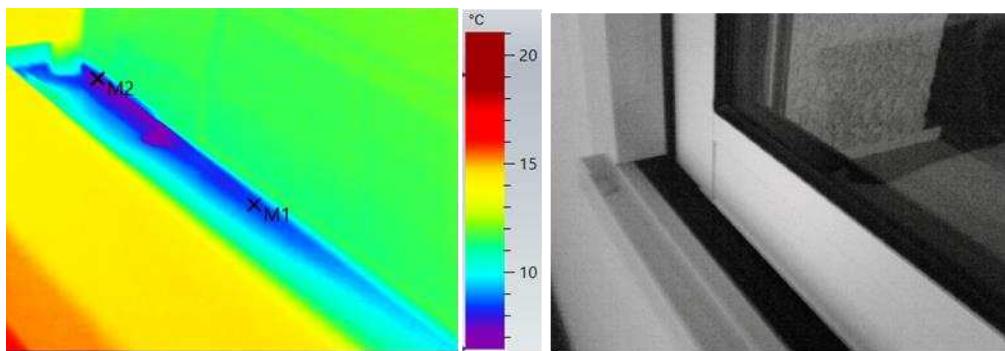
Figure 23. Left: Air leakage at the lower part of the window. Real image on the right.

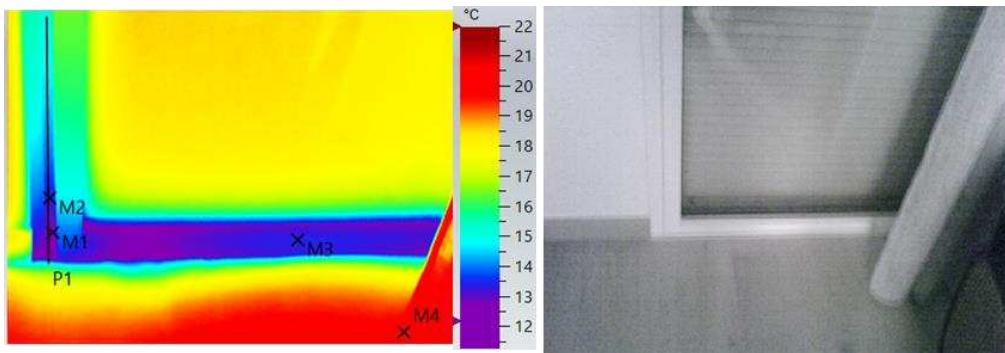
Figure 24, is the thermogram of a window door of the room indicated by the orange line in Figure 6. The thermogram, is not only showing low temperatures at the bottom part of window frame but also air leakage along line P1 and the temperature profile is indicated in Figure 25. Table 12, are temperatures at the window door frame.

Figure 24. Left: Thermogram of door window and the real image on the right.

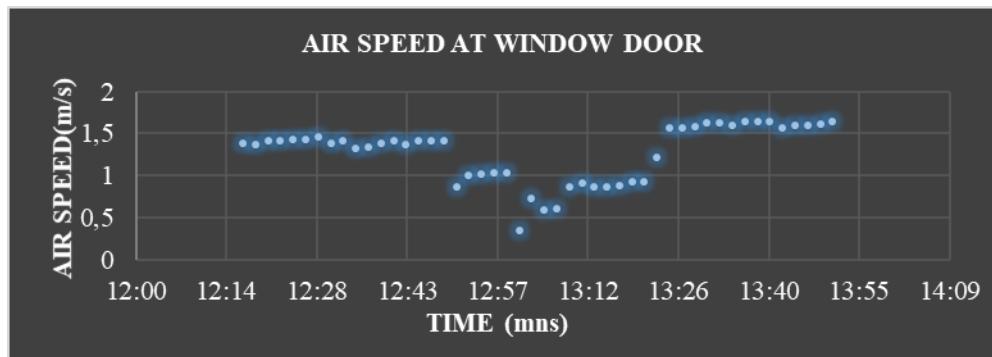
Only two relevant results are presented. The first one is along the window door at the orange line in Figure 6. The air speed was measured for more than two hours as illustrated in Figure 27 and it can be observed that the air speed difference is between 0.5 m/s to 1.6 m/s.

**Figure 27.** Measuring air speed at the window door facing the south.

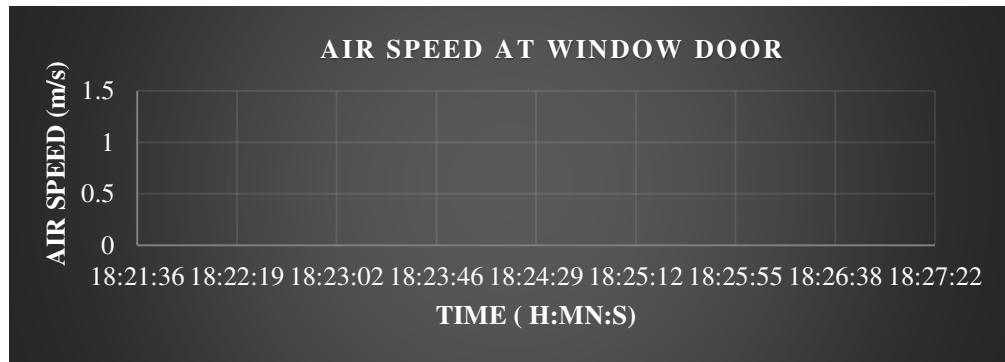
The other test was performed on the window door which is at the yellow line in Figure 6, in a north west direction. The air speed was measured for nearly 10 minutes and is represented in Figure 28. We can see that the maximum air speed is closed 1 m/s. Hence, these results attest that there exists an air leakage at some window doors.

Figure 28. Measuring air speed at the window door facing the north west.
