# Impacts of a Moderate-Sized Earthquake: The 2023 Magnitude ( $M_w$ ) 4.7 Leyte, Leyte Earthquake, Philippines

**Abstract:** On 15 January 2023, a shallow, moderate earthquake with a magnitude ( $M_w$ ) of 4.7 and a depth of one kilometer struck the northern part of Leyte Island in the central Philippines. Originating along the northern Leyte segment of the Philippine Fault, a well-established creeping fault, the earthquake caused significant geologic, structural, and socio-economic impacts despite its low magnitude. Probable surface rupture and landslides were reported, leading to a comprehensive field investigation. Our investigation revealed an ~8 km discontinuous surface rupture along the northern Leyte segment of the Philippine Fault, with a maximum left-lateral displacement of 2 cm—the first documented occurrence of such a phenomenon associated with an earthquake of magnitude less than 6, particularly along a creeping fault segment. The maximum ground shaking felt was reported at PHIVOLCS Earthquake Intensity Scale (PEIS) VI (very strong), equivalent to Modified Mercalli Intensity (MMI) VI along the fault strike. However, strong motion accelerographs recorded a peak ground

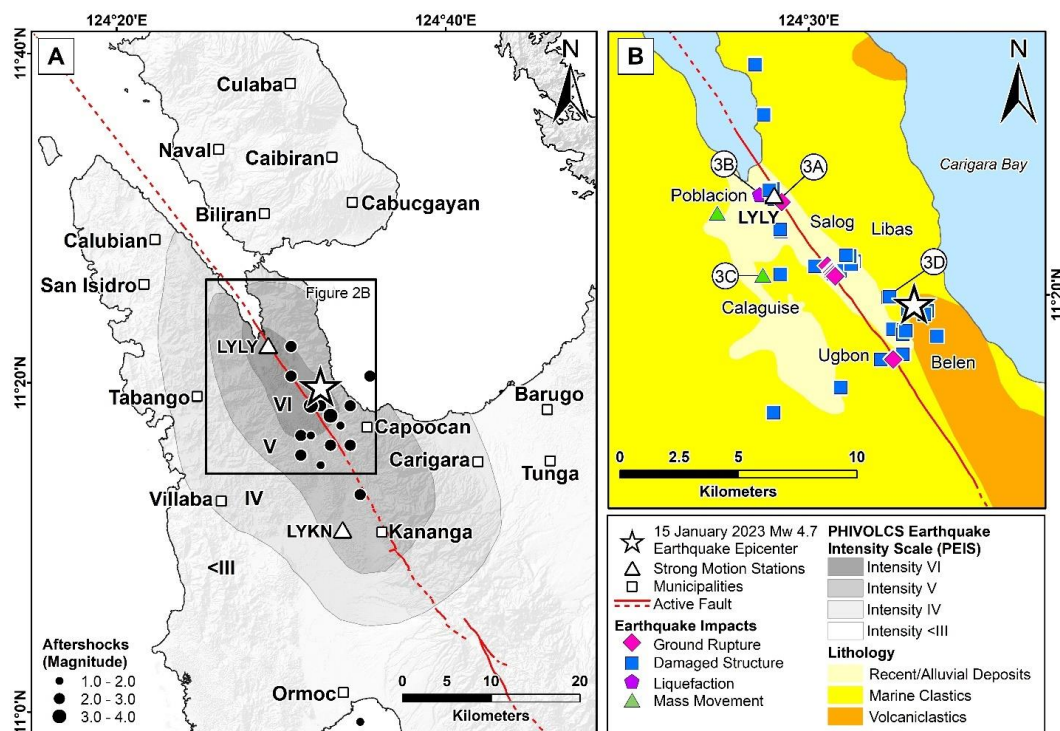
**Figure 2. The 2023  $M_w$  4.7 Leyte, Leyte Earthquake isoseismal, aftershock distribution, and earthquake impact maps.** (A) The isoseismal map was based on the latest earthquake information from DOST-PHIVOLCS [18] and the detailed intensity survey and impact assessment conducted in this study. Aftershock distribution (black circle) from 15 to 23 January 2023 was recorded by the Philippine Seismic Network [18]. (B) Spatial distribution of documented damages and geologic impacts (ground rupture, liquefaction, and mass movement). The geologic map was modified from Aurelio and Peña [26]. Circles with letters and numbers show the location of photos in Figure 3. The active fault trace (red line) is from Tsutsumi and Perez [11].

Based on the Rapid Damage Assessment and Needs Analysis report done by the municipality of Leyte, there were about 434 residential houses and 26 public infrastructures including schools and government buildings were affected by the earthquake [25]. The DOST-PHIVOLCS QRT documented damaged structures which are summarized in Figure 2B. Our assessment revealed that most of the damages were located near the epicentral area and can be attributed to poor quality or substandard construction materials such as CHB and reinforcing bars (Figure 4D). Notably, most of the damaged structures were located in alluvial and recent deposits (Figure 2B).

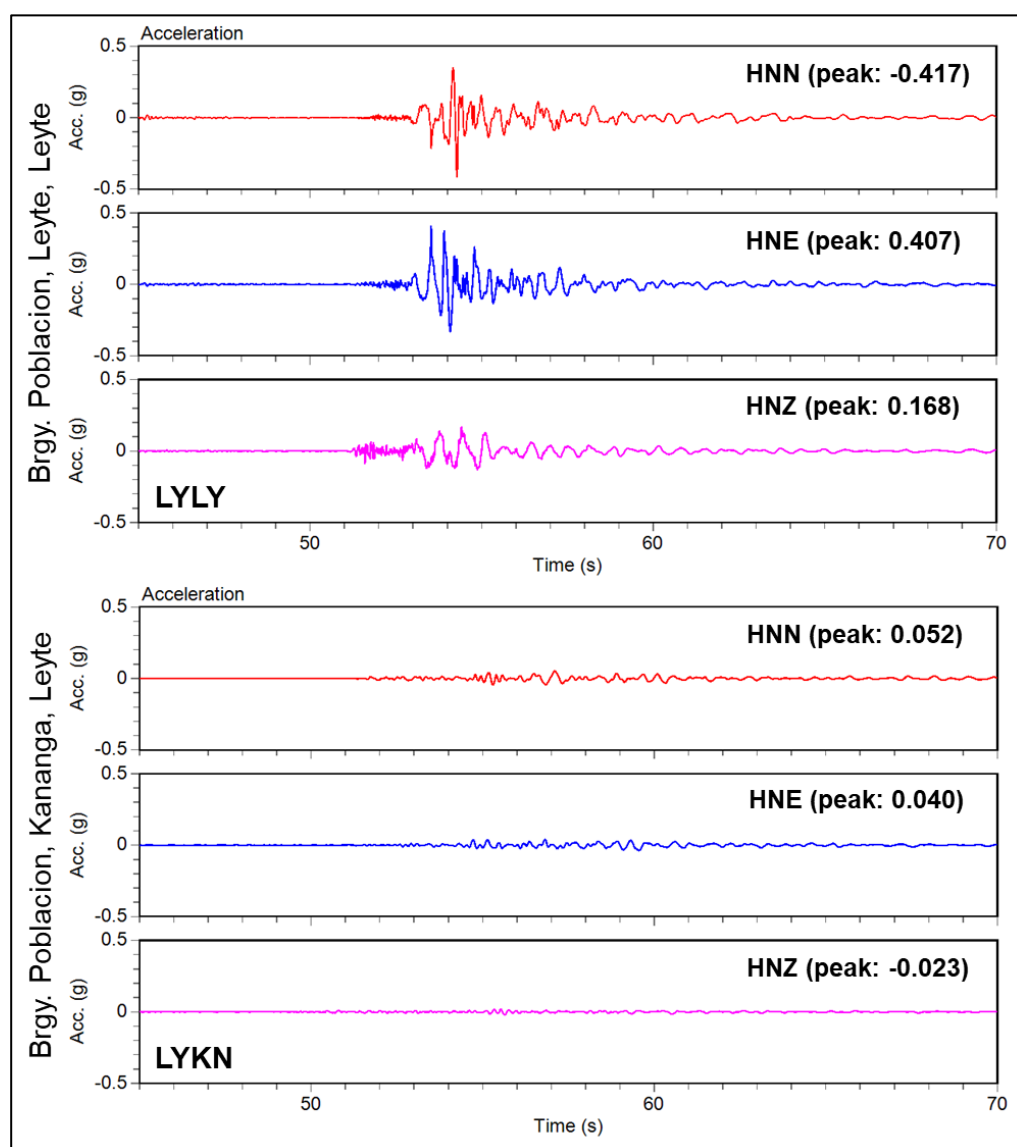
**Figure 3.** Peak ground acceleration (PGA) record from the Philippine Strong Motion Network (PSMNet) stations in Brgy. Poblacion, Leyte (Station code: LYLY) and Brgy. Poblacion, Kananga (Station code: LYKN). PGA value for the two sites corresponds to the expected ground shaking felt in the area and is influenced by the soft sediment subsurface as manifested by the geology and geomorphology of the area. Refer to Figure 2 for the location of the two (2) accelerographs.

For a more detailed assessment of the ground motion, data from two (2) accelerographs positioned near the epicenter were examined, both belonging to the Philippine Strong Motion Network (PSMNet) (refer to Figures 2 and 3). The first accelerograph (station code: LYLY) is located in Brgy. Poblacion, Leyte, and ~7 km NW of the epicenter recorded a peak ground acceleration (PGA) of 0.407 g equivalent to PEIS VIII (very destructive) [22] while the second accelerograph (station code: LYKN) located in Brgy.

The PGA value recorded in Brgy, Poblacion, Leyte (station code: LYLY) is relatively high (0.407 g) and is equivalent to PEIS VIII (MMI VIII) (Figure 2A and 3) [22]. This value seems to contradict the maximum earthquake intensity, PEIS VI (very strong), felt in areas along the trace of the fault based on reports and intensity surveys (Figure 2A). In some cases, recorded PGA value may be affected by local site amplification of the ground motion which may have been influenced by the subsurface geology of the area. LYLY is located in an area that is mainly overlain by thick sediments which is consistent with the

geology (alluvial deposits) and geomorphology (marshland) (Figure 2) [26]. Thus, site amplification is the reason why there was a relatively high PGA value recorded in Brgy. Poblacion, Leyte. A PGA value of 0.052 g was recorded in Brgy. Poblacion, Kananga (station code: LYKN), which is located ~16 km southeast of the epicenter (Figures 2A and 3), is equivalent to PEIS V (strong). This recorded PGA corresponds to the observed earthquake intensity felt in the area based on the intensity survey we have conducted (Table 1 and Figure 2A).

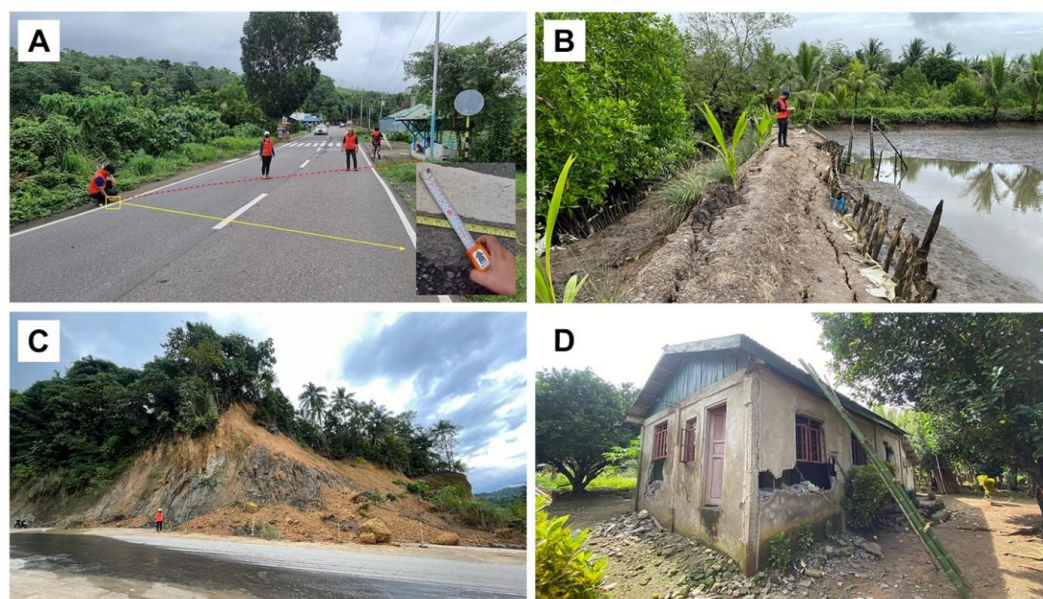
**Figure 4. Geologic and structural impacts of the 2023  $M_w$  4.7 Leyte, Leyte Earthquake.** (A) Observed road cracks (red line) along the national highway in Brgy. Poblacion, Leyte coinciding along the trace of the Philippine Fault – Leyte segment [11]. Inset: 2 cm left-lateral displacement measured along the offset road paint. (B) Lateral spreads (cracks) formed on the earth dikes beside fishponds in Palaypay District, Brgy. Poblacion, Leyte. (C) A shallow landslide consisting of soil rock and debris partly covered a road in Brgy. Calaguise, Leyte. (D) Damaged house (concrete hollow block) in Brgy. Belen, Leyte. Refer to Figure 2B for the location of photos.

It is uncommon for a magnitude  $< 6$  earthquake to have surface rupture [23, 24]. However, our field investigation revealed an 8-km-long northwest-trending discontinuous rupture associated with the 2023  $M_w$  4.7 Leyte, Leyte Earthquake that occurred along the previously mapped Philippine Fault – Leyte segment [11, 14, 15]. Detailed ground and drone surveys conducted during the investigation showed that the surface rupture affected at least three barangays (Brgys. Poblacion, Salog, and Ugbon) in Leyte (Figures 2B and 4A). The surface rupture was manifested as a continuous crack with discernable left-lateral displacement or parallel *en-echelon* visible cracks identified as Riedel shear structures. Measured displacements range from 1.5 to 2 cm. Figure 4A shows a portion of the surface rupture manifested as hairline cracks along a road with 2 cm horizontal displacement coinciding with the previously mapped active fault. Eyewitness accounts verified that the hairline cracks were caused by the earthquake. It also affected residential houses traversed by the active fault. These residential houses were also previously identified to be damaged by fault creeping in the past studies [14, 15]. A detailed discussion of this rare surface rupture is presented in Llamas et al. [25].

Documented liquefaction occurrences were limited to the marshlands with recent and alluvial deposits in the Palaypay District, Brgy. Poblacion, Leyte (Figure 2B) [26] and was near the epicentral area. In these sites, lateral spreads were observed along the earth dikes of a fishpond (Figure 4B). These dikes were made up of soil dug up from the adjacent fishponds. Ground cracks measuring up to 20 m in length and 4 cm of horizontal gaps were documented. These cracks are all nearly parallel to the length of the earth dikes and spread towards the fishponds. A house beside the fishpond was also damaged. Portions of the house sank in soil by 3 cm. According to the house owner, the house was built on top of the sandy fill dug out from the nearby fishpond. In other areas of the Palaypay District, ground failures also caused damage to some built-up structures. In two houses, the flooring of the houses is made up of concrete, sustained cracks, sank, and tilted towards the nearby marsh. In another two houses, the comfort rooms made of CHB also sank and tilted.

In the absence of sediment and water venting (or sand boils), it is difficult to attribute the lateral spreads and structural damages solely to liquefaction. The lateral spreads of the earth dikes may be gravity-driven, and the tilted CHB structures and damaged concrete floorings may just be poorly built. To determine if liquefaction could have caused these impacts, soil samples up to 3.5 m deep from the marshlands in Palaypay District were collected using a hand auger for grain size analysis.

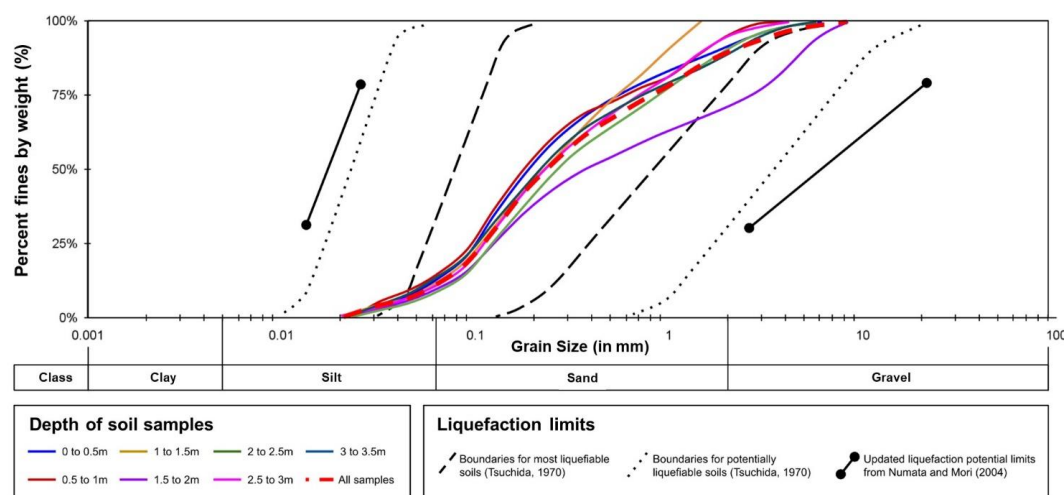
**Figure 5.** Grain size analysis of soil samples taken on the earth dikes that liquefied in Palaypay District, Brgy. Poblacion, Leyte with liquefaction limits set by [27 and 28].

Figure 5 shows the summary of the grain size analysis of soil samples we have collected and compares it to liquefaction limits on grain sizes suggested by Tsuchida [27] and Numata and Mori [28]. The majority of the collected soil samples have grain sizes ranging from very fine to very coarse sand (0.0625 to 2.0 mm) and are within the boundaries of most liquefiable soils (Figure 5) [27, 28, 29]. While the soil sample collected from 1.5 to 2 m depth has 30% of its grains that are granule-pebble sized (2.0 to 8.0 mm), this is still within the boundary for potentially liquefiable soils. With these soil properties and geomorphology coupled with the measured PGA of 0.407 g (recorded by LYL, 500m from Palaypay

District) (Figure 2A and 3), and as evidenced by subsidence and tilting of some buildings and lateral spreads on some earth dikes, we are therefore more certain that liquefaction occurred in these soils.
