# Micro and Macroscopic Analysis of Fatigue Wear of Gear Wheel Top Layer—An Impact Analysis of Thermochemical Treatment

**Abstract:** An analysis of form and size of the fatigue wear of gear wheel top layer of the prototype oil pump (type 3PW-BPF-24) is presented in the publication. The object of research was subject to endurance tests, so called labour resource test. During this test the pump was loaded in cycles with maximal working pressure. Additionally, continuous monitoring tests of exploitation and environmental parameters were conducted. After a completion of the endurance test the noticed superficial defects due to a phenomenon of the top layer fatigue and previously applied thermochemical treatment were measured and described. The work was finished with an analysis of obtained results and conclusions concerning a selection optimization of the thermal treatment parameters. Taking into consideration the presented results (suggestions) in the technology of improving strength properties of gear wheels (of this type oil pumps) may render it possible to obtain an appropriate fatigue endurance of the top layer, i.e. a minimization of observed superficial defects.

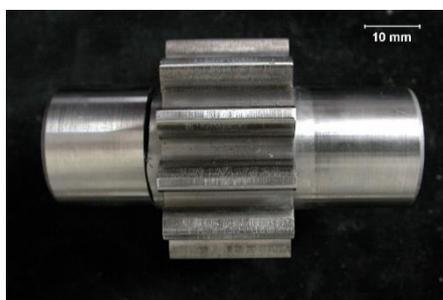
**Figure 1.** General view of gear wheel [42].

On the external surface of teeth both sides, the traces of exploitation in a form of chippings and of working surfaces wear – Figure 1 [42] were seen.

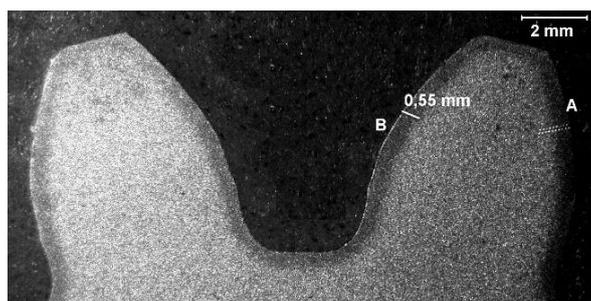
- the thickness of carburized layer (after mechanical working): 0.5-0.9 mm (marked in Figure 2);
- the core hardness: 29-42 HRC;
- the hardness of top layer of working surfaces: 60-64 HRC.

**Figure 2.** Tooth cross-section (visible changes of macrostructure resulting from the applied thermochemical treatment) [42].

The values given above were not fully reached due to high contents of residual austenite (which is described in a further part of this elaboration).

After cutting off a specimen perpendicularly to the tooth generating line, after its regrinding and pickling with use of the reagent Mi1Fe acc. to PN-H-04503:1961, some changes of macrostructure resulting from an application of the surface thermochemical treatment to the depth of about 0.55mm, shown in Figure 2 [42], were noticed. Additionally, the macroscopic analysis of external surfaces of the gear wheel also showed a presence of micropitting, which is a minute kind of superficial damage. Micropitting is caused by contact stress and cyclic loading which leads to a generation of microdamages on the surface of teeth. An occurrence of micropitting may indicate inappropriate operational of constructional parameters of the gear wheel.

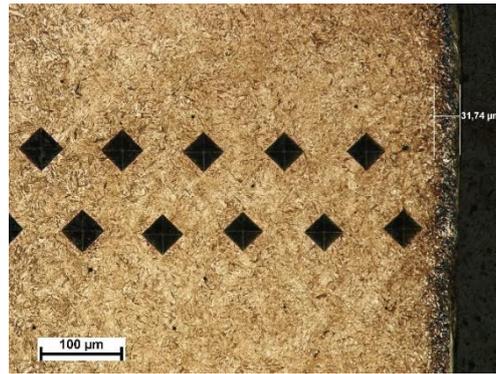
After pickling with the reagent Mi1Fe a structure typical for carbonized, heat treated objects was seen. A determination of a conventional depth of hardening after carbonization was carried out by a measurement of hardness at the cross-section along the normal to the carbonized surface, in the direction from the surface to the inside of material according to the standard PN-EN ISO 18203:2022-09. The measurements were taken with use of the Vickers method in the conditions according to PN-EN ISO 6507-1:2018-05. The Zwick 321 hardness tester, the load of 1 kG (9.807 N) acting within the time of 15 s, was applied. An average core hardness from five measurements, made with use of the Vickers method, is 445 +/-3.25HV1 [42].

The depth of the tooth carbonized zone from side A is about 593  $\mu\text{m}$ . An occurrence of about 30% residual austenite and then low-temperature tempered, fine acicular martensite of gradually decreasing carbon contents were detected – Figure 3. A cracked, strongly deformed layer of the thickness about 9  $\mu\text{m}$  was seen on the tooth surface - Figure 4 [42].

**Figure 3.** View of carbonized and hardened layer on the specimen cross-section from the A side with indentations of hardness distribution measurements and the layer of residual austenite (light microscopy, Mi1Fe pickling) [42].

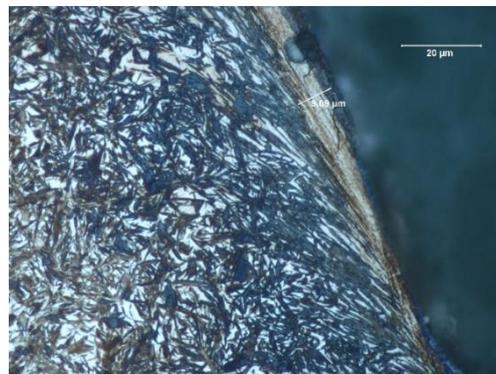
**Figure 4.** View of carbonized and hardened layer on the cross-section of the specimen from the A side - martensite with residual austenite with strongly deformed and cracked layer of the thickness about 9 μm (light microscopy, Mi1Fe pickling) [42].

In relation to the information given above, it is recommended to apply additional heat treatment, in a form of sub-zero treatment which will enable an efficient minimization of the residual austenite contents, an improvement of hardness and a dimensional stabilization which will contribute towards an extension of the pinion life and an improvement of its useful properties.

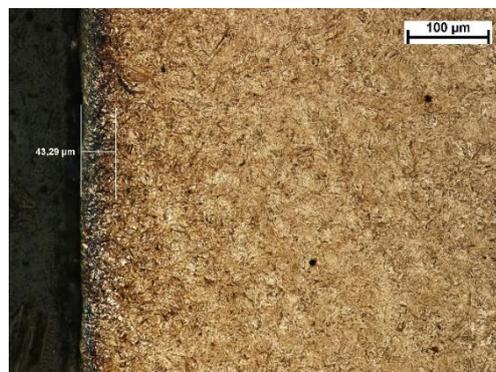
The depth of the tooth carbonized zone from the B side is about 542 μm. In the close-to-the-surface zone from the B side to the depth of about 43.29 μm an occurrence of about 30% residual austenite and then low-temperature tempered, fine acicular martensite of gradually decreasing carbon contents were seen - Figure 5. A cracked, strongly deformed layer of the thickness about 7 μm was detected on the tooth surface - Figure 6 [42].

**Figure 5.** View of carbonized and hardened layer on the specimen cross-section from the B side with indentations of the hardness distribution measurements and the layer of residual austenite (light microscopy, Mi1Fe pickling) [42].

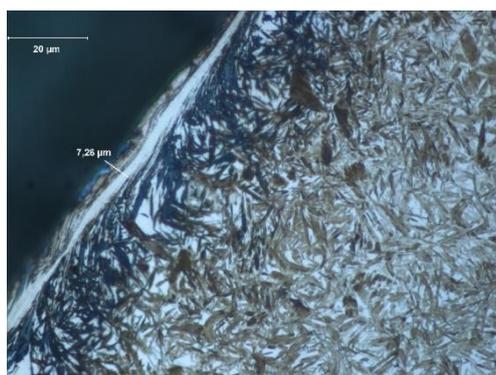
**Figure 6.** View of carbonized and hardened layer on the specimen cross-section from the B side-martensite with residual austenite with strongly deformed and cracked layer of the thickness about 7.3  $\mu\text{m}$  (light microscopy, Mi1Fe pickling) [42].

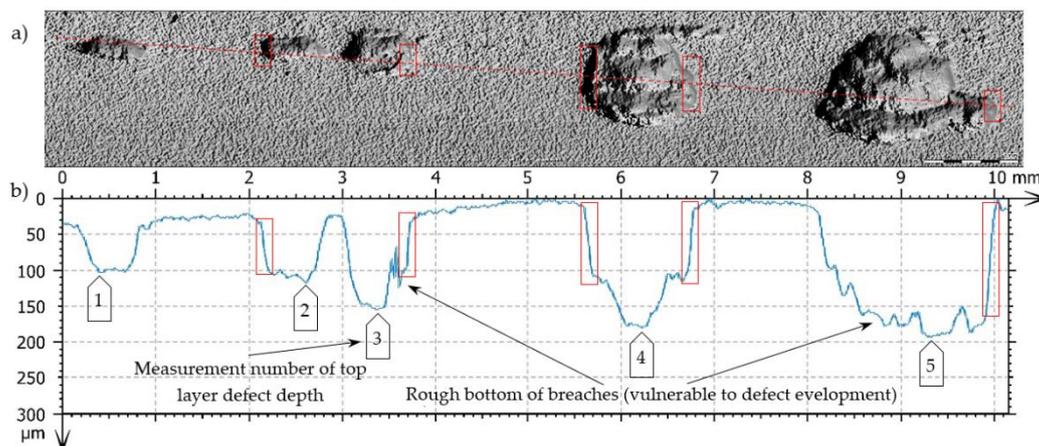
In the result of taking superficial scans 3D superficial fatigue damages (characterized by breaches of oval shapes and sharp edges, inclined perpendicularly to the surface of the teeth under analysis) - Figure 8, were diagnosed.

**Figure 8.** Fatigue pits (pitting) on the tooth working surface - magnification 5x; a) photo simulation, b) profile curve, - - - - line of cross - section, □ - indication of breaches edges inclined to the surfaces, subject to analysis at the angle close to 90° on the cross-section.

The main reason of generating this type of breaches includes exceeding of limiting contact stresses of the teeth collaborating surfaces. The degree of tolerating this kind of defects (their number, size and arrangements) depends mainly on the application area. In this case (at an assumption of the forecasted pump life due to a degradation development of the top layer of collaborating teeth), it does not have any big significance. Pitting breaches in the scope of dimensions 0.1-1.5 mm (Figure 8) and

even to 2.5 mm (Figure 9) do not exclude the pinion from its further (but temporary) exploitation. It should be borne in mind that correct filtration should be ensured. In this case a high pressure filter of exact purification should be installed directly after the pump to prevent against a failure of valves and receivers situated in the hydraulic line between the pump and the tank, caused by solid impurities.

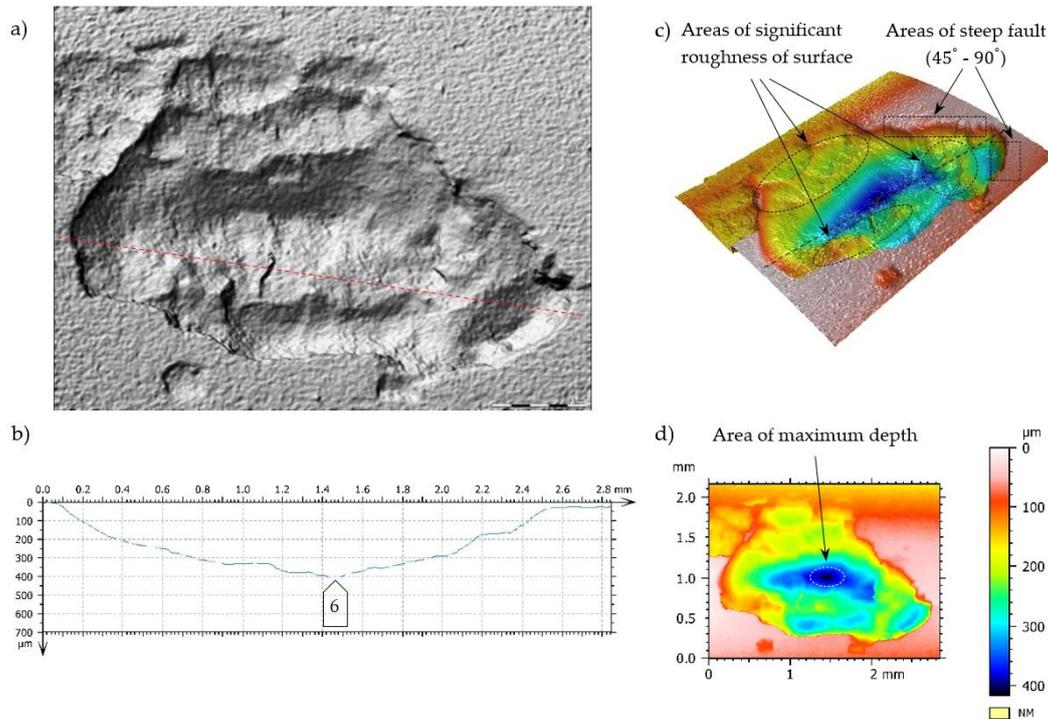
The observed breaches, generated in the result of the material chipping, have different dimensions, rough bottom and they occur locally or on a much smaller scale but on a bigger tooth surface (micropitting) - in particular below the pitch diameter of pinion. A linear arrangement of described defects was observed in some places - Figure 9.

**Figure 9.** Fatigue pit (pitting) on the tooth working surface - magnitude 5x. a) photo simulation, b) profile curve, c) and d) 3D superficial view - pseudocolour of surface with the depth visualization, - - - - lines of cross-section.

An advancing chipping of the material particles, which is presented in Figure 9 can lead, in extreme conditions, to a reduction of the teeth working surface to a degree which will make a further transmission of loads (in the case of gears) impossible. In some situations teeth of carbonized wheels can change their shape to the degree leading to their significant wear or even fracture in the result of pitting. Carbonized and hardened teeth of wheels, which were subject to pitting in the area of the tooth root connected with a significant wear, are vulnerable to fracture. The reason is an initiation and a development of fatigue cracks in the pits generated where the crumbled away material was. A significant noise accompanies an operation of gear wheels with considerable pitting [43].

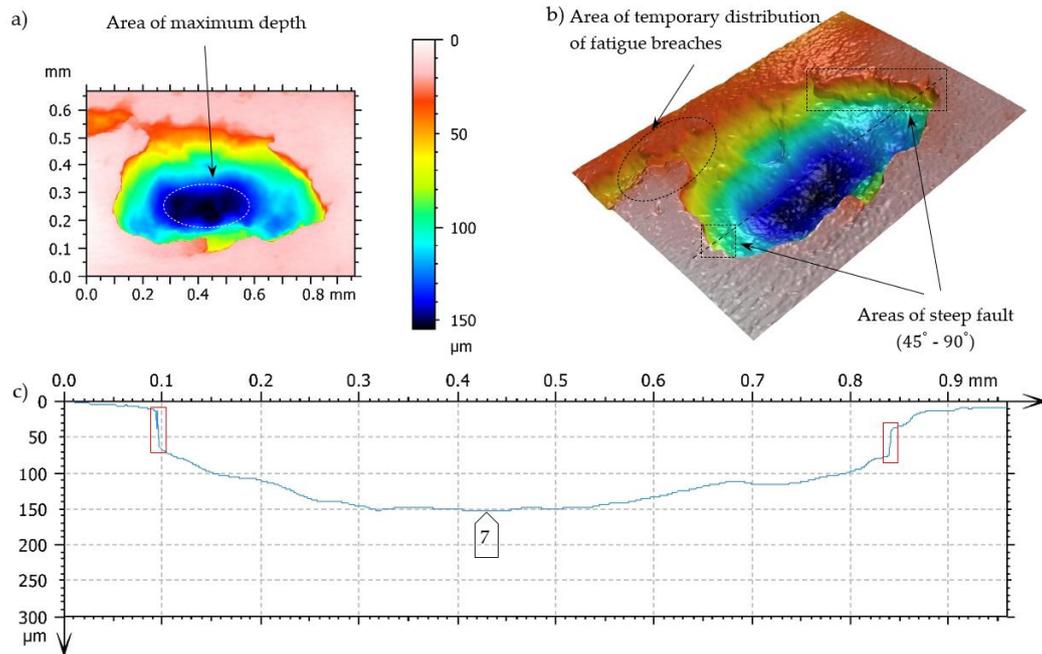
A surface increase of pitting cavities is caused very often by their mutual connecting. In Figures 10 and 11 the limiting state before a connection of two fatigue breaches is presented.

**Figure 10.** Fatigue pit (pitting) on the tooth working surface - magnitude 10x. a) and b) superficial 3D view - pseudocolour of surface with visualization of depth, c) profile curve, ----- cross-section line,  $\square$  - indication of breaches edges, inclined at the angle close to  $90^\circ$  to the surfaces under analysis, on the cross-section.

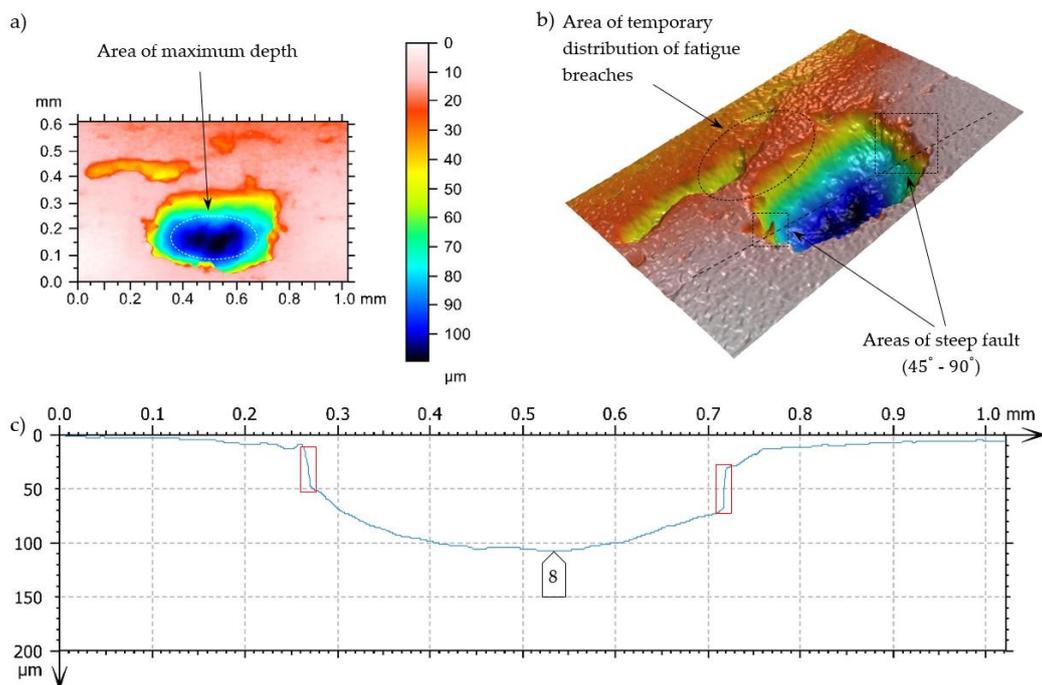
**Figure 11.** Fatigue pit (pitting) on the tooth working surface - magnitude 10x. a) and b) superficial 3D view - pseudocolour of surface with visualization of depth, c) profile curve, ----- line of cross-section,  $\square$  - indication of breaches edges, inclined at the angle close to  $90^\circ$  to the surfaces under analysis, on the cross-section.

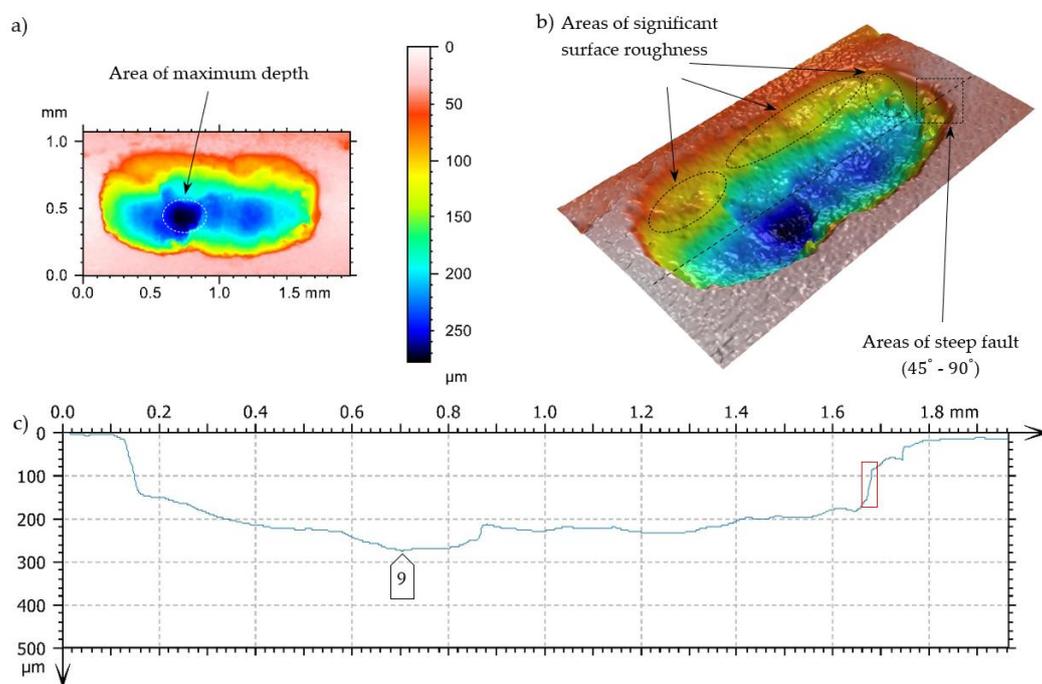
Destructive pitting develops naturally from non - destructive pitting, micropitting and that one in turn from a dull finish of surface and imperfections in the top layer of collaborating teeth. An essential issue also concerns a characteristic of chipping (Figures 8–12) as well as a relationship between its depth and thickness of the top layer, subject to heat treatment, thermochemical treatment. The present measurement technologies (optical metrology) enable to check a real depth of this type defects.

**Figure 12.** Fatigue pit (pitting) on the tooth working surface - magnitude 10x. a) and b) superficial view 3D - pseudocolour of surface with visualization of depth, c) profile curve, ----- line of cross - section,  $\square$  - indication of breaches edges, inclined at the angle close to 90° to the surfaces under analysis, on the cross-section.

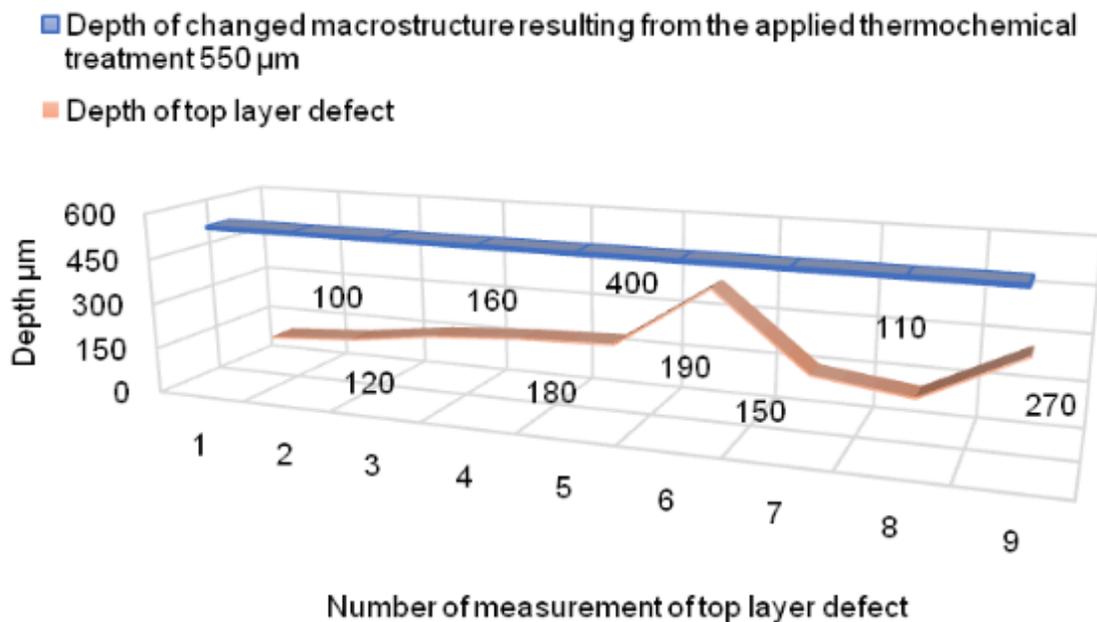
In the cases under analysis the defect depth of the top layer did not exceed the depth of layer subject to thermochemical treatment. A location of all the chippings is enclosed in the scope of the zone, having the structure of low-temperature tempering, fine-acicular martensite of comparatively decreasing carbon contents. The measurement data from Table 2 are graphically presented in Figure 13.

Figure 13. Graphical presentation of the data from Table 2.
