# Analysis of the 2022 El Tejado Ravine Mudflow (Quito, Ecuador) from the Sedimentological and the Published Multimedia Documents Approach

Posted Date: 23 April 2024

doi: 10.20944/preprints202404.1489.v1

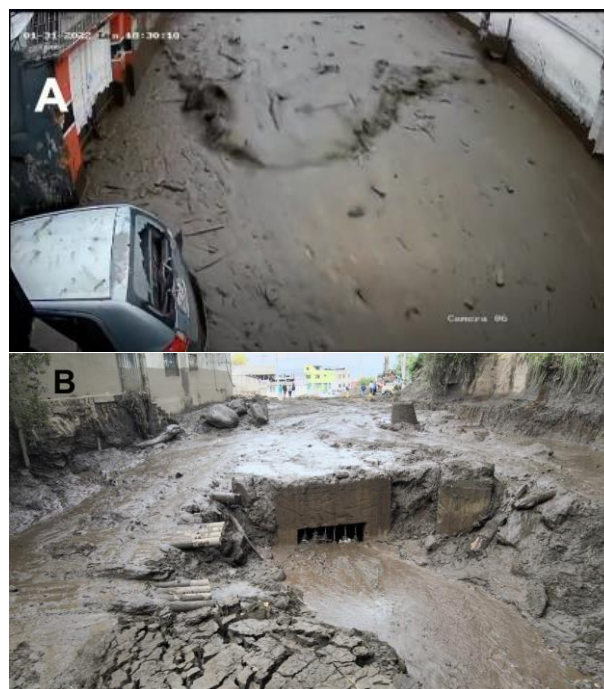
On Monday, January 31, 2022, between 6:00 PM [14] and 6:30 PM [15], local time, a mudflow was reported that overflowed the catchment structure (sewage collector) at the actual end of the El Tejado ravine in the urban boundary of the MDQ (Figure 2).

**Figure 2.** The mudflow crossing the Nuñez de Bonilla Street (A), picture extracted from ECU-911 video footage surveillance camera. Detail of the remained mud on the sewage collector at the end of the El Tejado stream after the mudflow pass. January 31, 2022 (B), obtained from [16].

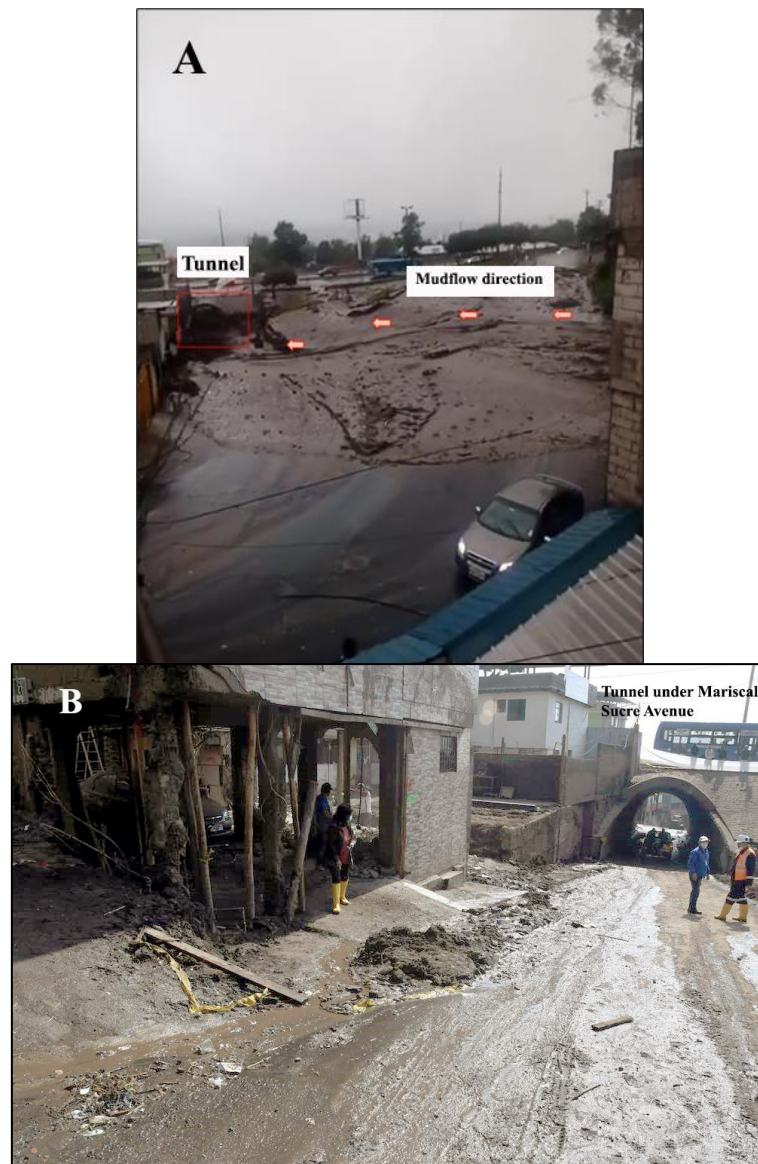
The analysis of the multimedia images and footage determined that only two videos were helpful for the analysis of the flow behavior [20]. The entrance of the mudflow to the urban area through José Berrutieta Street could be identified, and it was characterized as a continuous flow with a high sediment load and high energy (Figure 9A). The estimated surface velocity was 4 to 5 m/s by mapping specific frame points.

It must be emphasized that the flow showed a high carrying capacity, evidenced by the damage to the buildings in the sector and the height of the flood footprint [17]. A change in flow behavior was also determined by the increase in speed and energy caused by its passage through a tunnel under Mariscal Sucre Avenue (approximately 6.0 m in diameter; Figure 9B). That was evidenced in the dragged and transported vehicles, tree trunks (up to 3 m long), mesh fences, and 1.5 m in size rubble.

**Figure 9.** (A) The video frame shows the flow entering José Berrutieta Street through the tunnel and the flow direction from the existing clogged collector (right side of the picture behind the wall) [20]. (B) Damage and affected homes west of the La Comuna and the tunnel section (see vehicle size for scale) under Mariscal Sucre Avenue [17].

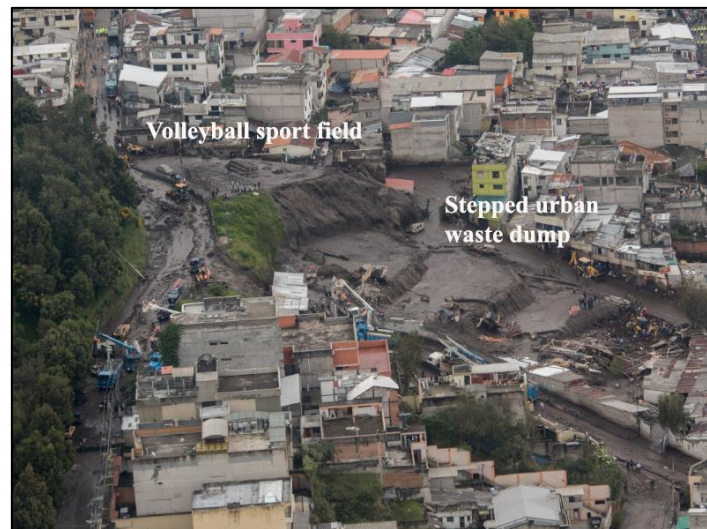
In this section, the flow presented a different behavior than the previous flow and the Southern Axis because, to the east of the volleyball sports field, there was a  $35^\circ$  inclination slope and 8 m high from the first step to the down next level. Under the volley field, there was a stepped waste dump with material of unconsolidated urban origin (presence of construction remains, pipes, plastics, and others) of  $2100 \text{ m}^2$  ( $\sim 6000 \text{ m}^3$  in volume) approximately (Figure 11). That slope caused a cascade effect

**Figure 11.** The volleyball sports field and the stepped urban waste dump are at the beginning of the so-called North Axis and N24C Street. Modified from [29].

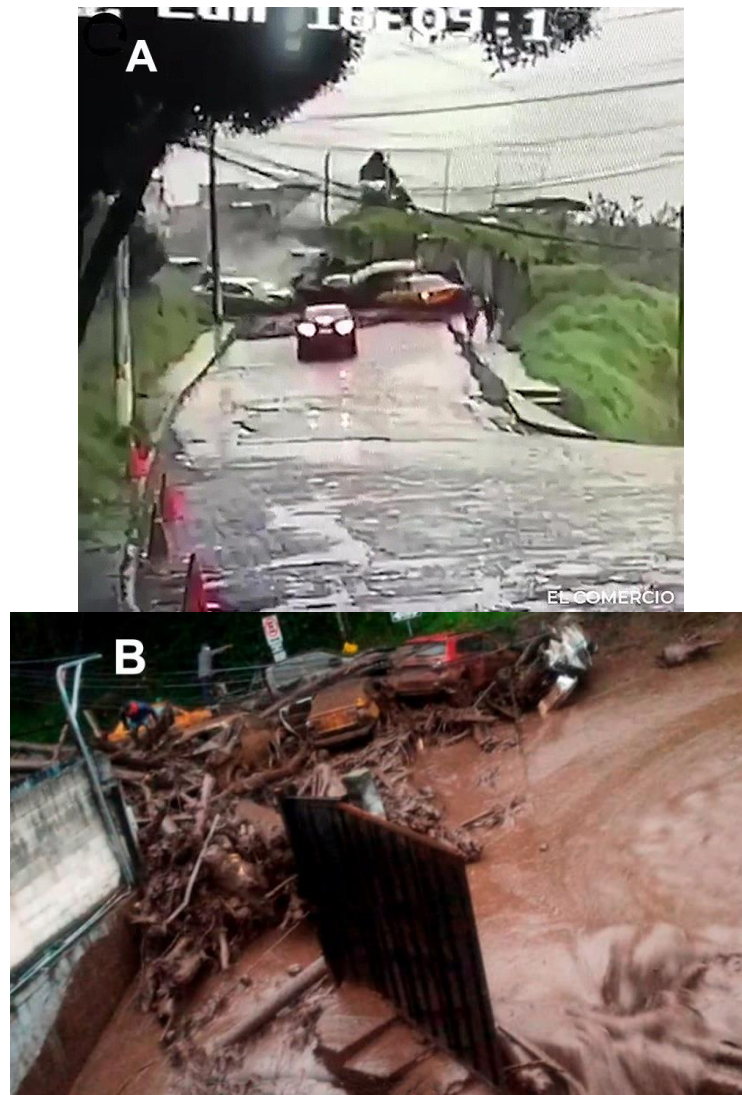
In the area where the main axes were divided, it could be observed that the flow moved south along José Berrutieta Street, forming a kind of barricade of tree trunks and vehicles that prevented its entry into a residential complex, the Colinas de La Gasca urbanization (Figure 14) and continued its journey with heading southeast, along the same street, until it reached La Gasca Avenue.

A video recorded by a private security camera located on José Berrutieta Street (UTM: 776953.9E, 9978729.3S) indicates that the start of the event south of the volleyball sports field and prior to the formation of the barricade was at 6:09 PM (with also a high degree of uncertainty because there is no information about the camera's time calibration). In addition, it can be seen that the flow advance has a high energy, evidenced by the towing capacity of several vehicles (which was part of the barricade at the entrance to the habitational complex; see Figure 14A,B).

**Figure 14.** Barricade formed by tree trunks and vehicles on José Berrutieta Street. (A) Obtained from [30]. (B) Picture obtained from a private security camera (80-CJB), frame: 444/613 [29].

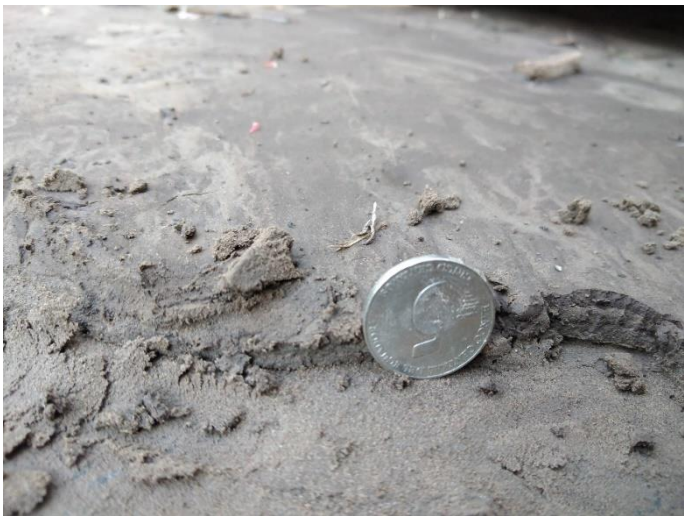
The furthest deposit was identified approximately 3.0 km from the collector on Cristóbal Colón Avenue, which is made up of fine sand and has less presence of organic matter (tree bark, leaves, small branches, and vegetation) and garbage. The deposit was less than 1 cm thick (Figure 16).

**Figure 16.** Deposit-related thickness to the mudflow is located east of the distal zone, approximately 3.1 km from the collector (five cents coin diameter is 21 mm).

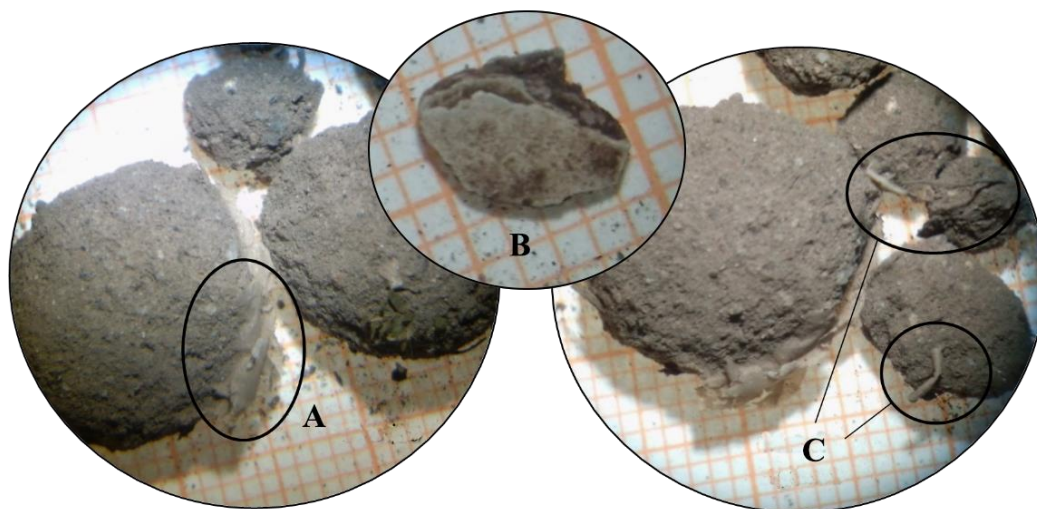
**Figure 17.** Fine gravel-sized silt aggregates in M2 sample (retained particles in sieve #4). (A) Plastic piece. (B) Undefined anthropic material. (C) Organic matter.
