Characterization of Micro-threaded Stem Taper Surface of Cementless Hip Endoprostheses

[Drago Dolinar](#) , Boštjan Kocjančič , Klemen Avsec , [Barbara Šetina Batič](#) , [Aleksandra Kocijan](#) , [Matjaz Godec](#) , [Mojca Debeljak](#) , [John T Grant](#) , [Timon Zupanc](#) , [Monika Jenko](#) *

Posted Date: 13 May 2024

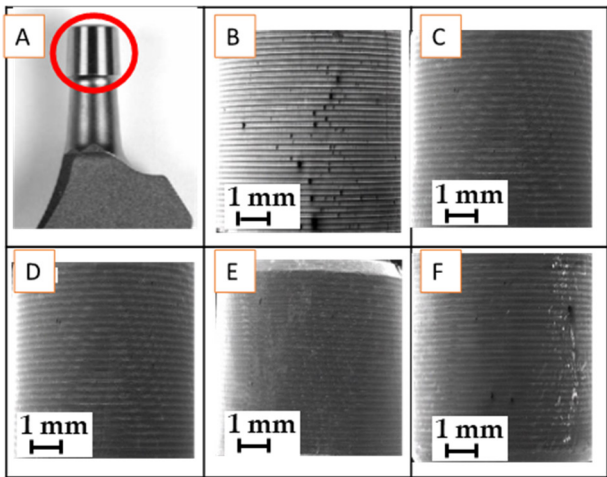
Figure 2. (A) micro threaded 12/14 stem taper, new Smith & Nephew, (B-F): 11x magnification SEM/SE images of different ZM 12/14 tapers and different manufacturers: (B) Allocasic Varial new, (C) Lima new, (D) retrieved I-212-32-month, Smith & Nephew, (E) retrieved I-31-129-month, Smith & Nephew, and (F) retrieved A383-239 month, Endoplus.

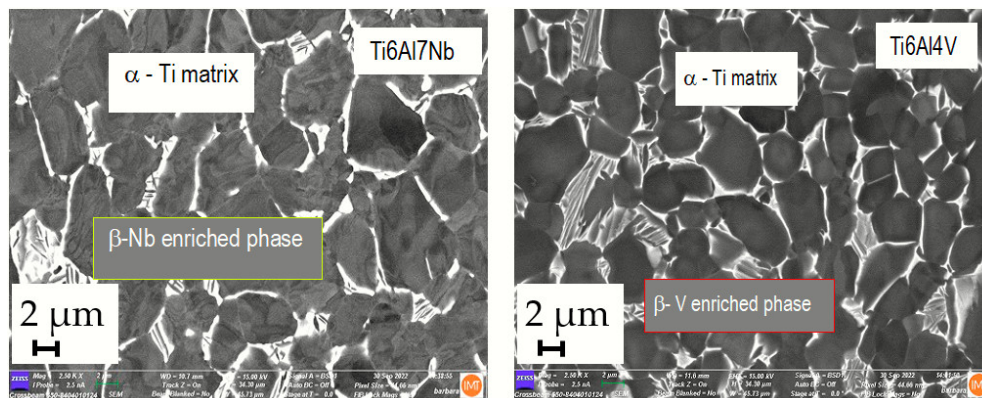
The microstructure of the stem taper of the implants manufactured from Ti alloys (Ti6Al7Nb and Ti6Al4V) is shown in Figure 3. A dual-phase microstructure is observed in the matrix, Ti phase is α -Ti (dark grey) and the Nb-rich or V-rich phase (light grey) is β -Ti (Figure 4). The dual-phase structure is confirmed using the EBSD method (Figure 5).

Figure 3. SEM/BE image of Ti6Al7Nb alloy microstructure (A283). It consists of two phases ($\alpha + \beta$). α -phase (dark) represents the matrix which has a close-packed hexagonal crystal structure (hcp), and the β -Nb-enriched β phase (white) in the body-centered cubic structure. (b) SEM/BE image of Ti6Al4V alloy microstructure of new Lima stem. α -phase (dark) represents the matrix, β phase V-enriched phase (white) at M2500.

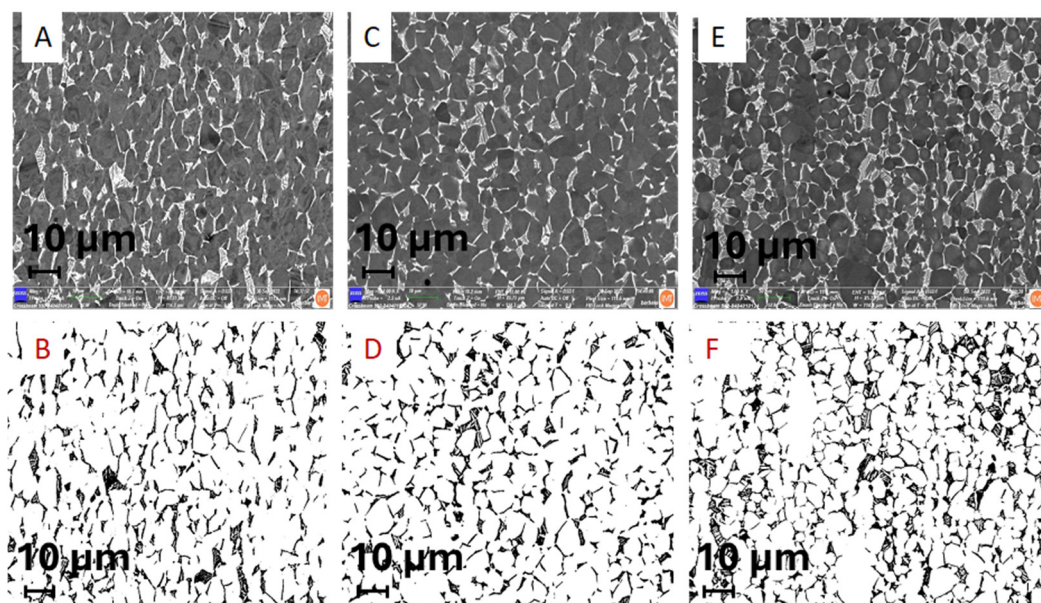
Figure 4. (A-B) BE/SE image of dual phase microstructure ($\alpha + \beta$) and their distribution of a stem taper retrieved after 239 months (ENDOPLUS, London, UK) prematurely failed due to aseptic loosening Ti6Al7Nb alloy A-283, M1000; (C-D) SEM/BE image of dual phase microstructure ($\alpha + \beta$) and phase distribution in stem taper prematurely failed after 3 months due to infection, I-31 Smith & Nephew (London, UK), M1000, (E-F) SEM/BE image of dual phase microstructure $\alpha + \beta$ and their distribution of new stem taper Lima, made of Ti6Al4V alloy, M1000 β -phase in the row below(b, d, e) is black. The amount of α (Ti, Al, O, N, matrix) and β (Nb or V enriched phase) is represented in Table 2.

Ti implant alloys have a dual-phase microstructure ($\alpha + \beta$). Their distribution was estimated using a field emission scanning electron microscope by SE (secondary electron image) and BE (backscattered electron image. Results are shown in Figure 4 and Table 2.

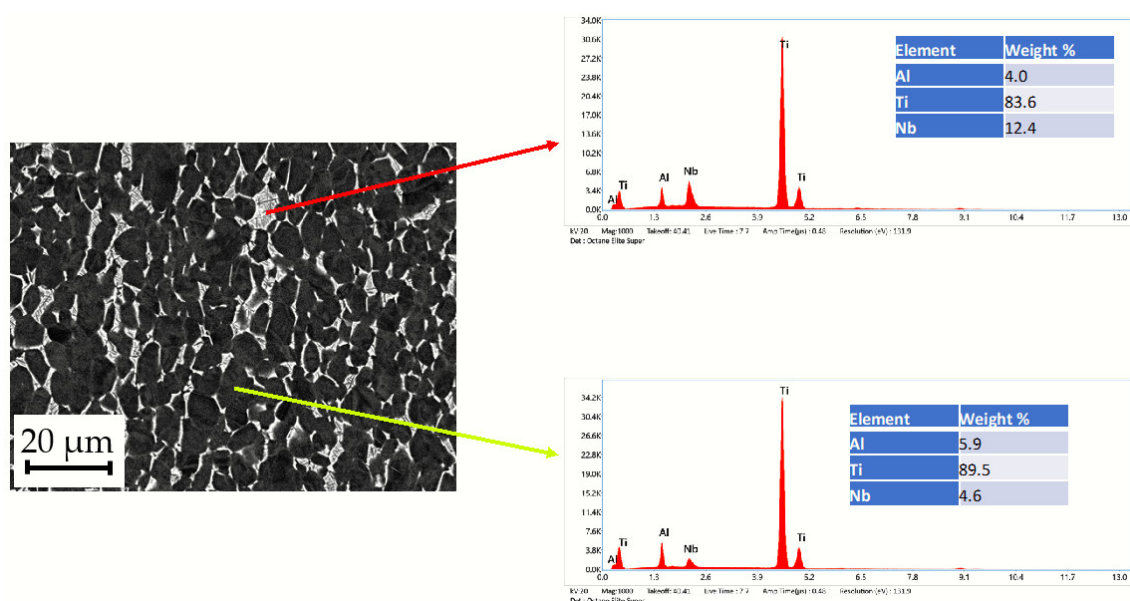
Figure 7. (a) SEM/BE image of A-283, Ti6Al7Nb alloy, stem-taper of the hip endoprosthesis, survivorship 239 months, aseptic loosening, microstructure dual phase is observed (b) Ti X-ray signal intensity, (c) Al X-ray signal intensity, (d) Nb X-ray signal intensity.

The SEM/EDS images of the surface chemistry are shown in Figure 7. The selected stem taper with a survivorship of 239 months, prematurely failed due to aseptic loosening. The typical ($\alpha + \beta$) dual-phase Ti6Al7Nb alloy is shown in Figure 7 a. Figure 7 b shows the distribution of Ti in the sample, (c) EDS mapping shows the distribution of Al in the microstructure and (d) SEM/EDS

mapping shows the distribution of Nb. We may conclude that the major dark grey phase is the Ti matrix, α -phase, and the light grey phase, enriched with Nb is the β -phase.

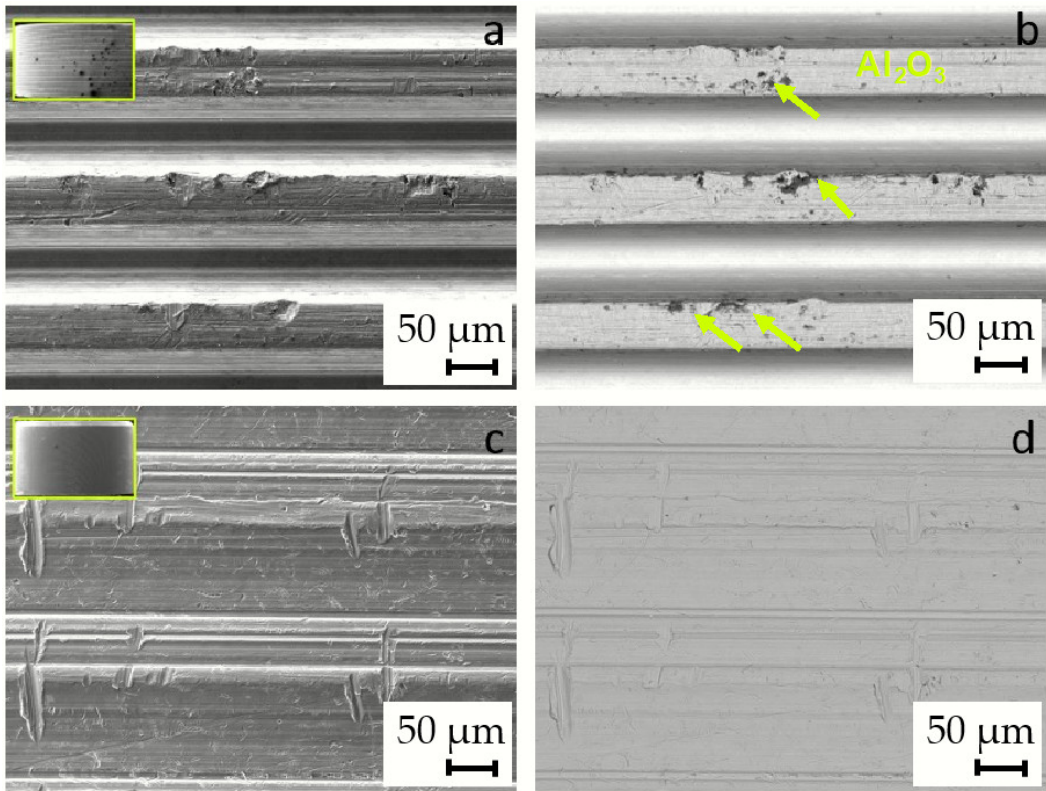
The images of the new, unused implants show some signs of abrasive damage and wear, which is attributed to the manufacturing process as seen in **Figure 8**. Some dark particles are visible in the backscattered electron images (BE), in the case of the Alloclassic implant (**Figure 8(b)**), while in the case of Lima Corporate implant taper, the surface seems rough, but no particles are visible in the (sub)surface area.

Figure 8. Images of the surface of the new, unused tapers. (a): SE image of Alloclassic new, (b) BE image of Alloclassic new; the remains of grit blasting are observed, dark particles, marked with yellow arrows, (c) SE image of Lima Corporate new, and (d) BE image of Lima Corporate new.

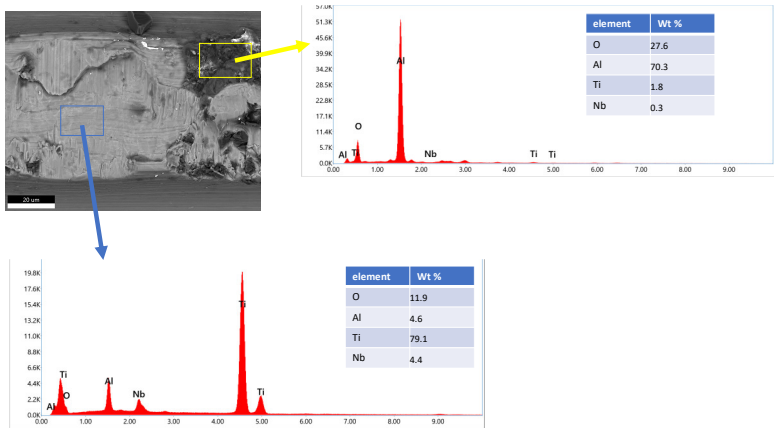
To identify the dark particles in the BE image of the Alloclassic taper part of the implant, we performed SEM/EDS mapping of a selected area. As is evident from the image in **Figure 9(b)**, the black particles are remnants of corundum (Al_2O_3) sandblasting that was performed as a finishing step in the taper manufacturing process. Additionally, the dual microstructure of the titanium alloy can be seen.

Figure 9. EDS analysis of a selected area of new Alloclassic taper (a) BE image of the area, yellow box indicates the remnants of Al_2O_3 (corundum) of micro threaded blaster finishing, blue box shows the matrix Ti6Al7Nb alloy.

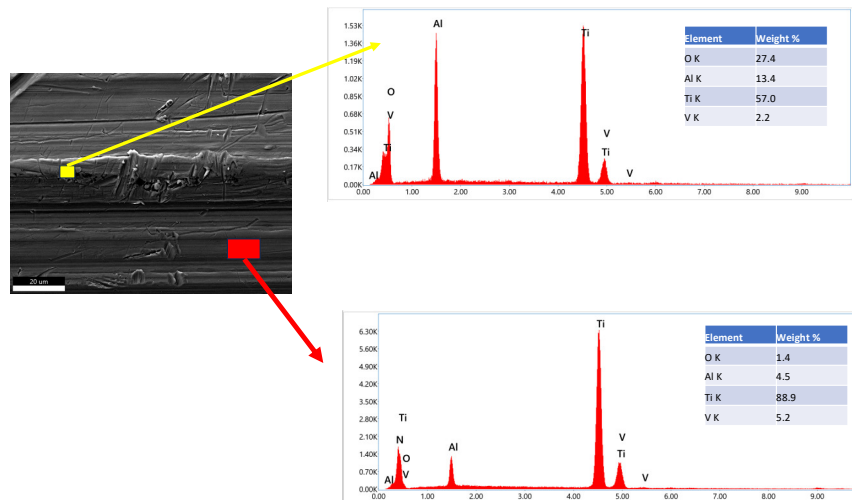
On the other hand, the new implant Lima Corporate, does not show larger dark particles that are visible in the backscattered electron image. The surface of the new implant nonetheless shows signs of abrasive wear, as is evident from **Figure 10**.

Figure 10. Surface damage (abrasive wear) of a new, unused Lima Corporate taper part of the implant. EDS mapping shows evidence of corundum Al_2O_3 particles implanted in the material due to the manufacturing process of the implant.

The new, unused tapers of the implants do not have a smooth surface, in both cases, and there is evidence of deposited material (Al_2O_3) from sandblasting, and mechanical wear damage is visible in both cases. It has been shown that corundum Al_2O_3 sandblasting remains from the process and affects the corrosion properties and can lead to an increased number of infections [11,12].

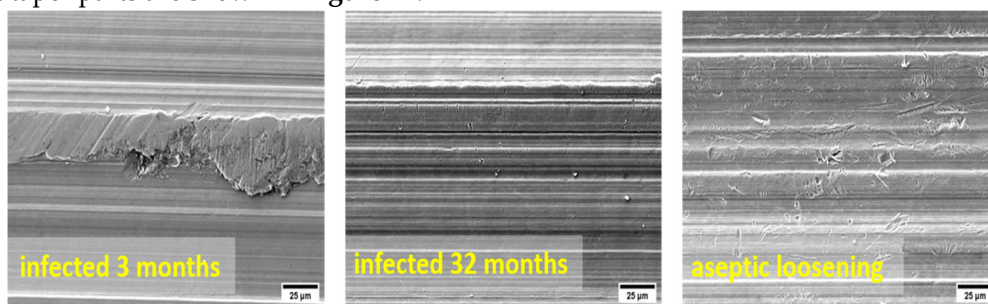
Three failed implants were chosen for examination with SEM/EDS. Two implants prematurely failed due to infection, the first one after 32 months and the second after 129 months, while the third implant failed because of aseptic loosening after 239 months. The images of the surfaces of the implant taper parts are shown in **Figure 11**.

Figure 11. SE images of the surface of the three failed implants. The surface area shown in the figures is $230 \mu\text{m} \times 170 \mu\text{m}$.

The surfaces of prematurely failed implants show signs of abrasive wear, like the new, unused implants, mainly due to machining and further sandblasting, as seen in **Figure 12** and **Figure 13**. No cracks or oxidation products are visible on the implant surfaces. Additional abrasive wear (most prominent in the case of the implant that failed due to aseptic loosening) could also be attributed to the revision surgery.

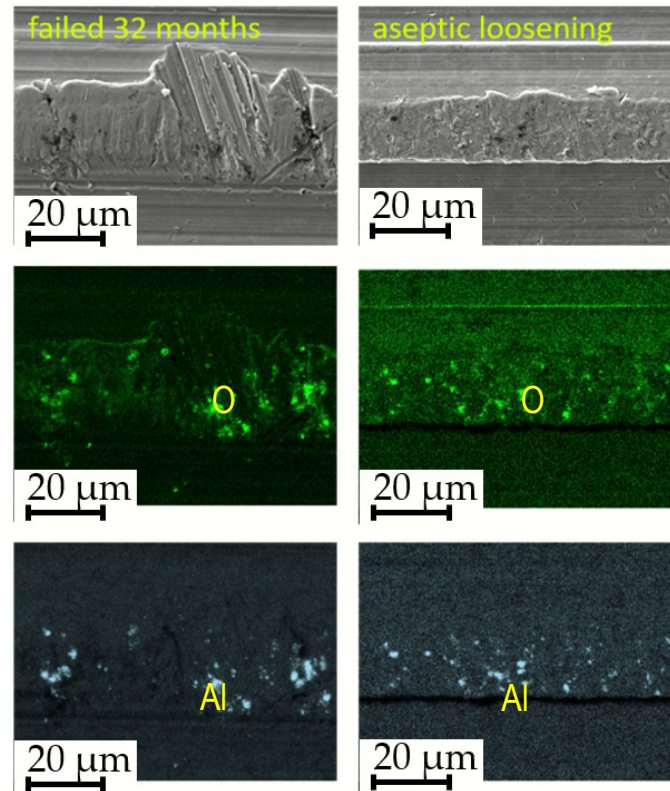
Figure 12. Evidence of corundum remains in an infected implant that failed after 32 months and an aseptically loosened implant after 239 months.

EDS mapping showed that there are some remnants of corundum in the subsurface layers of the failed implants, as is seen in Figure 12. The corundum remains are clustered, and the particle sizes are up to approximately 10 µm in diameter, with a similar distribution compared to the new Lima implants. No large particles (such as in the case of a new Alloclassic implant) were found on the examined surfaces of the failed implants. This is most evident from large-scale backscattered electron images, shown in Figure 13, upper panel. Only at higher magnification (lower panel of Figure 13, it

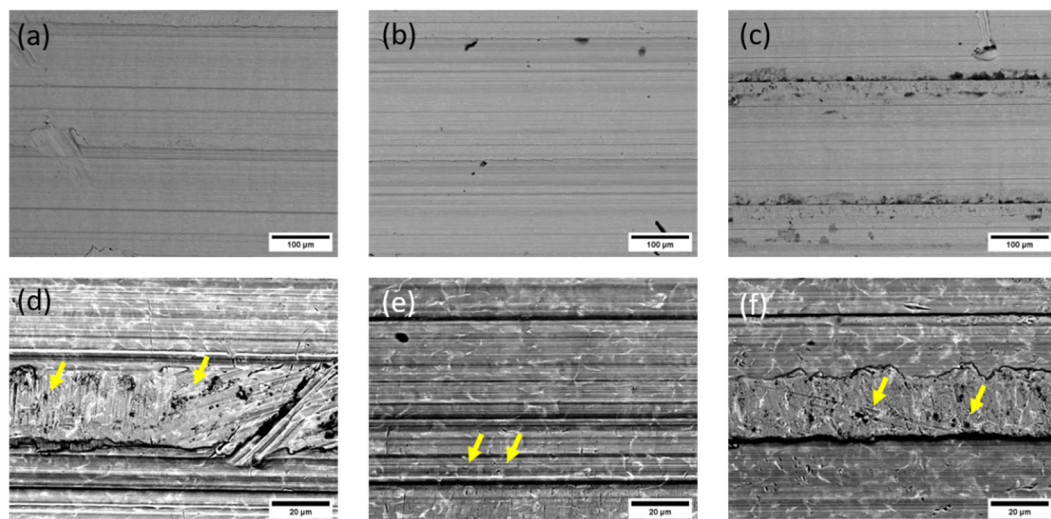
Figure 13. SEM/Backscattered electron images (BE) of the failed implant surfaces; (a) and (d) infected implant, failure time 3 months; (b) and (e) infected implant, failure -32 months; and (c) and (f) failure due to aseptic loosening after 239 months—the arrows in the lower panel point to locations of embedded corundum particle clusters.

is possible to distinguish individual clusters of small embedded corundum particles. In all implants, no signs of corrosion or cracks due to fretting were observed.

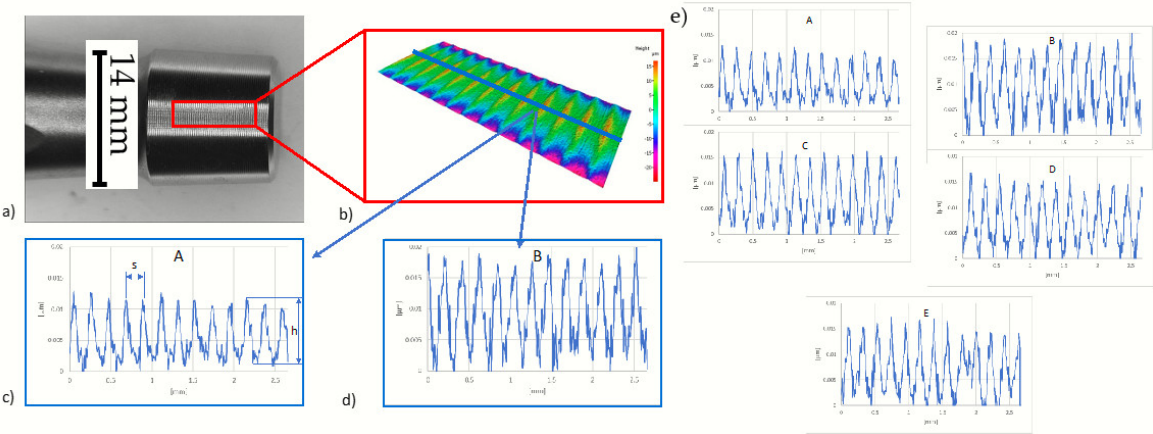
Figure 14. a) Image of male steam taper, b) 3D pseudo profile picture c) 2D roughness profile of stem A and d) 2D roughness profile of stem B, e) roughness of all five investigated stem tapers collected in Table 3.

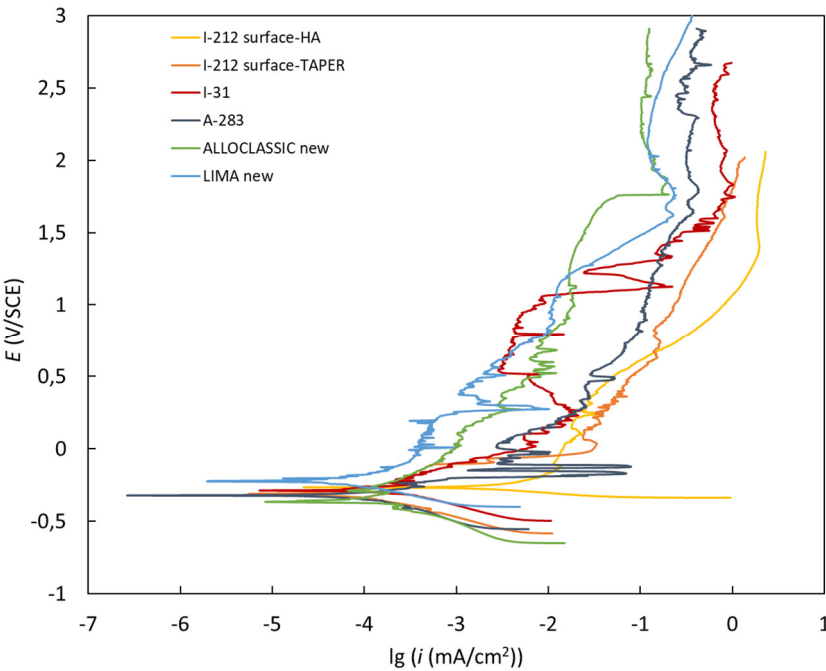
The potentiodynamic behaviour of the investigated materials in Hank’s solution is shown in **Figure 15**. All the investigated materials exhibited a broad range of passivation after the Tafel region due to the formation of a compact outer passive film, which inhibits the diffusion of aggressive species and therefore improves the corrosion properties of the material [30,32,33]. The corrosion potentials (E_{corr}), corrosion current densities (i_{corr}) and corrosion rates (v_{corr}) are listed in **Table 4**. The results show that the corrosion rates for both the new samples and the one with the longest exposure to real-body conditions were lower compared to the other three with shorter exposure times. The implants with shorter exposure times to real-body conditions were all subjected to infection, which

is probably related to the formation of conditions that are detrimental to corrosion. In contrast, new implants with an intact surface as well as the implant with the longest survival in real-body conditions showed an increased corrosion resistance.

Figure 15. Potentiodynamic curves for the investigated new and retrieved samples were measured in simulated physiological Hank’s solution at pH=7.8 and 37 °C.
