# Preserving Heritage Riverine Bridges: A Hydrological Approach to the Case Study of the Grau Bridge in Peru

[Joel Ccancappa Puma](#) , Alejandro Víctor Hidalgo Valdivia , [Alain Jorge Espinoza Vigil](#) \* , [Julian Booker](#)

Posted Date: 27 May 2024

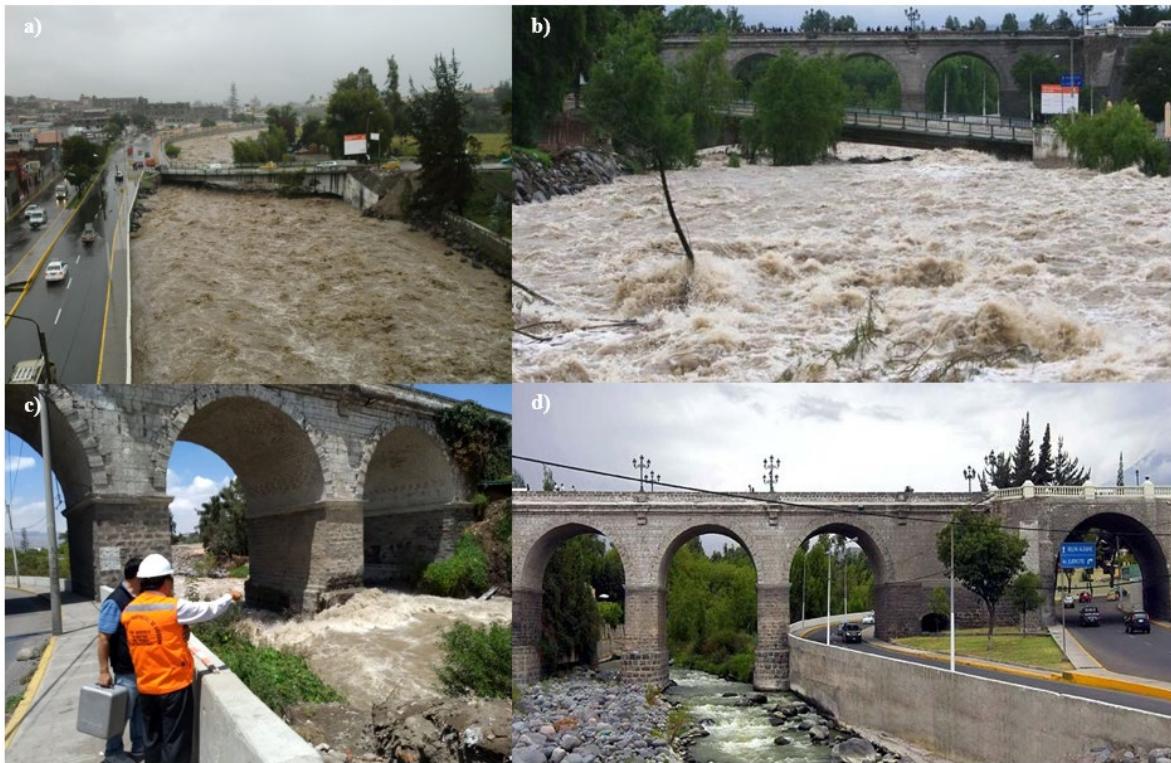
An example of the hydrological vulnerability situation faced by the city was on February 8, 2013, when there was an exceptional rainfall of 124.5 mm in 3 hours [29] and the most important creeks such as Del Pato, San Lazaro, Venezuela and Los Incas were activated, triggering a flash flood, affecting more than 280 buildings, 53 bridges (pedestrian, vehicular and railway) paralyzing the central areas of the city for more than a week [30]. These events aggravate the situation in the city, as they harm the population substantially on many levels [31]. In addition, it is usual for the bridges that cross the Chili River to be closed during January and February due to heavy rains, thus restricting

**Figure 5.** Hazards due to increased flow of the Chili River caused by heavy rains. (a) Lower Grau Bridge (2012) [33]; (b) Grau Bridge (2012) [34]; (c) Evaluation of the bridge due to erosion and scour; (d) Lack of maintenance puts the integrity of the Grau Bridge at risk (2021) [11].

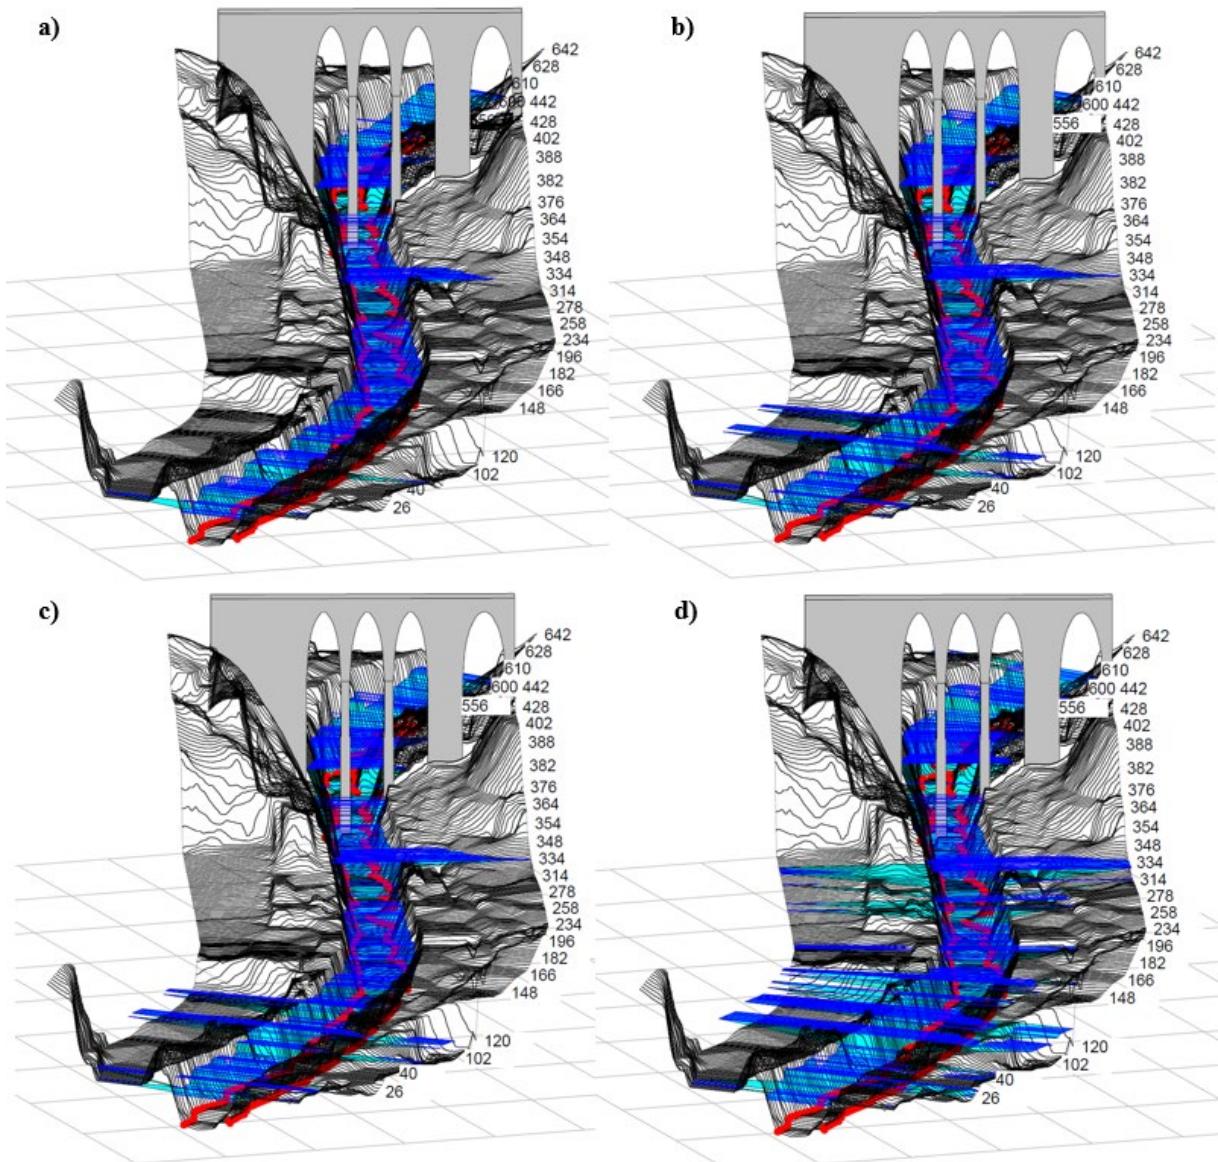
**Figure 7.** Hydraulic simulation for different return periods of the Grau Bridge with HEC - RAS software. (a) T=50 years; (b) T=100 years; (c) T=200 years; (d) T=500 years.

According to the results of Table 1 for return periods of T=200 and T=500 years simulated one-dimensionally 1D in HEC - RAS, they show river flow velocities greater than 3 m/s, which represents erosion problems along the channel, under a mixed regime. A supercritical flow condition ( $Fr > 1$ ) and

shear stresses greater than critical in the Km 0+448.0 section are evidenced, which represents a dragging of particles on the bed of the channel.

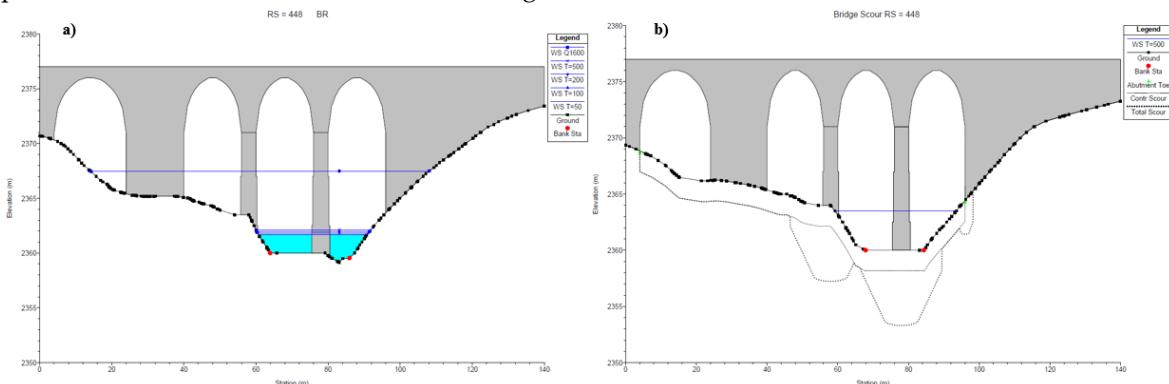
Regarding the scour study, general and local scour analyses were carried out, for which soil mechanics studies were conducted to determine the representative diameters of the bed. The d<sub>50</sub> (decile 50) was determined as 6.5 mm. The Lischitzvan-Levediev and Froehlich formula was used for non-cohesive soils. The one-dimensional (1D) hydraulic model was carried out in HEC - RAS (Figure 9), as this type of model has been shown to generate representative results regarding flood hazards in urban environments with defined and straight channels [42,43]. The hydraulic simulation considered boundary conditions, contraction (0.3) and expansion (0.5) coefficients and Manning's coefficients by Cowan's method [16]. Two hydraulic criteria were taken into account to carry out the simulation. First, for low flow, the energy equation, quantity of motion or momentum equation with dredging coefficient (Cd=1.33) was used because of the elongated piers with semicircular ends and the Yarnell equation because of the semicircular shape of the piers (K=0.9). Second, for high flow, the pressure and/or weir method with a submerged inflow and outflow coefficient of 0.8.

**Figure 9.** One-dimensional hydraulic simulation (1D) of the Grau bridge at section 0+448 with HEC - RAS. (a) Water depths for different return periods (T=50, 100, 200, 500 years) and 1600 m<sup>3</sup>/s; (b) Determination of general scour (2.0 m) and local scour (4.9 m).

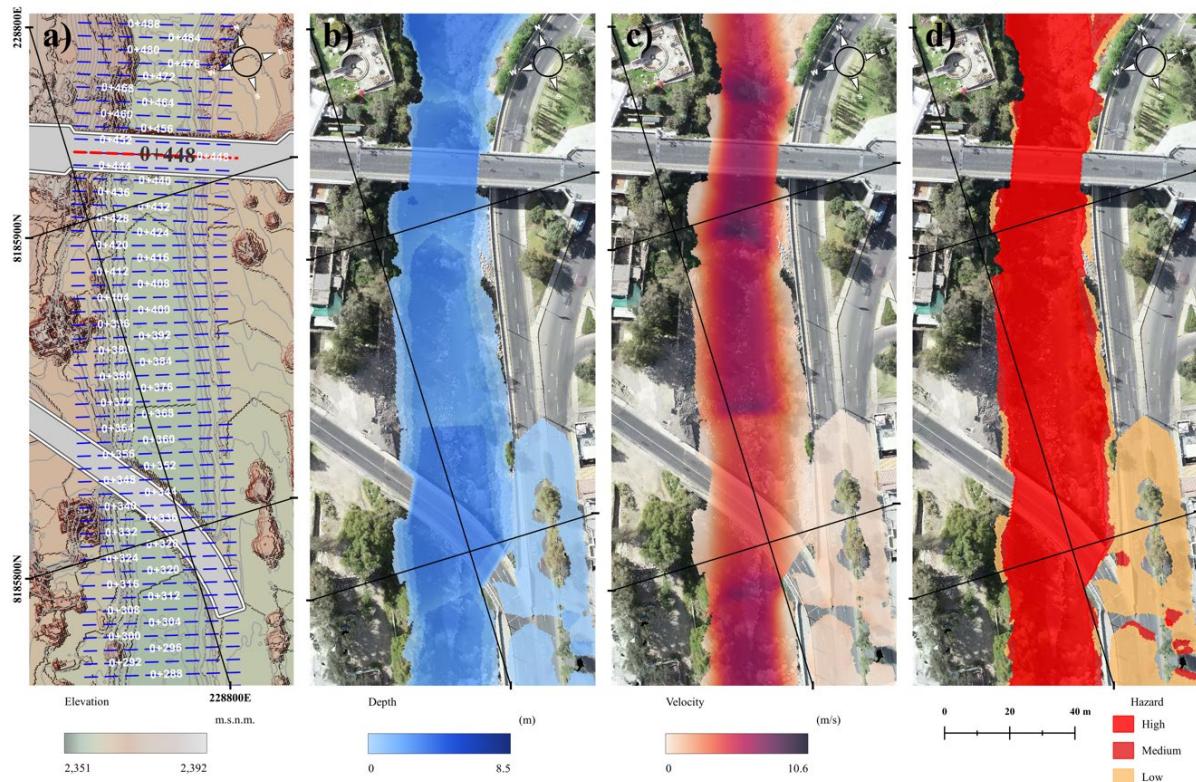
Water depths (Figure 10b), maximum velocities (Figure 10c), and the flood hazards (Figure 10d) were identified through a risk matrix. This matrix integrated hydrostatics and hydrodynamic forces to gauge the erosive potential of water during a maximum flood event. QGIS software served as the Geographic Information System tool, relying on calculations of raster pixel values [45]. This facilitated the identification of the hazard zone in the Grau Bridge location, promoting integrated risk management and enhancing resilience for formal planning versus informal growth [46,47] in the face of extreme events (Figure 10d). The strategic application of this hydrological disaster risk management system is vital for proactive planning and response to safeguard critical infrastructure like the Grau Bridge against potential hydrological threats.

**Figure 10.** Flood hazard map for a return period of  $T=200$  years for Grau Bridge and Bajo Grau Bridge; (a) Digital Terrain Model; (b) water depths, (c) maximum velocities; (d) flood hazards.

The first strategic recommendation involves the implementation of a hydrological disaster risk management system, anchored by a comprehensive risk map of the Chili riverbed. A critical step in this process is the assessment of hazards in the vicinity of the Grau Bridge. To achieve this, a two-dimensional (2D) simulation was conducted using HEC-RAS, as illustrated in Figure 10. This simulation evaluated potential risks, encompassing not only flooding but also erosion in submerged bridges, considering a return period of  $T=200$  years.
