# Proposal of a Sensorization Methodology to Obtain a Digital Model: The Case of the Dome of the Pious School of Valencia

[Luis Cortés-Meseguer](#) \* and [Jorge García-Valdecabres](#)

Posted Date: 5 June 2024

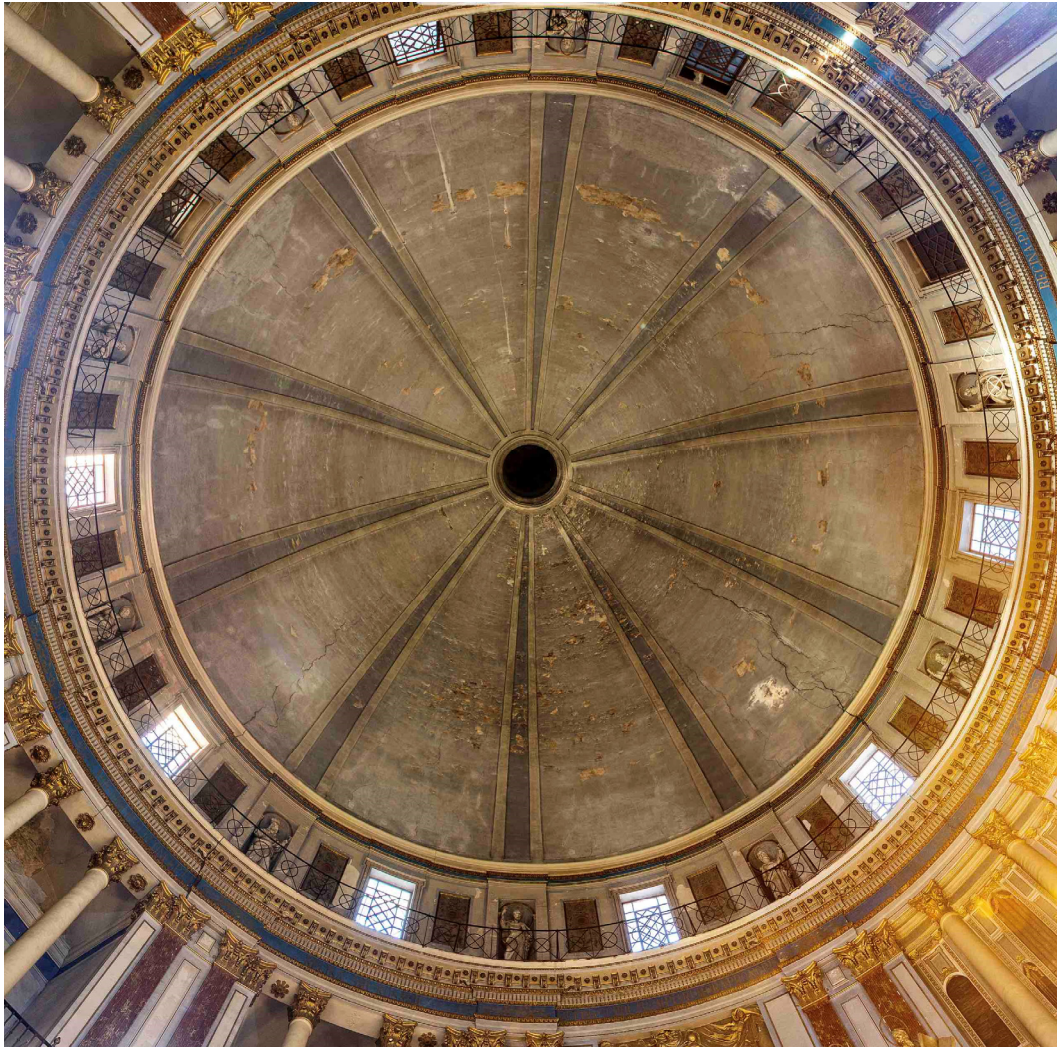
Rodríguez and Gil Piqueras [25] studied the lesions inside the dome after conducting a planimetric survey with laser scanning (TLS) and adjusting the color balance to observe degradation. They suggested the possibility of spalling in a pattern parallel to the dome due to the oxidation of the metal rings, initially reported by Zacarés [26].

**Figure 3.** View of the dome and the cracks in four different sectors.

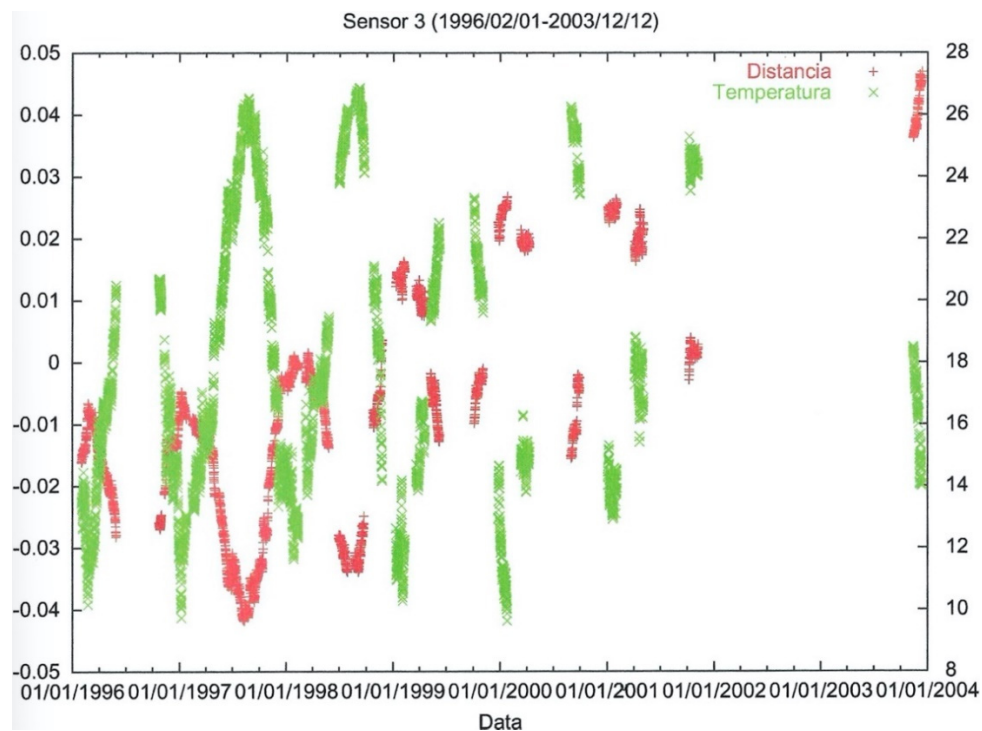
Between 1996 and 2003, Architect Rafael Soler's study carried out the sensorization of the dome to obtain the relationship between temperature and movement (opening/closing) of the cracks, similar to what was done in the dome of Santa Maria del Fiore [31]. The study of the extensive documentation collected, along with the interpretation of the results that record the movements of the probes over the analyzed time period, confirmed the inverse correlation between temperature variation and crack opening: as temperature increases, distance decreases, and vice versa (Figure 4). It is worth noting that in the analysis of the data, a drift is observed, meaning that the crack openings increased over time, due to thermal variations.

**Figure 4.** Scheme of relationship between temperature and crack movement, 1996-2003.

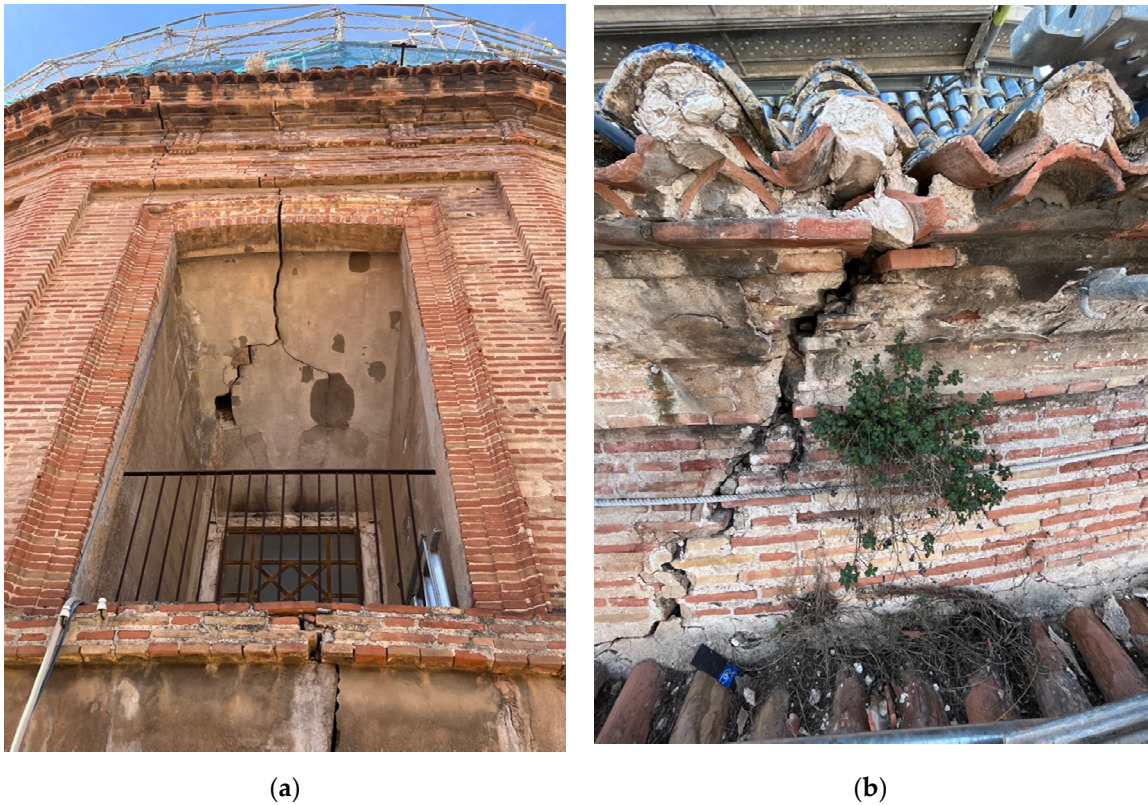
Clearly, the cracks that existed in four out of the ten sectors of the drum, with lintels and jambs of the openings being split, with the crack extending to the upper ring and prior to the start of the dome, as well as the displacement of two ribs in two of the ten sectors, indicate some movement of the fabric, and it can be affirmed that the cracks in the dome were not solely due to thermal inertia. Following these findings, Cortés and Alonso [34] carried out the complete parameterization of the dome and walls to analyze the behavior due to settlements, using the finite element method (Angle software), and obtaining results similar to those existing in the monument, providing an explanation for the cracks (Figure 5).

**Figure 5.** Cracks in drum and ring before dome; (a) cracks in one lintel and vault of sector four damaged sectors. (b) crack in ring before dome in sector G.

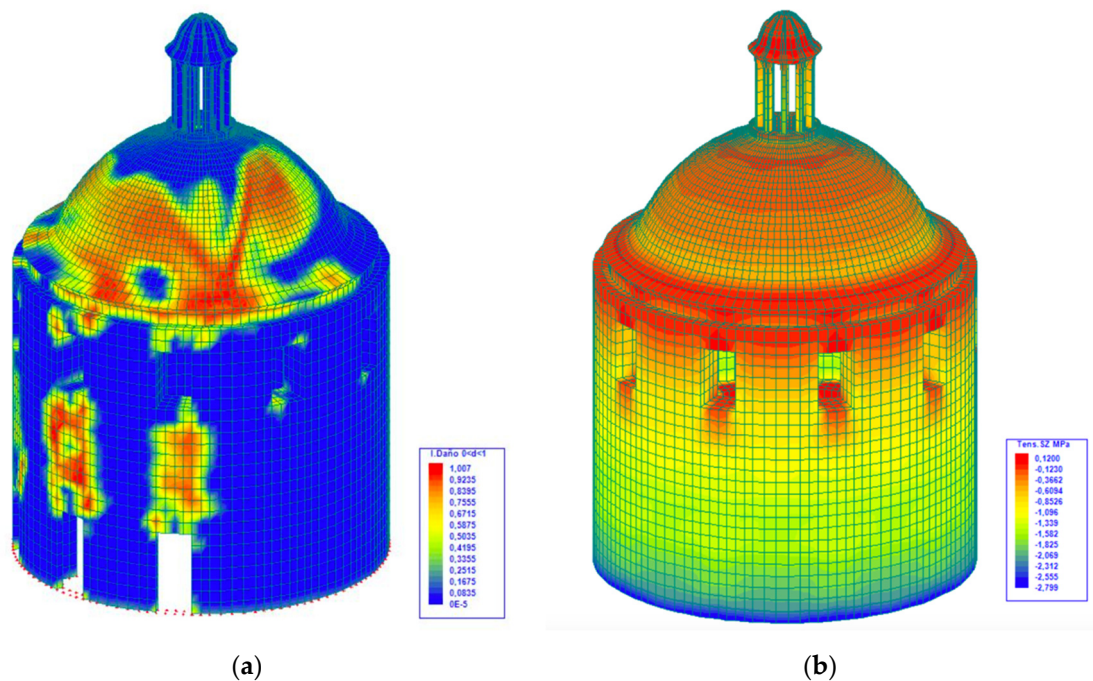
Alonso and Martínez [32] conducted a virtual theoretical study of the thermal behavior due to temperature variations on the dome, concluding that the combination of thermal and gravitational loads reaches tensile values much higher than what the fabric is capable of supporting. However, they established that the damages in the model did not correspond to the actual fissure state established in the Master Plan (op. Cit). In this study, they only analyzed the dome, without taking into account the supporting walls. However, Soler and Benlloch [33] stated that gravitational actions were not the cause of the injuries, given neither their location in elements of very different sections nor the various studies by graphic statics or finite elements thus concluded. They also established that seismic action did not seem to be the main cause of the damages; perhaps it could have been, at some point in the past, a contributing factor to the fissures in two sectors, which are not the ones with the most damage.

**Figure 6.** Cracks in drum and ring before dome; (a) fissure pattern with the hypothesis of a settlement of the vertical wall; (b) stress state of the dome showing tension at the base of the dome.

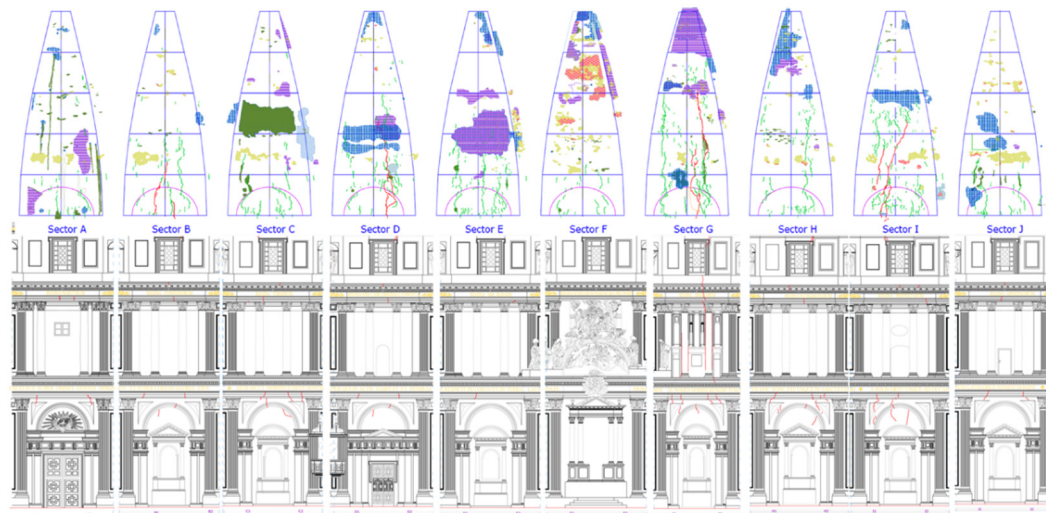
Prior to the restoration, the dome exhibited four large cracks in the calotte that extended from the interior to the exterior, as well as in the drum. Additionally, there was a displacement of two roof tiles, allowing water to leak into the interior. The tile covering was in a very poor state of conservation, with water infiltration causing dampness, salt deposits, and loss of plaster, among other issues. The exterior showed numerous broken tiles, vegetation, missing tiles, and tiles with enamel loss. Furthermore, the lantern had its openings blocked with honeycomb brick infill and red waterproof paint.

**Figure 7.** Study of Pathology of the Interior with the observation of damage in the dome derived from moisture and cracks.

Currently, the interior of the dome is undergoing restoration. Initially, the cracks in both the interior and exterior of the dome and its drum have been repaired. These cracks followed the direction of the meridians and were more or less centered, extending from the base of the dome to approximately 3/5 of the calotte's length, roughly 10.74 meters, in four of the ten sectors into which the dome is divided. Associated with these cracks, there are numerous other fissures that correspond only to the cracking of the coating.

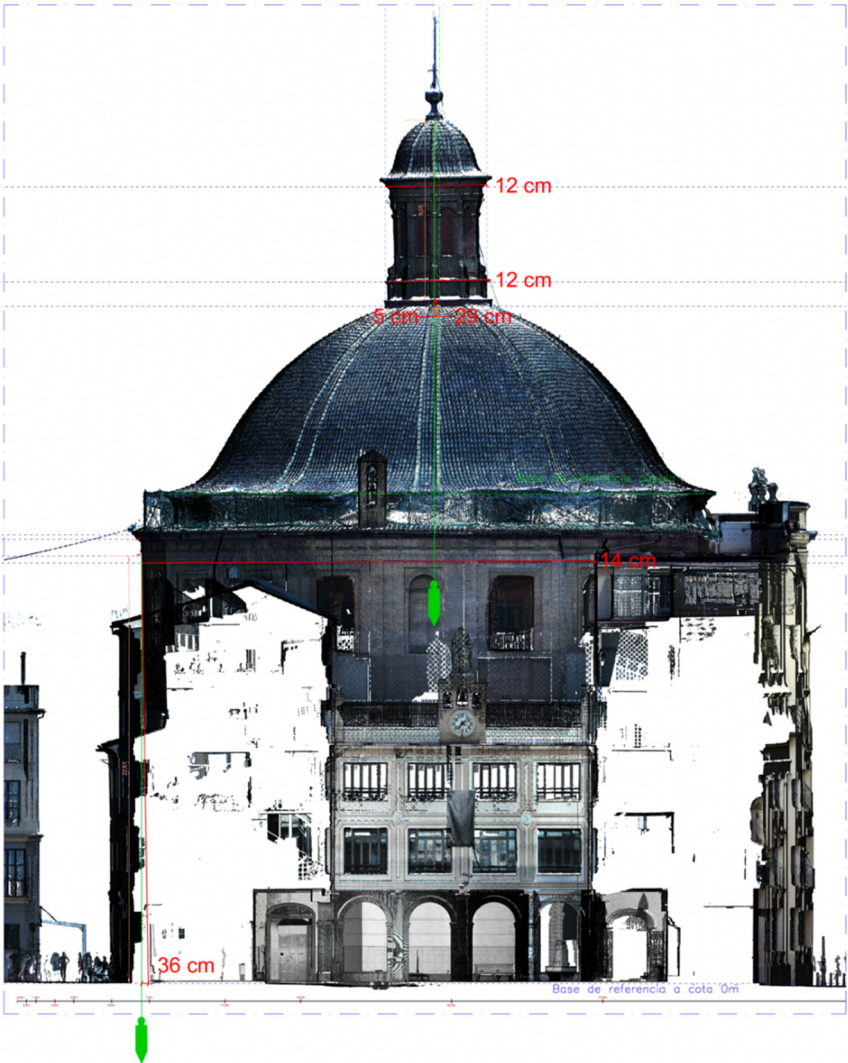
This study determined that the origin of the issues was the tilt of the drum, which consequently affected four sectors of the dome as it readjusted to its new state [36]. Additionally, the poor condition of the roof covering did not prevent water infiltration during rain, which affected the interior coating

Figure 8. Study of the tilts using orthoimage obtained from 3D Laser Scanning (TLS).

From the study of collapses, we know that the drum has a deviation of 36 cm from its base, and the horizontal planes in the dome bodies have rotated 14 cm. This study helps us address the disparity in opinions from all previous structural studies and explains the dome's cracks; as the drum deforms and there is a deviation, the ring cracks, and the dome readapts to the new stresses, resulting in cracks in the dome.

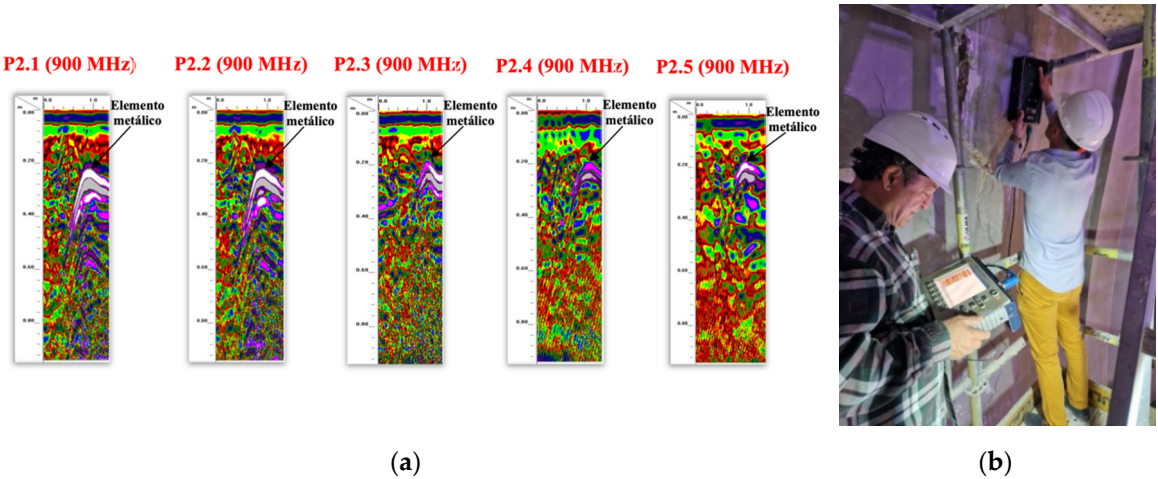
Figure 9. Geophysical study using ground-penetrating radar to detect “anomalies” in the dome and an image depicting the progress of the study within the dome; (a) radargram where anomalies in the waves are observed; (b) the execution of the geophysical study.

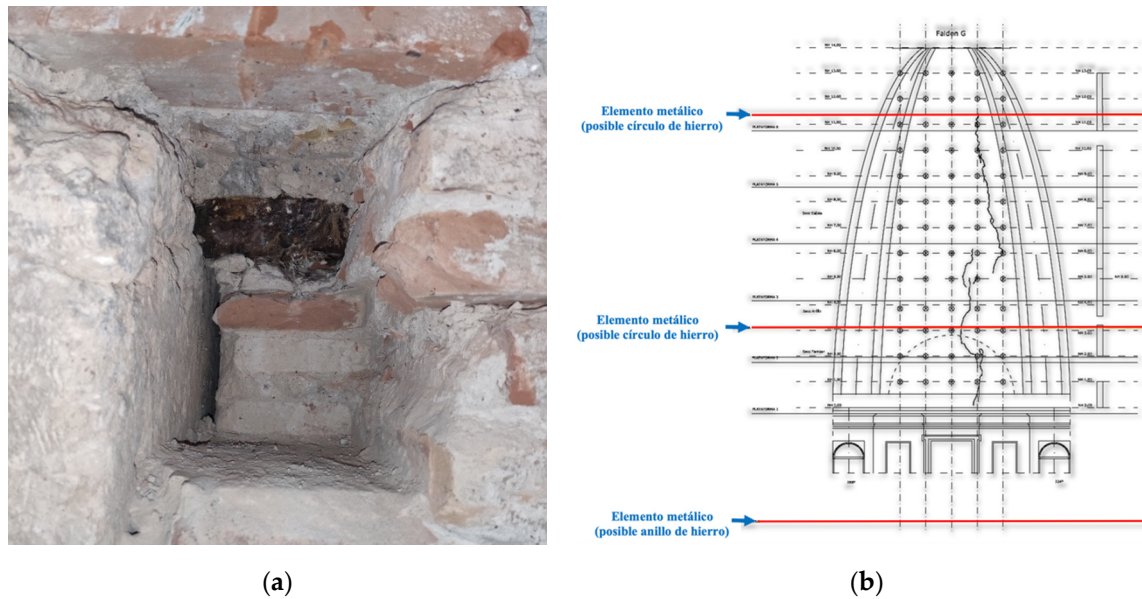
In these 3 sectors of the dome, a total of 31 2D geophysical radar profiles were conducted, and an archaeological window was opened to observe the mentioned ring. It consisted of a 5 x 5 cm iron bar covered with braided esparto, embedded in stone blocks approximately every 5 meters.

**Figure 10.** With the geophysical study, it has been possible to find the iron rings.; (a) archaeological window with the iron ring; (b) representation of the grid and red lines representing iron rings.

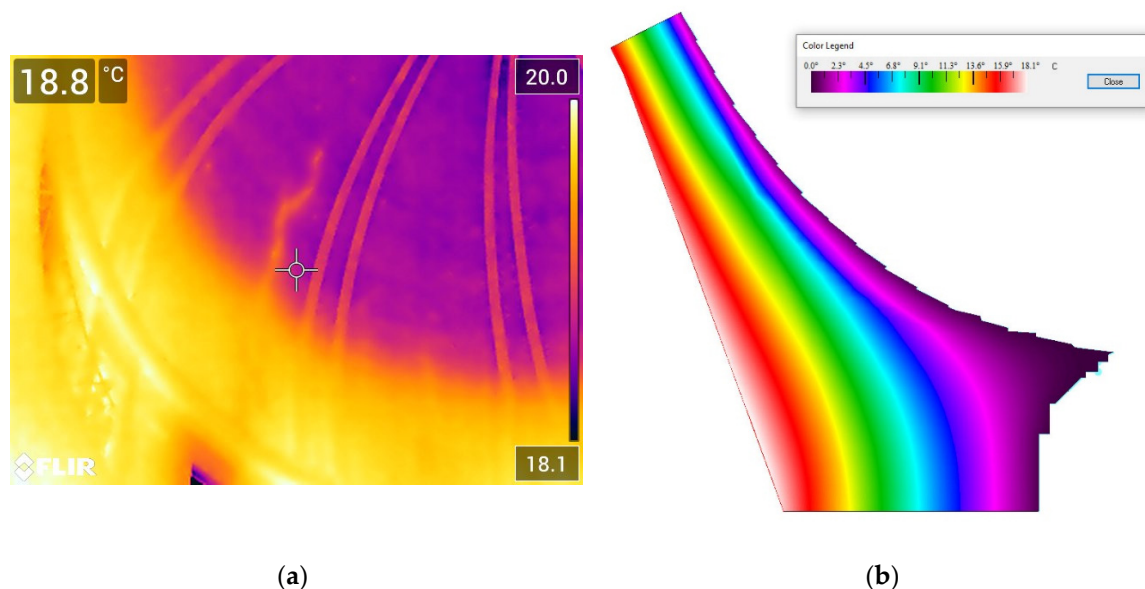
**Figure 11.** Thermal behaviour: (a) Image of thermal camera where the crack is a thermal bridge; (b) Parameterization of thermal behavior in the Therm software, given external temperature 0°C and internal 20°C.

From the observation of thermal camera, it was noted that the dome from the intrados starts from the drum, the ribs increase their thermal inertia, and highlighting the thermal bridge represented by the cracks, which have currently been repaired and sealed.

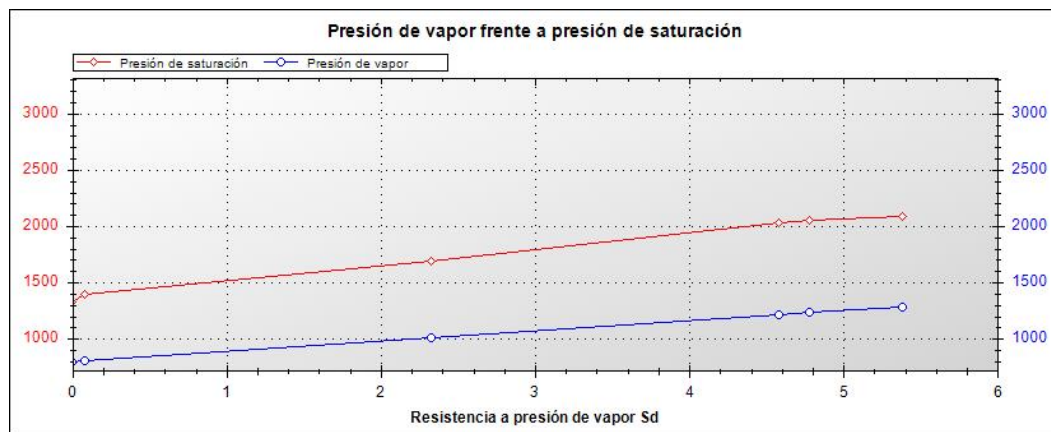
Thanks to its construction arrangement, including a 2 cm thick inner layer of plaster, a 45 cm thick solid brick dome, a layer of lime mortar, and glazed ceramic tiles, a more than satisfactory result has been obtained. This is because the saturation pressure is much higher than the vapor pressure, and no condensation occurs or accumulates. The graph shows two parallel lines (Figure 12) indicating the absence of condensation accumulation.

Figure 12. Study of the verification of interstitial and surface condensations of dome.
