Identification of Damage to Wood Pillar Foundations for Repairing House Construction Damage on Swampland

Nursyarif Agusniansyah

Department of Architecture, University of Lambung Mangkurat, Banjarbaru 70711, Indonesia;
arsitekminimalis@gmail.com

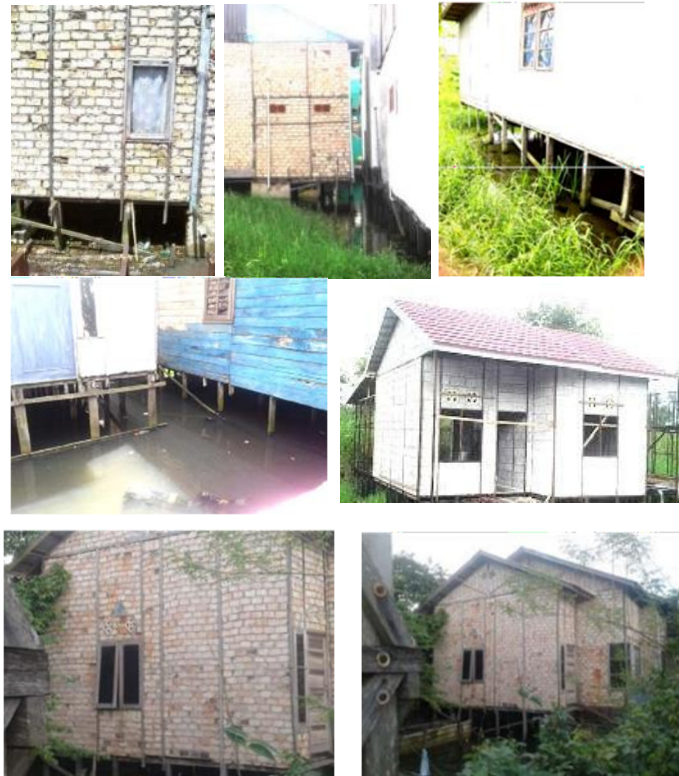
The problem with wood pillar houses is inseparable from the condition of the wood pillars and the wet soil conditions. The development of semi-permanent building types (Figure 1) with brick construction stands as a wall column filler. Treated as a permanent building finish, it is plastered and painted. Then, wooden floor materials are installed on ceramic tiles

Figure 1. Wooden Pillar Home Development Issues.

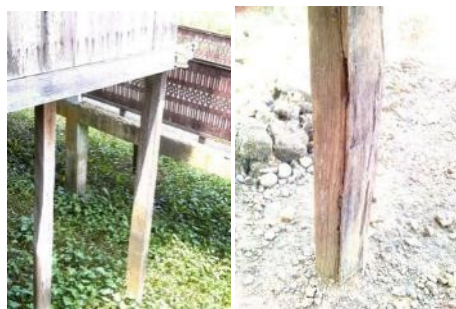
The source of the problem of building houses mostly comes from the wooden pillars. The strength of a wooden pillar is equivalent to the quality of the wood, so the damage to the material also affects the condition of the construction. The damage to the pillar may be due to the inability to carry the load on it, and it is also often due to soil and weather conditions (Figure 2).

Figure 2. Damage of Wooden Pillars.

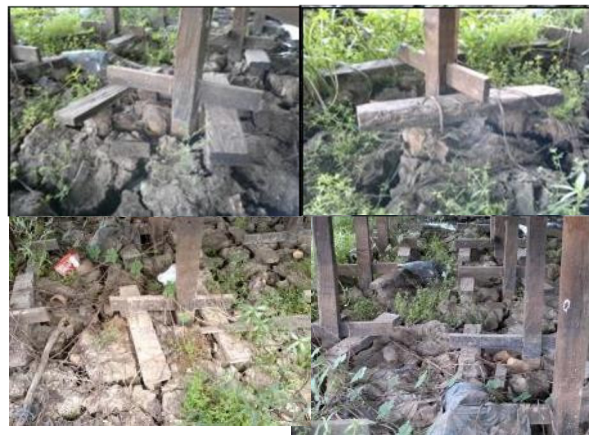
The wooden pillar is connected to the foundation part as an integrated part of a single unit. For the Banjarmasin area, use the cane ('kalang') and the beam ('sunduk') seen in the Figure 3. After the hook, there's a hook element that's used to withstand the loads. In this element, there is usually a variation in the foundation and the presence of various other types of foundation.

Figure 3. 'Sunduk' Arrangement Due to Construction Errors.

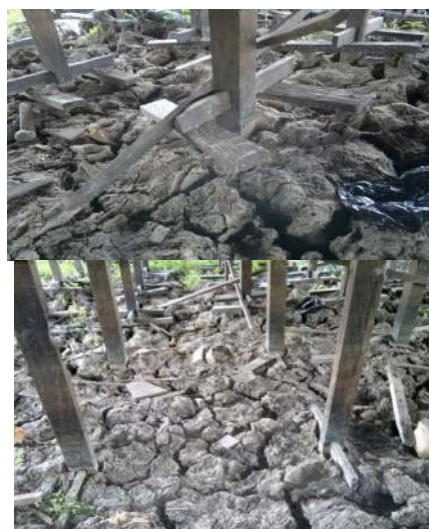
Figure 4. 'Sunduk' Condition.

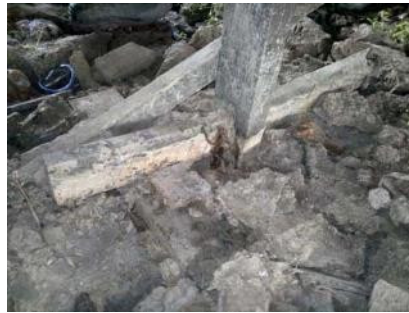
Figure 5. Broken 'Sunduk'.

Broken 'sunduk' from the picture, it can see the condition of the bottom of this wooden pillar. It appears that the mounting of the cuffs and braces when under the surface of the water becomes unclear by adjusting the position of the scissors. There is a field finding that there is a state of wood damage with the presence of a broken 'sunduk'. This could be the cause of the falling floor in the house anyway. Because of the quality conditions of the cane, often the remaining pieces of wood, small and have a wooden eye, resulting in a broken cane. However, because the position of these building elements is below the surface of the water, this often leads to invisibility. Photo taken from the field survey with the conditions of the dry land area, so this situation can be clearly seen.

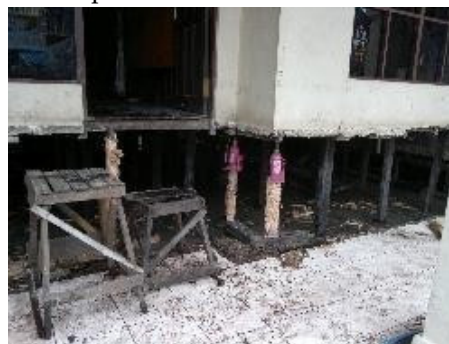
Other field findings include the activity of replacing wooden pillars by demolishing houses. (Figure 6). This was done because the position of the floor of the house needed to be raised.

Figure 6. Scratching House Pillars.

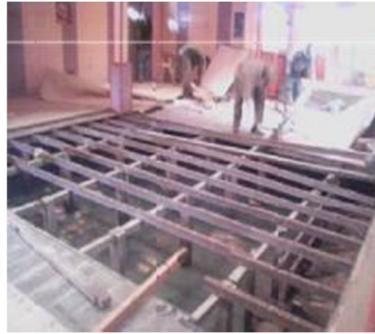
Damage to the wooden pillar elements can lead to floor settlement (Figure 7). The floor construction is visible with 50 cm floor beams, and is continuously raised by rows of wooden columns. Characteristic of the foundation fall and arched floor of the building is the presence of damaged and raised tiled floors as in Figure 8.

Figure 7. Falling And Folding Floor.

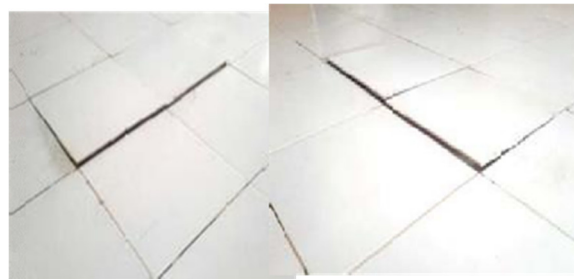
The characteristic of the fall of the foundation and the bending of the floor of the building is the presence of the ceramic floor covering that is broken and raised like in the Figure 8.

Figure 8. Ceramic Fractured on Floor.

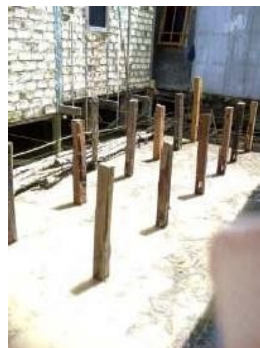
It was found that the development of the wooden pillar house was done by renovating horizontally to expand the space of the house with the addition of space (Figure 9). A wooden pillar is added to an empty plot.

Figure 9. Horizontal Home Extension.

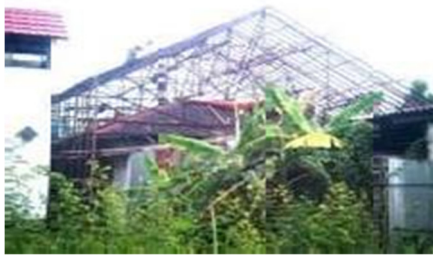
The most common thing about building houses with wooden frame structures is the repair or renovation of houses vertically (Figure 10). By demolishing the roof of the building and making it into a flat-scale house, the building burden increases. Even with the consideration of replacing the top material of the building with an even lighter material, this will increase the burden on the foundation.

Figure 10. Vertical Renovation.

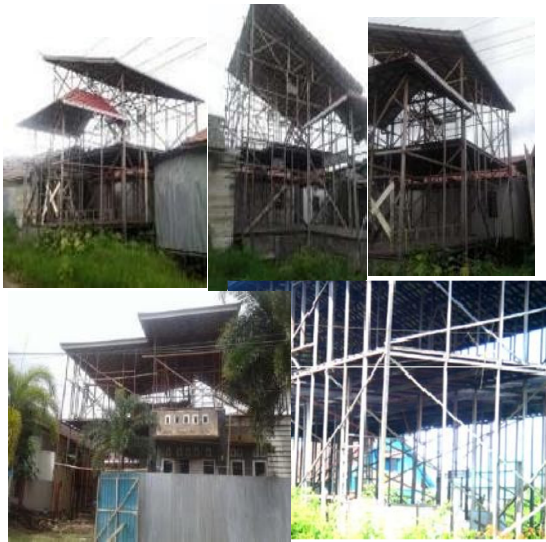
Besides, make the building of a house directly 2 (two) floors (Figure 11) and frequently done. But the foundations of the buildings used seemed to remain the same as the foundation conditions of the one-story buildings. Because the construction system and the material remained a row of wooden pillars on the bottom and a wooden frame on the building, Both of these cases actually require reinforcement of a wooden pillar to accept the added building burden.

Figure 11. Construction of a Two-storey House.

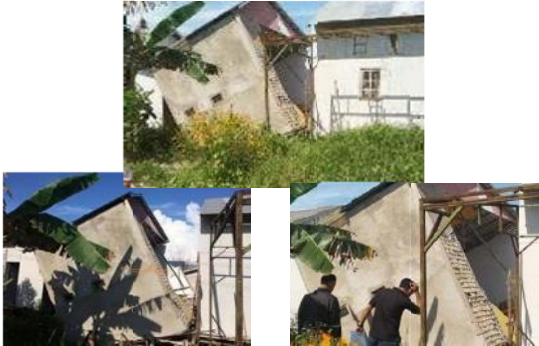
With more severe damage to the wooden pillars, there could have been some cases of house buildings that were not only bent but even collapsed (Figure 12 and 13). It is often said that this occurred because of the failure of the foundation of the house to follow its pillars. Errors in the selection of foundations, the lack of strength of the foundations and poles to carry the heavy building burden, or the depression and inexperience of the construction workers are often accused of being the cause. The wooden pillar is still involved.

Figure 12. Tilted House Building.

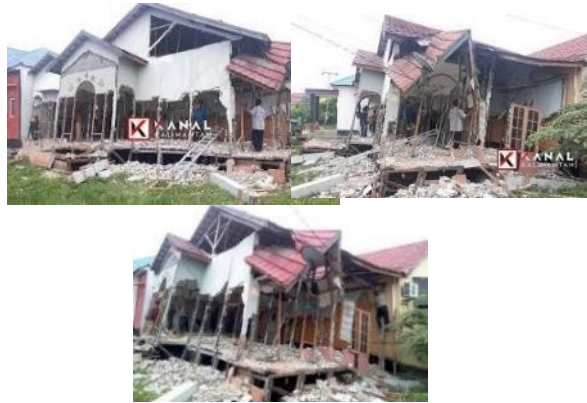
Figure 13. House Building's Collapsed.
