A Comparative Impact Assessment of Hail Damage to Tile and Built-Up Roofing Systems: Technical Review and Field Study

Posted Date: 25 July 2024

Gayatri Thakre ^{1,*}, Vinayak Kaushal ^{2,*} and Mohammad Najafi ³

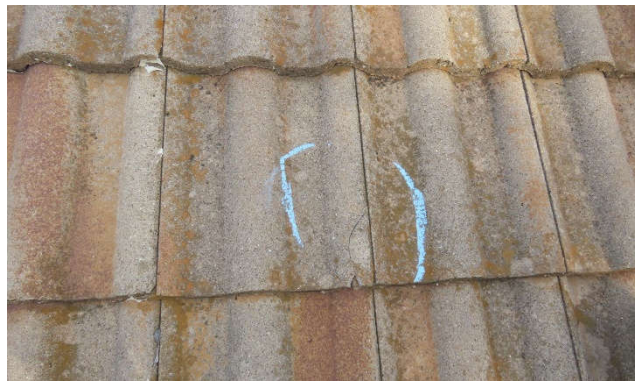
A total of 12 field tiles have larger fractures extending along the tile exposure, punctures, chipped with crescent-shaped cracks, and a point of fracture with radiating cracks. These have associated spatter marks up to 1 ½ inches and expose a bright-colored concrete edge. Approximately 85 tiles have fractured or chipped lower-right corner edges of the tiles throughout the roof on each elevation. The edges of the exposed tile are weathered, algae-covered, covered with adhesive sheets, or have caulking. Linear cracks or fractures along the length of the tile are commonly seen on the roof. The cracks are localized near the likely travel path, valleys, or near the roof penetrations. A few tiles have these open voids sporadically in the face of tile on several elevations. Table 6 depicts the typical functional hail-strike and non-strike damage for the roofs in consideration.

A crescent-shaped crack in concrete field tile with associated spatter mark

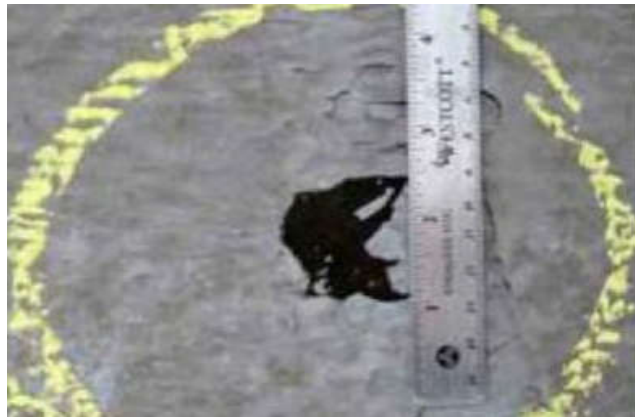
Built-up roofs with smooth and gravel surfacing were included in the study. The first two case studies included commercial building roofs with a smooth surface BUR for building 1 and a reflective coating as the top flood coat for building 2. The inspection of the metal surfaces indicated that the hail that struck the building and the roof surfaces was up to 2 ½ inches for building 1 and 2 ¼ inches for building 2. The top finished surface indicated circular indentations and penetrations consistent with hail impact. The hail stones caused damage to the entire top, and cracks or penetrations were present in the membrane when the test cuts were made.

A finish displacement in the top coat of the BUR system

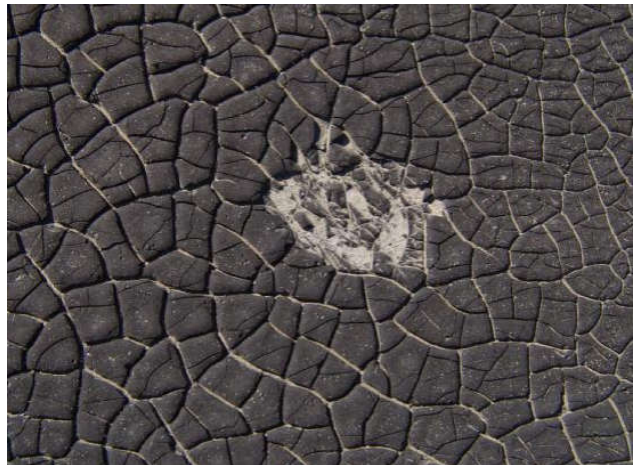
Circular cracks in BUR membrane with associated dull interiors exposed
