Wear Development in Oscillating Rolling Element Bearings

¹ Institute of Machine Design and Tribology (IMKT), Leibniz Universität Hannover

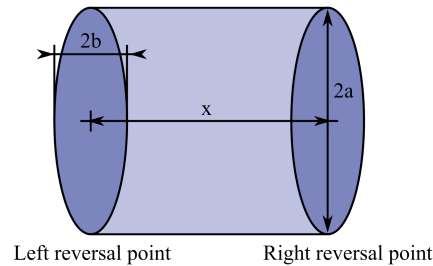
Figure 1. Illustration of the amplitude ratio $x/2b$. In dark blue the Hertzian contact ellipse in the reversal points of the oscillatory motion is shown.

of oscillating movement with an amplitude ratio $x/2b > 2$ is higher when using an IPC controller. The amplitude ratio is defined as the quotient of the distance that the center of the contact travels relative to the bearing raceway x and the width of the contact ellipse $2b$. Figure 1 illustrates the amplitude ratio $x/2b$.

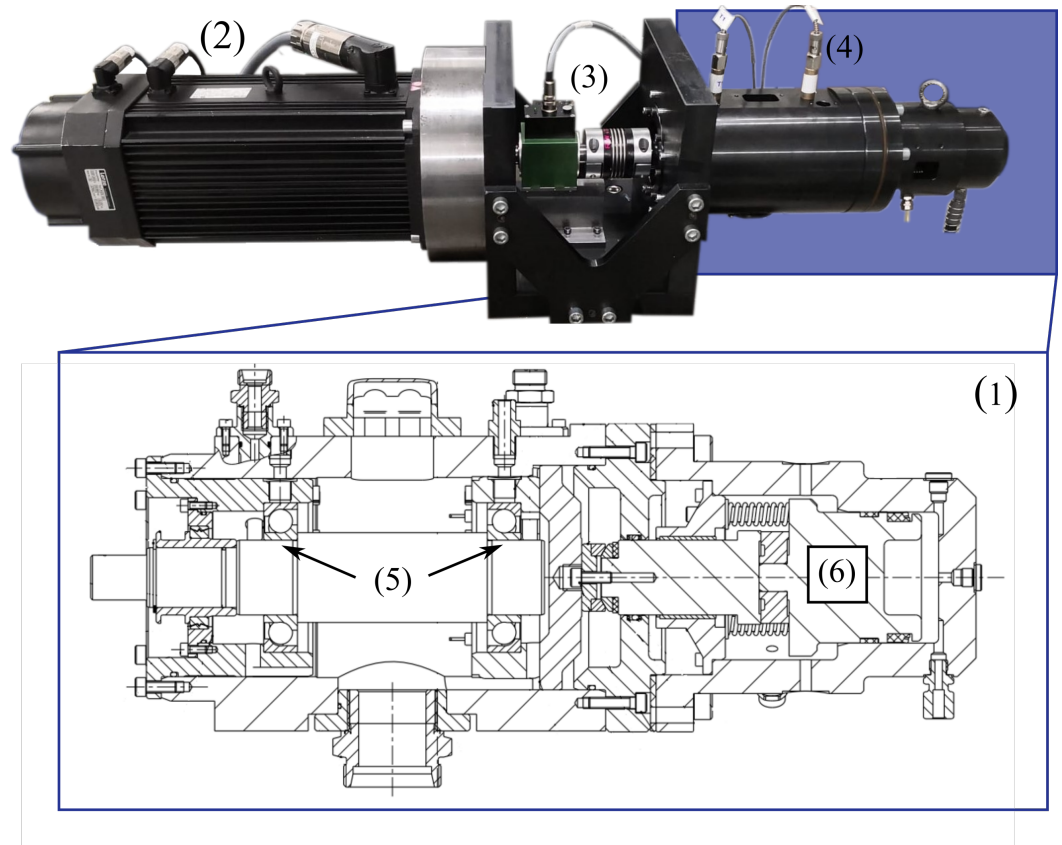
Figure 2. The upper part shows a picture of the complete test setup including the servo motor the torque shaft and the test unit. The lower part shows a drawing of the test unit that contains the two angular contact ball bearings of type 7208.

The experiments presented in this paper were carried out on two different setups. One setup was used to perform the experiments on type 7208 angular contact ball bearings (ACBB), the other one uses type 7220 ACBB. The basic structure of the test rigs is similar, thus only one rig is explained in detail. Figure 2 shows the above mentioned test setup for the type 7208 angular contact ball bearings. A position-controlled asynchronous servo motor allows oscillation with variable amplitude and frequency. It drives a shaft on which two unsealed angular contact ball bearings are mounted in x-arrangement (facet-to-face). Drive and shaft are connected by a torque measurement shaft with an integrated incremental encoder. The bearings are axially loaded by a hydraulic load unit. The temperature on the bearing outer rings during the tests is monitored by PT100 sensors.

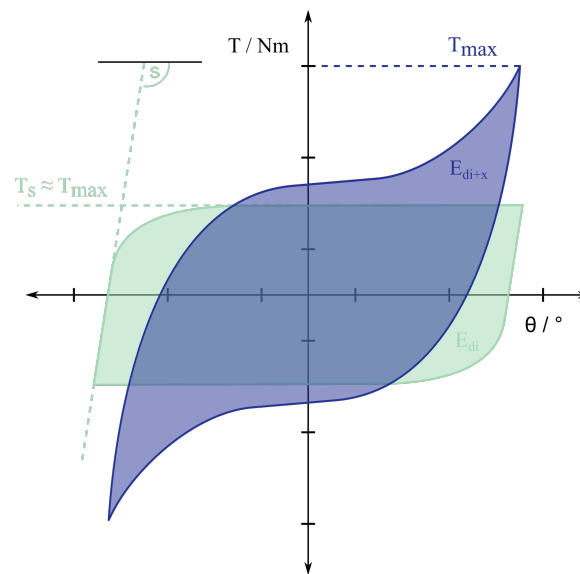
Figure 3. Two exemplary torque curves that can arise qualitatively during the experiments. In green the torque curve of the undamaged bearing, which corresponds to the model curve set up according to DAHL with the slope s and the steady-state torque T_s , is shown. The qualitative torque at advanced damage formation is shown in blue. The area of the curves $E_{d(i)}$ (green) and $E_{d(i+x)}$ (blue), shown in transparent colors, correspond to the dissipated energy for the respective oscillation cycle.

In order to gain an understanding of the mechanisms involved in the wear progression the angle synchronous torque during the test run is recorded. Figure 4 shows two exemplary torque curves over the oscillation angle. The curve shows a torque curve of an undamaged bearing as was first explained by DAHL ET AL. and later further discussed by TODD ET AL. [23,24]. With the slope s of the curve after the reversal point that comes from an elastic response of the contacting partners and the steady-state torque T_s at fully developed rolling. For an undamaged bearing the steady-state torque is close to the maximum torque during an oscillation cycle $T_s \cong T_{\max}$. During the course of our tests the shape of the torque curve changes so that curves like the blue one in Figure 4 emerge. Here, a significantly increased T_{\max} is observed in the reversal points. The angle-synchronous torque allows the calculation of the dissipated friction energy E_d , which can be viewed as the integral of the enclosed areas E_{di} of N friction curves. In Figure 4 the areas E_{di} (green) and $E_{d(i+x)}$ (blue) are displayed for the exemplary torque curves.

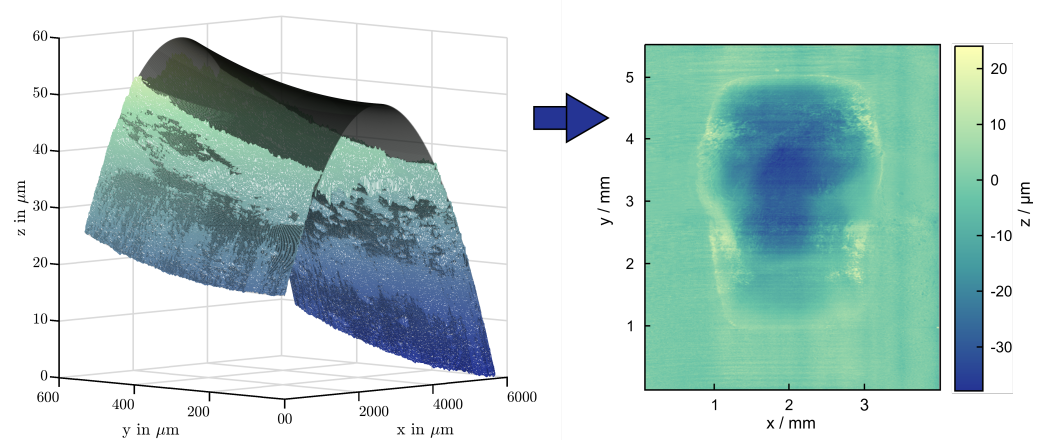
Figure 4. The left figure shows in blue/green the measured real profile of a damaged raceway surface of a 7220 bearing. The interpolated undamaged raceway surface is shown in black. The right figure shows the difference image of a damage mark in a 7208 bearing, which results from the difference of interpolated surface and real profile.

image of the whole wear mark with surrounding non-worn areas is acquired. The non-worn areas are interpolated with second-degree functions to create a model of the original raceway surface. By subtracting the worn surface from the original surface, a difference image is created from which the worn volume of a damage mark is determined.

In contrast to the laser scanning microscopic measurements of the 7208 bearings, the procedure is applied differently for the larger bearings of type 7220. Due to the larger dimension of the wear mark, about 4×8 mm, the curvature of the raceway makes a complete topographic examination difficult and time consuming. Therefore, only a section of the wear mark was investigated with the laser scanning microscope using the same procedure as described above. To gain repeatable results, the lateral extension of the wear mark is investigated to find the position of the upper third part of the wear mark, which is usually characterized by the most prominent wear damage. Hence, the measured wear volume calculated for the 7220 bearing are not reflecting the total amount of worn material per damage mark. Instead, they are used as a benchmark to characterize the wear damage produced by different test configurations and parameter sets. As the wear volume only covers a fraction of the wear mark it is multiplied by factor of 15, which is derived from dividing the height of the contact ellipse at a pressure of 2.5 GPa by the height of laser scan. The idea of this factor is to achieve a wear volume, which closer represents a complete wear mark. Even if the absolute values after adjusting are inaccurate, it simplifies the comparison of results.

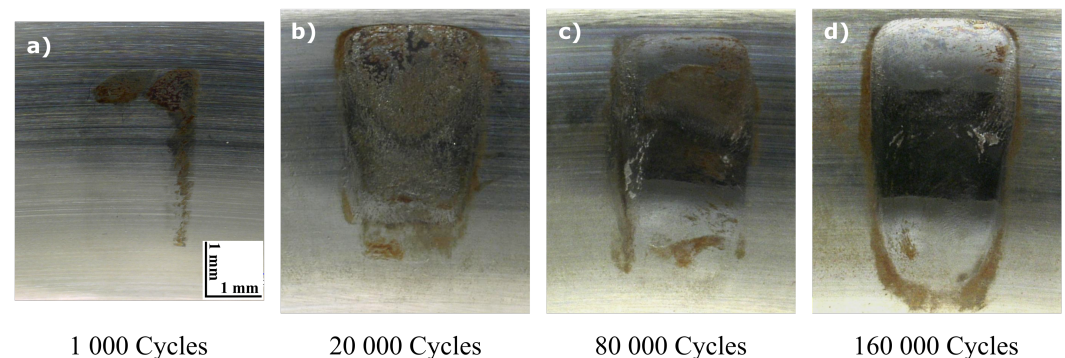
Figure 5. Damage on the inner Raceway of a 7208 rolling element bearing for different oscillation cycle numbers N ; Experimental parameters: contact pressure $P_{IR}=2$ GPa; oscillation Angle $\theta=7^\circ$; oscillation frequency $f=5$ Hz; Grease: Fully formulated Li Grease

To show how the damage marks on the inner raceway of the bearings are developing Figure 5 shows representative damage marks after different cycle counts. Figure 5 a) shows a contact area with starting corrosive wear after 1 000 cycles. At this cycle count most contact areas are not showing signs of severe wear, others like the one in the figure are partly showing corrosive wear. After 20 000 cycles (Figure 5 b)) every contact area shows severe damage that has spread over the entire area swept by the rolling elements. In the damage mark, smaller micropits and as a result a rough looking surface can be observed. In addition, reddish-brown and blackish-brown corrosive products are visible. At a more advanced stage, after 80 000 cycles, the damage pattern shown in Figure 5 c) appears. Some parts of the wear mark still appear reddish-brown and on the left side at middle height a bigger material spall can be observed. It is also noticeable that large parts of the damage mark have been smoothed and have a mirror-like appearance. After 160 000 cycles (Figure 5 d)), as after 80 000 cycles, a material spall is found on the right side of the mark at mid-height. Almost no corrosive products can be seen in the damage mark; these are only found at the outline of the mark. At this point, almost the entire ground of the damage mark appears to be polished and has a mirror-like appearance.

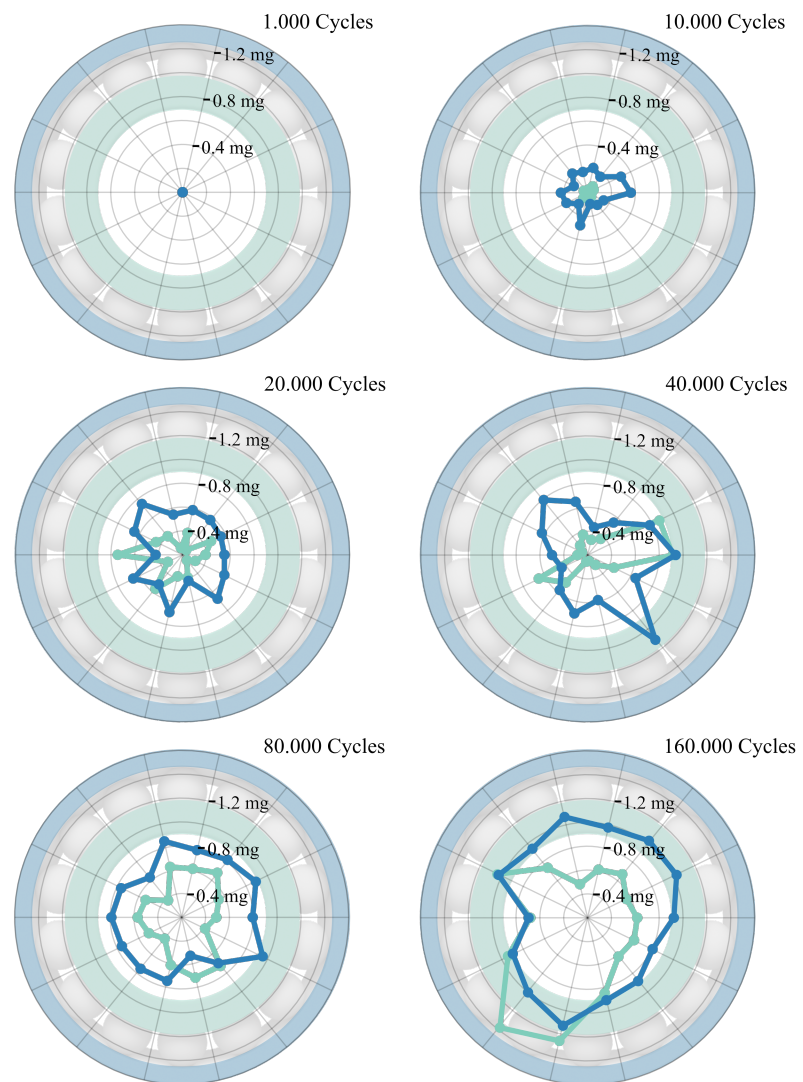
Figure 6. Representation of the measured wear volumes of the individual damage marks on the raceway of the inner ring (green) and the raceway of the outer ring (blue).

The wear volumes of the individual wear marks are shown in Figure 6. For each bearing examined after a defined number of cycles, a corresponding polar plot is shown, divided into 14 segments corresponding to the number of rolling elements. The mass loss of the marks on the inner ring is shown in green and the mass loss of the marks on the outer ring at the respective position on the bearing ring is shown in blue. The mass loss is determined by the measured wear volume and the density of 100Cr6 of $\rho_{100Cr6} = 7.8 \frac{g}{cm^3}$. After 1 000 cycles most of the marks are still undamaged and almost no macroscopic wear can be determined with the applied method. After 10 000 cycles, a clear increase in mass loss can be seen, especially on the outer ring. It is also clear that all marks around the circumference of the bearing show macroscopic wear, but not all damage marks wear

uniformly. While some marks already show a mass loss of 0.4 mg, other contact points lost less than 0.2 mg. The mass loss on the inner ring is still significantly lower than on the outer ring. After 20 000 cycles, a significant increase in mass loss can also be recorded on the inner ring. Here, the difference between the individual wear marks is even more noticeable. While individual marks show less than 0.1 mg, one wear mark already has a mass loss of 0.6 mg. As expected, the mass loss continues to increase with increasing number of cycles and reaches its maximum at 160 000 cycles, which corresponds to the maximum tested cycles. Here, a maximum of approx. 1.2 mg per mark is measured on the inner ring.

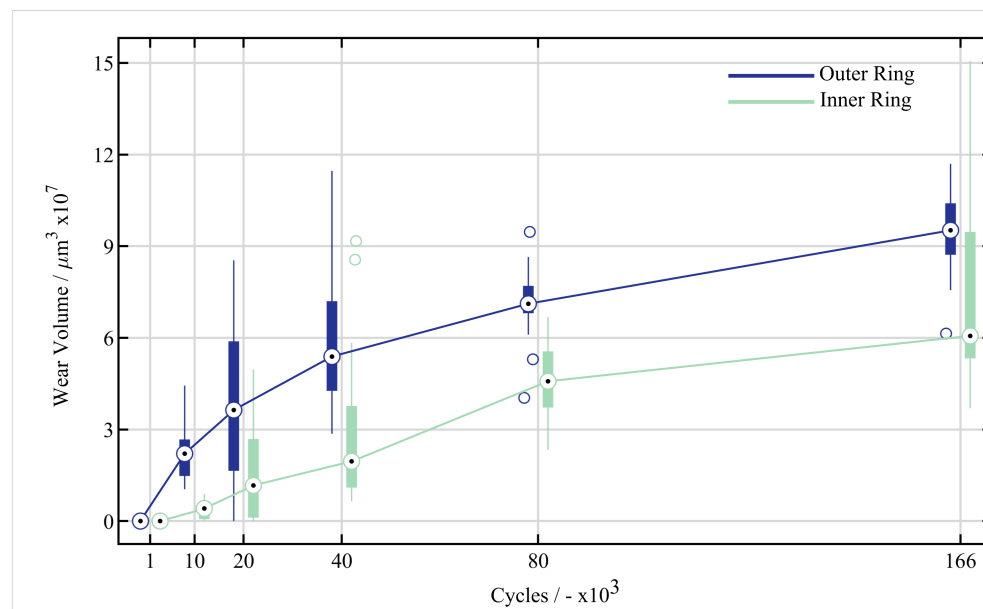
Figure 7. Box plot of the mass loss per contact area on the raceway against the number of oscillation cycles. The turquoise boxes represent the results for the inner raceway, the dark blue boxes for the outer raceway.

Figure 7 shows the measured wear volumes in a box-plot. The wear volume is shown on the y-axis and the number of cycles on the x-axis. The determined values of the inner ring are again shown in green, the values of the outer ring in blue. The median of the values is represented by a black dot in a white circle. The ends of the thick bars represent the 25 % quantile and 75 % quantile, respectively, the ends of the thin bars the minimum and maximum, respectively, and the fetch circles in the corresponding color the outliers. It is noticeable that –as was to be expected from the previously shown figure– the scattering of the wear volumes per damage mark is large, i. e., not every rolling element raceway system behaves in the same way. If we follow the wear volume at the inner and outer ring,

we notice a degressive trend with increasing cycle number. A steep increase during the first 20 000 cycles is followed by a significantly shallower rise in the range from 80 000 to 160 000 cycles. It is also noticeable, that the slope of wear volume on the outer ring is greater in the initial phase than the slope of the wear curve on the inner ring. Towards the end of the experiments, the slope equalizes.

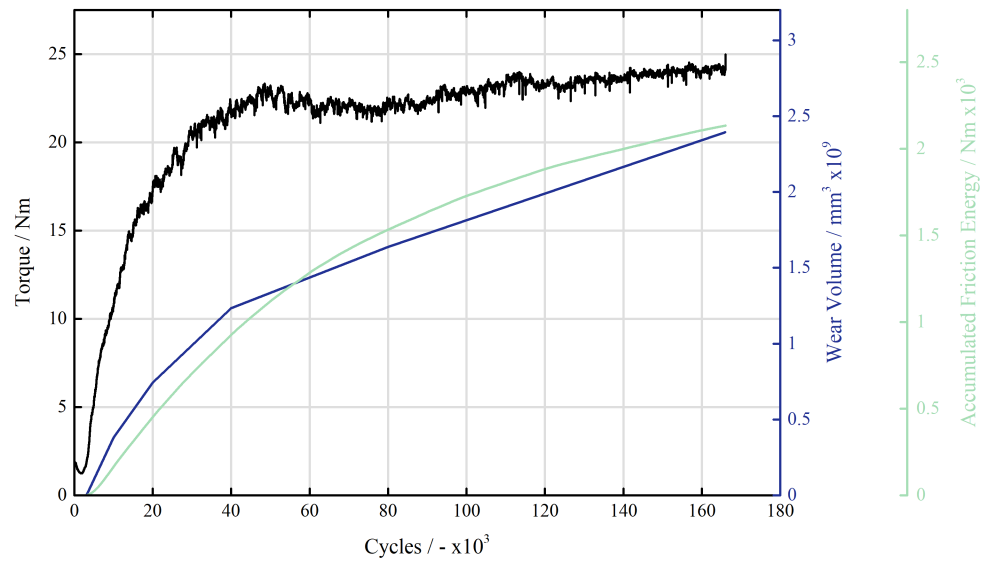
Figure 8. Course of the maximum torque per oscillation cycle (black), the accumulated dissipated energy (green) and the linearly interpolated wear volume (blue) over the number of cycles.

In order to establish a connection between the wear volume and torque, both the progression of the maximum torque per oscillation cycle (black), the summed wear volume on the bearing raceway (blue), and the summed frictional energy are shown versus the number of cycles in Figure 8. The course of the maximum torque starts at a low value of less than 2 Nm. After about 3 000 cycles, the torque starts to increase steeply and reaches a local maximum value of about 23 Nm after about 50 000 cycles. Up to the end of the test at 160 000 cycles, the torque remains almost constant in the further course and only increases by around 1 Nm. The green curve in Figure 8 shows the accumulated dissipated energy, which results from the torque curves as described in Section 2.2. The frictional energy shows a degressive behaviour, unlike what one would expect from the maximum torque. At this point, it is important to take a closer look at the shape of the torque curves over the number of cycles. This is because even if the maximum torque remains at an almost constant high level towards the end of the test, the enclosed area within the torque curves decreases from a certain point in time onward.

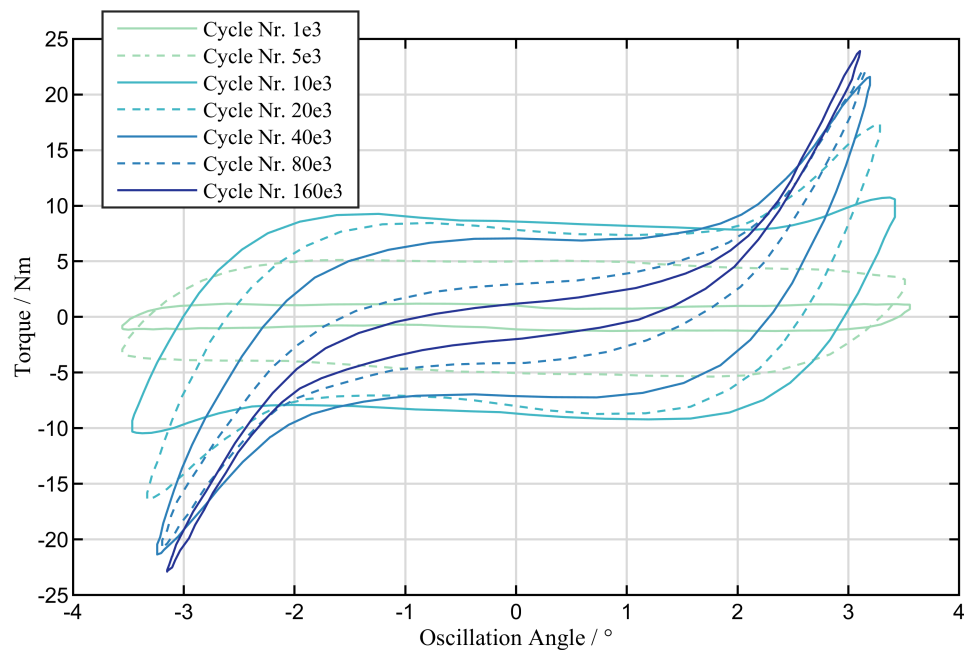
Figure 9. Plot of torque curves versus oscillation angle for selected oscillation cycles during the test.

Figure 9 shows selected torque curves at the times when the bearings were analysed for wear. In light green is the torque curve after 1 000 cycles, which is similar in shape to the curve one would expect for an undamaged bearing, see Section 2.2. After 10 000 cycles, the shape is still qualitatively similar to the expected curve for an undamaged bearing, but the torque during the oscillation cycle has already increased significantly. The maximum torque during the oscillation cycle of approx. 10 Nm is reached about 1.5° after the reversal points. After 20 000 cycles the shape of the curve starts to change. Peaks start to form at the reversal points, which are decisive for the maximum torque in the following curves. But even in the middle of the curve around an angle of 0° , the torque has continued to increase. From this point on, pronounced peaks form at the reversal points, which lead to an increase in the maximum torque. In the middle of the oscillation cycle around an angle of 0° , however, the torque decreases. While values of ± 8 Nm are observed at 0° for the curve at 20 000 cycles, after 160 000 cycles only approx. ± 2 Nm are measured.

A similar behaviour can be observed in Figure 9 during the tests with type 7208 bearings. As indicated in the previous chapter, the change in shape of the torque curves is associated with a degressive change in dissipated energy during every cycle. Analogous to the investigation of the smaller bearings, the relationship between wear volume and dissipated energy is evaluated for the type 7220 bearings. Hence, the energy wear factor according to 2 is calculated for the underlying test. Characterised by the friction torque development over the first cycles, no wear damage is considered for the first 50 cycles due to the slight decrease in friction torque. However, the steep increase in friction torque for the continuing cycles is associated with failing lubrication but wear volume measurements and the images of wear mark show (see Figure 11) that it takes about 1 000 cycles to form first corrosive wear damages and loss of material. Figure 16 shows the calculated energy wear factor for the underlying test of type 7220 bearings with 40 000 cycles. Similar to the smaller bearings, it is characterised by a steep increase over the very first cycles, beginning at about 500 cycles. However, the peak value is reached earlier than for the 7208 bearings.

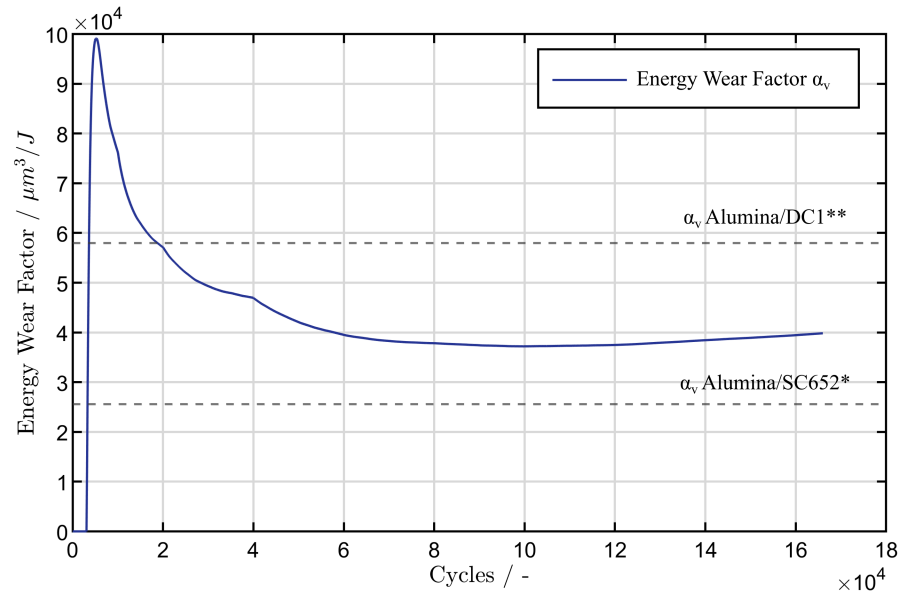
Figure 10. Representation of the energy wear factor determined here above the number of cycles (blue). *Energy wear factor for an Alumina/SC652 contact in the oscillating ball-disk test under pure sliding found in [22]. ** Energy wear factor for an Alumina/DC1 contact in the oscillating ball-on-disc test with pure sliding found in [22].

This results in the energy wear factor $\alpha_{v,n}$ shown in figure 10. For the first 3000 cycles, which show no increase in torque, it is assumed that the grease lubrication is still effective to prevent wear in most contacts, so that $\alpha_{v,0-3000} = 0$. From this point on, there is a steep

increase to a value of about $99\,171 \frac{\mu\text{m}^3}{\text{J}}$ at 10 000 cycles. Subsequently, $\alpha_{v,n}$ degressively decreases until becoming almost constant after 80 000 cycles. The horizontal black lines are energy wear coefficients measured by FOUVRY in a different test setup that will be further discussed in Section 4.

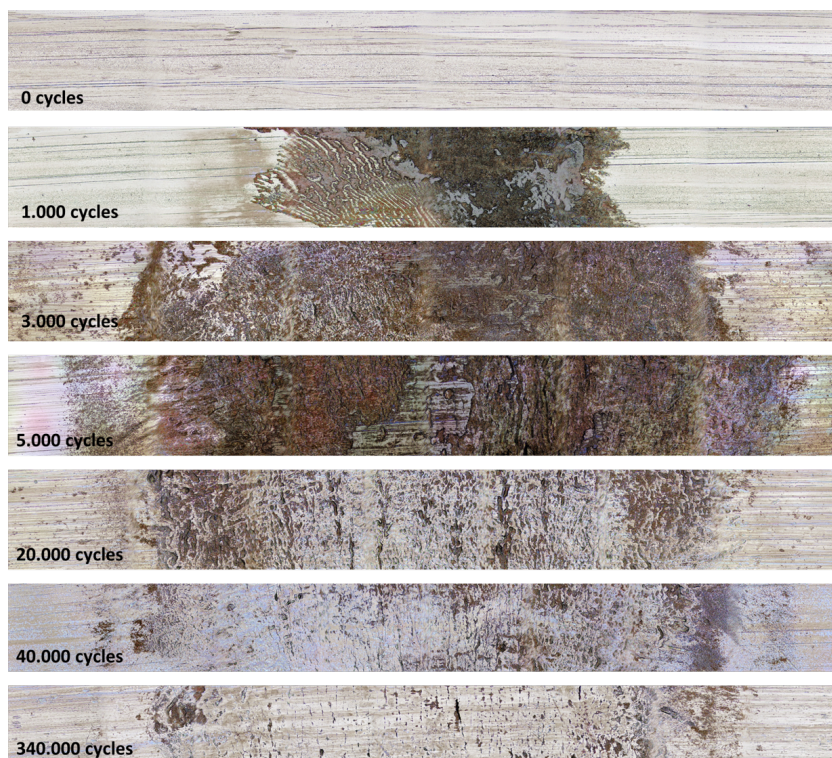
Figure 11. Sectional images of wear damage marks of type 7220 bearings for different oscillation numbers in ascending order (top-bottom)

The phenomenological investigation of the wear marks show different stages of wear damage. After about 1 000 cycles reddish-brown and blackish-brown corrosive products can be found on the raceway areas affected by the oscillating movements. With increasing cycle number this corrosive wear spreads to almost the complete width of about $x + 2b$. In addition, the surface becomes rougher and local erosion of the surface is forming till 5 000 cycles. With further increasing number of cycles, the appearance becomes shiny and polished. The corrosive products seem to disappear. However, there are no large differences between 40 000 and 340 000 cycles, despite the wear mark looking a bit more polished towards the center.

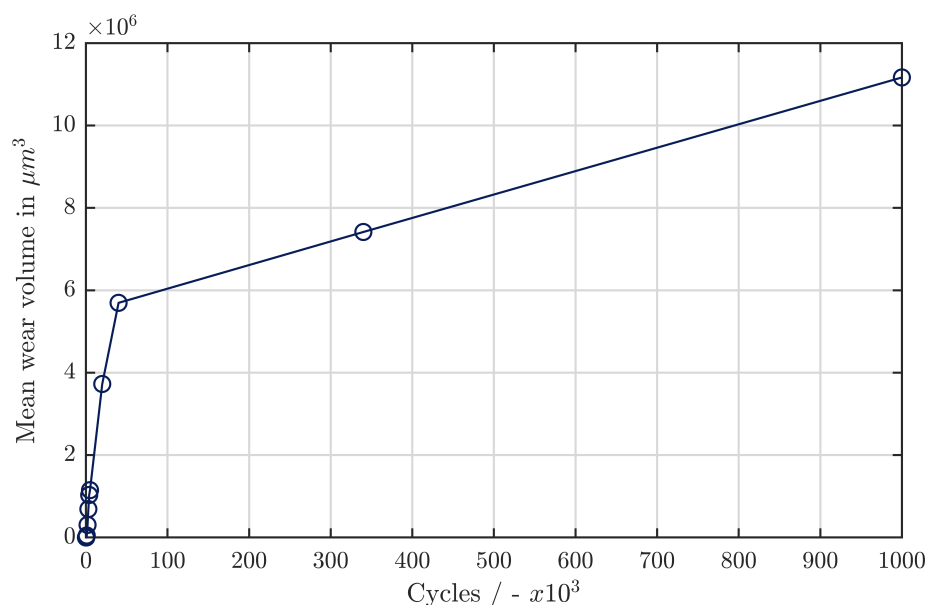
Figure 12. Mean value of wear volume per wear mark section for different numbers of oscillation cycles

Figure 12 shows the wear volume calculation of several investigated wear marks and tested bearings at different numbers of cycles. The data points are the mean values of several wear marks investigated with respect to the associated amount of cycles. The graph is characterised by a steep increase of wear volume between 500 and 40 000 oscillation cycles. Increasing the number of cycles even further does not lead to a significant increase in wear volume. Even after 1 million cycles the characteristic wear volume has only roughly

doubled compared to 40 000 cycles. However, the number of tests conducted for such high amount of cycles is limited, which makes the interpretation somewhat difficult.

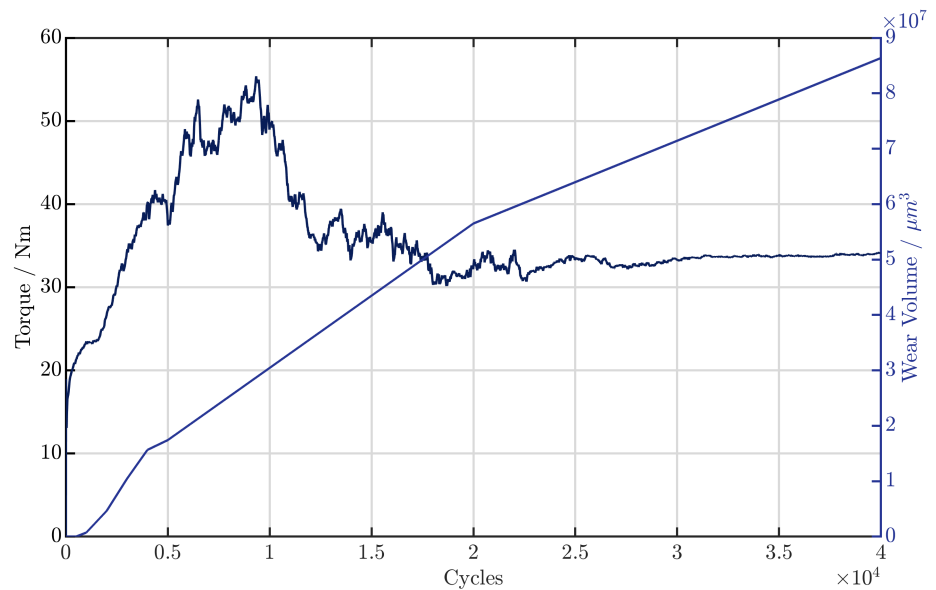
Figure 13. Peak of torque signal and interpolated and scaled wear volume of one wear mark for each oscillation cycle during a test with 40 k cycles

As discussed in the previous chapters the torque signal is a strong indicator of wear damage forming on the raceways. Figure 13 shows the torque development for a test with 40 000 oscillation cycles and test parameters from Table 2.

The graph shows the peak torque value for each oscillation cycle during the test and the linear interpolated wear volume from the data points from Figure 12 scaled according to

Section 2.2 to represent one wear mark. The underlying test and its data will be investigated in more detail. The torque signal is characterized by a steep rise, starting with only a few cycles of movement. The step rise has an almost linear characteristic starting from the load depended baseline torque of the bearings of about 15 Nm for the very first cycles and ending at about 55 Nm at about 10 000 cycles. Between 10 000 and 20 000 cycles, the torque level declines to about 35 Nm. No major change in the torque signal can be observed between 20 000 and 40 000 cycles. In contrast to the investigations with type 7208 bearings, the changes in the friction torque seem to happen at fewer oscillating cycles. Figure 14 shows the first 2 000 oscillation cycles from Figure 13. The first 50 cycles are characterized by a decreasing friction torque. Afterwards the friction torque is rising according to the foregoing description.

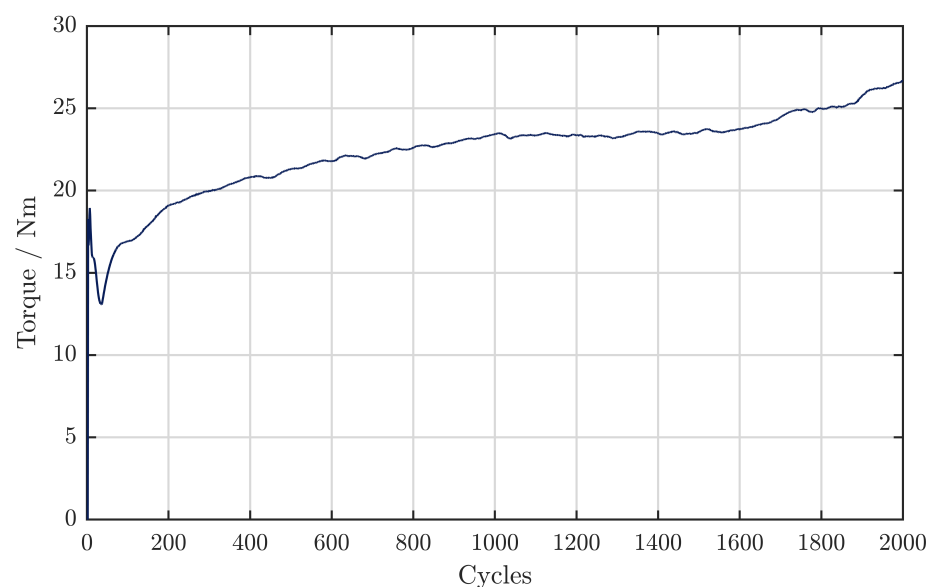
Figure 14. Peak of torque signal for the first 2000 cycles

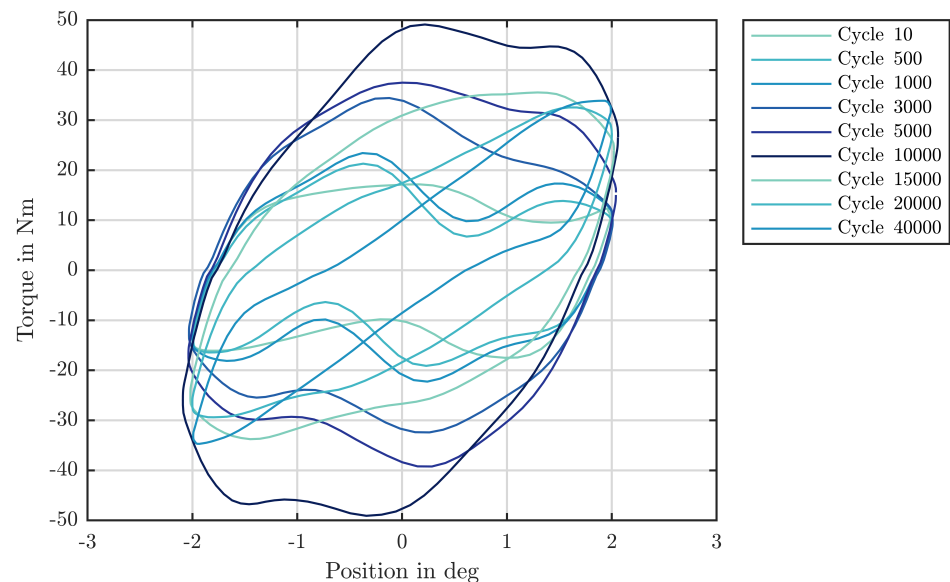
Figure 15. Torque curves versus oscillation angle plotted at different numbers of cycles during a test with a total of 40 k cycles

Figure 15 shows the torque signal plotted over the oscillation angle at different numbers of cycles during the same test like in Figure 13. The oscillating movement with an oscillation angle of 4° was carried out at a mean oscillation angle of 0° with a sinusoidal characteristic. Hence, the turning points of the movements are at 2° and -2° and the 0° position is characterised by the highest rolling speed of about $6 \frac{\circ}{s}$. Starting with the first cycles, the characteristic of the torque curve changes. Between 10 and 10 000 cycles the torque signal rises noticeably at the 0° position where the speed is at its highest value. In addition the torque level at the turning points also rises with more cycles leading to an overall larger area and wider appearance of the torque curve. From 10 000 cycles on, the shape of the torque curve changes its characteristics again. The torque level at high speeds seems to decrease, whereas the torque level at the turning points is rising even further.

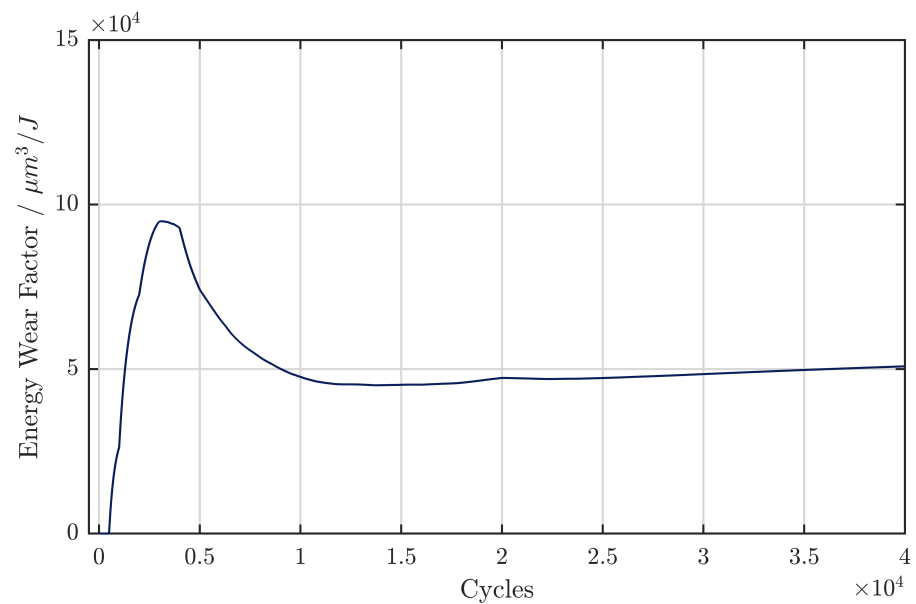
Figure 16. Energy wear factor for a test with type 7220 bearings and 40 k cycles according to Section 2.3

The energy wear factor is decreasing after the peak value and reaches an almost constant value of about $46\,000 \frac{\mu\text{m}^3}{\text{J}}$ at 10 000 cycles.

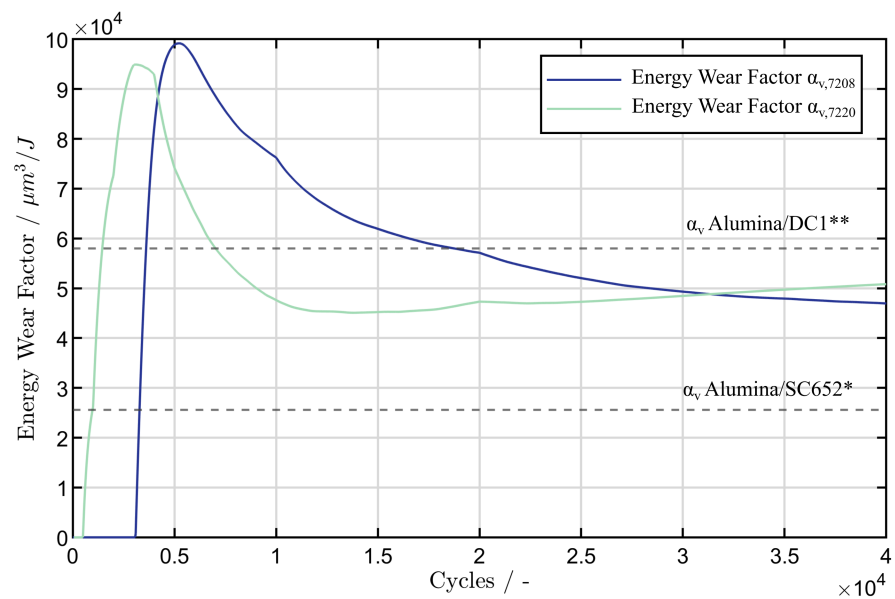
Figure 17. Comparison of the curves of the energy wear factors for the tests with bearing type 7208 (green) and 7220 (blue). *Energy wear factor for an Alumina/SC652 contact in the oscillating ball-disk test under pure sliding found in [22]. ** Energy wear factor for an Alumina/DC1 contact in the oscillating ball-on-disc test with pure sliding found in [22].

pairing of Alumina and HSS-Steel, the upper line at approx. $57\,000 \frac{\mu\text{m}^3}{\text{J}}$ for a pairing of Alumina and sintered steel (DC1). The material properties, including those of 100Cr6, of which the bearings and rolling elements investigated here are made, are listed in Table 3. It should be noted that FOUVRY'S tests were performed on dry contacts without lubrication. Since the energy-wear coefficients are nevertheless of a similar order of magnitude to the bearing tests under grease lubrication, it can be assumed that the lubricant only initially has a wear-inhibiting effect, but becomes almost useless in the course of the tests. This paper shows the results from tests conducted with two different bearing sizes lubricated with the same grease. All foregoing descriptions of the different wear mechanisms apply to the investigations on both bearing sizes. However, there are differences in the test results. Looking at Figure 17 the wear initiation and the transition between adhesion and abrasion happens earlier for the larger bearings.
