# Study on the Characteristics and Geomorphologic Evolution Patterns of Loess Landslides on the Heifangtai Terrace, China

Keywords: loess landslide; agricultural irrigation; loess terrace; geomorphologic evolution; FLAC 3D

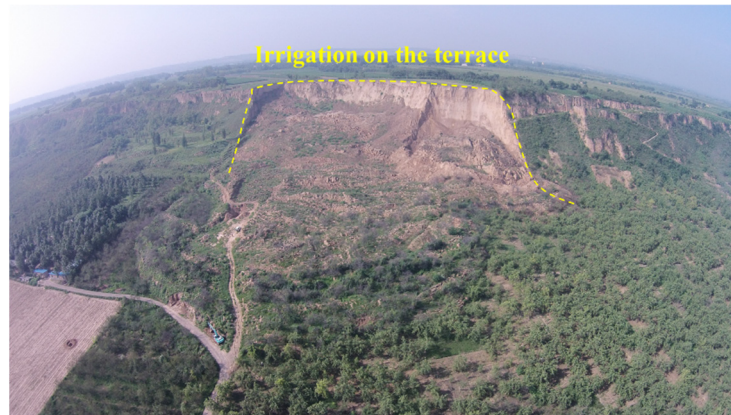
**Figure 1.** Photo of a typical landslide on the Heifangtai terrace due to irrigation, Gansu Province, China.

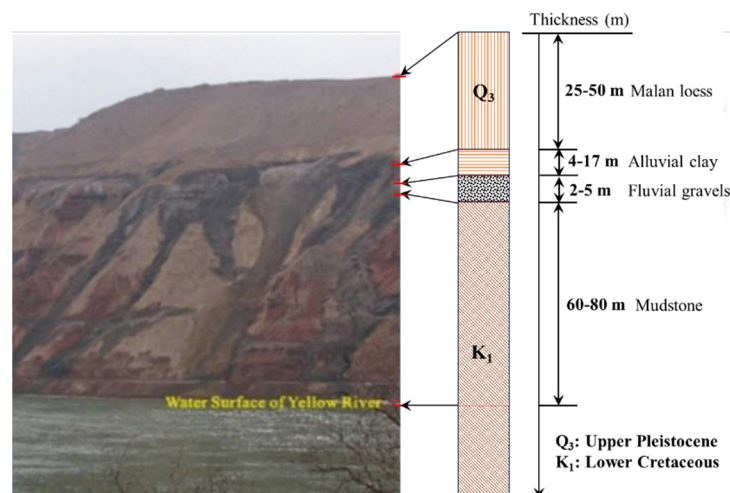
**Figure 3.** The lithological profile of the Heifangtai terrace.

The topography and geomorphology of the study area are relatively simple, mainly characterized by loess platforms, valley, and loess landslide geomorphology. The combined area of Heitai and Fangtai is approximately 15 km<sup>2</sup>. Heitai represents a typical loess plateau geomorphology in Northwestern China, covering an area of about 12 km<sup>2</sup> within the research area. It predominantly forms the 4th-order terrace of the Yellow River. The elevation difference between Heitai and the surface of river is about 100-120 meters. The Heitai extends in an east-west direction, with narrower sections at its eastern and western ends. The lithological profile of Heifangtai is composed of four layers (Figure 3): (1) the top layer is made up of upper Pleistocene aeolian Malan loess, with a thickness of about 25-50 m; (2) the alluvial clay layer, about 4-17 m thick; (3) the third layer is the fluvial gravel, which is mixed with sands, about 2-5 m in thickness; (4) the bedrocks are composed of lower Cretaceous mudstone, about 60-80 m thick [16].

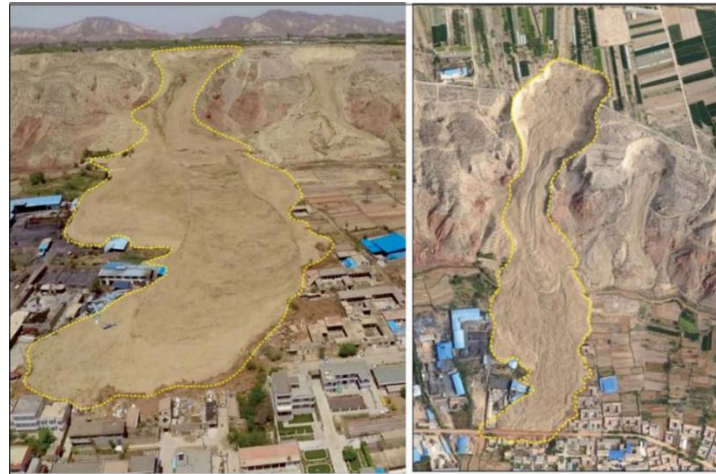
**Figure 6.** Photos of loess mudflow in Dangchuan region.

This type of landslide exhibits typical flow characteristics, with the shear outlet located at the bottom of the Q3 loess layer. Under the influence of groundwater, the loess undergoes liquefaction, leading to a reduction in strength and triggering landslides. Mudflow-type landslides are characterized by high-speed and long-distance movement. Loess mudflows in the study area have relatively long sliding distances, proposing the greatest threat to agriculture and roads in the lower part of the plateau. The No. 1 Dangchuan landslide that occurred on April 29, 2015, is a typical example of loess mudflow (Figure 6). The occurrence of this landslide can be divided into two stages. Initially, a landslide mass of approximately  $5 \times 10^4 \text{ m}^3$  slid from Heitai terrace to the second-level terrace of Yellow River. About three hours later, a faster-moving landslide mass of around  $35 \times 10^4 \text{ m}^3$  rapidly moved downstream. The final deposit of the landslide accumulation reached a thickness of up to 17 m.

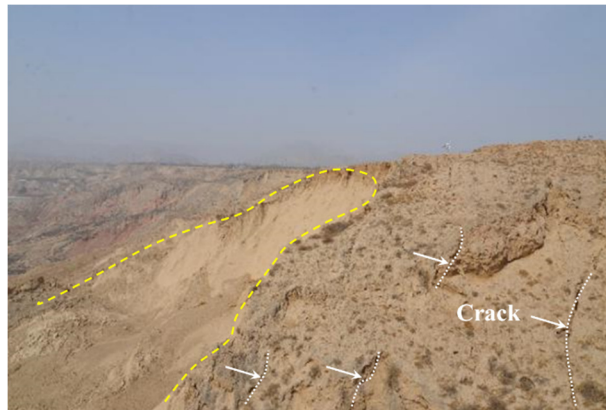
**Figure 8.** Photo of loess collapses in Dangchuan region.

Loess collapses are widely distributed in the study area, primarily controlled by the cracks near the edge of the terrace (Figure 8). Loess collapse occur within the unsaturated Q3 loess layer. Their scale has been gradually increasing, posing an escalating threat. The occurrence of loess collapse is mainly triggered by the infiltration of irrigation water and rainfall along the cracks near the edge of the terrace. This process induces the softening of the structure of the unsaturated loess layer and reduces the matrix suction in loess. In recent years, they have also been infrequently observed in the Dangchuan and Huangci region. Although the scale and impact of landslide collapse are smaller

compared to loess mudflow, ongoing collapses often lead to the formation of large through cracks at the rear of the landslide. Along these cracks, the influence of groundwater can trigger subsequent landslides.

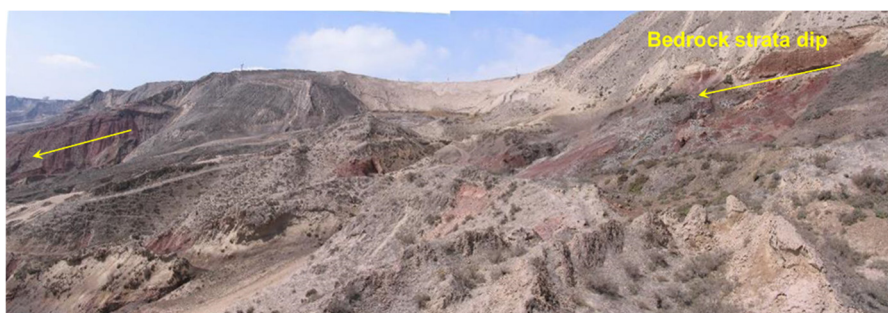
**Figure 9.** Photo of landslides caused by loess-Mudstone interbedded layers, Huangci region.

Landslides caused by loess-Mudstone interbedded layers are the most widespread type of landslide in the research area. For this type of landslide, the main sliding surface is located on the surface of the bedrock, and the landslide mass moves along the bedrock surface in a direction consistent with the inclination of the bedrock layers. The mechanism behind the occurrence of this type of landslide involves the infiltration of groundwater, which reduces the strength of the mudstone, leading to deformation and failure. Therefore, these landslides are characterized by a long incubation period, large-scale occurrences, and relatively short sliding distances. The Huangci landslide in the study area is an example of this type of landslide (Figure 9).

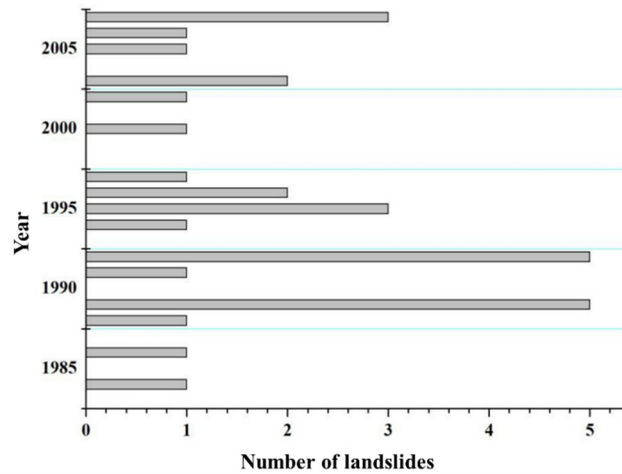
**Figure 10.** Annual distribution of landslides (from 1980 to 2010).

Under unchanged geological conditions, the occurrence of landslides exhibits certain regularity in annual frequency. From the 1960s to the present day, landslides have shown an overall increasing trend with localized decreases on an annual span. This regularity is related to the annual variations in factors such as rainfall, temperature, and geological activity in the research area (Figure 10).

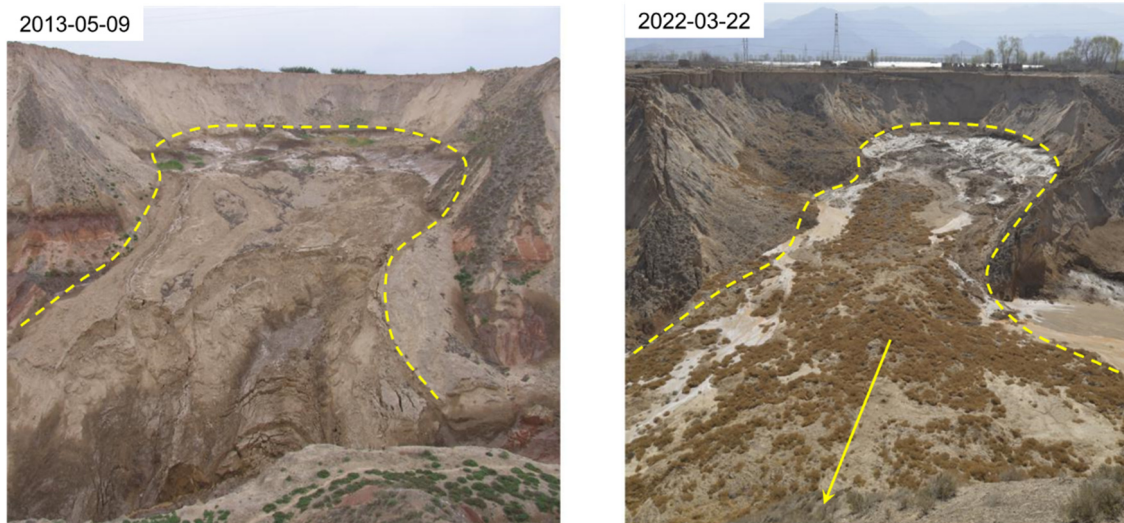
**Figure 12.** Photos of the Moshigou landslide in 2013 and 2022.

Figure 12 shows the Moshigou landslide. Over a span of nine years from 2013 to 2022, small collapses and landslides have continuously formed along the back edge of the concave terrain. The accumulated debris flows in a fluid state into the Moshi Gou due to the influence of groundwater, while the back wall of the landslide undergoes erosion, leading to the gradual enlargement of the concave terrain.

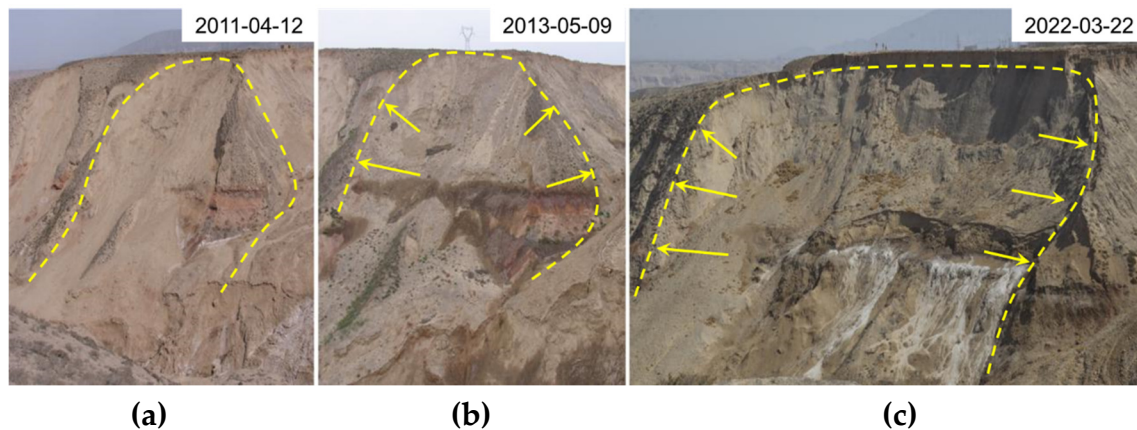
**Figure 13.** The lateral evolution pattern of landslide in Dangchuan region.

In Figure 13(a), the left side of the landslide developed shallow slumping bodies as shown in Figures 13(b) in 2013. However, with the rise of the water level, the slumping body continuously extended to both sides, creating a larger lateral sliding surface. This differs significantly from the landslide pattern shown in Figure 13(c).
