Influence of the Arrangement of the Cells/Modules of a Traction Battery on the Spread of Fire in Case of Thermal Runaway

[Ana Olona](#) and [Luis Castejón](#)*

Posted Date: 4 December 2023

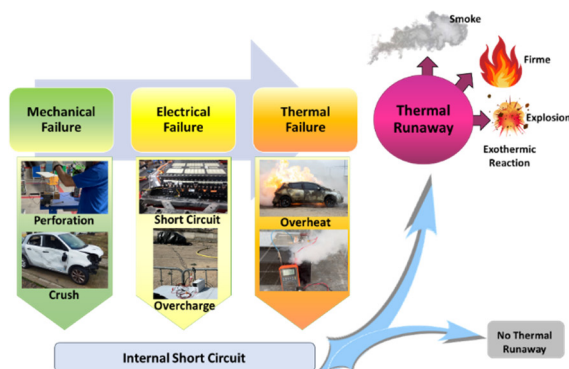
Figure 1. Thermal runaway mechanism of lithium-ion battery for EVs [11].

A lithium-ion battery can fail due to mechanical, electrical, or thermal failures at the cell, module, or battery pack level (Figure 1). These failures occur as a successive series, leading to the phenomenon of TR. Thermal failure can occur due to overheating, which can be caused by incorrect contact connections or excessive heat in the vicinity of the battery pack, such as from a fire caused by a car accident. In addition, overheating can occur during fast charging with a supercharger. This failure can also be caused by an internal short circuit, which occurs due to cell separator failures, contamination, manufacturing defects or dendrite formation (lithium build-up) on the anode. This failure can also occur due to defects during cell manufacturing that cause an internal short circuit.

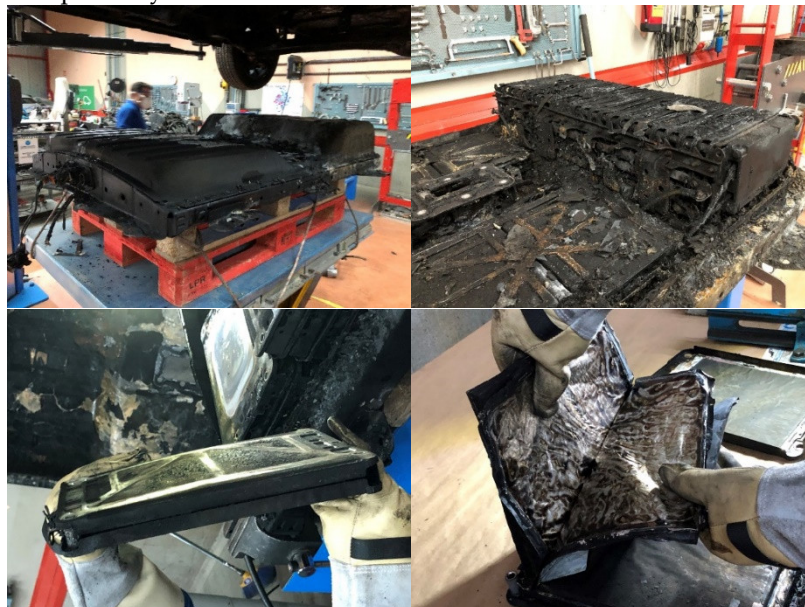
Figure 5. Pictures of the state of the battery pack, the module, and the lithium-ion cells inside the battery pack.

Once the test had been carried out and the necessary quarantine time had elapsed, the cells were dismantled to see how they behaved and their condition according to the position they were in. The aim was to analyze how the enclosure was damaged, according to the position of each cell within the enclosure. Moreover, deformation suffered by each of the cells was studied. Finally, the condition of these cells has been perfectly documented.

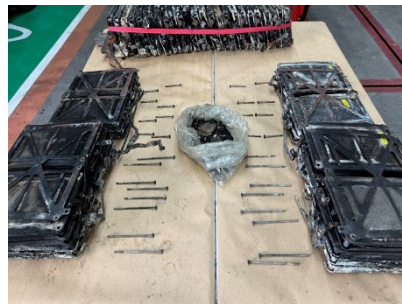
Figure 7. Burnt Nissan Leaf battery disassembled in the arrangement in which it is in the vehicle.

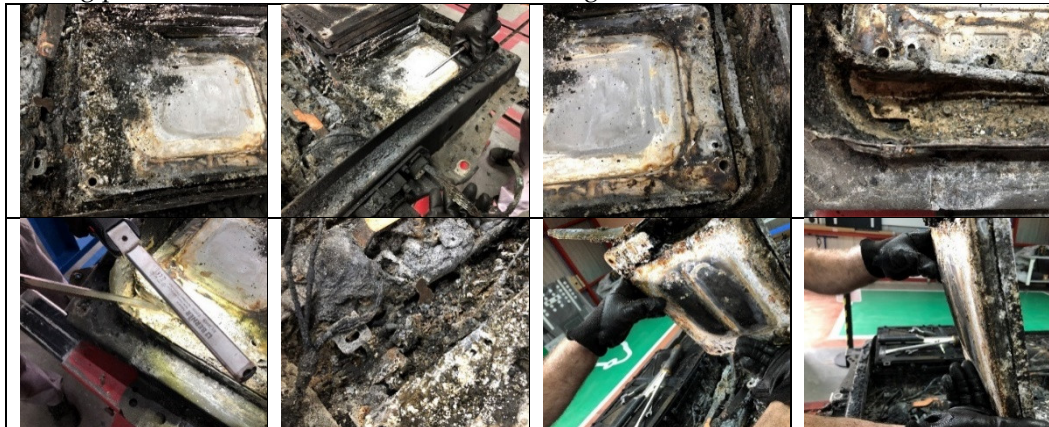
Figure 8. Images of the condition of module 30 (horizontal arrangement) of the battery pack of the burnt Nissan Leaf vehicle. This module has been identified as the most damaged between the modules in the horizontal arrangement.

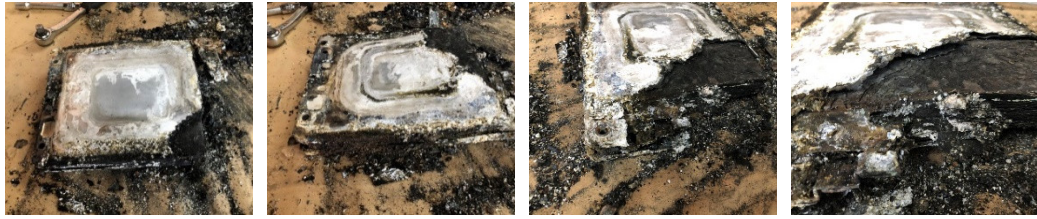
Figure 9. Images of the condition of module 11 (vertical arrangement) of the battery pack of the burnt Nissan Leaf vehicle. This module has been identified as the most damaged between the vertically arranged modules.

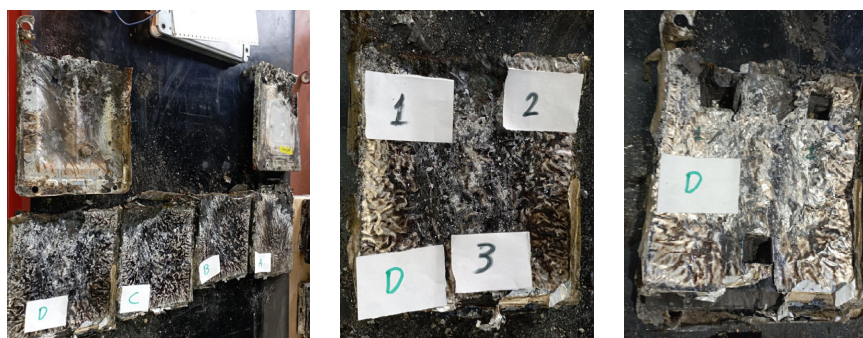
Figure 13. Obtaining samples from a module 30 calcined cell.
