Enhancing Riverbank Protection along the Jamuna River, Bangladesh: Review of Previous Countermeasures and Morphological Assessment through Groyne-based Solutions using Numerical Modeling

Keywords: riverbank protection; erosion-deposition; groynes installation; hydro-morphodynamic simulation; sand-bar movement

Enhancing Riverbank Protection along the Jamuna River, Bangladesh: Review of Previous Countermeasures and Morphological Assessment through Groyne-Based Solutions Using Numerical Modeling

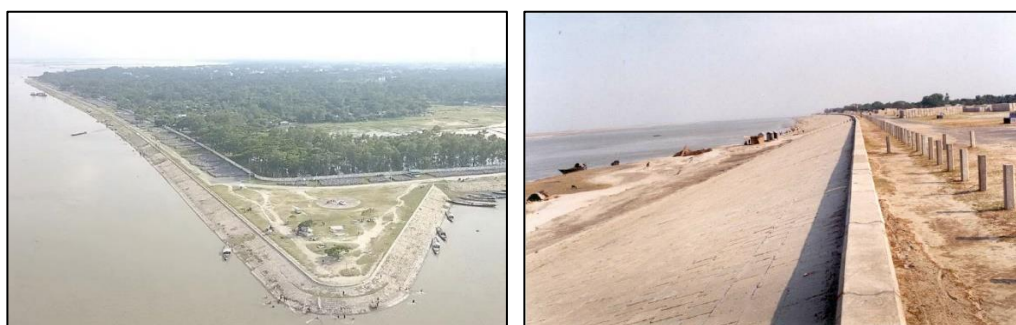
Figure 2. Sirajganj hard point along with the revetment (Source: Google image, and [7]).

The Sirajganj town protection initiative began several decades ago, featuring the Ranigram groyne at the upstream end of the current revetment structures. Both the groyne and revetment, armored with concrete blocks but lacking a filter layer, have suffered local damage. The significance of the Sirajganj Hard Point (Figure 2) extends beyond town protection and plays a crucial role in preventing the widening of the Jamuna River. Additionally, it safeguards Jamuna Bridge, ensuring that the river width remains within a specified upstream corridor [9].

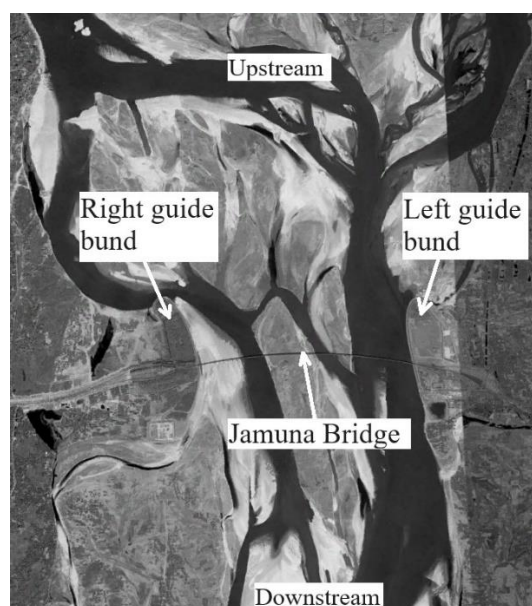
Figure 3. Guide bunds of the Jamuna Bridge (Google image)

The construction of the Jamuna Bridge in 1998 included two guide bunds that play a pivotal role in regional connectivity, linking Bhuapur and Sirajganj (Figure 3). These guide bunds effectively minimize river width, improve stability along riverbanks, protect bridges from erosion, and contribute to comprehensive river management, thereby safeguarding transportation routes. While the eastern channel near the left guide bund maintained a consistent course, the right guide bund significantly influenced the adjacent channel, leading to noticeable alterations. Over the years, a discernible trend emerged as the channel gradually shifted upstream of the western guide bund, resulting in significant changes in the river sandbars.

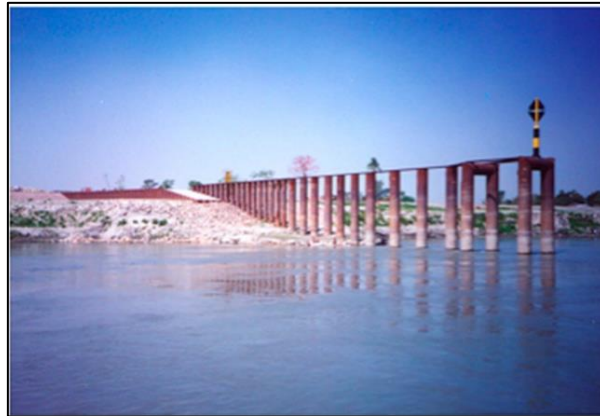
Figure 4. Kamarjani permeable groyne (Source: [14])

In response to the 1988 flood, the World Bank's Flood Action Plan (FAP) launched Project 21 for erosion control along the Brahmaputra-Jamuna River. Focusing on Kamarjani village's right bank, the project aimed to build cost-effective bank protection, including a groyne test structure safeguarding 1700 m of the riverbank [13]. However, permeable groynes (Figure 4) constructed from 1994 to 1995 suffered damage and proved ineffective in preventing erosion, with limited impact on the river course and sandbar dynamics.

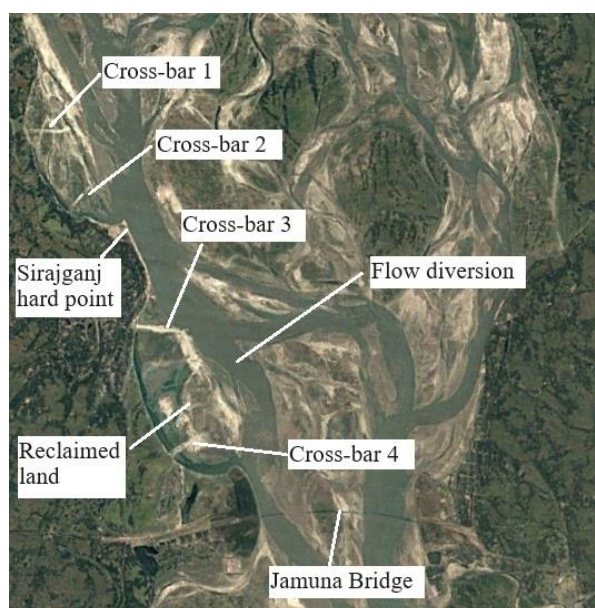
Figure 6. Four cross-bars implemented near Sirajganj town.

Following the construction of the Jamuna Bridge, persistent erosion occurred both upstream and downstream of the Sirajganj hard point, resulting in partial damage to the revetment. To tackle these challenges, the Bangladeshi Water Development Board (BWDB) strategically implemented the construction of four cross-bars along the right bank of the Jamuna River from 2011 to 2015. Crossbars 1 and 2 were positioned upstream of the hard point, whereas crossbars 3 and 4 were placed downstream (Figure 6), accompanied by dredging and filling during construction. This intervention led to substantial land reclamation, effectively addressing bank erosion, and transforming reclaimed land into an economic zone. The combined impact of the cross bars and dredging also induced a significant shift in the major channel, diverting it from the right bank and causing substantial morphological changes in the area.

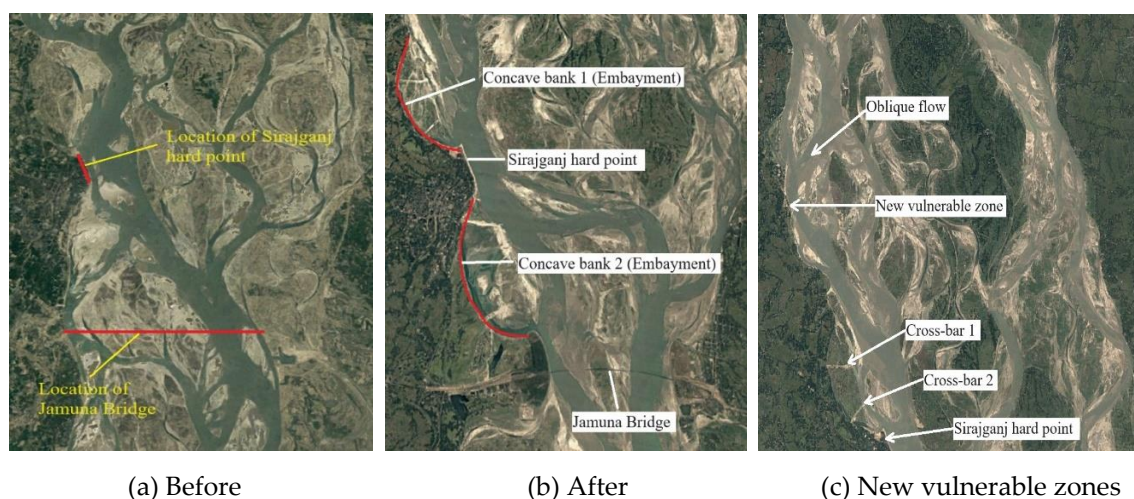
Figure 7. Formation of two concave banks due to construction of guide bund and hard point along with the formation of new vulnerable area after construction of the cross-bars.

An important discovery here is that, following the construction of the right guide bund and hard point, two concave banks resembling embayments were created due to bank erosion (Figure 7b). This occurred because the width of the river was reduced by several kilometers during the construction of the bridge guide bund. Consequently, the upstream flow attempts to impact the banks upstream to gain entry, leading to the erosion and formation of these concave banks. For concave bank 1, there is a slightly concave bank immediately upstream from the nose of the hard point. When the hard point is constructed using robust materials, a similar situation occurs with the upstream water current, ultimately causing the riverbank to erode and form a concave shape.

With the completion of the four crossbars, there is a possibility of a new concave bank or the emergence of erosion-prone zones just upstream of cross-bar 1. This potential development arises from the likelihood that crossbar 1 might alter the upstream flow, causing it to impact the upstream bank at an angle and potentially create an additional embayment. Consequently, our goal is to identify the optimal locations for implementing new countermeasures, such as groynes, further upstream from the current cross-bar 1. To accomplish this objective, simulations were conducted using different options to identify the most effective locations.

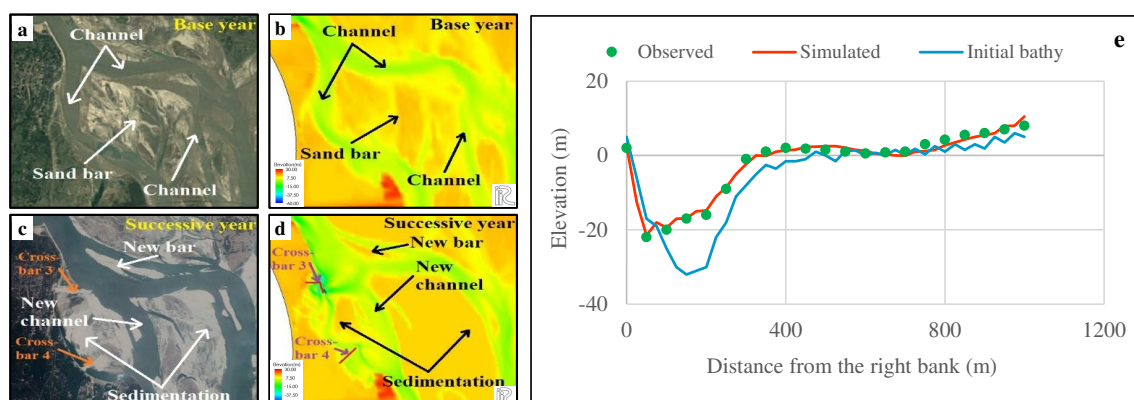
Figure 10. Reproduction of the change scenarios for morphological verification. (a) Satellite image for base year, (b) initial model bathymetry for base year, (c) satellite image for successive year, (d) model output for successive year, and (e) cross-section comparison at Sirajganj hard point [20].

The iRIC Nays2DH software was employed for morphological verification through simulation, incorporating bathymetry data of the Jamuna River and implementing interventions such as cross bars around Sirajganj, dredging, and filling [28]. The validation utilized a discharge value of 72,661 m³/s for the upstream boundary derived from post-crossbar installation data (2011-2012). The simulation results were compared with the satellite imagery [29] post-cross-bar construction, and the results are shown in Figures 10(a-d). Notably, the thickness reduction in the previous channel between crossbars 3 and 4 reduced the erosion susceptibility. Dredging and filling led to the formation of new channels that were accurately replicated in the model. A quantitative comparison at the Sirajganj hard point (Figure 10e) confirmed the accuracy of the model. The channel shifting, erosion, and deposition patterns were aligned with the observed data, indicating satisfactory morphological verification.

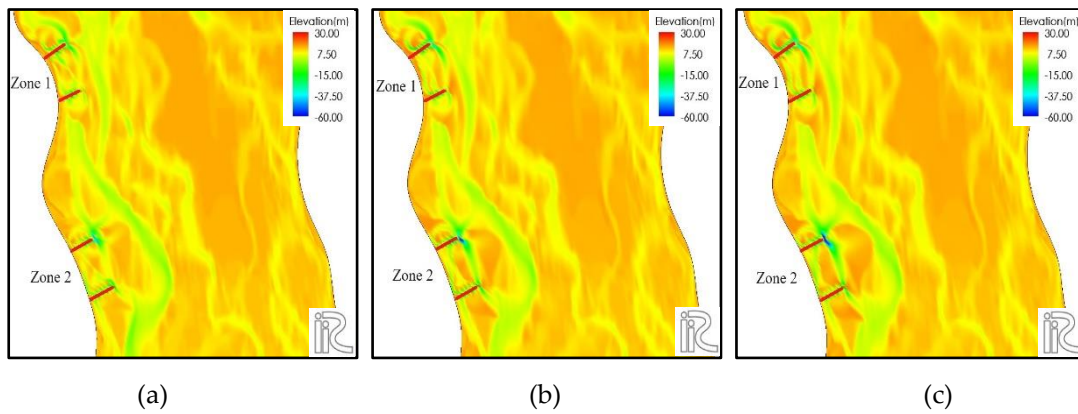
Figure 15. For Case_3, model output for elevation due to (a) annual average flood, (b) 100-year flood, and (c) 200-year flood.

Figure 15 shows a thorough examination of Case 3, presenting the model output for elevation under three distinct discharge conditions is illustrated (Figures 15a, 15b, and 15c). In the context of the average annual flood, 100-year flood, and 200-year flood, the output scenarios closely resemble those of the previous cases. Consequently, the effects of the groynes in Zone 1 persisted within its surrounding area, and likewise, the effects of the groynes in Zone 2 were confined to its territory, echoing the patterns observed in Cases 1 and 2. A notable gap existed between the two affected zones, making the length of the river a pivotal factor influencing the combined effect of the groynes installed in different zones. Notably, owing to the absence of a major channel adjacent to the riverbank between these two zones, no groynes were installed in that region. Consequently, for this specific case, the output scenarios exhibited a pattern like that observed previously and were delineated by their respective zones.

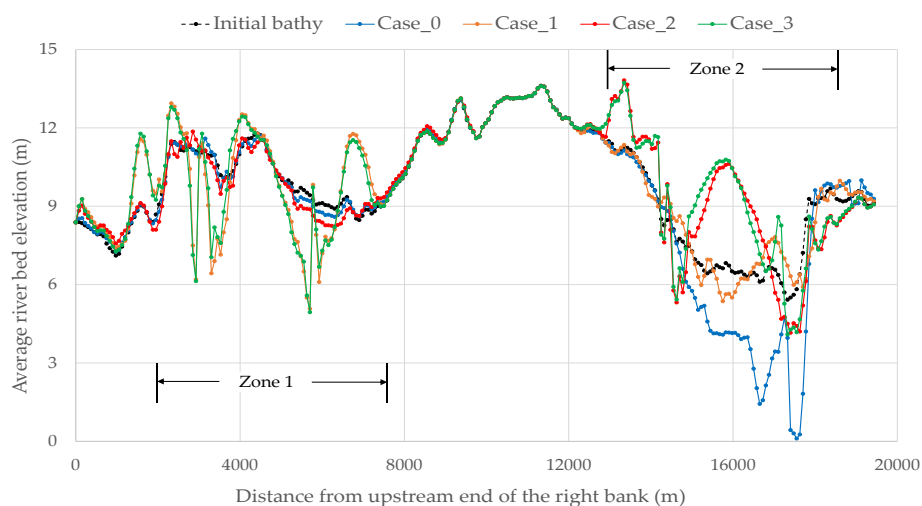
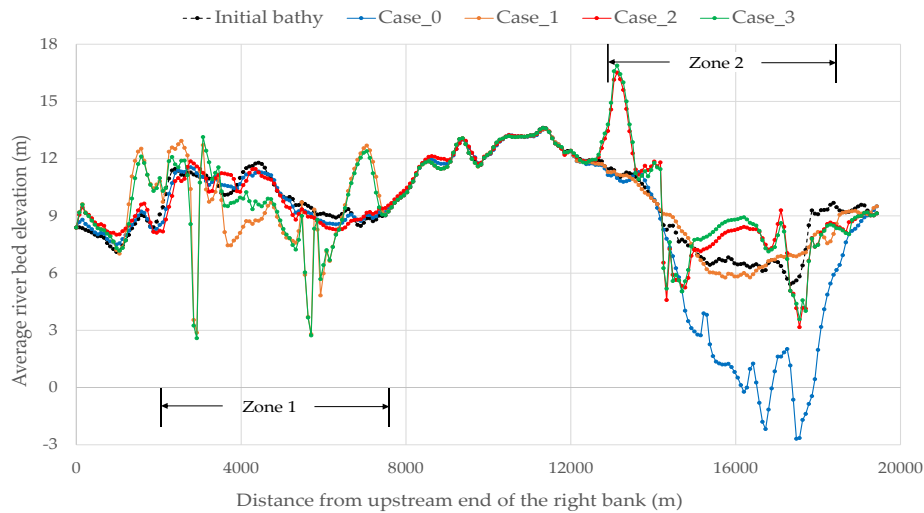
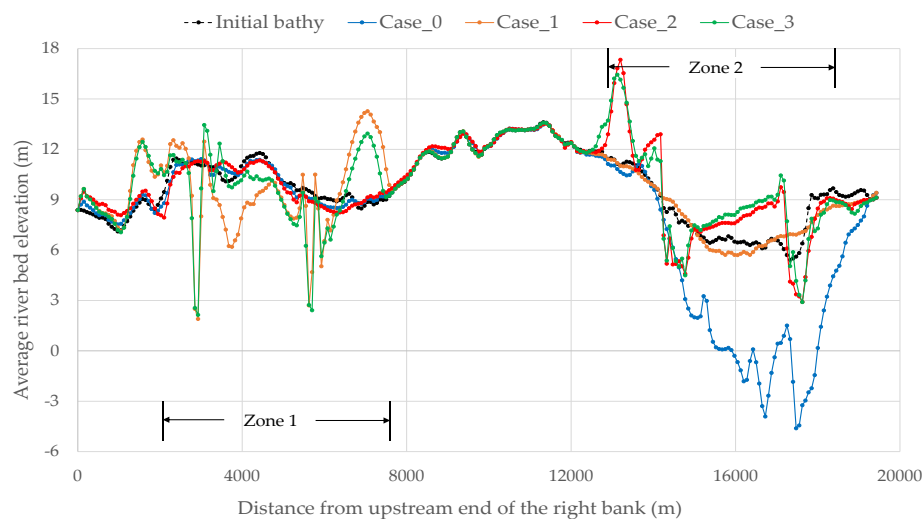
Figure 16. Illustrating the contrast in average bed elevation from the initial bathy to the final condition of all cases, spanning from the right bank to 700 m across the river for (a) annual average flood, (b) 100-year flood, and (c) 200-year flood.

Figure 16 provides an exhaustive overview of average bed elevation alterations in close proximity to the right bank. Specifically, Figures 16a, 16b, and 16c delineate the fluctuations in average bed levels resulting for each case considering annual flood discharge ($70,309 \text{ m}^3/\text{s}$), 100-year flood discharge ($117,941 \text{ m}^3/\text{s}$), and 200-year flood discharge ($126,180 \text{ m}^3/\text{s}$), respectively. The average bed elevation near the bank enables a comprehensive analysis of erosion-deposition patterns along the riverbank.

In Case_0, the figures illustrate significant erosion occurring around Zone 2, and this erosion intensifies with higher discharges. The impacted erosion zone extends approximately 2.0 km along Zone 2 and continues to expand with increasing discharge. In contrast, there is minimal change in bed elevation at Zone 1 for this particular case. This quantitative analysis makes it evident that, under critical high discharge conditions, Zone 2 is more vulnerable than Zone 1.

For Case_1, all three figures demonstrate the presence of two prominent erosion zones flanking the two groynes in Zone 1. This phenomenon may be attributed to the alignment of the adjacent channel and the configuration of the convex bank of the river. Notably, in the case of the annual average flood, a modest deposition zone is discernible between the groynes; however, in the context of the other two flood scenarios, erosion predominantly governs the dynamics of this intermediate zone, overshadowing any deposition tendencies. In this instance, there is a modest impact in Zone 2, resulting in a reduction in the amount of erosion compared to Case_0. This effect may be attributed to the discontinuity of one channel created by the groyne insertion at Zone 1 (refer to Figure 13). However, it is noteworthy that despite this improvement, Case_1 does not represent a fully efficient option for the comprehensive safeguarding of the riverbank.

In this analysis, a noteworthy observation is the presence of two significant deposition zones — one upstream of the first groyne and the other situated between the two groynes, aligning closely with the characteristics of the natural scenario. The quantity of deposition at the upstream portion increases with higher input discharge. Regarding the area between the groynes, the deposition varies across simulations. Remarkably, from the upstream end up to the commencement of Zone 2, the average bed elevation remains relatively stable. The quantitative data also indicates that there is minimal impact on Zone 1 due to the presence of these groynes. However, it is notable that two minor erosion zones are observed adjacent to the groynes. Two potential causes for these erosion zones are postulated. Firstly, it is suggested that water circulation between the two groynes may induce some erosion in that location. Secondly, the two-dimensional nature of the software may contribute, as the groynes are modeled as obstacles with sharp edges, leading to erosion as the flow navigates around them. It is essential to note that this erosion occurs over the entire 700-meter width of a lengthy channel strip. Previous experience suggests that such small erosions, when averaged over the channel width, do not significantly impact the bankline.

Case_3 is the combination of the Case_1 and Case_2. The results also show the similar pattern as the previous. The figures reveal two prominent erosion zones flanking the Zone 1 groynes, attributed to channel alignment and riverbank convexity. During the annual average flood, a modest deposition zone appears between groynes, but in other floods, erosion prevails, overshadowing deposition. For Zone 2, upstream of the first groyne and between the two groynes, noteworthy deposition zones align with natural patterns, intensifying with higher discharge. The groynes minimally impact Zone 1, causing two minor erosion zones, potentially due to water circulation and software limitations. These erosions, averaged over the 700-meter channel width, align with past experience, showing minimal impact on the bankline.
