Not peer-reviewed version

Conservation of Defensive Military Structures Built with Rammed Earth

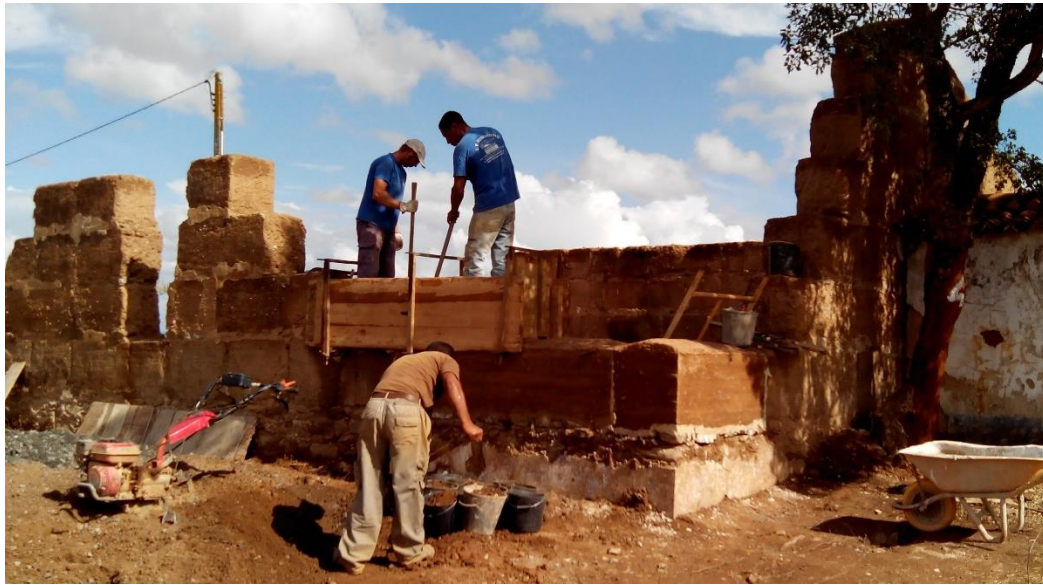
Figure 1. Example of civil rammed earth being produced in Santiago do Cacém, Portugal.

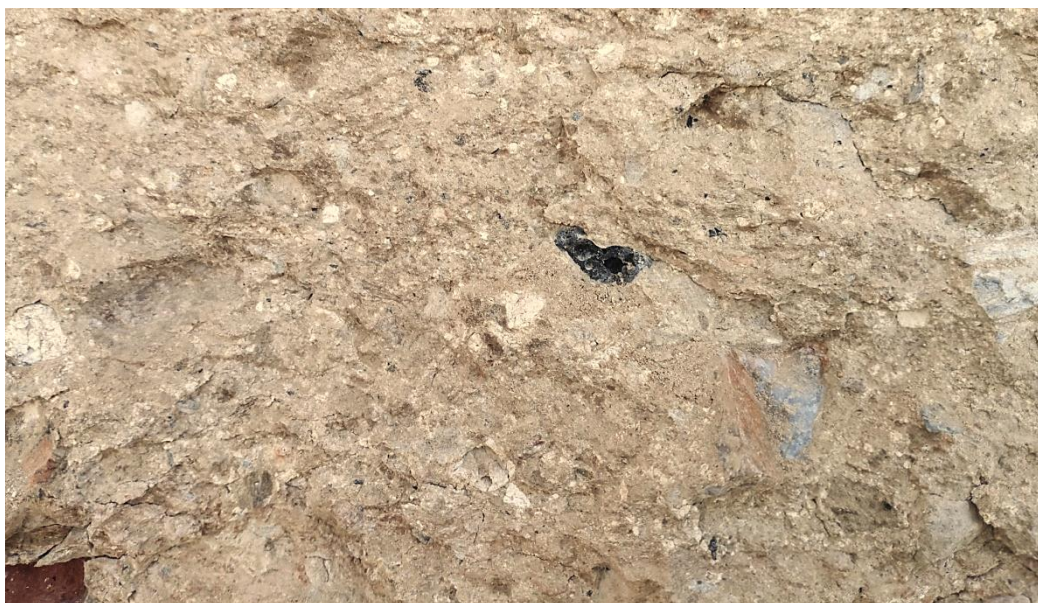
Figure 4. Detail of the presence of lime lumps in military rammed earth.

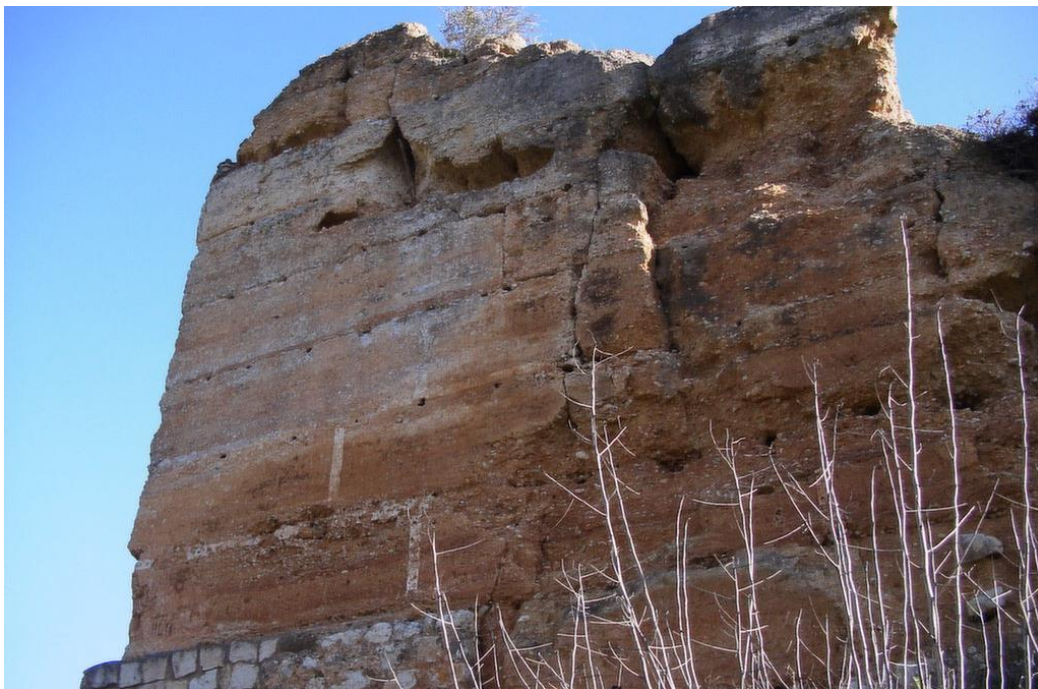
Figure 6. Detail of simulated ashlar stone masonry, in a rammed earth fortification.

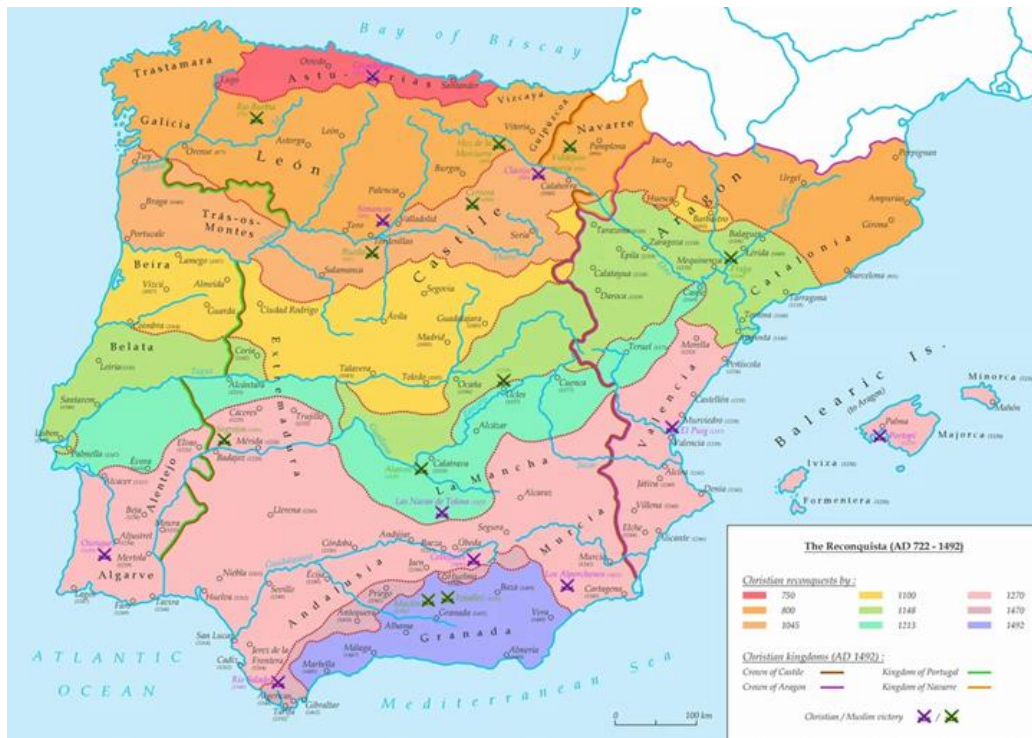
Figure 7. Schematic representation of the stages of the *Reconquista* (Christian re-conquest) of territories occupied by Muslims in Iberian Peninsula, with the Portuguese territory in the southwest, marked with a green line [25].

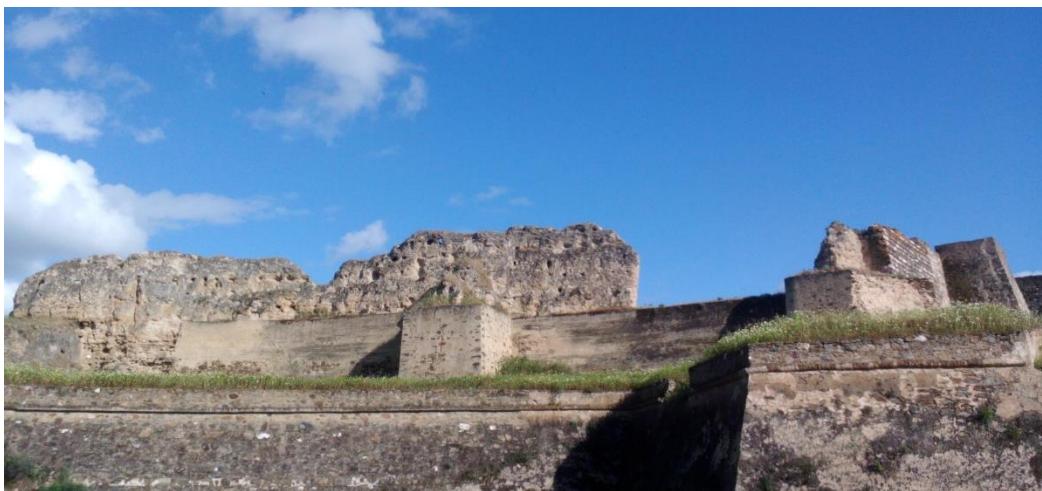
Figure 8. Example of a military rammed earth structure, built and rebuilt in different historical phases (Juromenha, Portugal).

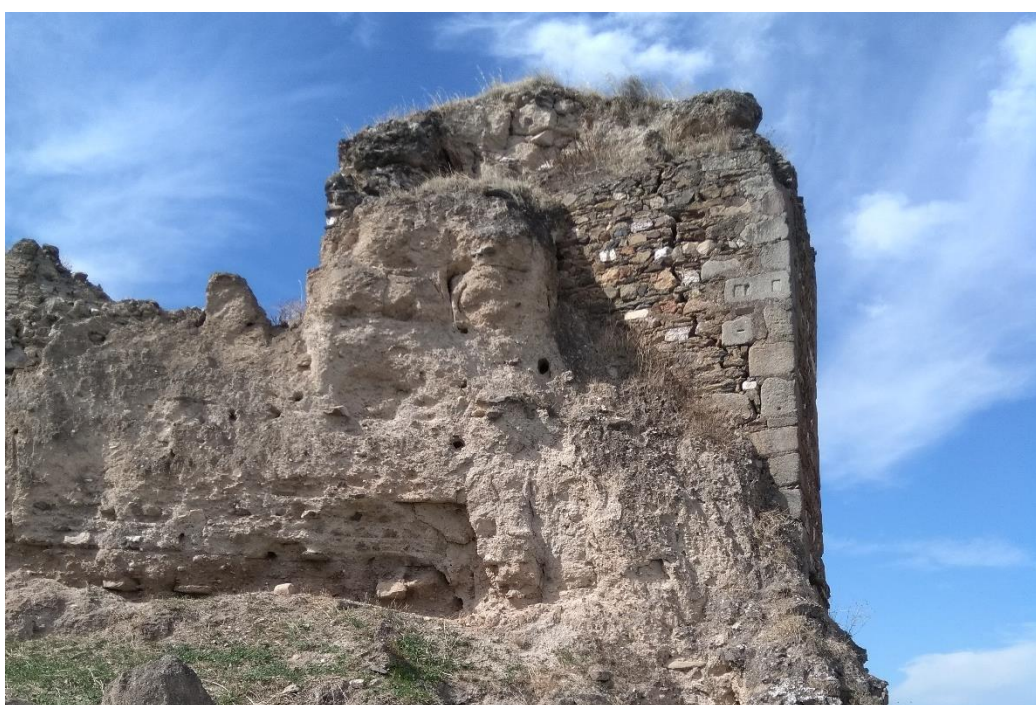
Figure 9. Action of water and structural failure in a military rammed earth structure (Juromenha, Portugal).

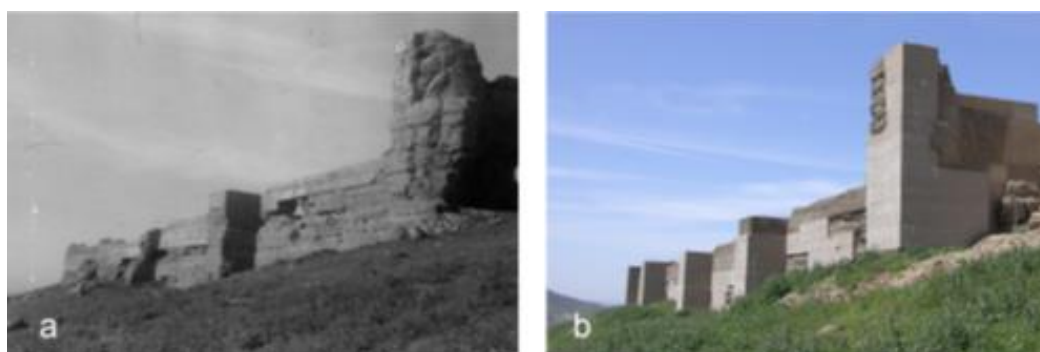
Figure 10. Recovery of volumes in a military rammed earth fortress to avoid collapse (Reina, Spain): a) before intervention; b) after intervention [31].

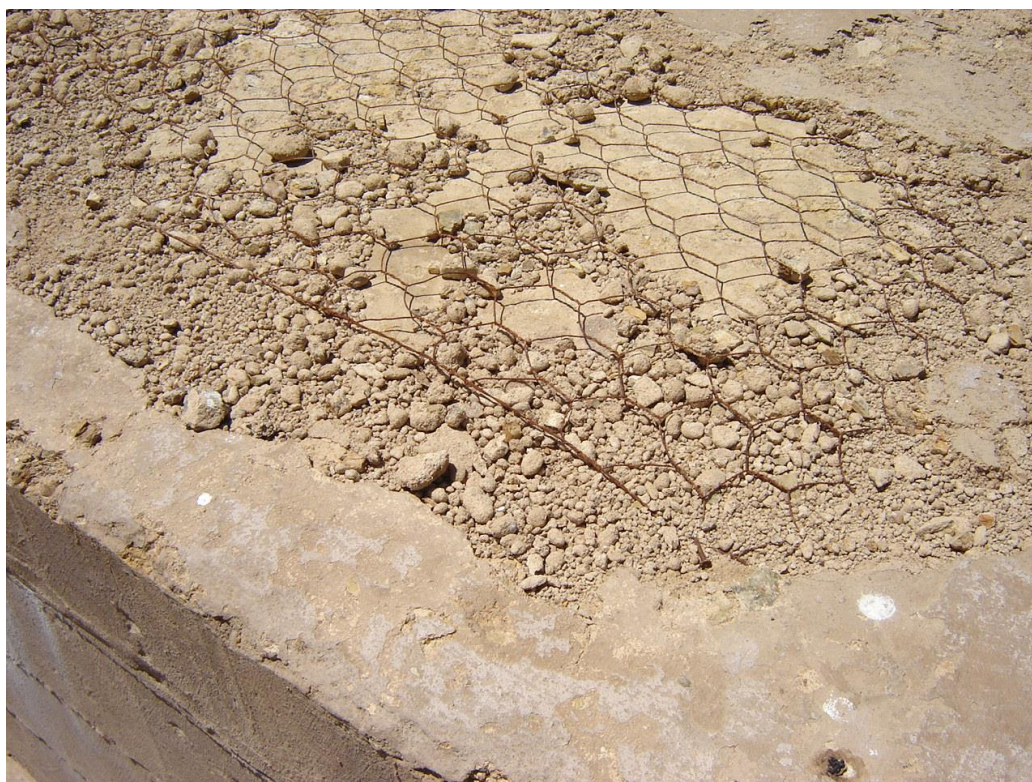
Figure 11. Detail of incompatibility of materials in an intervention for conservation of a rammed earth fortification, causing damage in the structure.
