# Strategies of Urban Aggregation for Cultural Heritage Protection: Evaluation of the Effect of Facade Layout on the Seismic Behavior of Terraced Masonry Buildings

Maria Rosa Valluzzi

Department of Cultural Heritage, University of Padova, Italy – Piazza Capitaniato 7 35139 Padova;  
mariarosa.valluzzi@unipd.it; Tel.: +39 049 8275576

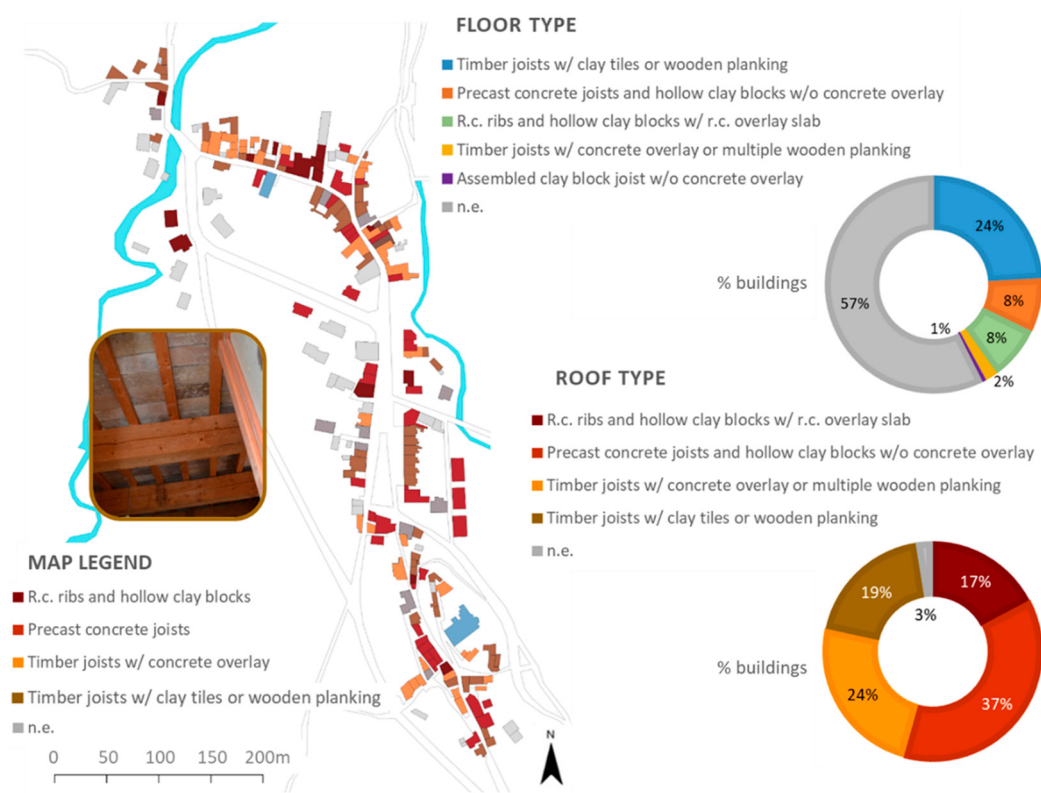
**Figure 4.** Distribution of roof types in buildings of Pievebovigliana: map with example of traditional solution (timber joist with clay tiles in picture) and diagrams of relative frequency of diaphragm types (floors and roofs).

Today, in roof types, precast concrete joists with low shear reinforcement and without any overlay prevails (37%), compared to timber joist with low-reinforced concrete overlay (24%) or without it (19%). In situ r.c. rib-hollow clay block composite systems are also present (19%), either in recent buildings or as replacement of previous roofs in more ancient ones (hamlet and 'castle' areas). Currently, the typical roof made of timber joist with clay tiles or wooden planking persist mainly in the central area of the village (see picture in Figure 4).

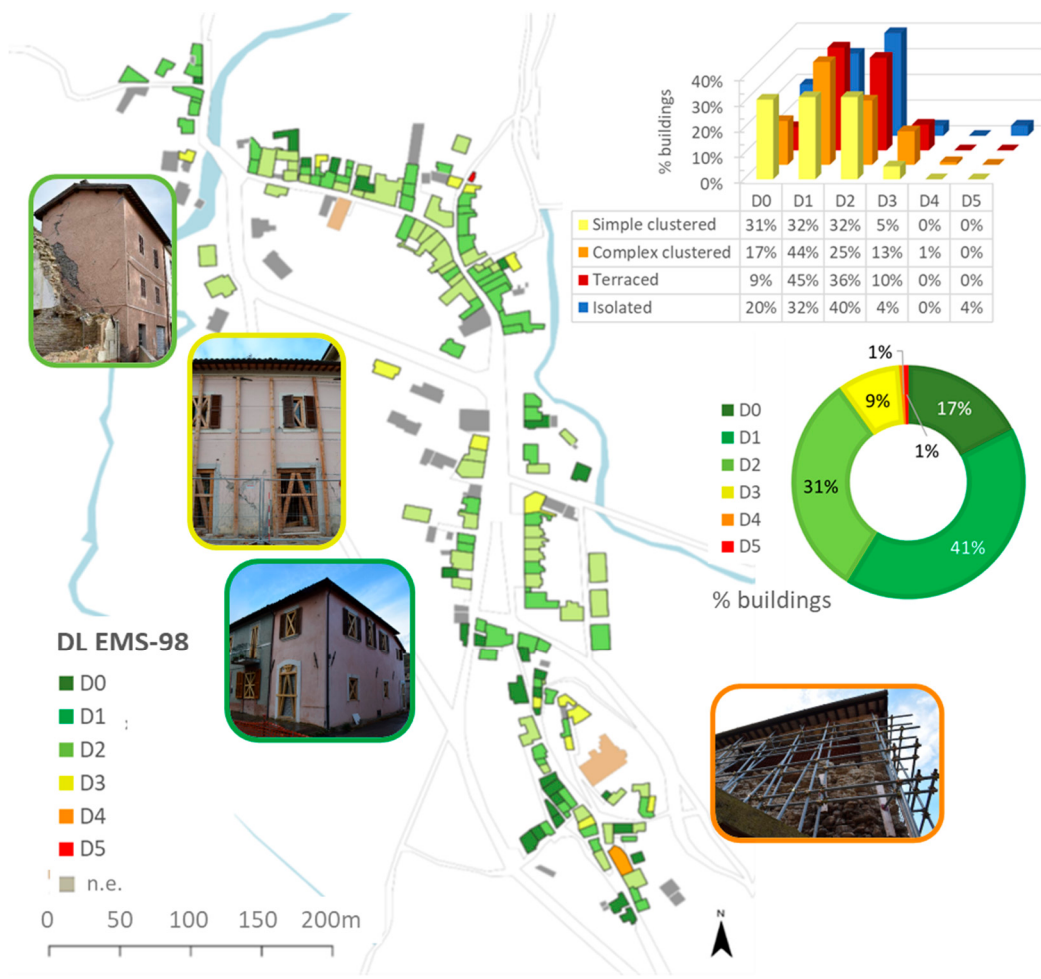
**Figure 5.** Distribution of damage level (DL) in buildings of Pievebovigliana according to EMS-98: map with example of damage (from D1 to D4 in pictures) and diagram of overall relative frequency; histogram of relative frequency of DL related to aggregation type of buildings.

According to the EMS-98 classification, Pievebovigliana was interested by an overall medium-low damage, which is mainly distributed between D1 (41%, 66 buildings) and D2 (31%, 50 buildings) classes (Figure 5). They were observed especially in the hamlet (in 50% of its buildings for D1 and 33% for D2) and in the ‘castle’ (37% for D1 and 20% for D2) areas. In the entire village, the hamlet also had the only collapsed building (1%, D5); also, in the ‘castle’, only one building suffered very serious damage (1%, D4). D3 affected 14 buildings (9%) that were mostly equally distributed among the three areas; no damage (D0) was observed in 28 buildings (17%), which were mostly located in the ‘castle’ (31% of its buildings) and the 1900 expansions (15%). This area had 37% of its buildings in D1 and D2 classes, and the 11% in D3 class.

Figure 5 also shows the distribution of DL according to the building types (cfr. Figure 1). The simple clustered buildings were interested almost equally by D0, D1 and D2. D3 was especially observed in complex clustered buildings and terraced ones. Isolated buildings primarily showed D2 and D1 levels. As expected, D3 affected the head and corner units (14% of buildings), which in total are present in the 50% of the aggregates (either terraced or clustered buildings) (cfr. §2.2); instead, only the 4% of the intermediate units (35% of the total) were affected by D3. Intermediate units mostly showed D1 (51%) and D2 (33%), while D0 was limited to 12% of buildings. D0 affected head or corner units for 23% and 14% of buildings, respectively; D1 for 39% and 33% respectively; D2 for 23% and 38%, respectively. D4 was observed in an isolated building and D5, in a head unit only.

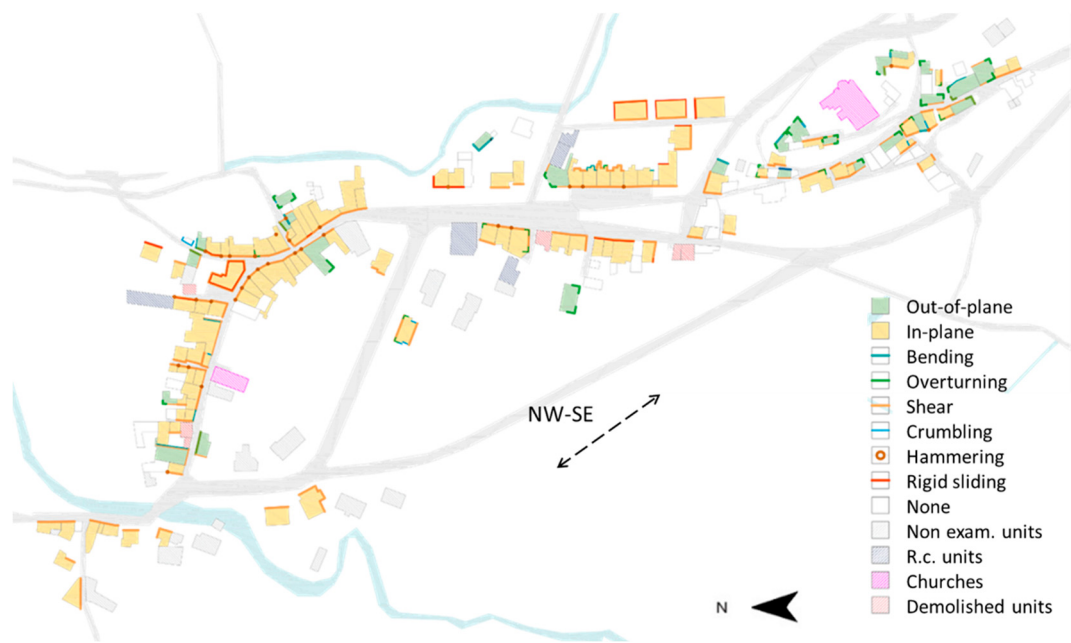
**Figure 9.** Distribution of main mechanisms activated on building facades in Pievebovigliana according to main orientation of seismic swarm.

with the orientation of the Apennines and its faults. Figure 9 shows the distribution of damage activated after the 2016 earthquake, pointing out the mechanisms occurred in the walls of the facades. The most damaged walls were those along the N-S direction, which underwent IP failure, whereas the much less OP mechanisms mainly occurred on walls along the E-W direction. This correspondence between the main development of facades and the predominant direction of the seismic actions may not be coincidental, due to the seismic history of that area, and certainly made the whole center more resistant to face the earthquake.
