# Involvement of Geological and Social Conditions in Complex Mass Movements. The Quilloturo Flood in Ecuador (2024)

Complex landslides have characteristics and parameters that are difficult to analyze. The landslide on June 16, 2024, in the rural community of Quilloturo (Ecuador) caused severe damage (14 deaths, 24 injuries, and hundreds of affected families) related to the area's geological, social, and anthropogenic conditions. Its location in the eastern foothills of Ecuador's Cordillera Real (Royal Mountain Range) exacerbated the effects of a landslide involving various processes (mud and debris flows, landslides, and rock falls). This event was preceded by intense rainfall lasting more than 10 hours, which accumulated and caused natural damming of the streams prior to the event. The lithology of the investigated area includes deformed metamorphic and intrusive rocks overlain by superficial clayey colluvial deposits. The relationship between the geological structures found, such as fractures, joints, schistosity, and shear, favored the formation of blocks within the flow, making mass movement more complex. Geomorphologically, the area features a relief with steep slopes, where

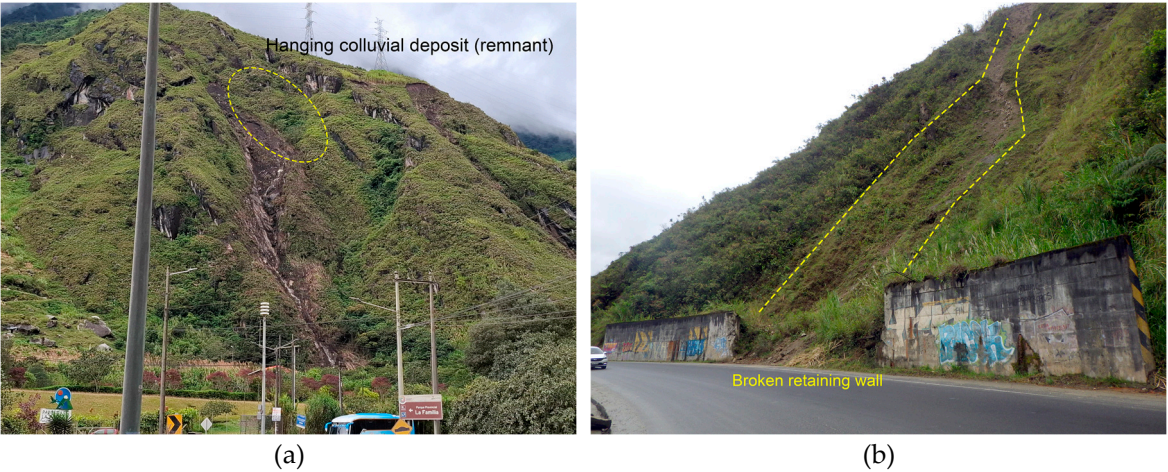
**Figure 4.** (a) A picture of the southern slope of the hill located NE of the Agoyán dam, showing a partially eroded surface deposit from the last rainy season in June 2024, which was channeled through the drainage system to (b) Broken retaining wall.

the Baños-Puyo road; (b) The retaining wall was destroyed by the impact of a flow (according to a resident of La Merced) composed of rock fragments such as gneiss or paragneiss.

Most of the mass movements that have occurred in the area in recent years are small. However, due to the presence of mountainous areas with steep slopes, these processes possess high energy, which is why they form very rapid flows that may be channeled. This characteristic causes these processes to generate strong impacts, even leading to the destruction of mitigation works (Figure 4b).

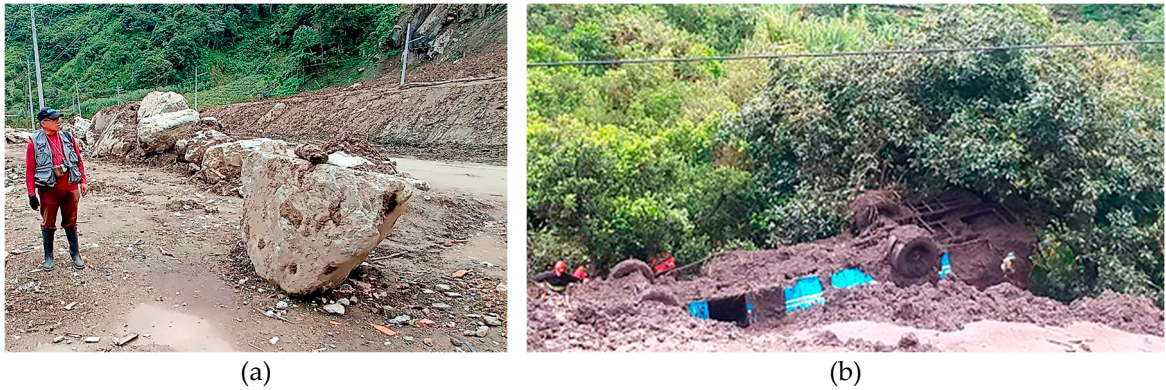
**Figure 5.** (a) Some boulders settled at the toe of the landslide, which were embedded in the mudflow materials. The analyzed landslide materials comprised vegetal soil overburden, mud, alteration soil, and rocks, being a complex mass running downslope; (b) The effect of the 2018 mass movement in the El Placer area, where a bus and its passengers were towed down the slope of the road (modified from [25]).

The most recent one, the Quilloturo mudslide, occurred on June 16, 2024, and is one of the most impactful events recorded to date in this area (Figure 5a), serving as the starting point of this investigation and resulting in a total of 14 victims being inventoried.

The existence of stratified rocks (in thick layers) of volcanoclastic origin is corroborated by the composition and structures of the tabular blocks ( $\leq 3$  m in diameter) of fine-grained rocks present in the deposit formed during the mass movement that affected the Quilloturo area in 2024 (Figure 5a).

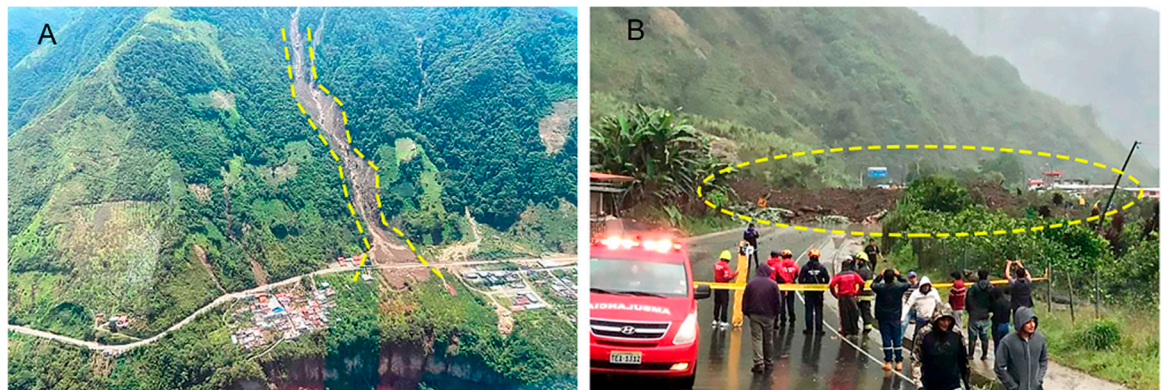
**Figure 6.** (A) Alluvial-type mass movement generated on August 11, 2022, in the Los Chivos ravine (Modified from [27]). (B) Detail of the deposit generated by the mass movement of the same event as the previous one affecting the E-30 road and nearby houses (Modified from [28]).

Another similar and significant event occurred in 2022 following a period of heavy rains that also dammed up in a ravine, generating a mudflow (affecting a house with three people and a heavy vehicle) [26] (Figure 6a,b). The community identifies this event as the Los Chivos mudslide, making it a local reference point for debris flows, their warning signs, and the damage they can cause.

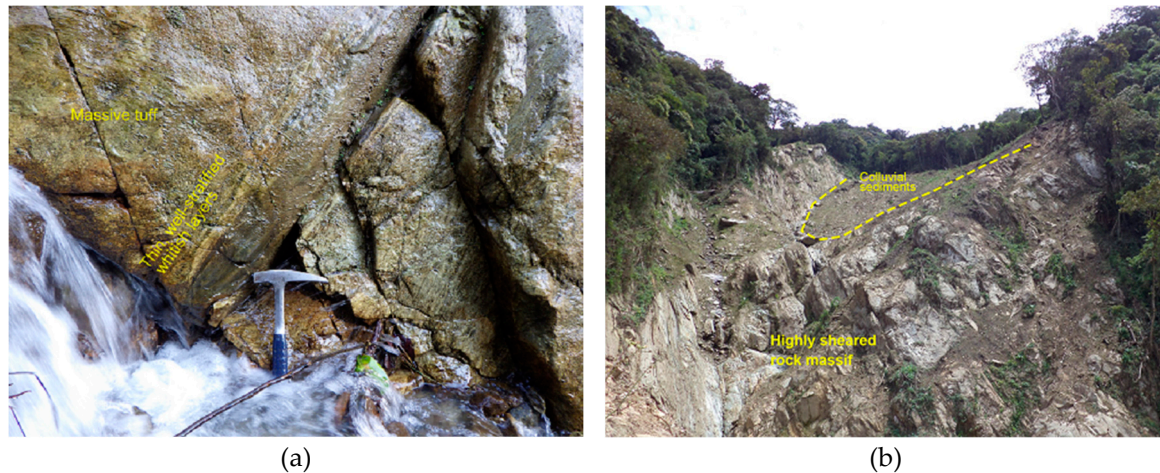
**Figure 9.** (a) Image of a rock mass exposed northwest of Río Verde, showing thin, whitish layers interbedded with massive volcanic tuffs; (b) Remnant of colluvial deposit consisting of meter-sized blocks exposed on the left bank of Quebrada Quilloturo, part of which detached during the June 2024 event.

The current surface deposits in the study area include colluvial, colluvial-alluvial, alluvial, and alluvial fan deposits (Figure 9b). The colluvial deposits located in El Puyal or on the slopes north of the La Merced-Quilloturo road are covered by a layer of topsoil up to 1 m thick. Colluvial deposits are found in several areas (located NNW of Quilloturo and El Placer). In general, these deposits consist of meter-sized fragments of deformed granodiorites, metamorphic rocks, and altered rocks (basement rocks) with a sandy to silty matrix and variable thickness (on the order of 3 m). The colluvial deposit in the middle basin of the Quilloturo ravine is part of a remnant of the deposit mobilized during previous events (June 16, 2024) (Figure 9b).

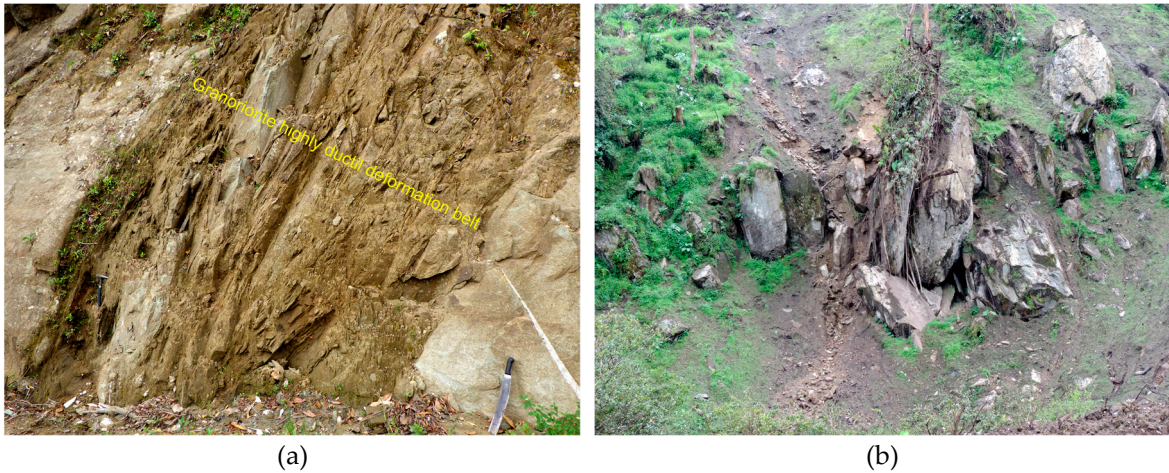
**Figure 10.** (a) Outcrop of a shear belt or band showing intense deformation and remnants of the deformed rock, affecting granodiorites exposed along the Río Verde-Llanganates Road; (b) Megablocks of sheared granodiorite or diorite are exposed on a slope north of Quilloturo.

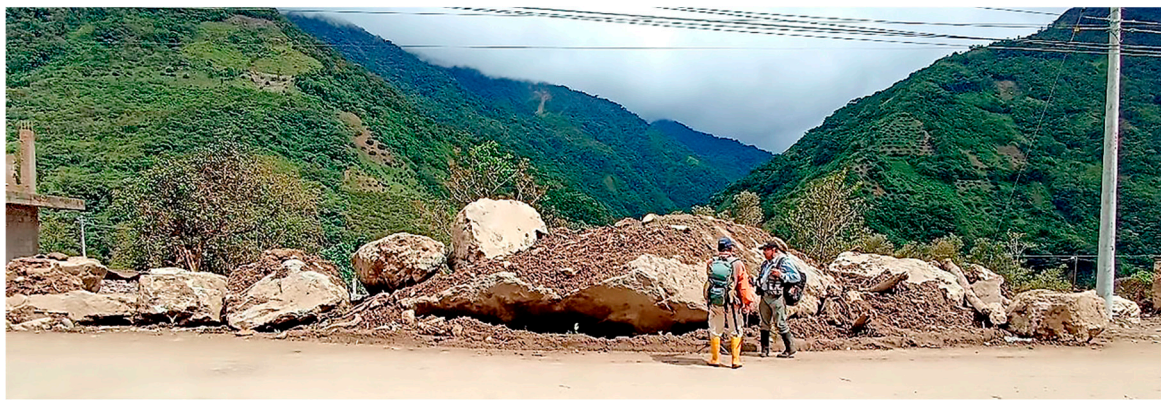
**Figure 12.** Panoramic view of several boulders on the E-30 road. The big one has a diameter of more than 9 m (June, 2024 event).

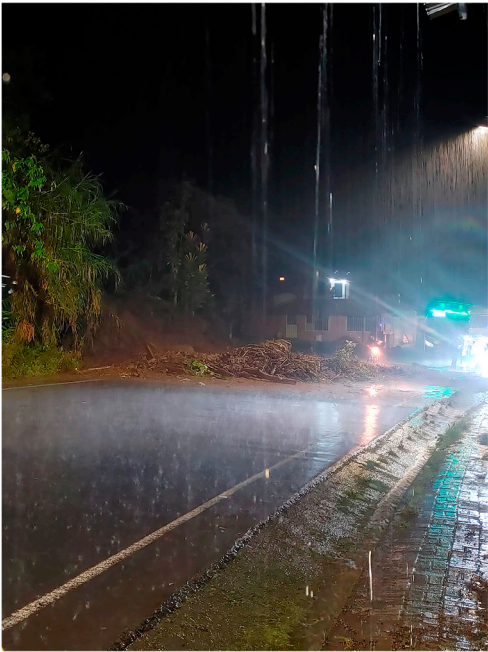
Figure C1. Rain and vegetation deposits on the road in the event on June 16th at 2:00 AM.

Between 2:00 and 2:30 AM on June 16, a landslide occurred (apparently the local term for a debris flow) that generated a prolonged noise lasting approximately two minutes, waking the residents. The mass movement consisted of grass, vegetation, soil, and rocks (Figures C1 and C2).

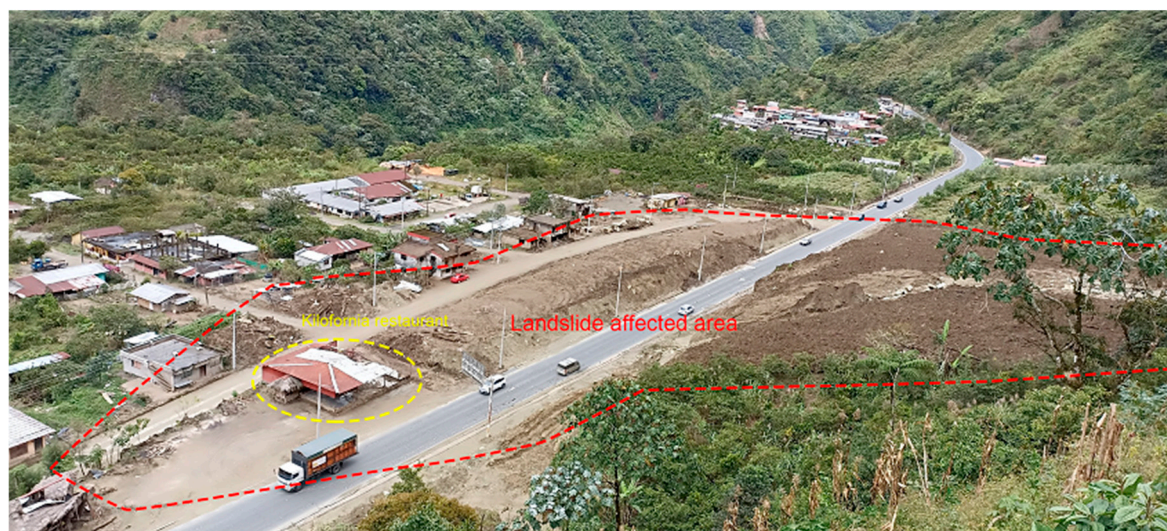
**Figure C3.** Details of the area affected by the mudslide. Note that the accumulation of material is located west of the restaurant.

West of Quilloturo, the area most affected by the mudflow was identified, characterized by the displacement of blocks up to 9 meters in diameter, which destroyed homes and other structures. According to witnesses, the houses were lifted and displaced by the mudslide. One of the most affected buildings was a two-story house located west of the *Kilofornia* restaurant (Figure C3), next to the highway, which was displaced approximately 8 meters from its base. In general, it was determined that the greatest impact was concentrated in the first row of houses located north and west of the hamlet of Quilloturo.
