Towards the Resilience of Attica Region's Provincial Road 3 in Greece, Due to Slope Failure by Applying Civil Engineering Techniques and a Semi-Quantitative Assessment Approach

Keywords: engineering resilience; matrix; civil engineering landslide mitigation measures; robustness; adaptability

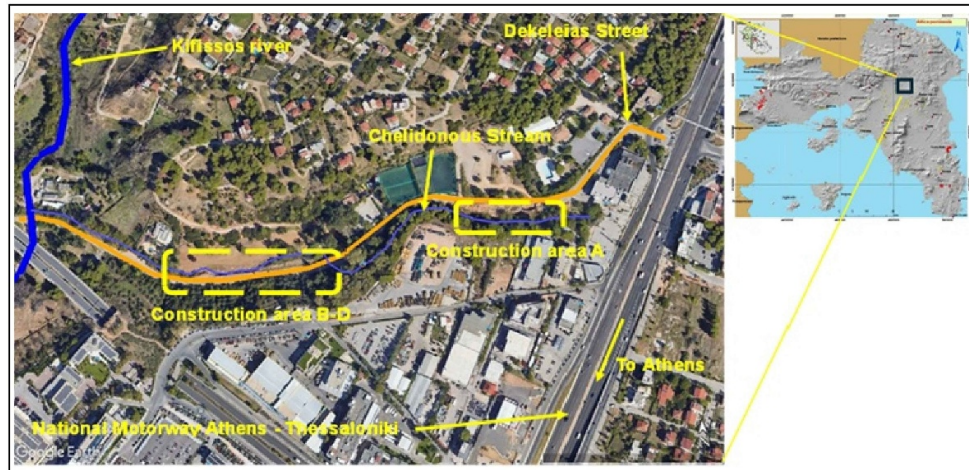
Figure 1. Excerpt from Google Earth (© Google Earth), showing Dekeleias road (orange line), Chelidonous stream (thin blue line), Kifissos river (heavy blue line) and the areas under site investigation, design and construction. This place is located in the northern (Kifissia municipality) part of the Athens capital city of Greece, adjacent to the National Motorway from Athens to Thessaloniki [7].

The case study is focused on Dekeleias Street (named Provincial Road 3, under the jurisdiction of the Region of Attica, very close to the National Motorway from Athens to Thessaloniki, adjacent to the Chelidonous Stream, which is a tributary of the Kifissos River, one of the most significant rivers in the Attica Region), where failures have occurred on the road surface. In the examined area, the last two decades (e.g., 2005-2022), slope failures, subsidences and undermining have taken place at the boundaries of the road with the banks of the stream. These failures can be attributed to surface erosion because of inadequate drainage of rainwater and to wider instability of the adjacent slopes due to the erosive action of the stream (Figure 1, 2).

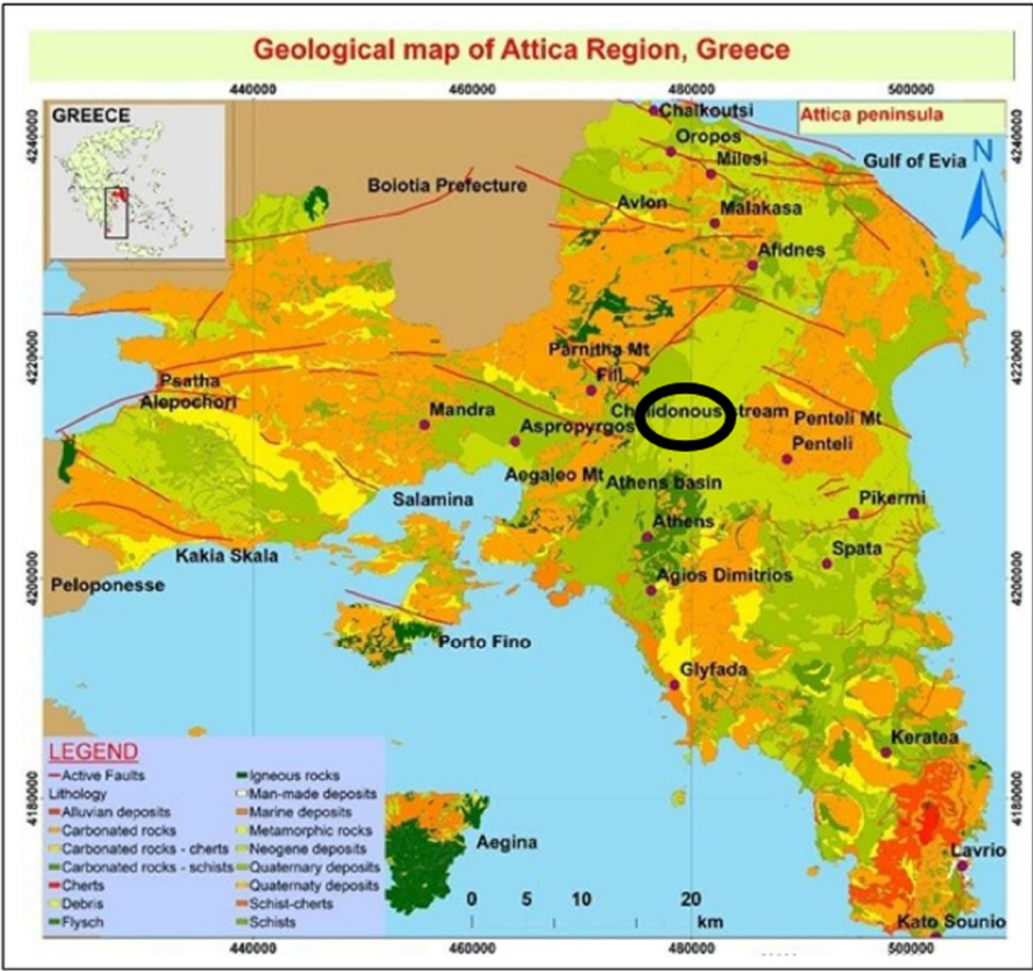
Figure 3. Geological map of the Attica Region [8]. The examined area is indicated by the black semicircle.

The study area is in the western foothills of the Penteli Mountain, specifically east of the Kifissos River and adjacent to the Chelidonous Stream (Figure 3). The morphological topography of the area is characterized by a gentle, flat terrain with very gentle slopes. The wider area geologically consists of Neogene and Upper Miocene formations. The road section under study runs through the Kifissos Lake formations, according to the geological map of IGME (e.g., Greek Geological Research Institute), geological sheet of Kifissia (1.50.000 scale).

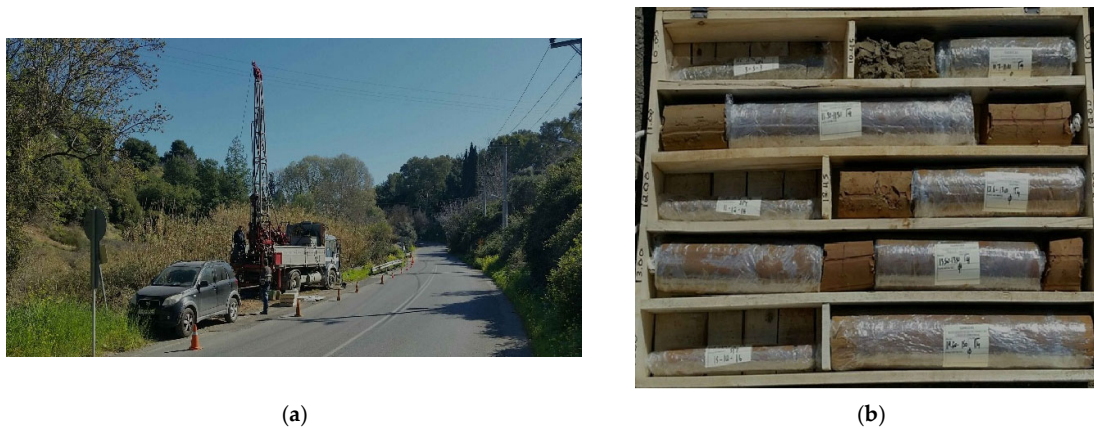
Figure 4. (a) Borehole drilling, (b) part of the borehole findings (Sand to Clayey geomaterial) is depicted [6].

To investigate the nature of the formations along the failures of the problematic section of Dekeleias Road, four sample boreholes with a total depth of 65 meters and field and laboratory tests were carried out. The field work took place in March 2018 (Figure 4a, b).

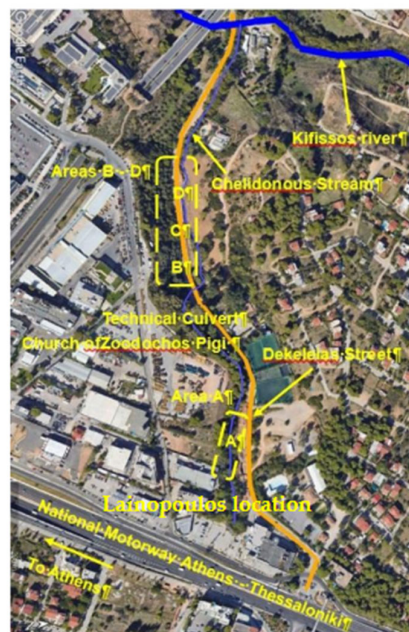
Figure 5. Visualization of the division of the study area into subareas A to D on a satellite image (source: Google Earth).

Considering the results of the geotechnical investigation, the field and laboratory tests and all available data, the following sections with uniform geotechnical characteristics were distinguished [6]: (a) modern artificial embankments, (b) alluvial deposits and (c) lake and pond formations. An aquifer level was detected in all the executed boreholes. In two boreholes, the water level corresponded with the bed of the Chelidonous stream, which passes a short distance away. In the other two boreholes, the phenomenon of artesianism occurred. Based on the evaluation of the abovementioned formations, geotechnical measures were proposed for design parameters, range and characteristic value for each of them, and geotechnical simulations were prepared for the areas under consideration. After evaluating the findings of the geotechnical investigation and considering the geometrical characteristics of the areas in which the geotechnical problems were identified, the study areas were divided into subareas such as A, B, C and D (Figure 5). The division of the areas also considered the morphology of the road slopes, the geological and geotechnical conditions, the distance of the road from the Chelidonous stream and the failure mechanisms evaluated per area.

The main factor causing the failure mechanism in areas B to D is the flow of the Chelidonous stream, which causes erosion at the foot of the road slopes (Figure 5). The erosion of the foot and the gradual change in slope gradient to steeper gradients cause generalized slope stability problems affecting the existing Dekeleias Road in the form of soil movement and subsidence of the roadway on the stream side. It should be noted that in areas where the stream, due to its natural flow, is near the Dekeleias road, such as in areas B and D, the foot of the road slopes is also the boundary of the streambed, and as a result, the instability problems were more pronounced. In area C, the stream moved away, and the erosion problems appeared milder [6].

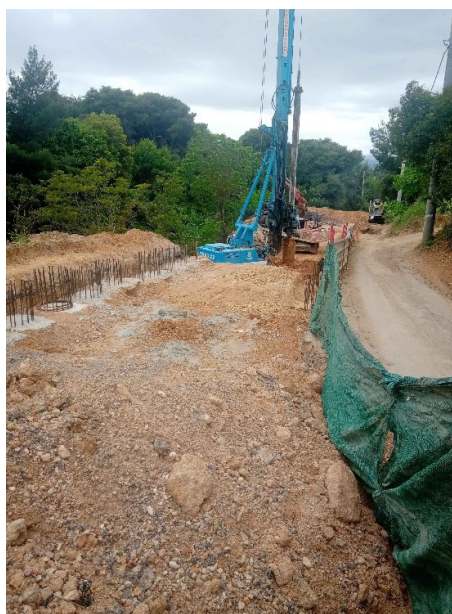
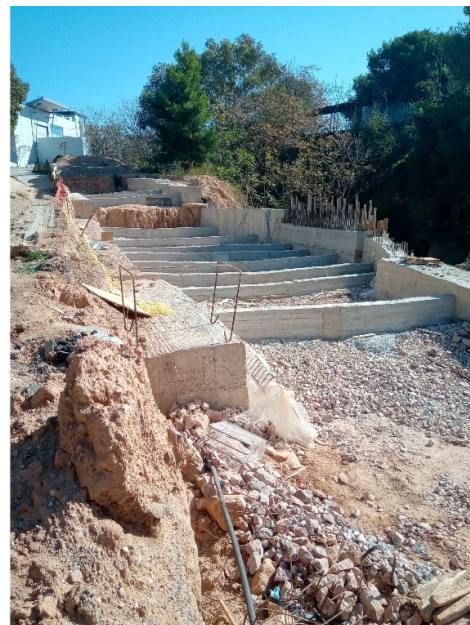
Figure 6. Views from Area A construction: (a) cutter bar machine, (b) pile walls made of intersecting piles (Author's archive).

In Area A, the main contributing factor to the failure mechanism is estimated to be, based on the failure morphology, the flow of the stream as the stream bed approaches the roadway slope (Figure 5). Area A was divided into three subareas (A1, A2, A3). Subarea A1 starts after the turn from the Athens Lamia Highway (Lainopoulos location) and extends 8.50 m to the west. To address the erosion mechanisms in subarea A1, it was decided to construct a pile wall with interlocking piles Ø1.00 m with the reinforced piles having an axial spacing of 1.7 m. Subarea A2 starts from the end of area A1 and extends 32.90 m to the west. In this area, significant undermining has occurred on the existing road with the crown of the existing steep slopes bounded within the road zone. To address the erosion mechanisms, anchor walls 3.0 m and 5.5 m high constructed founded on interlocking piles of Ø1.00 m diameter at 1.7 m intervals. In this section, the retaining elements (piles, retaining walls) needed to be anchored. Subarea A3 starts from the end of area A2 and extends 5.10 m towards the west. To address the erosive mechanisms in area A3, it was decided to construct a pile wall with intersecting Ø1.00 m piles with the reinforced piles to have an axial spacing of 1.7 m (Figure 6a, b).
