# Initial Responses of Riparian Vegetation and Wetland Functions to Stage 0 Restoration of Whychus Creek, Oregon

Vladimir Krivtsov <sup>1,2</sup>, Karen Allen <sup>3</sup>, Tom Goss <sup>4</sup>, Lauren Mork <sup>5</sup> and Colin Reginald Thorne <sup>6,\*</sup>

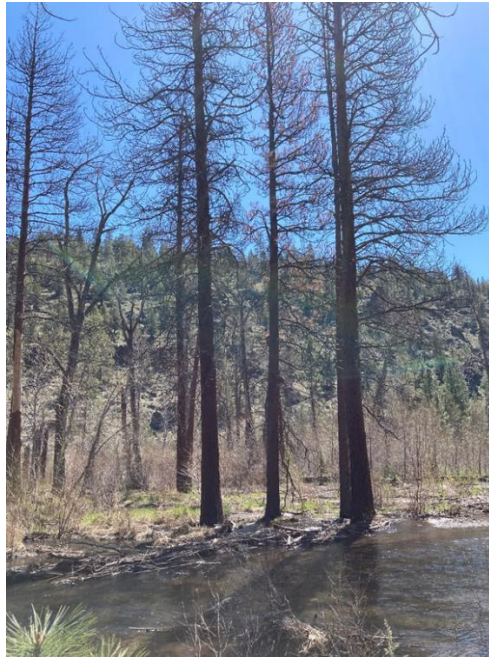
**Figure 5.** Dying ponderosa pines (*Pinus ponderosa*) observed following restoration of Canyon Reach 4 that fully reconnected the anthropogenically-incised stream to its floodplain and rehydrated the hyporheic, alluvial aquifer; raising the water table to near the floodplain surface within a few days.

There was an inconsistency with this indicator series concerning Ponderosa pines (*Pinus ponderosa*), which have the status Facultative Upland, meaning that they may occur in wetlands. Ponderosa pines grow across a 1,500 m range of elevations throughout the Cascades (Allen and Breshears 1998; Allen et al. 2002) and were observed in all three study reaches of Whychus Creek. However, while the mature ponderosa pines in 'Canyon Reach 3' were thriving, those at 'Camp Polk Meadow' and 'Canyon Reach 4' were either in poor health, dying, or dead (Figure 5), which is inconsistent with their indicator status of Facultative Upland.

We attribute the deterioration of the ponderosa pines in Canyon Reach 4 and at Camp Polk to the rapidity with which water tables in those reaches rose following restoration. We conclude that the pine trees had insufficient time to adapt to the wetter conditions in the rehydrated floodplains despite their indicator status being Facultative Upland.

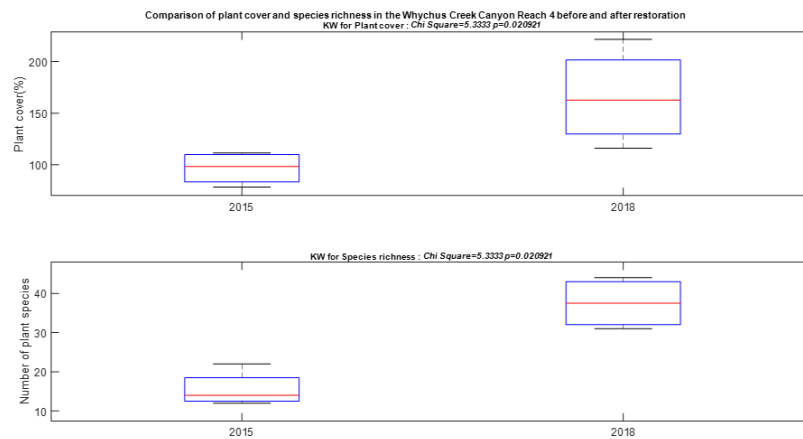
**Figure 6.** Comparison of box plots and Kruskal-Wallis test statistics for (a) normalised abundance (% of total plant cover) and (b) species richness (number of plant species) for all the plants recorded at 'Canyon Reach 4' in the 2015 and 2018 transect surveys. Statistically-significant differences (95% level of confidence,  $p \leq 0.05$ ) are displayed in italics. Data used to prepare this plot may be found in Appendix 1 in the Supplementary Materials.

When aggregated for all observed plant groups, our results for the transition reach demonstrate statistically-significant increases in both percentage cover and species richness (Figure 6a and b, respectively).

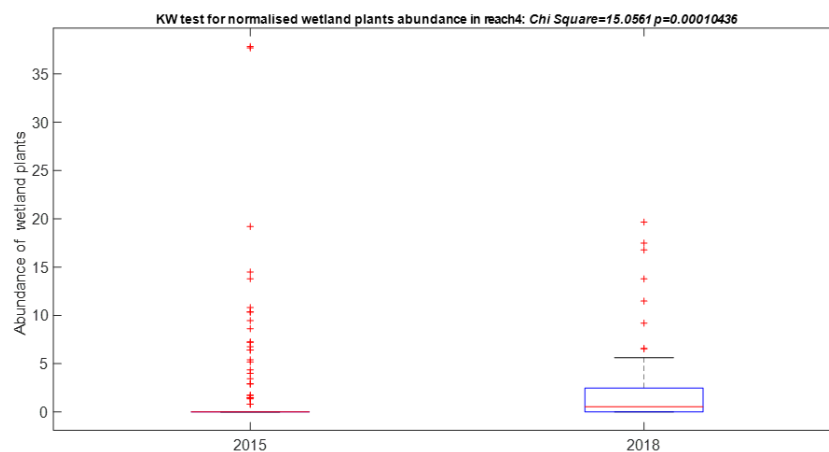
**Figure 7.** Comparative box plots and Kruskal-Wallis test statistics for pooled, normalised wetland plant abundance (expressed as percentage of total plant cover) along all transects in 'Canyon Reach 4' prior to (2015) and post-restoration (2018). Wetland plants are those with indicator status OBL and FACW. Statistically-significant differences (95% level of confidence,  $p \leq 0.05$ ) are displayed in italics. Data is found in Appendix 1 in the Supplementary Materials.

In our analysis, wetland species were considered to be plants with indicator status OBL or FACW, while upland plants were considered to be those with the indicator status FACU or UPL. As plants with FAC (i.e., facultative) indicator status are found in *both* wetlands and uplands, they were not included in our comparison of changes specific to wetland and upland plants. Analysis of the normalised plant abundance data pooled for all four transects show that the abundance of wetland (Figure 7) and upland (Figure 8) plants had both increased significantly ( $p < 0.05$ ) during the two-years since restoration.

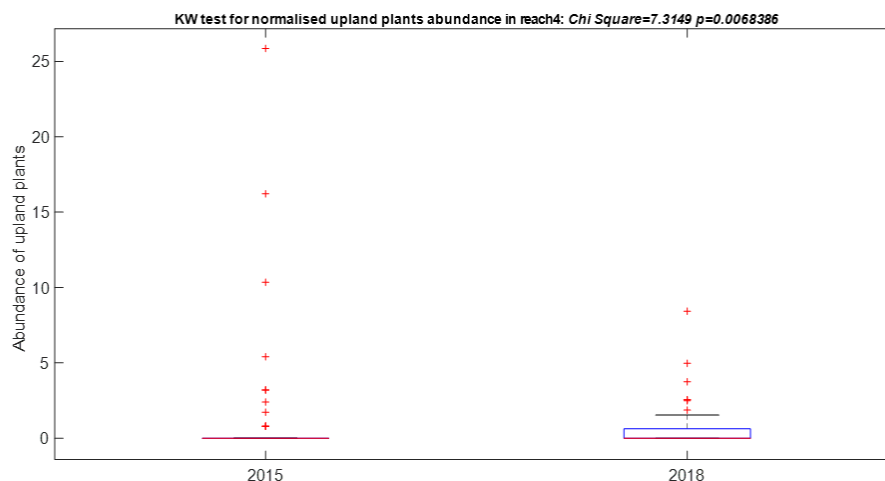
**Figure 8.** Comparative box plots and Kruskal-Wallis test statistics for pooled, normalised upland plant abundance (expressed as percentage of total plant cover) along all transects in 'Canyon Reach 4' prior to restoration (2015) and post-restoration (2018). Upland plants are those with indicator status FACU or UPL. Statistically-significant differences (95% level of confidence,  $p < 0.05$ ) are displayed in italics. Data are listed in Appendix 1 in the Supplementary materials.

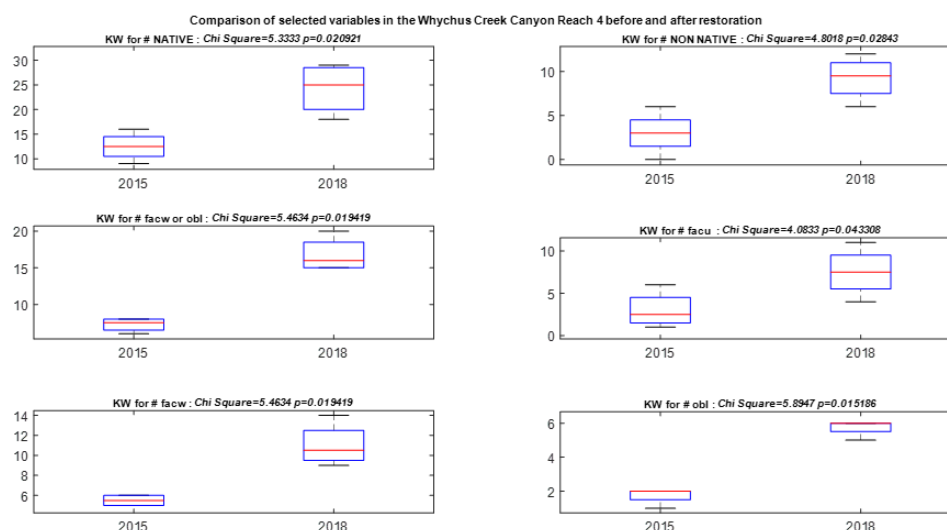
**Figure 9.** Comparative box plots and Kruskal-Wallis test statistics for species richness for plants rated as (a) Native, (b) Non-native, (c) FACW=Facultative Wetland or OBL=Obligate Wetland, (d) FACU=Facultative Upland, (e) FACW=Facultative Wetland, or (f) OBL=Obligate Wetland. Statistically-significant differences (95% level of confidence,  $p < 0.05$ ) are displayed in italics.

The results of transect surveys for the species richness of specific plant groups are plotted in Figure 9. There were significant ( $p < 0.05$ ) increases in species richness of native plants and non-native plants, and those with the statuses of obligate wetland, facultative wetland, and facultative upland. In short, the results for species richness show similar tendencies to those noted above for plant abundance.

Results for species richness (Figure 9) are similar to those for abundance in that values for all plant indicator statuses increased following restoration. Increases recorded in non-native species have been noted and volunteers are assisting with on-going efforts to control the spread of non-native species and noxious weeds.
