Challenges to Sustain a Cultural Landscape along an Antique Watercourse in Bursa, a World Heritage Site in Türkiye

Keywords: cultural landscape; antique watercourse; sustainability; natural and architectural heritage; stream rehabilitation

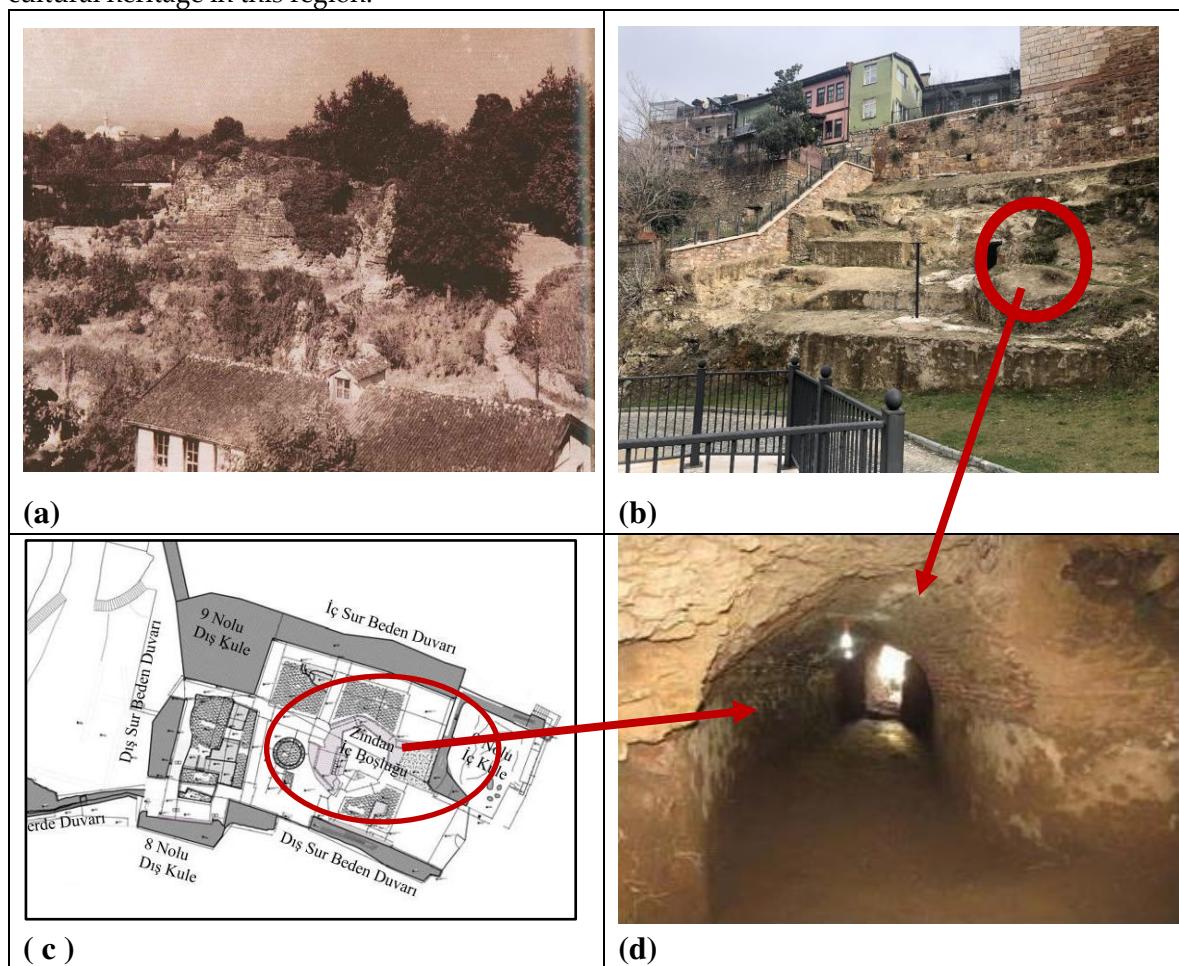
Two walls of a dungeon, rising on the incline of the travertine rocks at the east side of the streambed, have been uncovered in recent excavations (**Figure 4a and 4b**). The tower's outer shell stones and the walls of the *Zindankapi* (Dungeon Gate) section are reflected in the massive travertines that line the Cilimboz waterway. There is a tunnel-shaped cellar hidden within the Citadel's rocks, as reported by Yilmaz [22]. The original width was 3.00 m, and the new height is 2.75 m; it is a brick-vaulted ceiling (**Figure 4c and 4d**). For centuries, the public relied on this ancient tunnel for access to water and transportation of supplies. Travelers who visited Bursa in the 19th century noted that the valley was dotted with hermitages that had been founded in the late 7th century [23–25]. In addition, the Ottomans took advantage of its water flow to power a 100-volt dynamo (coal-fired steam engine) that illuminated the city and ran several water mills. One of these mills was restored and reused as a restaurant, but the others have since collapsed and are no longer in existence. The Cilimboz Creek also had a significant impact on the growth of industrial infrastructure by providing the impetus for the construction of numerous factory buildings in the Muradiye District, located on the western side

Figure 4. Before (a) and after (b) the excavations around the Zindankapı region, (c) The documentary plan drawing, and (d) the photograph of the tunnel. (Sources: (a) from the archive of Bursa Metropolitan Municipality, (b) photographed by the Author, 2023, (c) and (d): Yılmaz, "Şehir Sur Zindanları", 179, 185.).

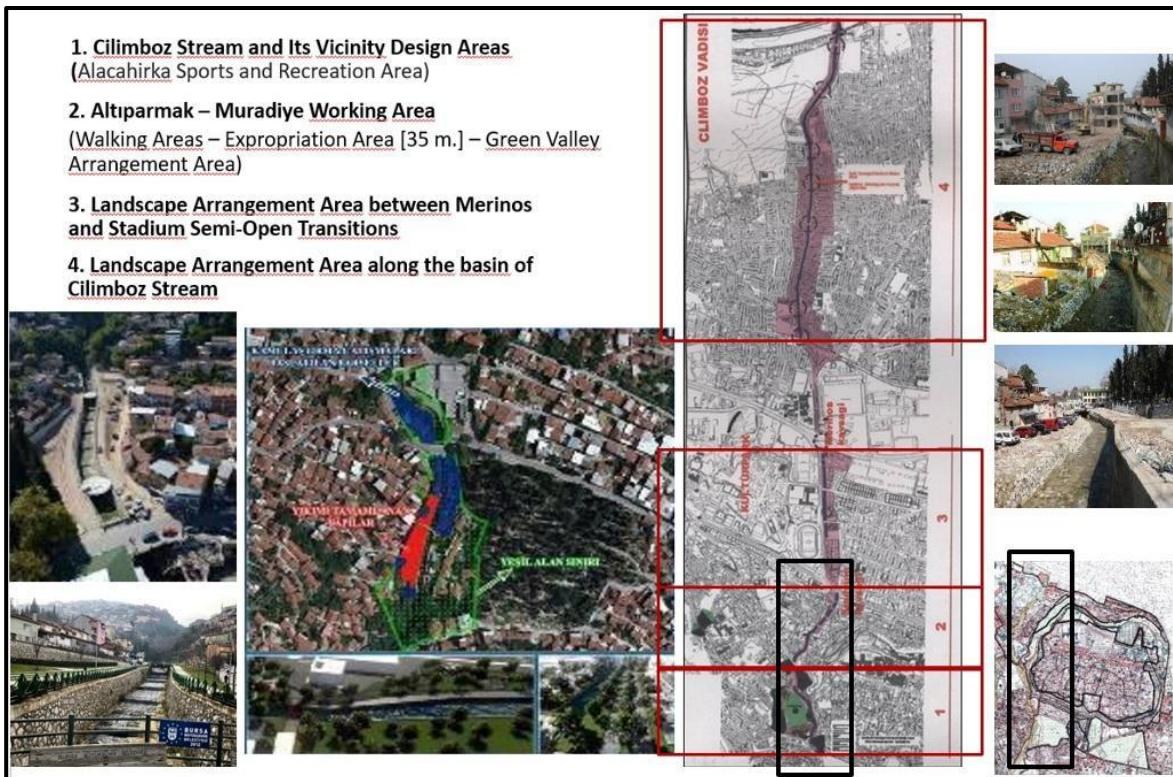
of the area between Cilimboz Creek and *Fabrika-i Humayun*, this project attempted to open the top of the streambed, which had been covered in concrete (Imperial Factory). 'The Alacahirka Sports and Recreation Area Land Use Project' ensured the preservation of the bridges, fountains, and trees in and around this streambed. Additionally, the central section of Bursa's local government, Osmangazi Municipality, mandated the development of plans for the rehabilitation of two canals that join the Cilimboz Creek.

Figure 6. The sub-project areas of the Cilimboz Stream rehabilitation project (source: archival of Bursa Municipality).

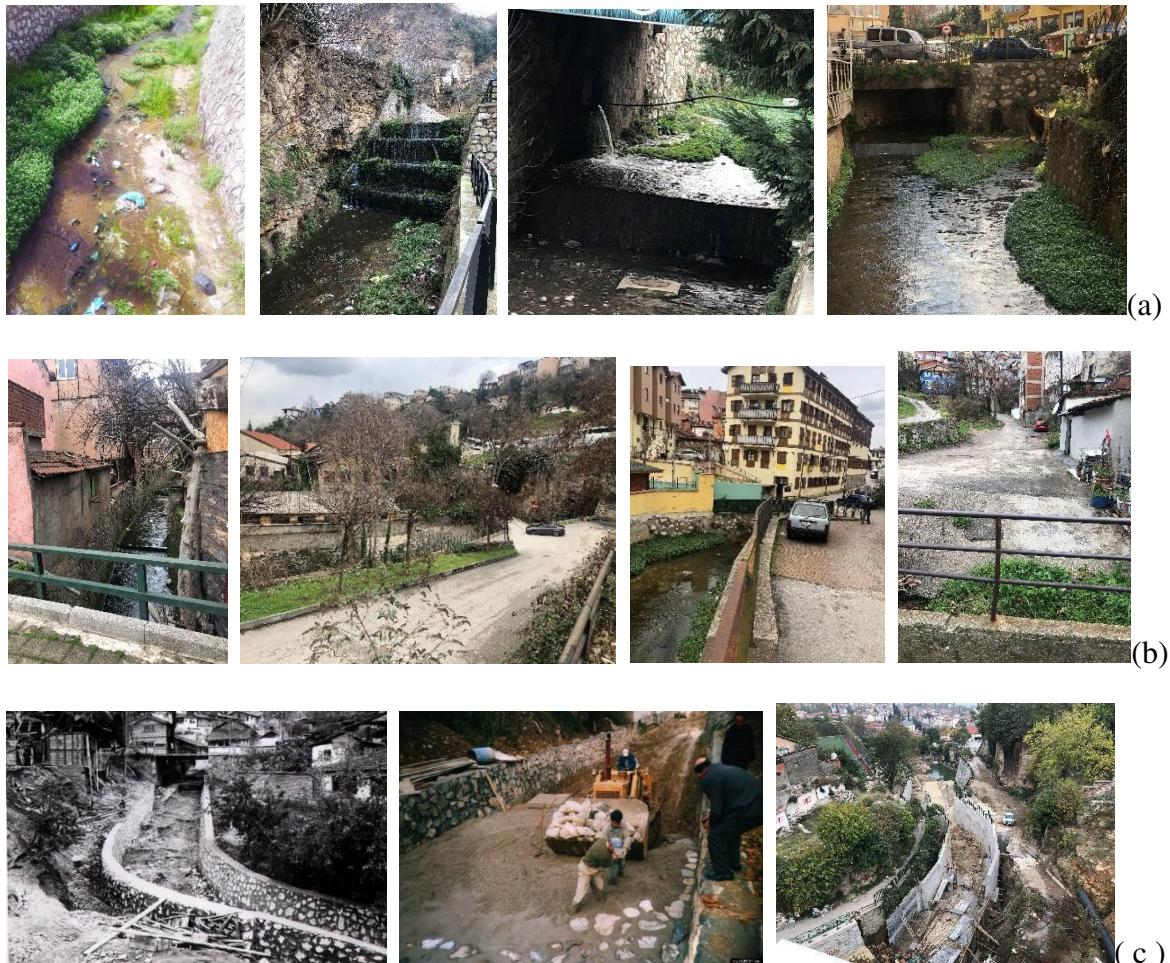
Water and solid waste pollution, which was caused by a lack of infrastructure, were significant problems that threatened the integrity of the ecosystem in the study area (**Figure 7a**). Meanwhile, the local government and other related institutions started covering streams by using asphalt to let vehicular traffic drive over, which has contributed to changing the ecosystem of the streambed in time. Moreover, the bottom of the *Cilimboz* Creek was covered with cement and stone masonry, which negatively affected the aquatic life that existed there before the restoration work (**Figures 7b**

Figure 7. (a) Solid waste and water pollution within the Cilimboz Stream bed, (b) Covering the stream bed with asphalt for vehicle transportation, (c) Ground covering within the streambed with reinforced concrete and stone masonry (sources of historic photographs: archives of the State Hydraulic Works (DSİ), Bursa City Museum, and the currently photographed by the Author, 2022).

and 7c). The lack of risk management strategies that should be mentioned in all related urban design, restoration, and rehabilitation projects for the conservation of this natural heritage against pollution and potential floods has also caused changes in the habitat of the area. Accordingly, the public's health might be at risk due to the frequent poor water quality caused by contaminant loading. To prevent or lessen coastal erosion, flooding, and increased pollution loads, it is obvious that Cilimboz Creek itself must first be monitored by qualified scientists and experts interested in stream rehabilitation.

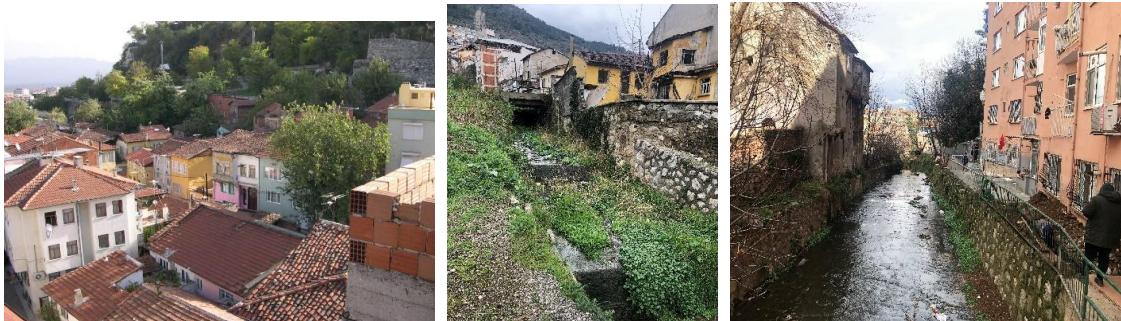
Figure 8. Views of buildings constructed in the Cilimboz Valley; most of these buildings were constructed illegally when new immigrants from rural areas came to the city (the Author, 2022).

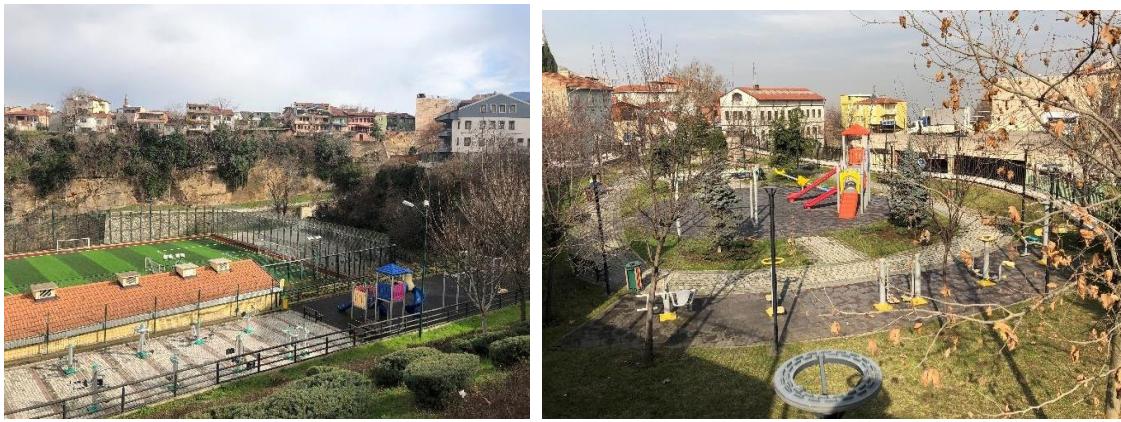
Figure 9. Urban design projects along the Cilimboz Stream bed; Alacahirka Sports and Recreation Area, Children Playground Design (the Author, 2022).

The first expropriation works applied along the slopes of Cilimboz Creek were frequently mentioned in the local newspaper, *Hakimiyet*. According to the news article (dated April 4, 1959), Bursa Municipality decided to evacuate and demolish eight houses after inspecting the northern Cilimboz Valley to see if it was a landslide zone. Meanwhile, the municipality also considered the assessment of the local archaeologist committee, which noted that the ruins of the Citadel walls in this location may also pose a risk to the residents [31]. In addition, the City Council had changed the zoning regulations to allow the construction of a nine-story parking lot at the northern end of the creek, in 1978. Following the flood and water pollution in this streambed, urban development activities were prepared under the pressure of housing and migration in the 1980s. All of these natural and man-made forces have caused consistent changes to the architectural character of this historic urban landscape. The stream rehabilitation and restoration projects were put in place to ensure stability and the authenticity of the cultural heritage in this study area. As one of them, the "Alacahirka Landscape Design Project" attempted to renovate a number of green spaces along this urban waterway for "playground areas" and "sportive amenities" (**Figure 9**). However, the layout of such a recreation area, which is accessible to kids and teenagers, on this stream bed flooding occasionally, may be dangerous for people's safety.

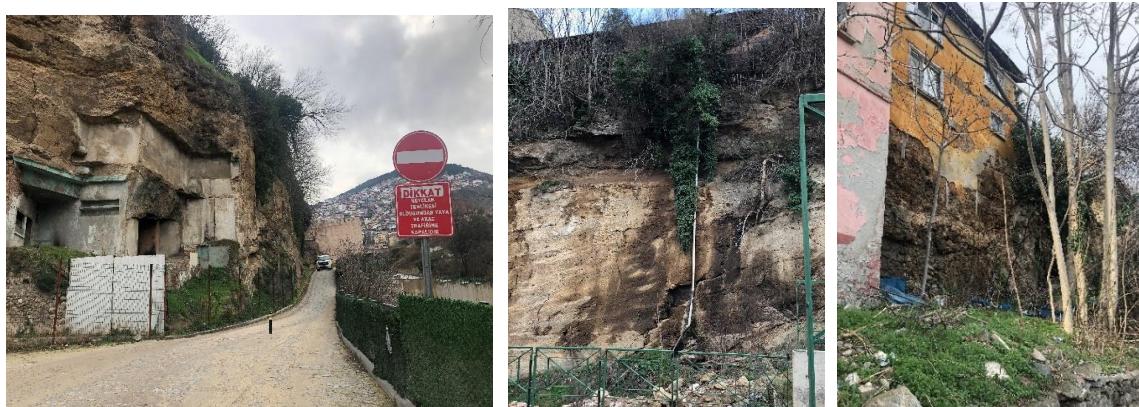
After Cilimboz Creek was partially covered with asphalt for vehicular use, issues such as the structural stability of ancient buildings deteriorating occurred as a result of vehicle vibrations and pollution of the facades (**Figure 10**). The negative effects of these urban development activities have long-term altered the authenticity of this historic urban area. As mentioned in the principles of the Muradiye Conservation Development Plan (1991), some historic structures, such as the Fabrika-i Hümeyun (Imperial Factory), Yilmazipek, and the Duraner family's silk factory, were converted to

Figure 10. Facade deterioration on historic dwellings and structural cracks on the travertine cliffs, both caused by construction on the slopes of the Citadel walls (the Author, 2022).

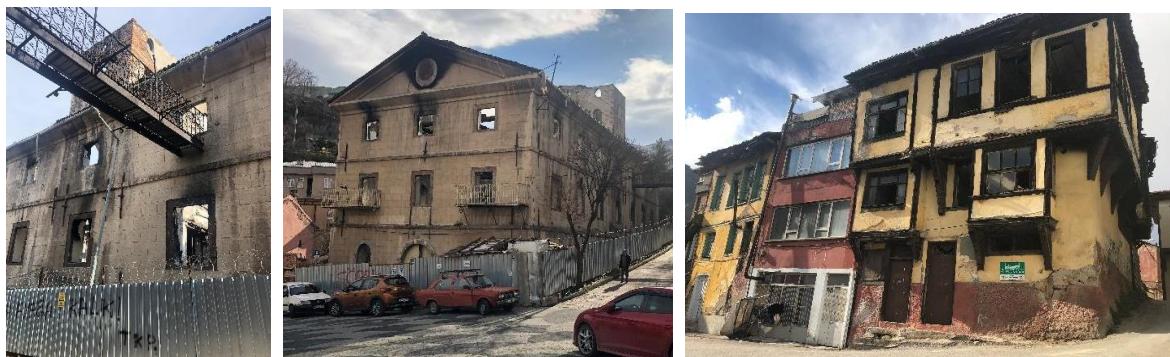
be used in cultural facilities. The industrial heritage of this region has been further harmed by graffiti and other illegal implementations, but the majority of the historic manufacturing buildings along the Cilimboz Creek are still vacant. As a result, the functional renovations have changed both the spatial character of these abandoned historic structures and their surrounding landscape (**Figure 11**). Due to the damages caused by the expropriations carried out by the Great Municipality of Bursa, most of the abandoned industry buildings and historic houses require immediate maintenance and consolidation. More importantly, houses built close to the stream bed are in great danger of collapsing or being destroyed, especially in the event of a flood or earthquake.

Figure 11. Damaged and vandalized buildings (the Author, 2023).

The primary restoration and repair work done after the numerous fires in these structures was inadequate scientifically, resulting in structural deformations and even collapses, significantly altering this historic neighborhood. Because conservation decisions were not made with a comprehensive perspective, integrity was lost, making it more difficult to identify the distinctive architectural features of the structures in the Cilimboz Valley (**Figure 12**). The Conservation Development Plan prepared for the Muradiye District also notably lacked laws about Cilimboz Creek and its surrounding historic urban landscape. This plan was later updated in the 2000s, and the perimeter of its flood zone was expanded. As a result, the stream's service road was widened by five meters, allowing for the construction of new structures two meters above the highest watermark. The streambed, however, was not sufficiently cleaned up due to accumulated trash and overflowed. The buildings in the streambed collapsed as a result of the overflowing in Cilimboz Valley in October 2010, resulting in human casualties.

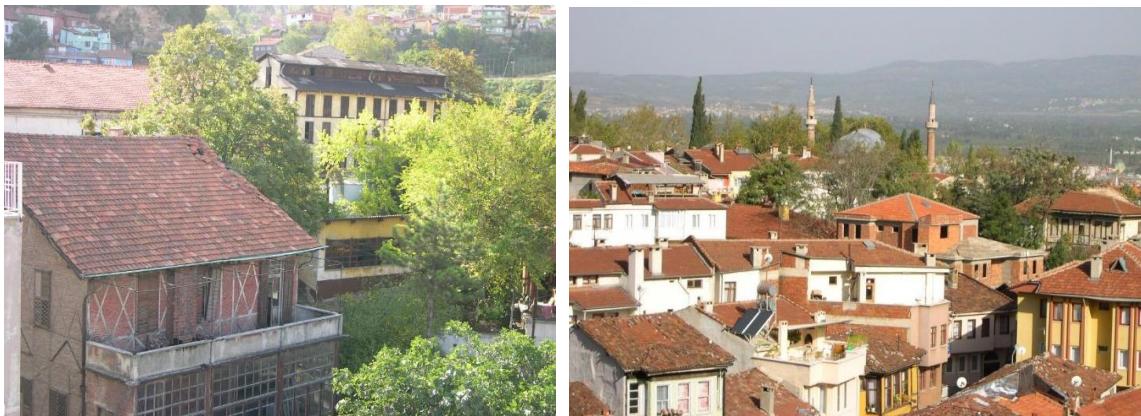
Figure 12. Photographs showing the decrease of clear historical views within the Cilimboz Valley (the Author: 2021).

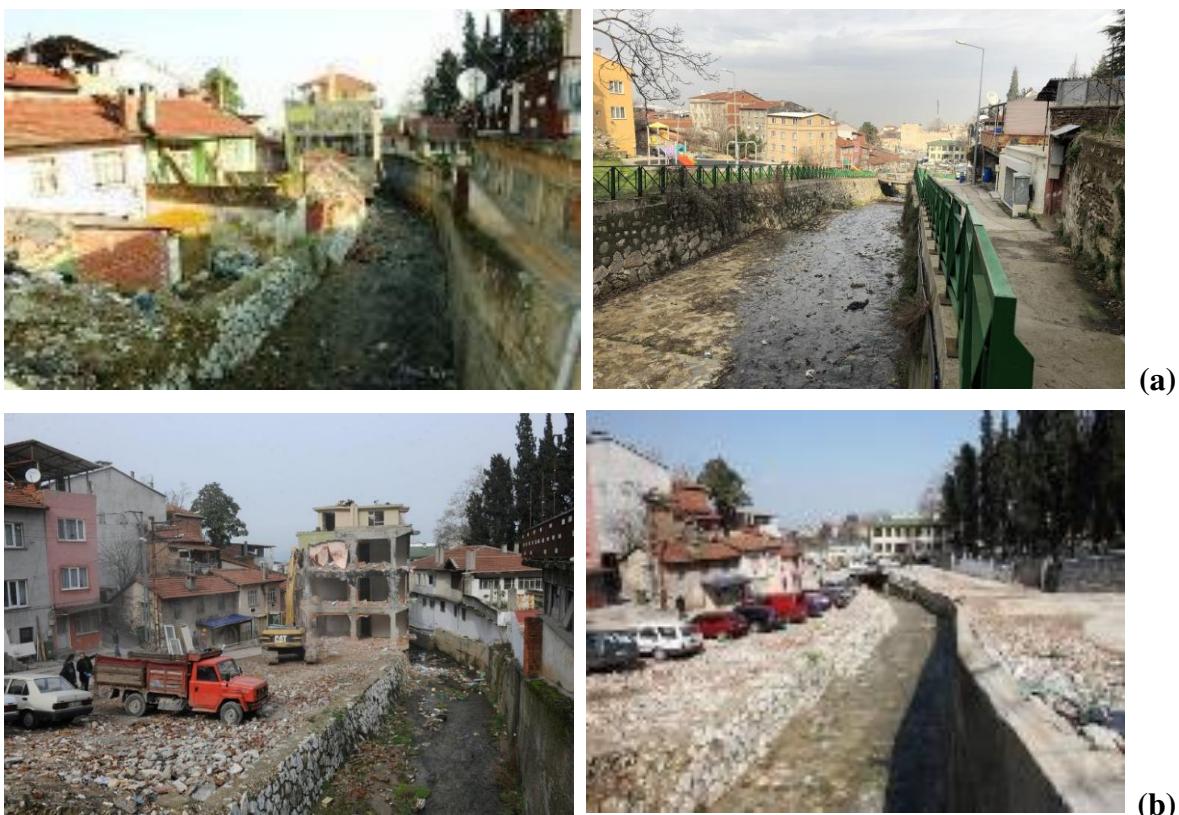
The municipality expropriated and destroyed the majority of the multi-story structures in the zoning parcels (a total of 45 parcels) along the streambed as part of a stream rehabilitation project (**Figure 13**). Historic dwellings in the Alacakırka and Pınarbaşı Districts were to be demolished, and the Urban Design Project recommended that the houses within 7700 square meters of the stream be

Figure 13. (a) Before and after a flood along the southern part of the Cilimboz Creek, (b) The process of rehabilitation, expropriation, and demolition of the buildings constructed along the Cilimboz Valley. (sources: the archive of Bursa Municipality).

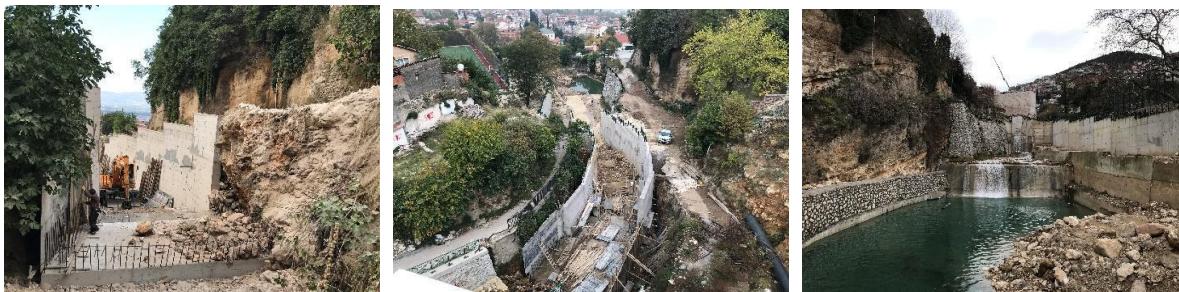
demolished. Unfortunately, neither information on how many of the destroyed structures were listed in the list nor any kind of paperwork regarding what had previously been done to the buildings was gathered. As these public improvement projects moved toward the north end of the Cilimboz Valley, the State Hydraulic Works (*DSİ*) expanded and covered the streambed along the slope of the Citadel walls with concrete and stone. Natural riverbeds have been converted into constrained, narrow river corridors with tunnels made of concrete and other artificial materials, all of which are detrimental to the creek's ecology. As a result, the original boundaries of this ancient waterway are no longer discernible (**Figure 14**).

Figure 14. The process of rehabilitation; concrete covering the bottom of the Cilimboz Creek (source: the archive of DSI (the State Hydraulic Works)).

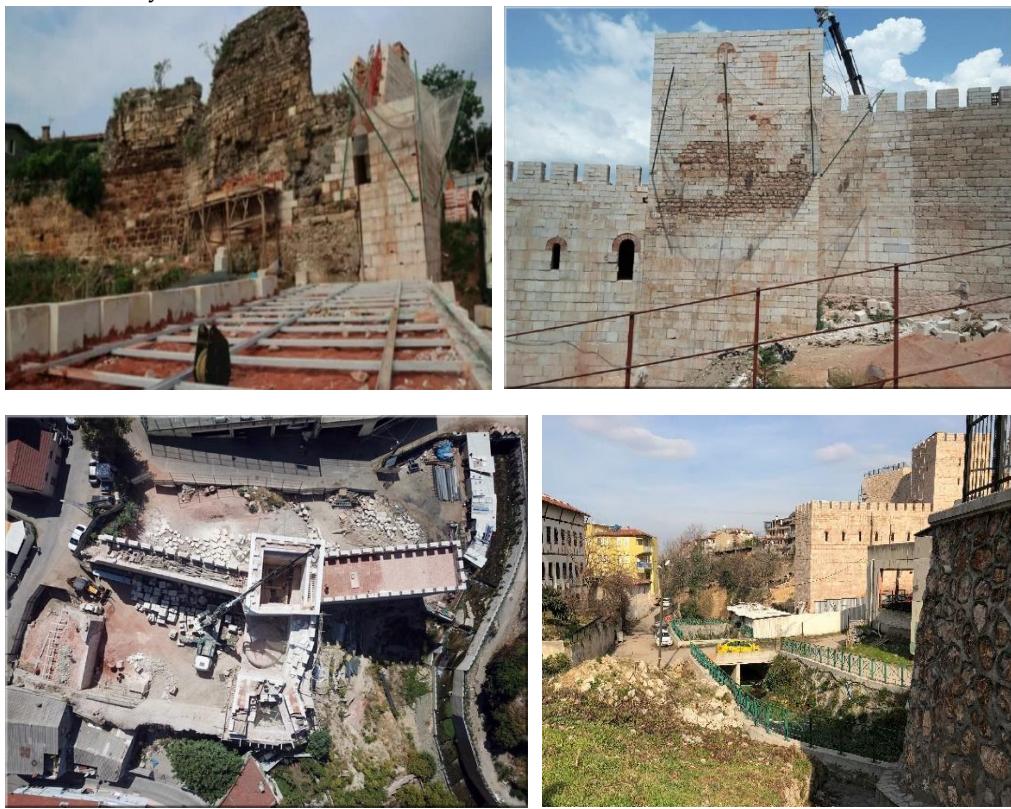
In addition to these implementations, the southwest corner of the Citadel's walls between two gates, *Zindankapi* and *Yerkapi* were reconstructed by using modern building materials. Although the reconstruction approach is still open to discussion within the scope of national and international conservation projects, there is an extremely important problem in this practice. This practice of rebuilding without being supported by sufficient scientific evidence may also be a mistake for future generations, since it leads to the emergence of an almost completely imperceptible urban element that is quite different from the original, both in form and structure (Figure 15). Even though the renovated remains of these gates serve as new landmarks in this historic urban region, recognizing the distinctive identity of the architecture along the *Cilimboz* Creek has become dangerous. These erroneous and unconscious reconstructions now pose a risk to the sustainability and perceptibility of the multi-layered character of this cultural environment. Besides, inconsistencies between the old and modern structures applied in these reconstructions result in the creation of a 'replica' conflicting with ideas of authenticity and the essence of the location.

Figure 15. The reconstruction process of the historic Citadel walls (sources: archive of Bursa Metropolitan Municipality (2021) and the Author, 2022).
