# Anterior Aesthetic Rehabilitation of Midline Diastema Using Direct Composite: A Case Series

Keywords: anterior teeth; bioclear matrix; direct composite; midline diastema

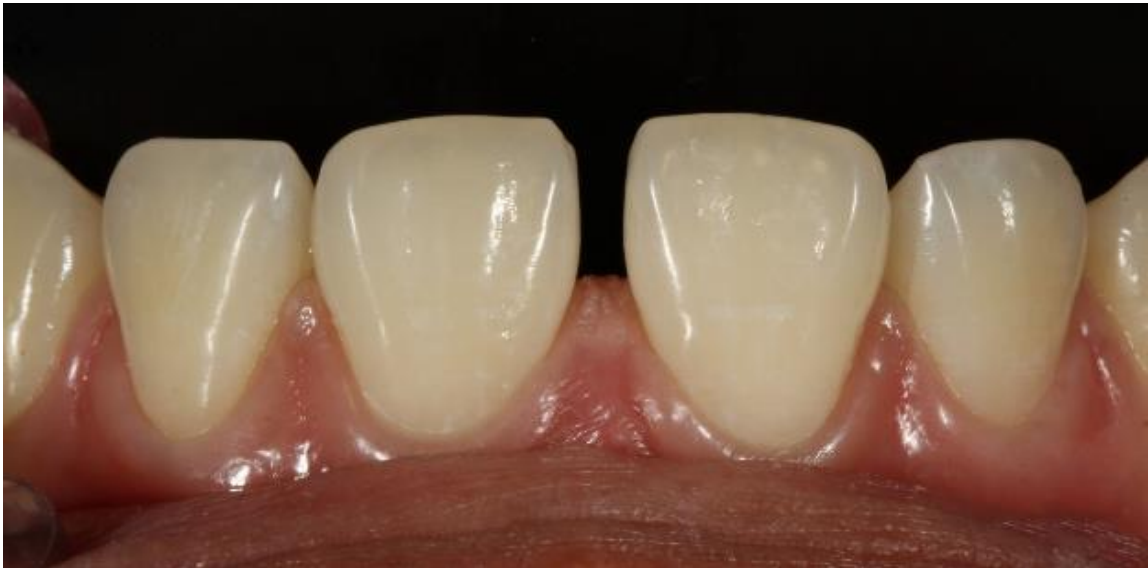
**Figure 1.** Preoperative image showing midline diastema.

A 23-year-old female patient visited our clinic with a chief complaint of an unpleasant gap between her upper central incisors. To enhance the appearance of the smile, the patient desired to

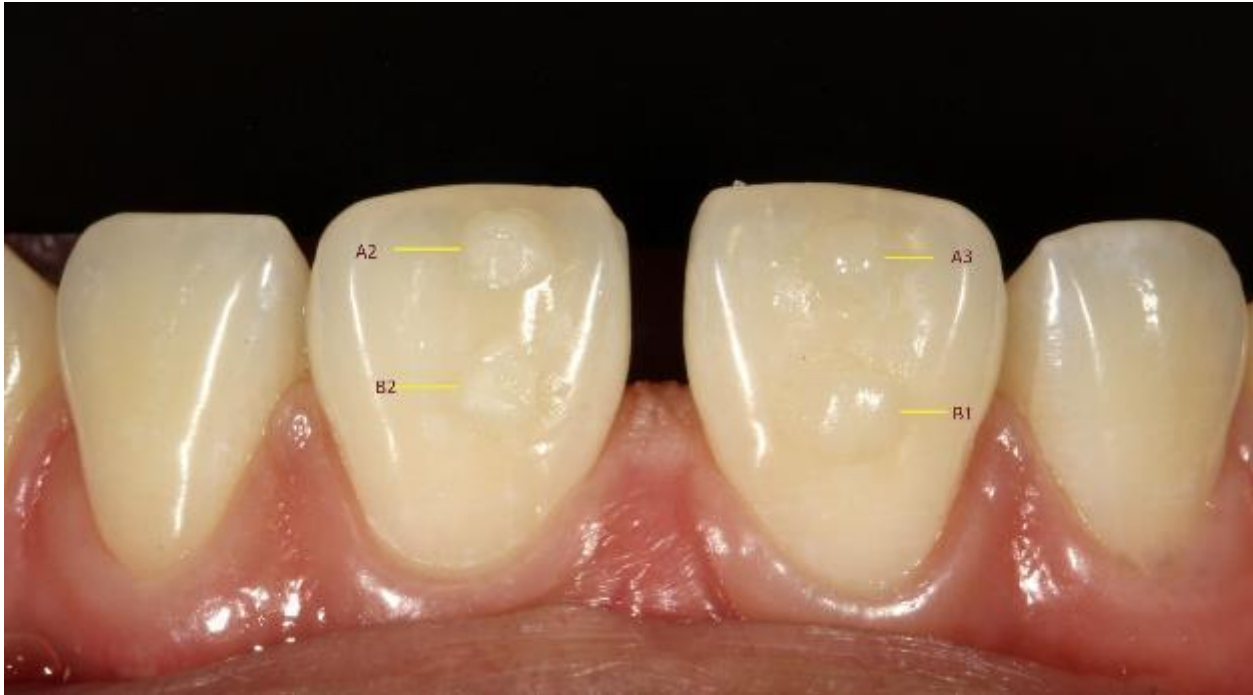
**Figure 2.** Button technique for shade selection.

The "button technique" was used for color selection (Figure 2), which involved placing a section of composite on the structure and picking its color. The best option for choosing an enamel shade is to place the composite in the incisal third, where the thickness of the enamel allows for the observation of the enamel shade.

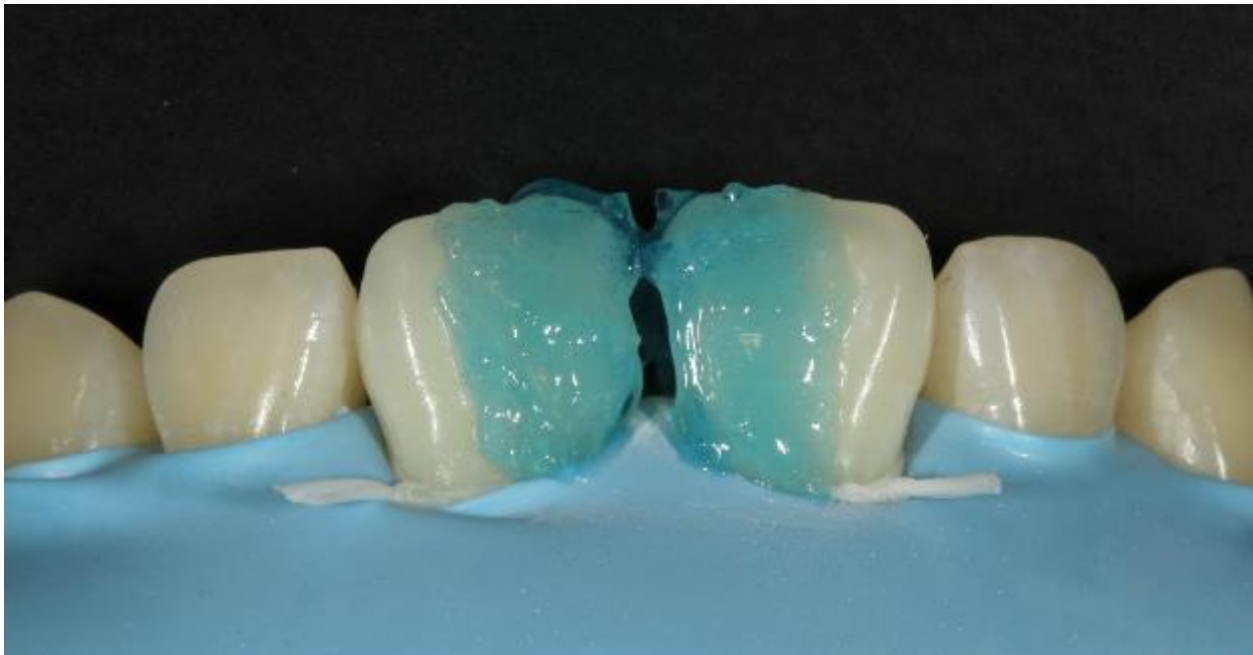
**Figure 3.** Acid ethcing with 37% phosphoric acid after rubber dam isolation.

A rubber dam was used as a mode of isolation. Additionally, it is particularly helpful since it improves access to the teeth's cervical region by retracting the papillae [4]. The enamel surface was etched with 37% phosphoric acid for 20 second (Figure 3). Following a 40-second surface rinse, the tooth was thoroughly dried. For the highest bond strength quality and the smoothest transition between the composite and tooth surface, the etched area was marginally wider than the working area [5].Following the placement of the bioclear matrix, the bonding agent Tetric N-Bond (Ivoclar) was applied, and the composite was light cured at approximately 460 nm.

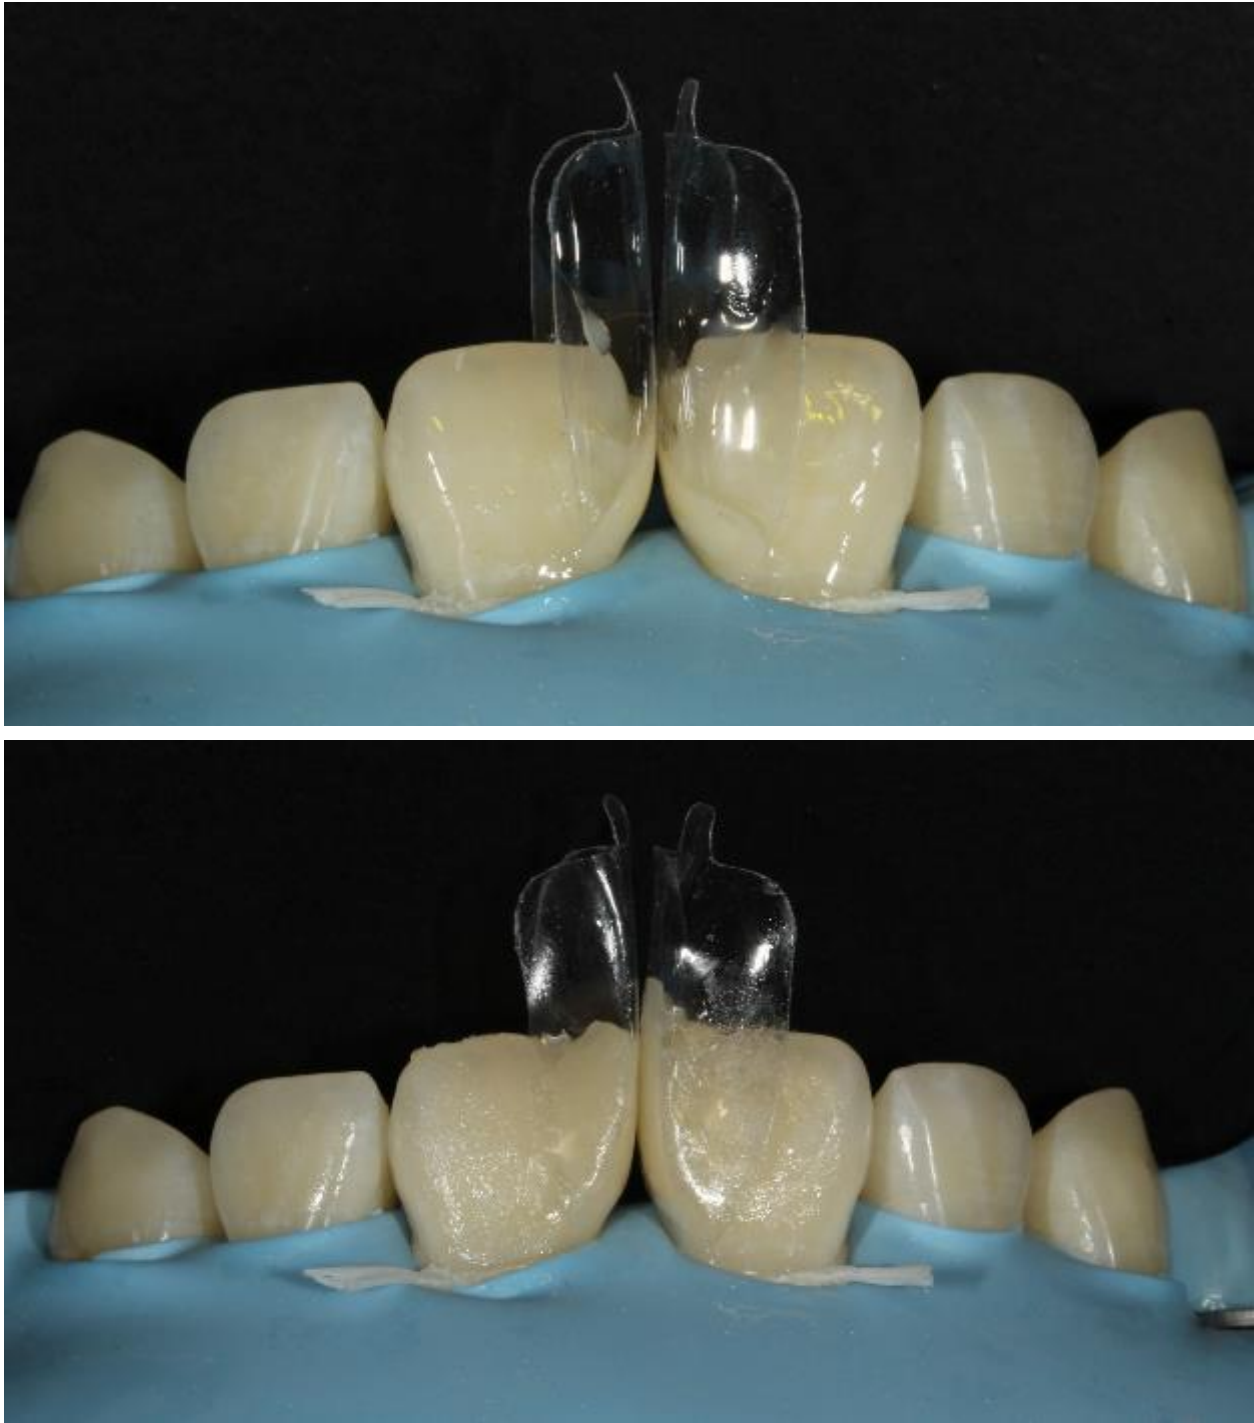
**Figure 4.** Flowable composite filling in the cervical area after placement of the bioclear matrices.

A small increment of flowable composite (Ivoclar Tetric N-flow) was injected into both teeth to fill the critical cervical area (Figure 4). The ideal material for this initial increment is a flowable composite rather than a paste composite [6]. Placing a paste composite in this space without creating cavities or disrupting the matrices would be practically impossible [7]. The uncured flowable composite was subsequently filled with paste composite. This procedure is known as the "Injection molding technique" and the "Snow plow technique." (Figure 5)

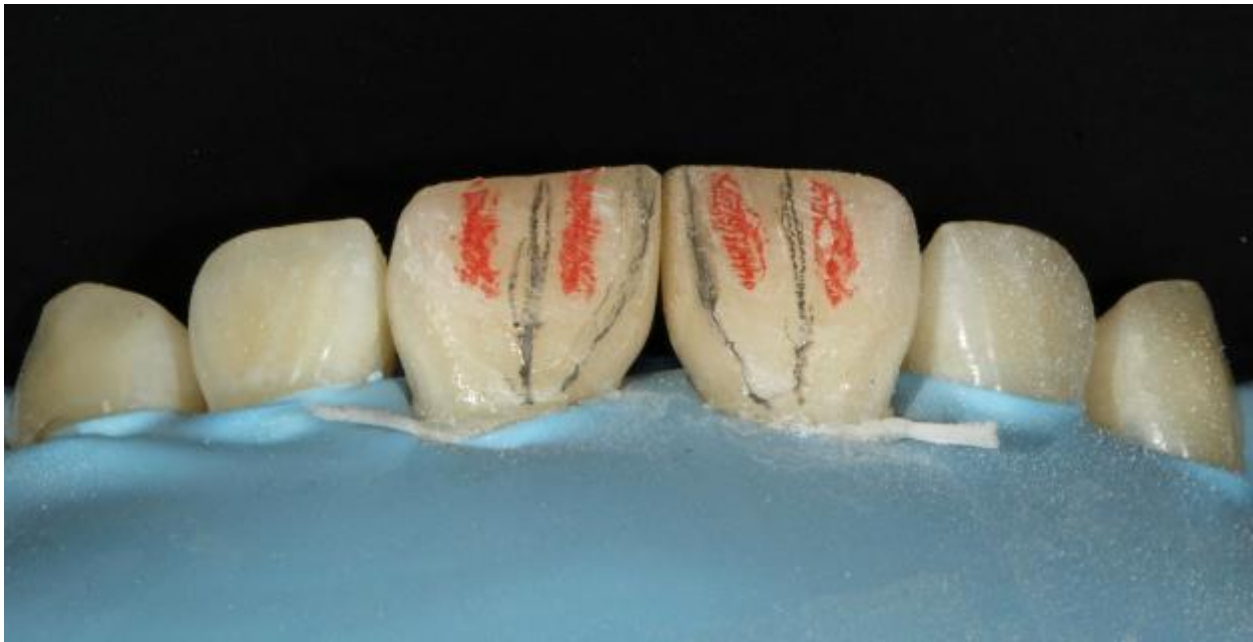
**Figure 5.** Uncured flowable composite subsequently filled with paste composite.

Once the restoration was complete, a polishing kit (Shofu Super Snap -X -Treme, 8 mm size, black (L507) was used to define the correct fundamental anatomy after the hypothetical transitional lines were drawn with a pencil (Figure 5). A red pencil was used for secondary characterization (Figure 6). These grooves are more open in the incisal region and narrower in the cervical region. We were able to achieve the best esthetics for the patient after the procedure (Figure 7a). On 2 years follow up, the restoration was intact with no failure.

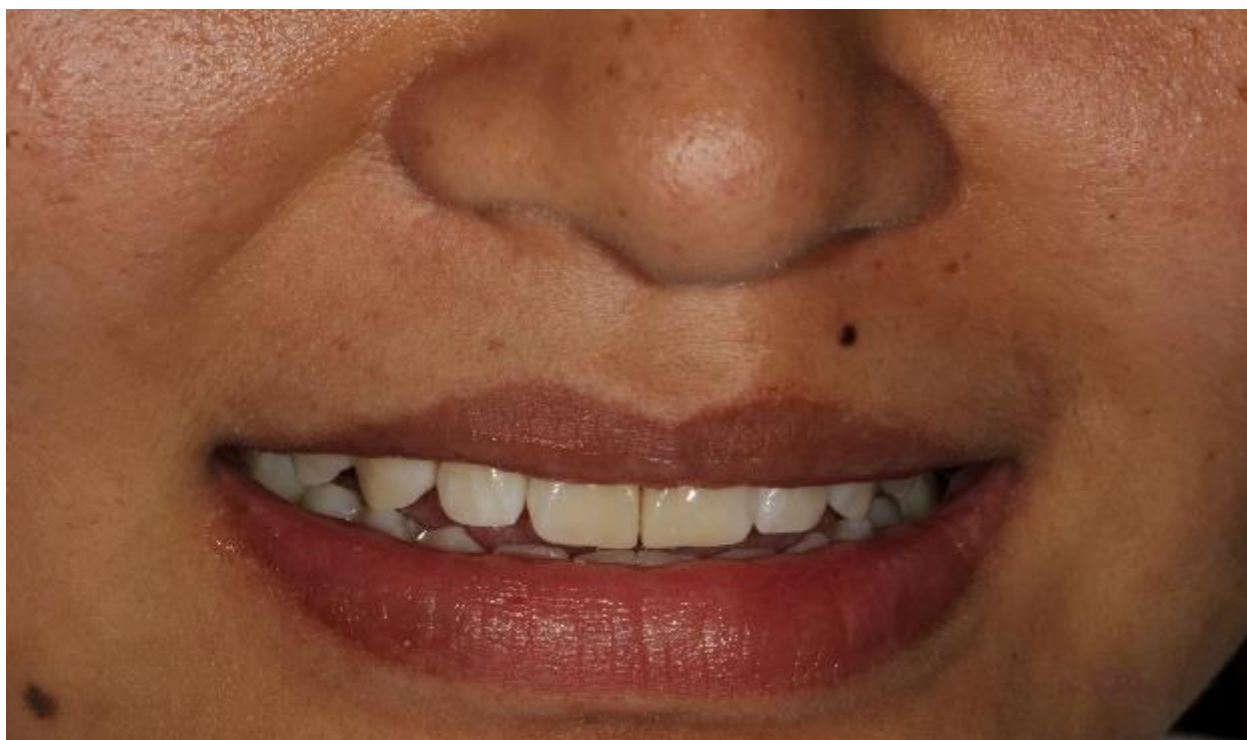
**Figure 7a.** Final outcome immediately after removal of the rubber dam.

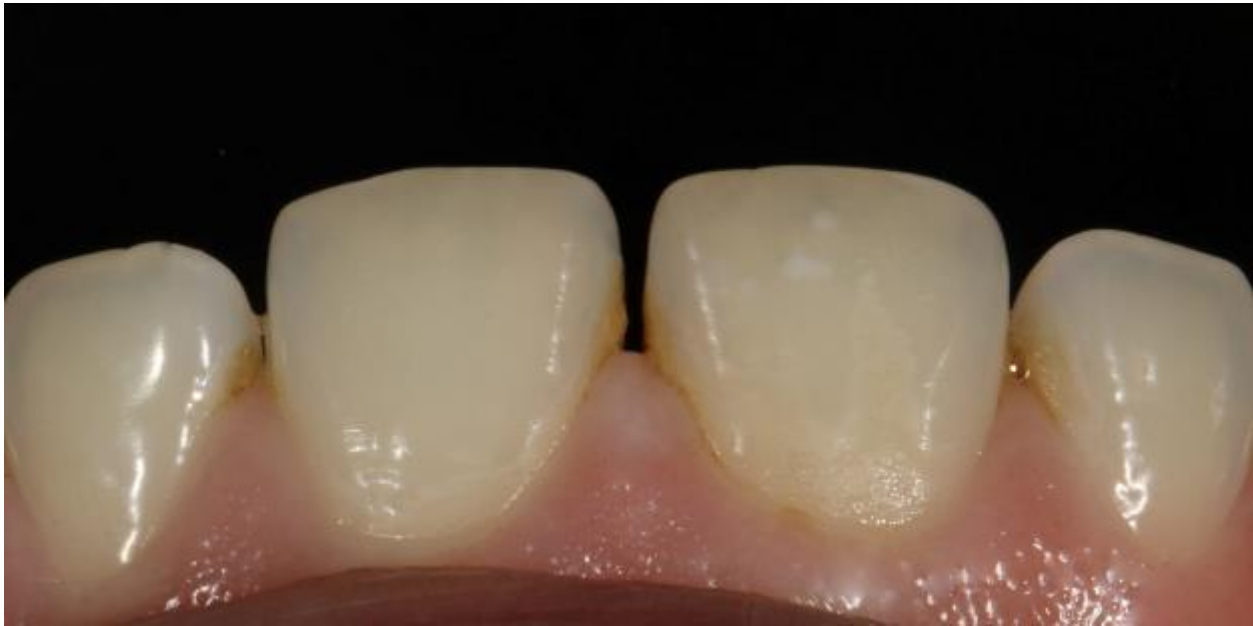
**Figure 8.** Clinical image showing midline diastema.

A 21 year-old female patient presented to our clinic with the primary complaint of psychological anguish caused by an unsightly appearance due to midline diastema (Figure 8).

The patient's medical history did not indicate any systemic disorders, and clinical examination revealed a significant gap between the maxillary central incisors. A periodontal examination revealed no pockets and confirmed the patient's dental hygiene. For both maxillary central incisors, direct aesthetic midline diastema closure via a composite layering approach was considered because it is a more expedient, conservative, inexpensive, and aesthetically pleasing option.

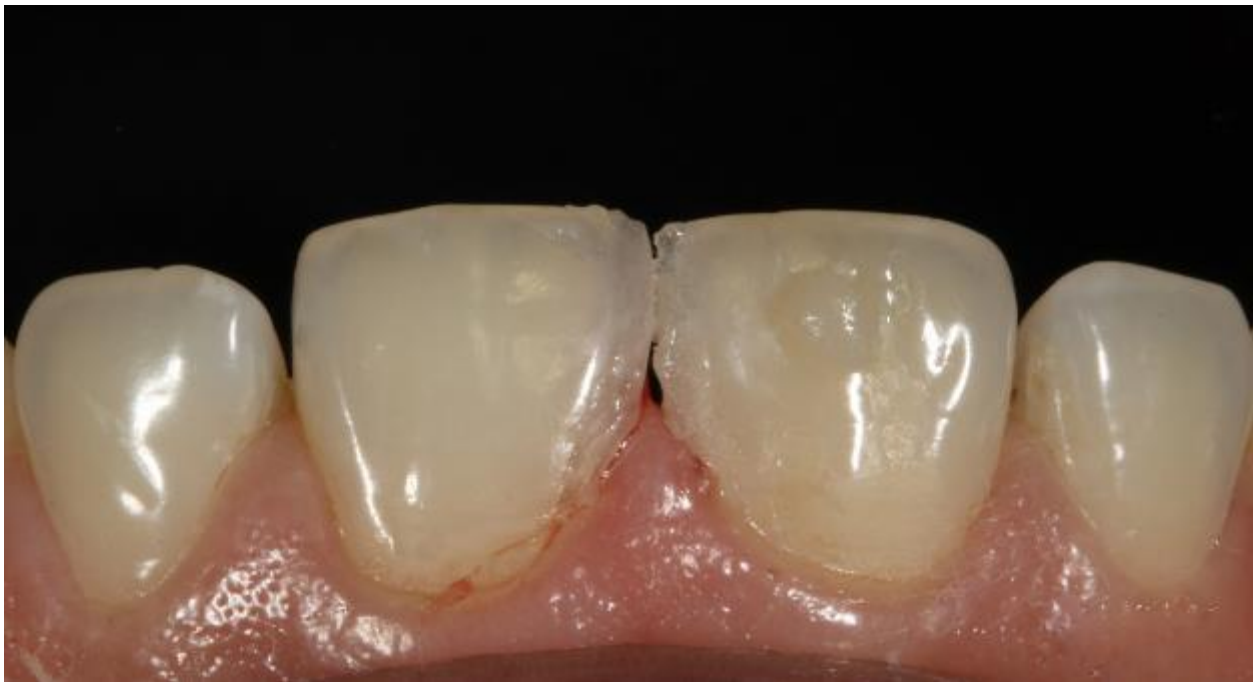
**Figure 9.** Shade selection.

Preoperative radiographs were taken first. The tooth to be repaired was then shaded, and composite shade A2 (VITA classical shade guide) was chosen for the composite restoration (Figure 9). Isolation was achieved by placing a rubber dam (Figure 10). Both central incisor mesial surfaces were treated with 37% phosphoric acid for 15 seconds, washed for 20 seconds, and then lightly dried with air (Figure 11). To ensure proper contact between the two maxillary central incisors, bioclear matrices were positioned (Figure 12). The etched surface was coated twice with Ivoclar's Single Bond universal adhesive, (Figure 13), which was then air blasted until it stopped moving and polymerized for 20 second under LED light.

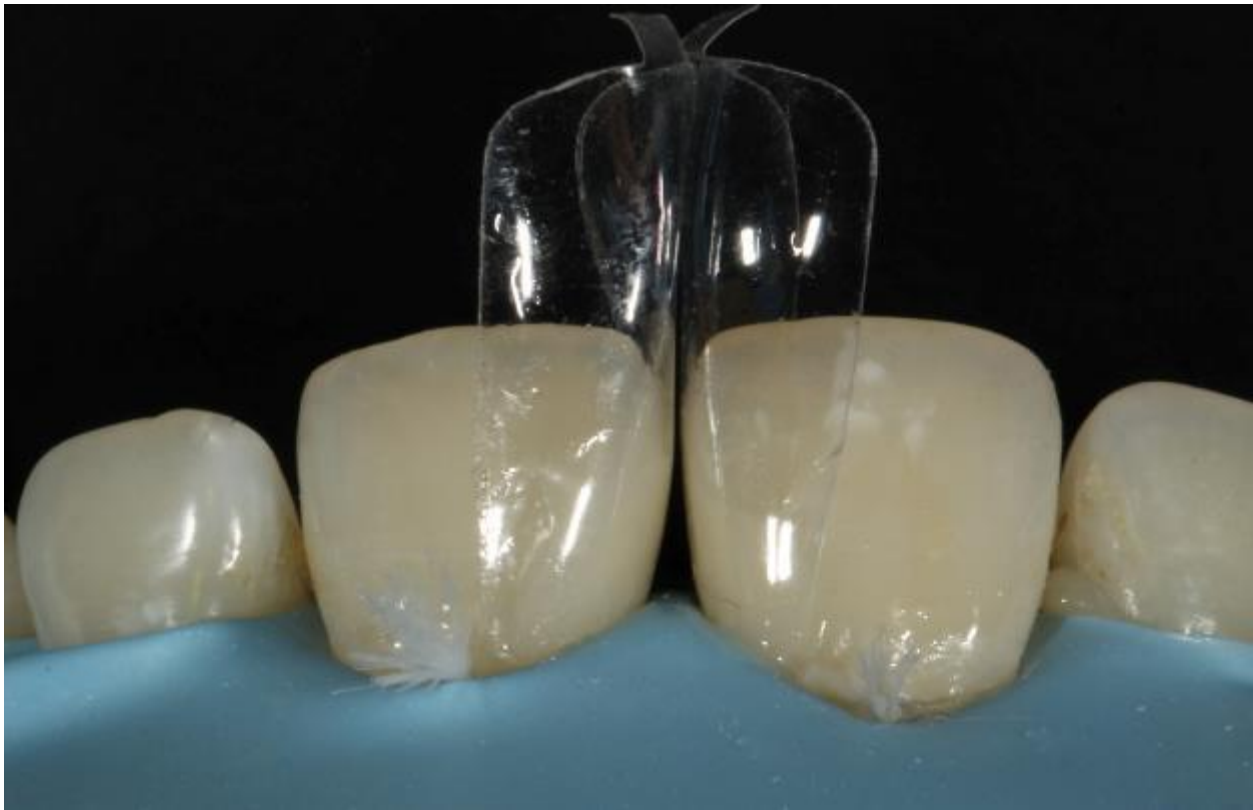
**Figure 14.** Placement of the flowable composite in the cervical region.

The cervical region was filled by gently inserting a small amount of flowable composite into both teeth (Figure 14). Paste composite was then used to fill the uncured flowable composite. After the line angles were marked (Figure 15), the restoration was finished and polished using a polishing kit (Shofu Super Snap Rainbow kit) and a smooth tapered diamond bur (Shofu preparation set). Detailed polishing from coarse to fine grains was accomplished with polishing discs and a low speed handpiece. The patient was happy with the outcome (Figure 16). At the 2-year follow up, the restoration was intact with no failure (Figure 17).

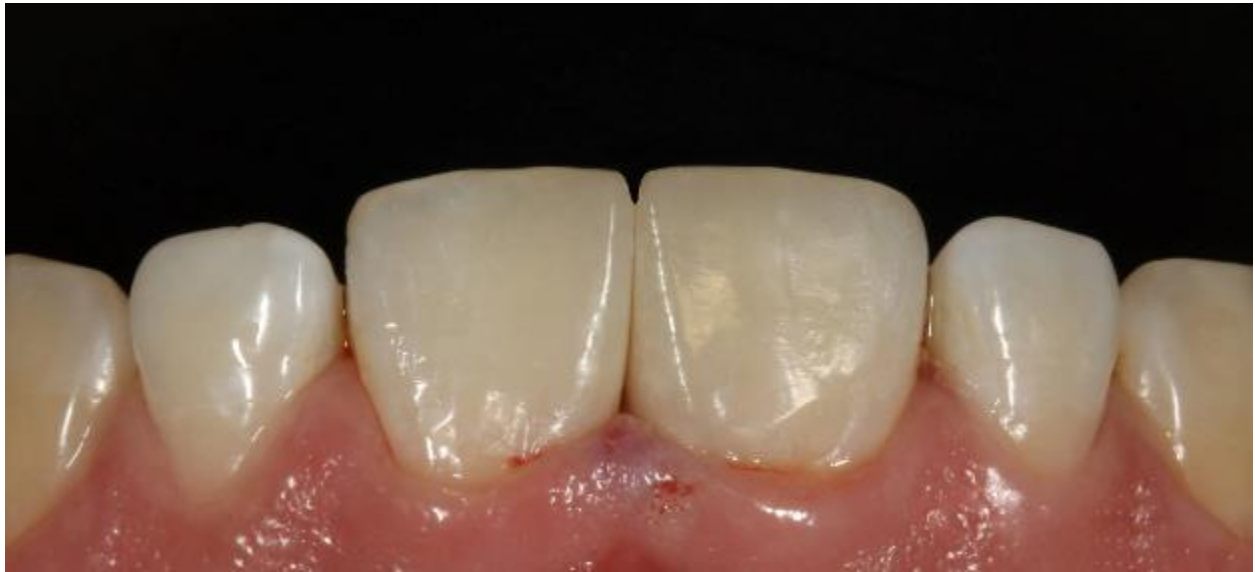
**Figure 16.** Final outcome after the removal of the rubber dam.

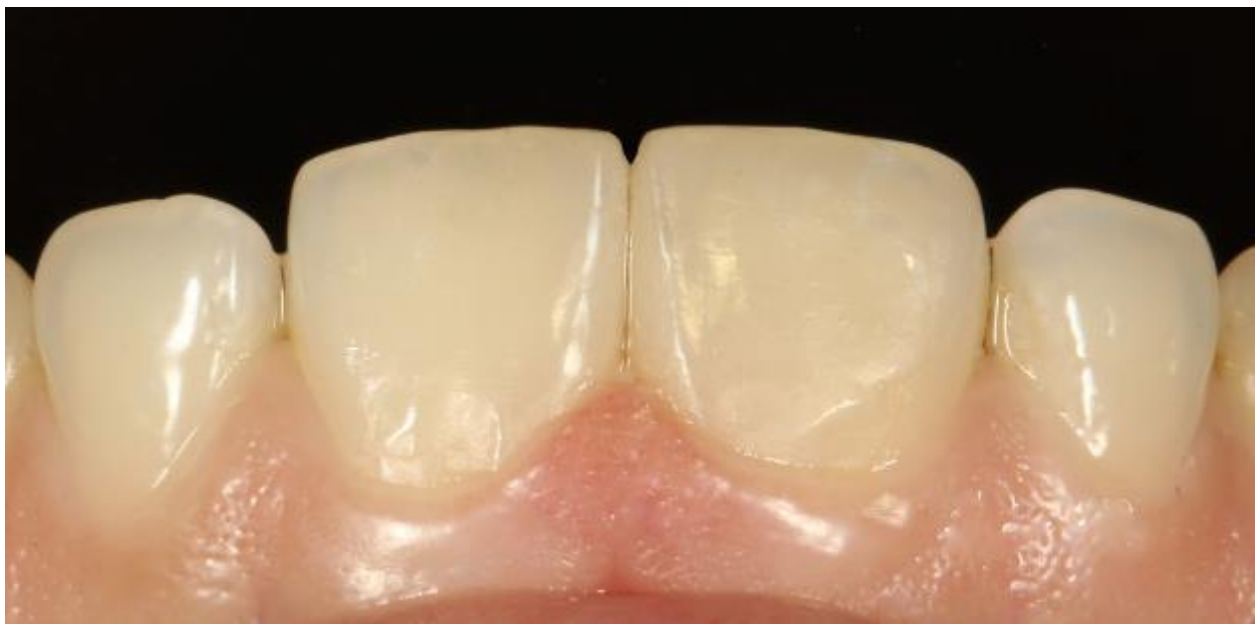
**Figure 17.** Follow-up image after 2 years.

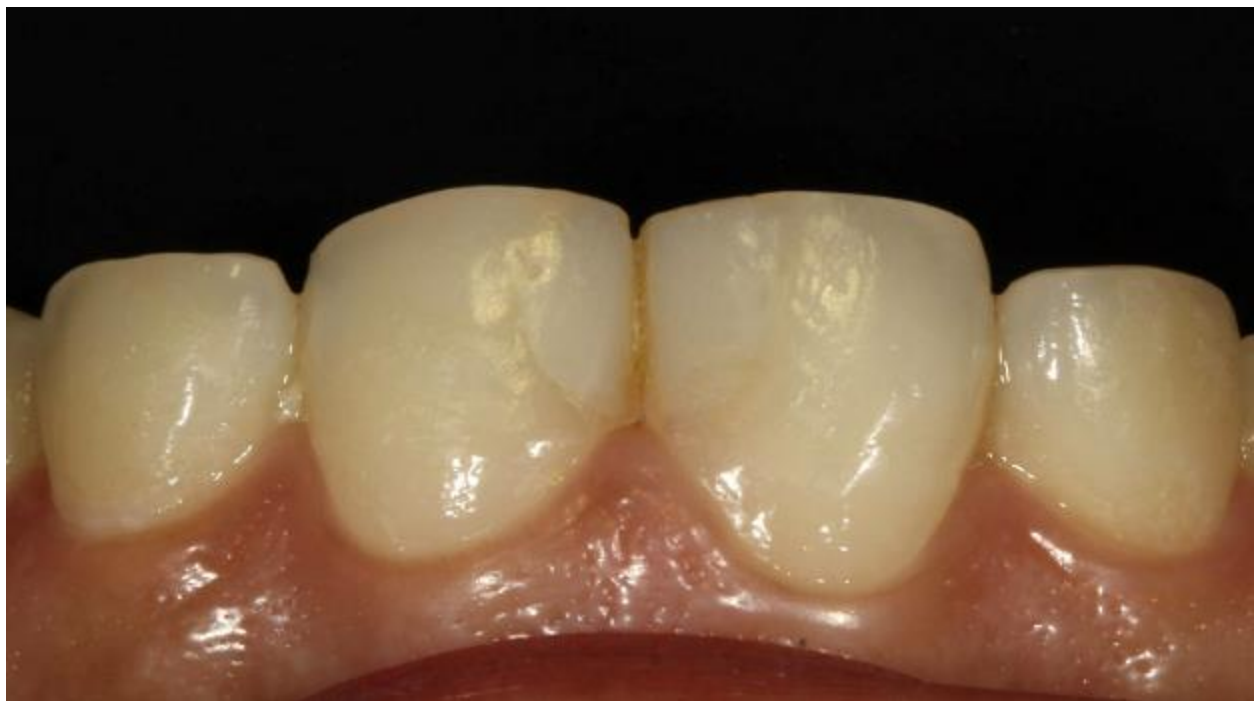
**Figure 18.** Previously restored teeth showing mismatched shade.

A 27 year old colleague came to our dental facility to have her maxillary central incisors repaired. She was grumbling about the odd form and mismatched shades of the restored teeth (Figure 18). First, the shade was chosen prior to the tooth dehydration process. Before the case was managed, we found that the two incisors were joined by a composite. A diamond bur was used to cut the composite placed in the diastema, followed by rubber dam isolation (Figure 19). To harmonize the color of the tooth with that of the composite, enamel beveling is required (Figure 20). Featheredge bevel to the enamel surface is the preferred technique; chamfers or butt joints are not ideal. After the mechanical preparation of the tooth, light-cured calcium hydroxide was added to protect the pulp. 37% phosphoric acid was used to etch the enamel border (Figure 21).

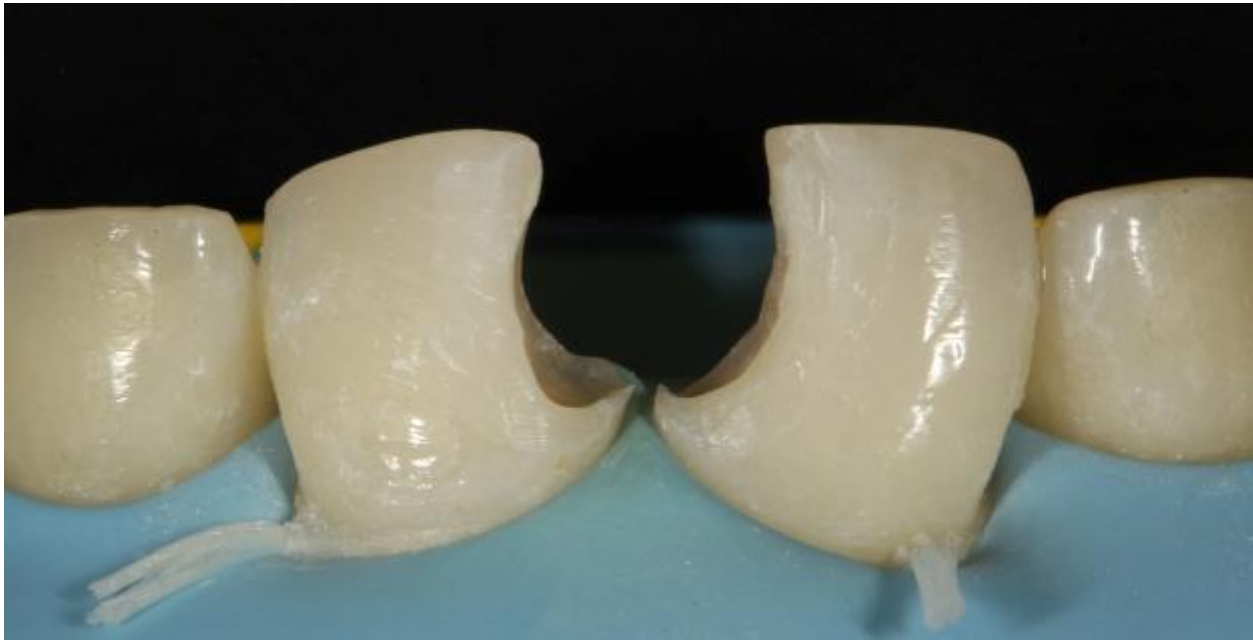
**Figure 20.** Removal of old restorative material with enamel beveling.

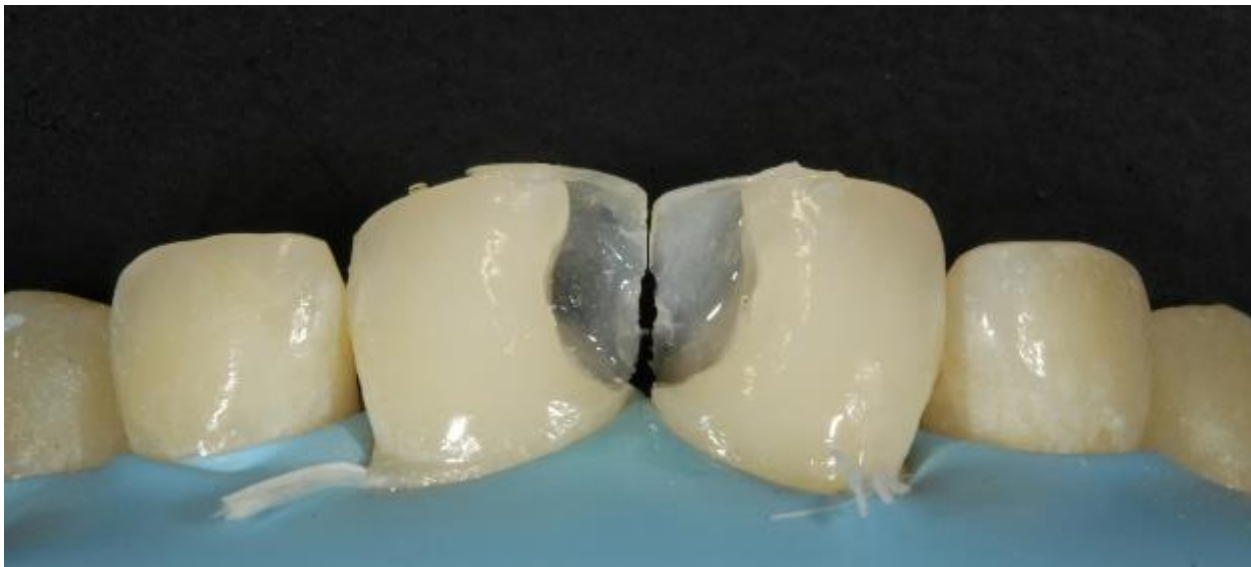
**Figure 22.** Creation of the palatal shell with the help of a mylar strip.

Mylar strips were used to provide high translucency enamel shade for the palatal shell after several layers of bonding agent were used to strengthen the bond (Figure 22). Sectional matrices

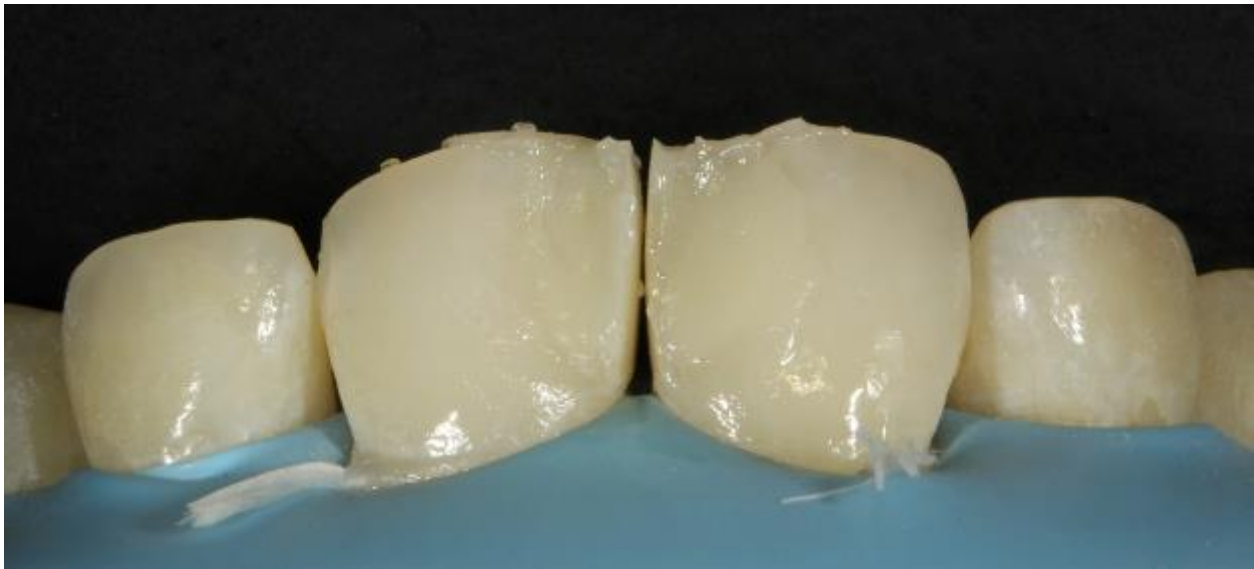
**Figure 24.** Tooth contour created with a sectional matrix showing gaps in between.

were applied to build proximal walls (Figure 23). The most crucial thing was to modify the composite on the band wall in an effort to prevent the emergence of gaps. (Figure 24). Once the tooth's contour was restored, we began applying the dentin composite portion from the bevel to the incisal area (Figure 25). To avoid compromising the final value and to provide the restorations with the necessary translucency and opalescence features, the final layer of enamel was made half as thick as the native tooth enamel. Red and led pencils were used to mark the primary and secondary characterizations (Figure 26).

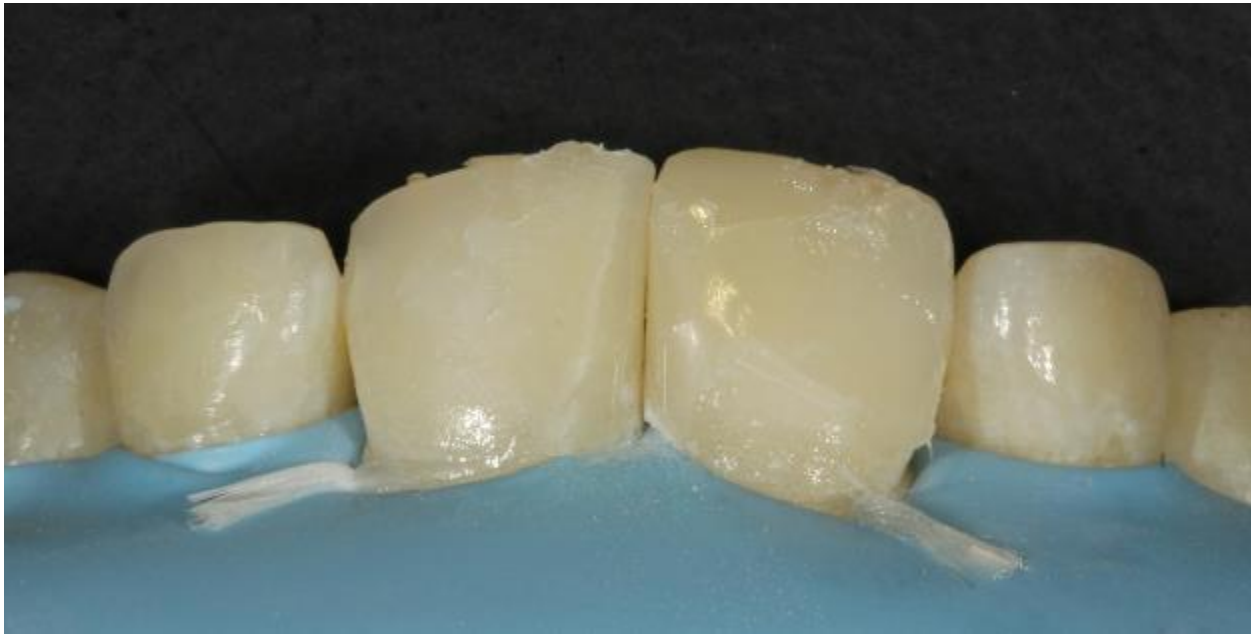
**Figure 25.** Application of a dentin composite followed by an enamel composite.

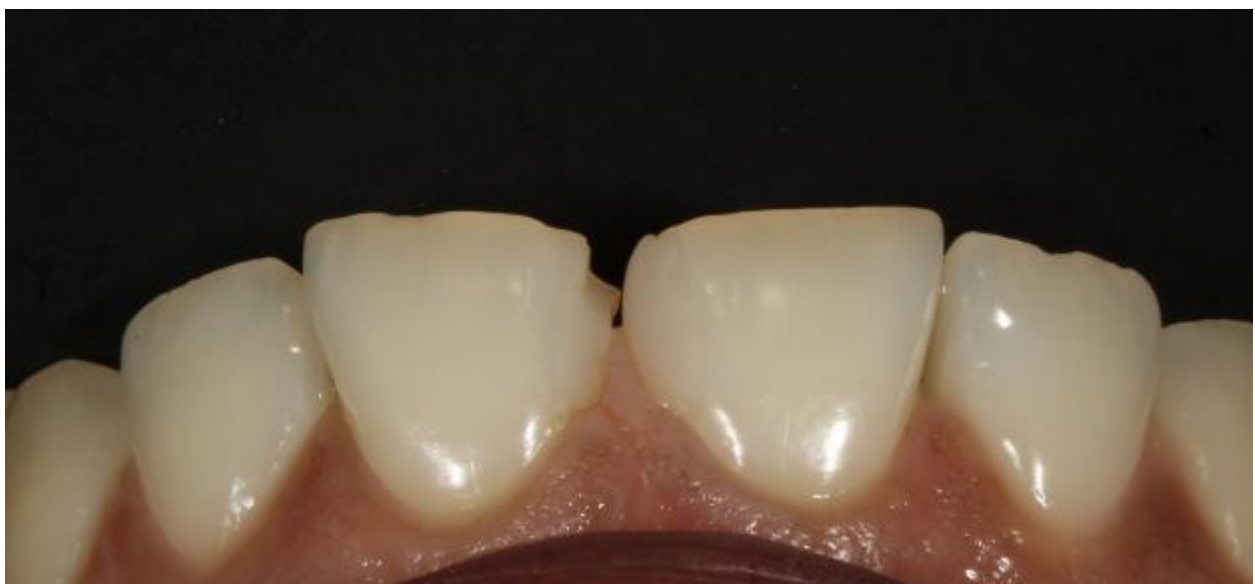
**Figure 28.** Preoperative image showing a fractured restoration with poor aesthetics.

The patient was dissatisfied with the filling of her maxillary central incisors due to poor aesthetics (Figure 28). We started the re-restoration process by selecting the appropriate shade. By placing a section of composite on the structure and choosing its color, the "button technique" was used to choose the shade (Figure 29). To isolate the site effectively, rubber dam isolation was carried out (Figure 30). A Shofu Snap Kit Black Disk was used to prepare the tooth and remove the old filling (Figure 31).

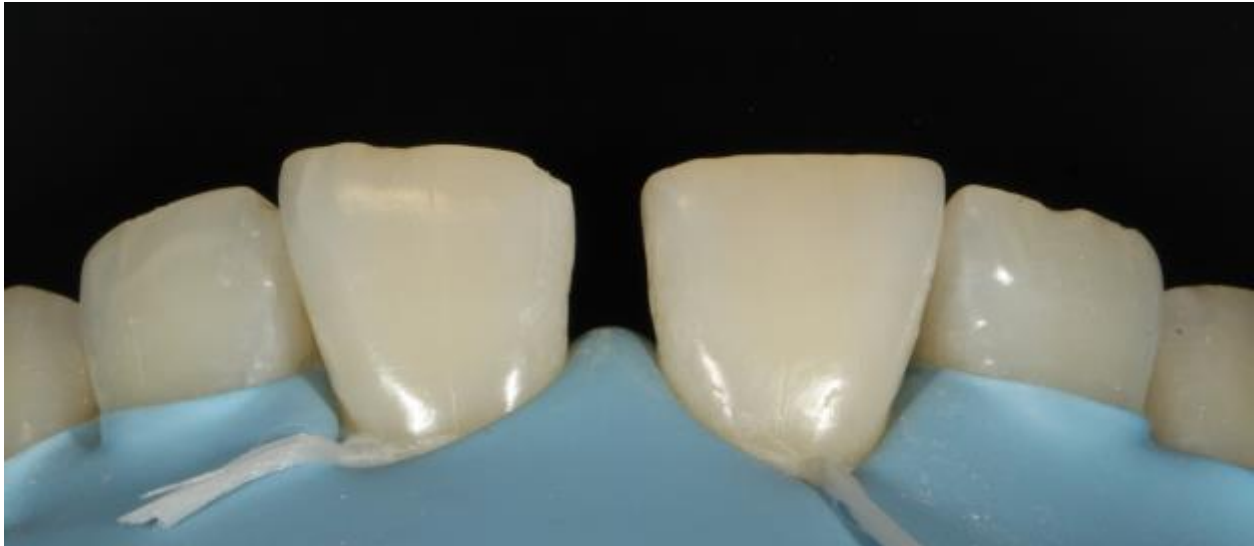
**Figure 31.** After removal of the old restoration.

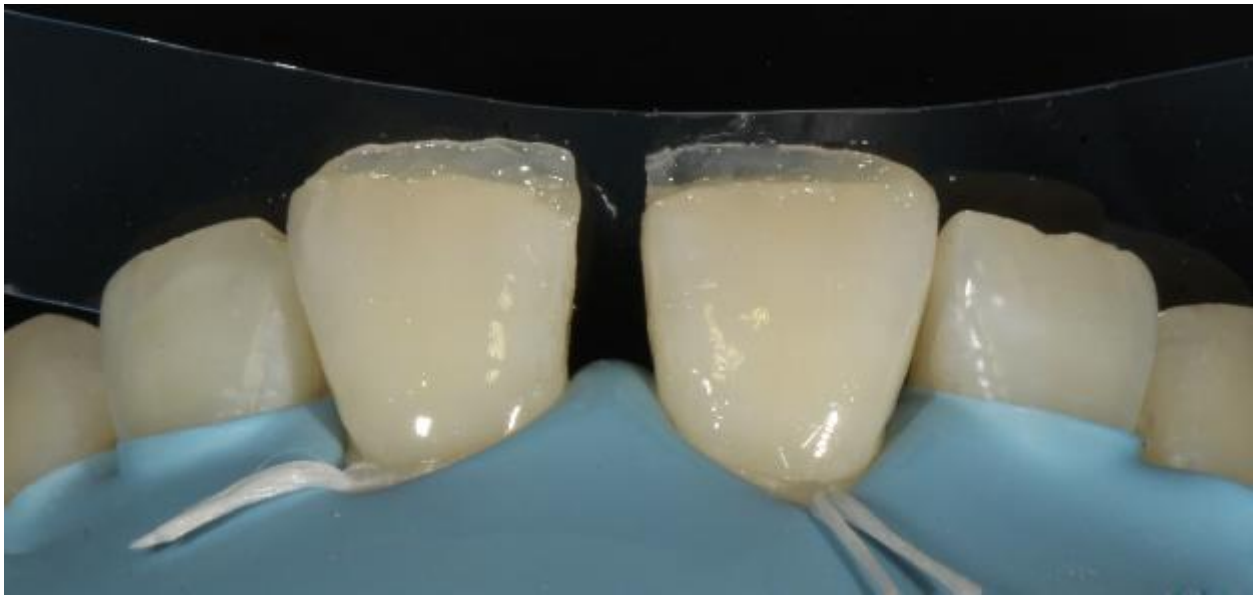
**Figure 33.** Incisal edge made with a Mylar strip.

37% phosphoric acid was used to etch the enamel surface for 20 seconds (Figure 32). The tooth was then thoroughly dried after 40 seconds of surface rinsing. A new incisal margin (Ivoclar A2E) was established using mylar strips (Figure 33). To verify the contact, two bioclear matrices were positioned (Figure 34). To fill this important cervical region, a tiny initial increment of flowable composite was carefully injected into both teeth (Figure 35). The uncured flowable composite was subsequently filled with paste composite. Following the completion of the restoration, the discs and burs were used to define the correct primary anatomy after the hypothetical primary lines were drawn (Figures 36, 37, 38). A photograph was taken after the rubber dam was removed. (Figure 39).

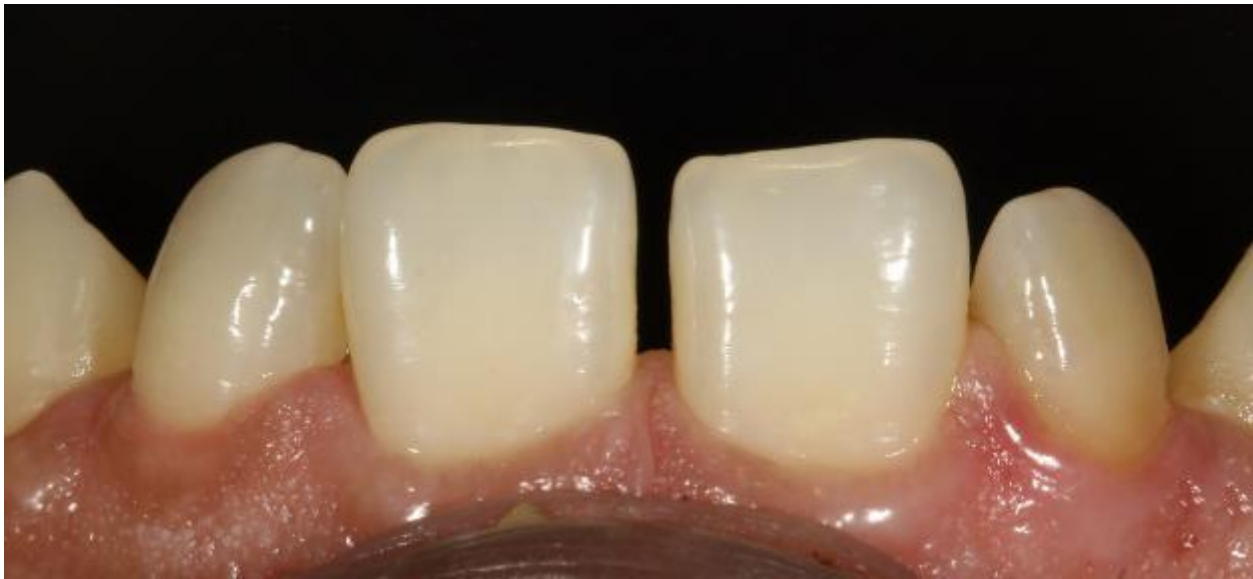
**Figure 40.** Clinical image showing midline diastema.

The patient, a 23-year-old man, was referred to our dental office by his orthodontist to schedule the closure of several diastemas (Figure 40). The patient was concerned about the ceramic veneers as a choice of treatment. Despite being the most effective tool available to restorative dentists for achieving the highest level of aesthetics, indirect ceramic partial restorations are costly and typically require some tooth preparation. Direct composite veneers should be the first choice, particularly for young patients.

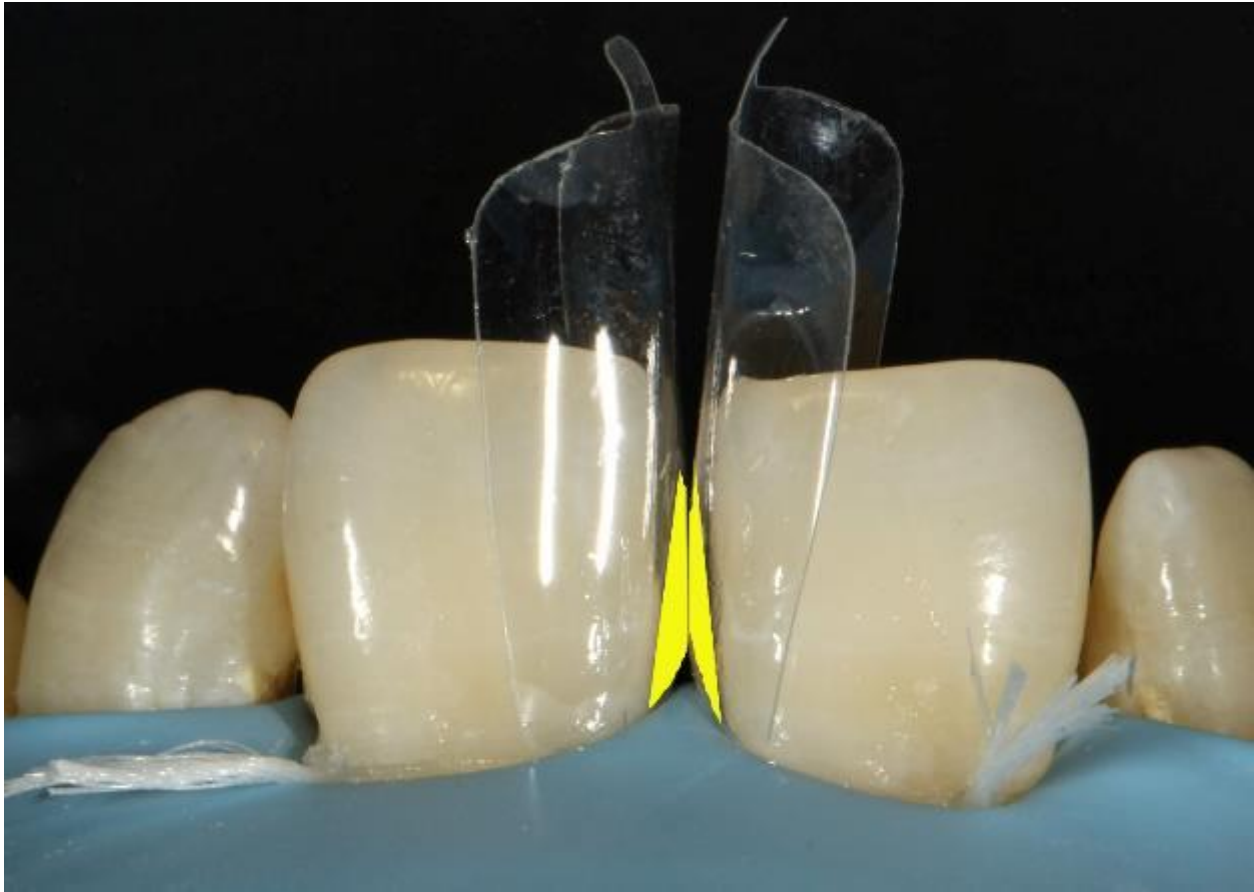
**Figure 42.** Improper contact even after placement of the Bioclear matrices.

The management process began with rubber dam isolation, followed by shade selection and enamel etching with 37% phosphoric acid (Figure 41). Bioclear matrices were positioned between the central incisors, but the gap was still present (Figure 42). Therefore, we decided to make a palatal shell (Figure 43). The palatal expansion was created freehand toward the midline. To ensure that the diastema space was spread evenly, the palatal shell was extended to the midline, supporting the bioclear matrices (Figure 44). This important cervical region was filled by carefully injecting a small initial increment of flowable composite into both teeth. (Figure 45). After that, the paste composite was injected into the flowable, uncured composite and light cured. The final removal of the bioclear resulted in the following outcome (Figure 46). The principal line angles were drawn once the repair was complete (Figure 47). Finishing and polishing were performed with burs and discs (Figure 48). We can appreciate the final outcome after rubber dam application, as shown below (Figure 49, 50).

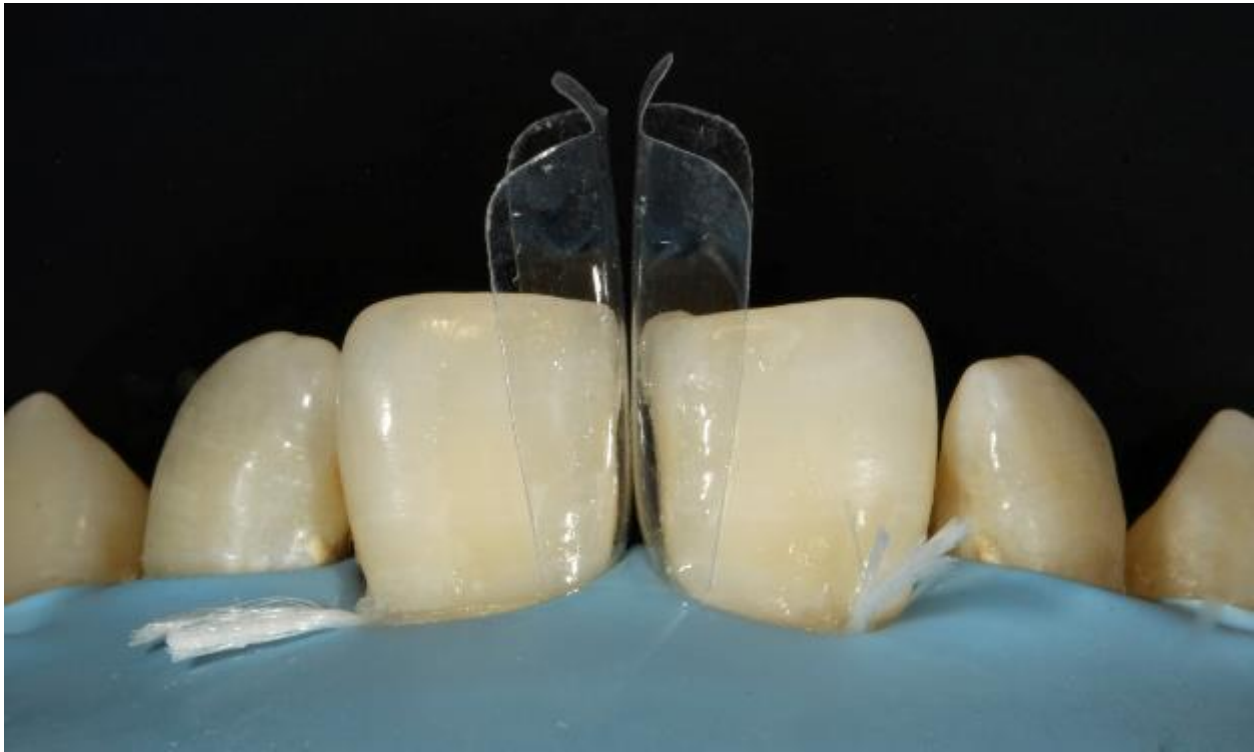
**Figure 44.** Palatal shell extending toward the midline, supporting a bioclear matrix.

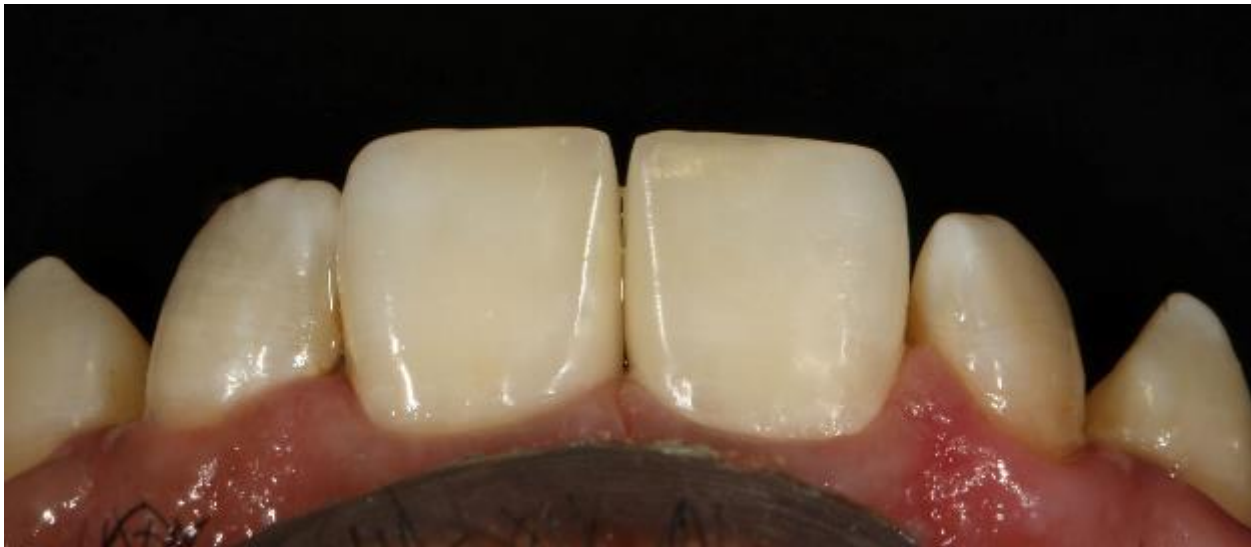
**Figure 49.** Final outcome showing aesthetic restoration.
