Review

Keywords: biofilm; colonization; degradation; microorganisms; subtidal, intertidal and splash zones; extracellular polymeric materials (EPS)

Biodeterioration and Chemical Corrosion of Concrete in the Marine Environment: Too Complex for Prediction

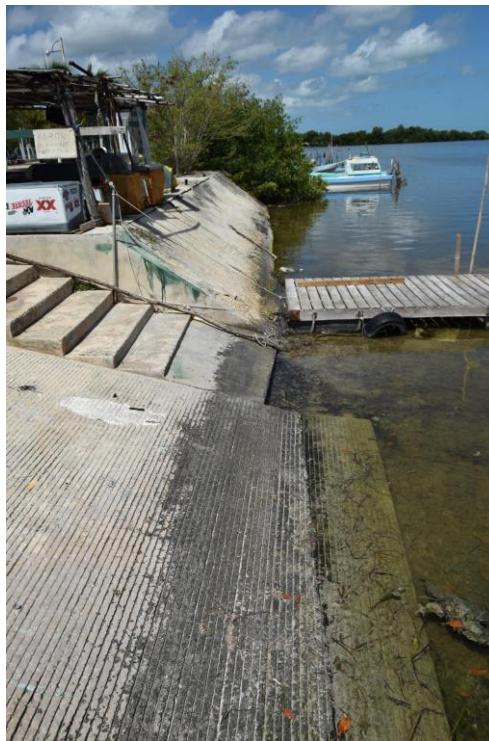
Figure 1. Concrete docks for artisanal fishing boats in Campeche, southern Mexico. Note that areas reached only by the marine spray appear devoid of (visible) microbial colonization, whereas intermittently submerged surfaces are covered by black biofilms. Permanently submerged areas are heavily covered by phototrophic communities. San Francisco de Campeche, Campeche, Mexico.

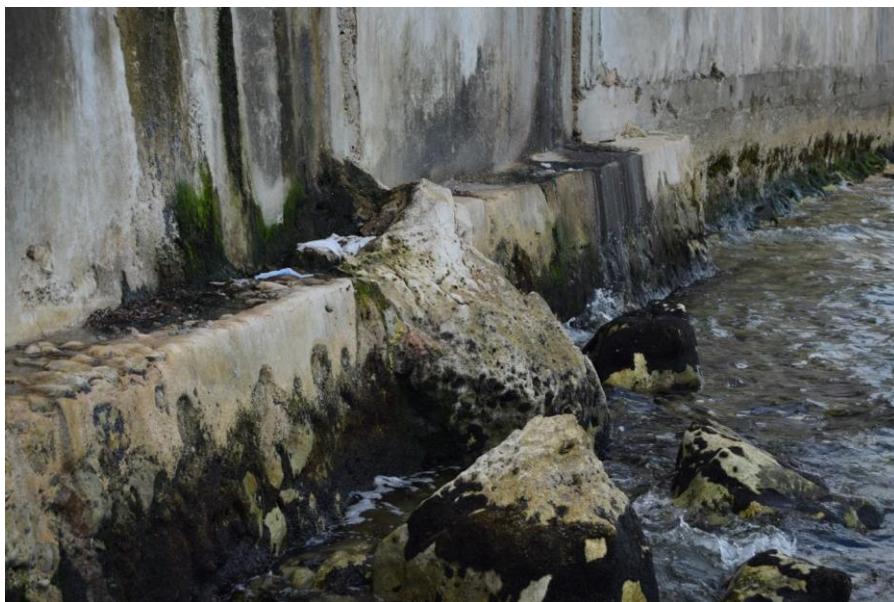
Figure 2. Intertidal concrete structures such as the base of this fisherman's house, built over a rocky shore, exhibit a heterogeneous coverage of microorganisms. Lerma village, Campeche, Mexico.

Figure 2 demonstrates intense corrosion and biofilm formation on a vertical concrete structure in Campeche, Mexico.

The intertidal zone shows deep pits and cracks in the concrete, associated with dark biofilms, while the splash zone above demonstrates black/green biofilms, but without the intense corrosion of the intertidal zone. It is possible that the microbiological colonization has protected this area from the normally more intense chemical corrosion that occurs in the splash zone. Alternatively, it may be the greater wave impact at the wall base that is at least partially responsible for greater physical degradation.

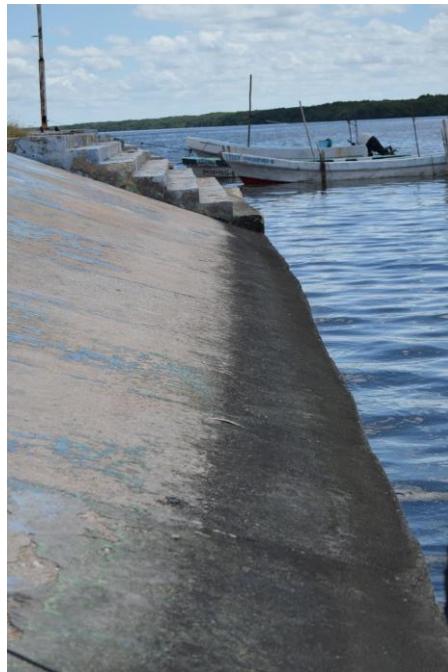
Figure 3. Biofilms covering concrete surfaces often exhibit a black phenotype indicating the likely presence of scytonemin-producing cyanobacteria as a functional adaptation for water stress and excessive insolation. San Francisco de Campeche city, Campeche, Mexico. .

A similar, but less intense, situation can be seen in Figure 3. Here, corrosion (surface spalling) of the concrete in the more inclined splash zone can be seen, but the intertidal zone is covered by a dark gray/black biofilm, with associated, relatively light, biodegradation.
